Tree Condition Assessment for 2 trees located at 70 Hanover Street, Fitzroy

Site address (Tree Location): 70 Hanover Street, Fitzroy
Tree assessment conducted: 3 October 2025
Assessed by: Mark Reynolds (Principal Consulting Arborist – Arbor Survey Pty Ltd)
Under instruction from: Jack De Lutiis (Focus Group Investments)

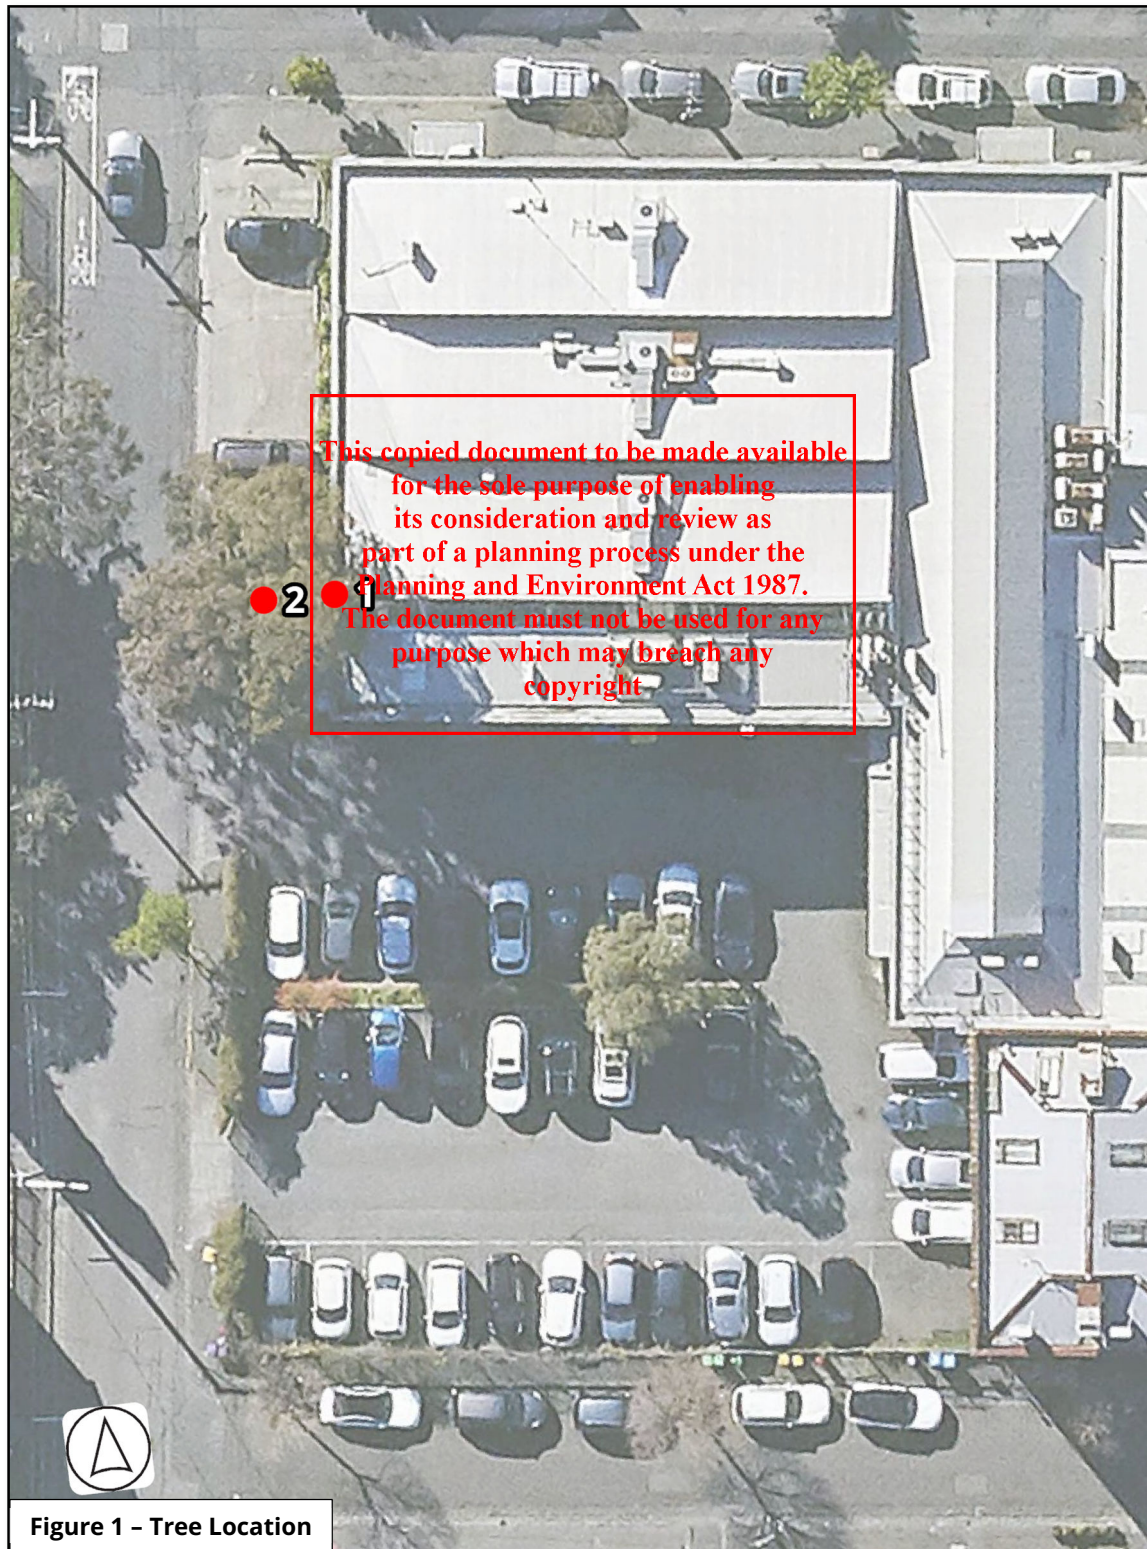
Figure 1 - Tree Location

The two trees are located close to the western boundary line at 70 Hanover Street, Fitzroy growing in a very small garden bed between the existing building to the east and footpath to the west. The trees are also constrained by concrete/ asphalt car parking spaces to the north and south of the trees. The tree location plan in Figure 1 below shows the location of the trees relative to the existing infrastructure.
