Greenwood Consulting P/L

William Ross Architects Pty Ltd

Sacred Heart Girls College Warrigal Road Hughesdale

Arboricultural Construction Impact Assessment

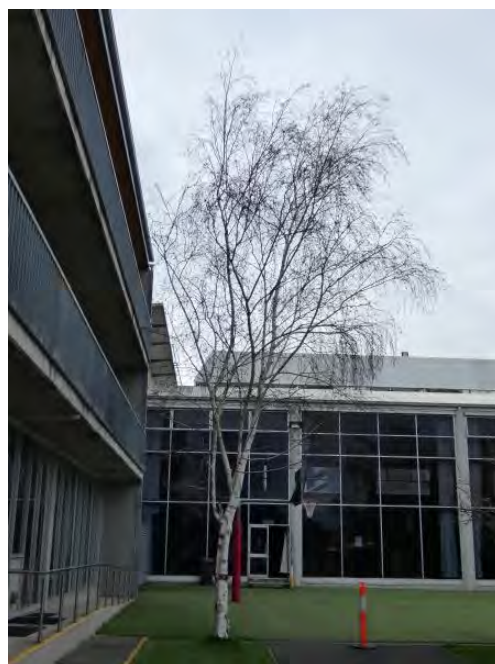
Height (m):	12	Structure	Good
Width (m):	7	Health:	Good
DBH (cm):	23 Measured	Maturity:	Mature
Origin:	Exotic	ULE (years)	15 - 30
Retained?:	Removed	Form:	Good
Retention Value:	Moderate		
Removal / retention reason:	N/A.		
Amenity value:	Moderate		
Works Required:	N/A.

SRZ (m):	1.7	Works priority:	N/A
TPZ (m):	2.8	Construction Proximity:	0.1
mTPZ (m) = TPZ

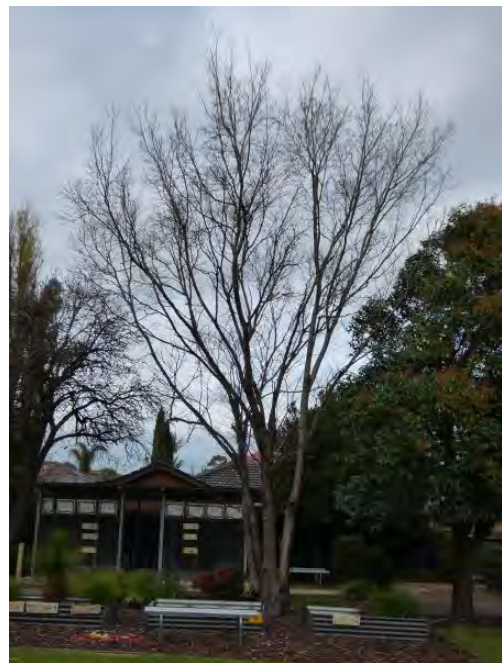
Tree ID: **10**

Height (m): 13 **Structure** Fair
Width (m): 10 **Health:** Good
DBH (cm): 43 Measured **Maturity:** Mature
Origin: Exotic **ULE (years)** 30 - 60
Retained?: Removed **Form:** Good
Retention Value: Moderate
Removal / retention reason: N/A.
Amenity value: Moderate
Works Required: N/A.

SRZ (m): 2.4 **Works priority:** N/A
TPZ (m): 5.2 **Construction Proximity:** 0.1
mTPZ (m) = TPZ

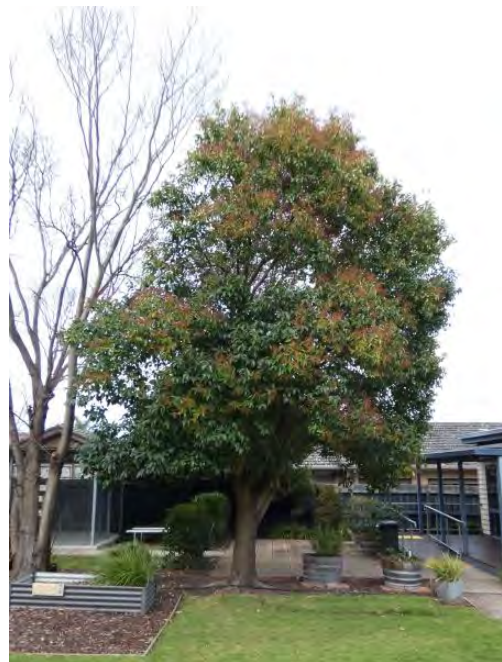
Tree ID: **11**

Height (m): 9 **Structure** Good
Width (m): 9 **Health:** Good
DBH (cm): 38 Measured **Maturity:** Mature
Origin: Exotic **ULE (years)** 15 - 30
Retained?: Removed **Form:** Good
Retention Value: Low
Removal / retention reason: N/A.
Amenity value: Low
Works Required: N/A.

SRZ (m): 2.3 **Works priority:** N/A
TPZ (m): 4.6 **Construction Proximity:** 0.1
mTPZ (m) = TPZ

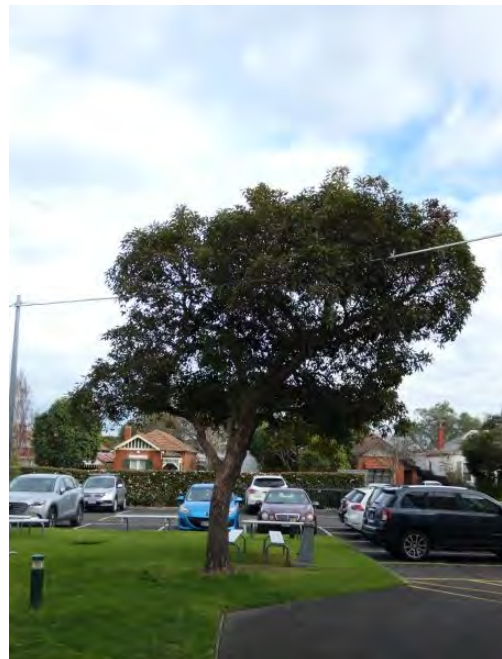
Tree ID: **12**

Height (m): 7 **Structure** Good
Width (m): 7 **Health:** Good
DBH (cm): 32 Measured **Maturity:** Mature
Origin: Australian **ULE (years)** 30 - 60
Retained?: Removed **Form:** Fair
Retention Value: Low
Removal / retention reason: N/A.
Amenity value: Low
Works Required: N/A.

SRZ (m): 2.1 **Works priority:** N/A
TPZ (m): 3.8 **Construction Proximity:** 0.1
mTPZ (m) = TPZ

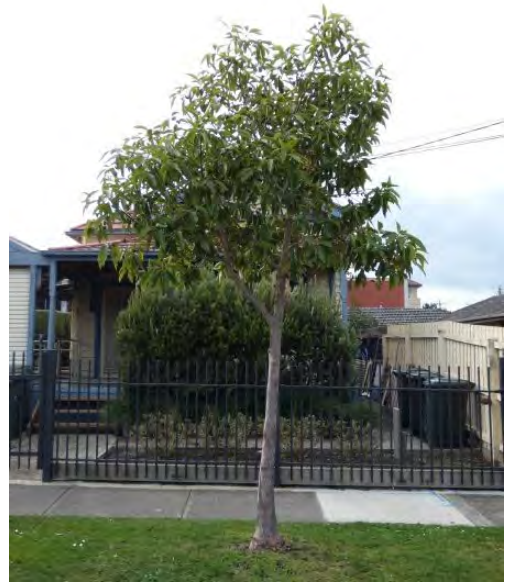
Tree ID: 13

Genus / species: *Lophostemon confertus*
 Evergreen Queensland Brush Box
Height (m): 4 **Structure:** Good
Width (m): 3 **Health:** Good
DBH (cm): 10 Measured **Maturity:** Immature
Origin: Australian **ULE (years)** 30 - 60
Retained?: Retained **Form:** Good
Retention Value: Low
Removal / retention reason: Road reserve.
Amenity value: Low
Works Required: N/A.

SRZ (m): 1.5 **Works priority:** N/A
TPZ (m): 2.0 **Construction Proximity:** 2.7
mTPZ (m) = TPZ

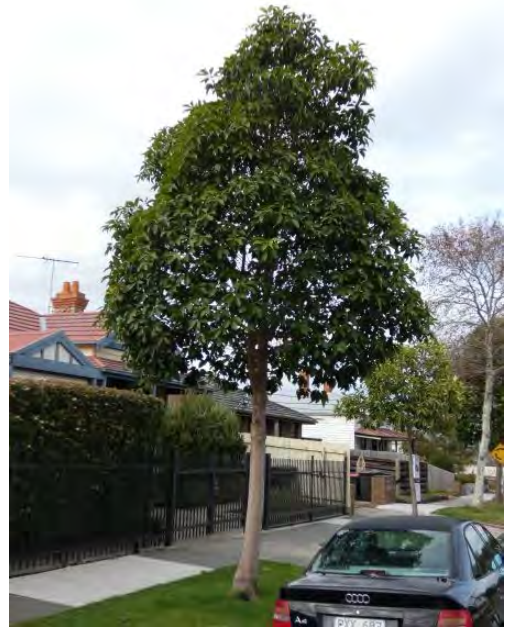
Tree ID: 14

Genus / species: *Lophostemon confertus*
 Evergreen Queensland Brush Box
Height (m): 7 **Structure:** Fair
Width (m): 4 **Health:** Good
DBH (cm): 18 Measured **Maturity:** Immature
Origin: Australian **ULE (years)** 30 - 60
Retained?: Retained **Form:** Good
Retention Value: Low
Removal / retention reason: Road reserve.
Amenity value: Low
Works Required: N/A.

SRZ (m): 1.5 **Works priority:** N/A
TPZ (m): 2.2 **Construction Proximity:** 3.9
mTPZ (m) = TPZ

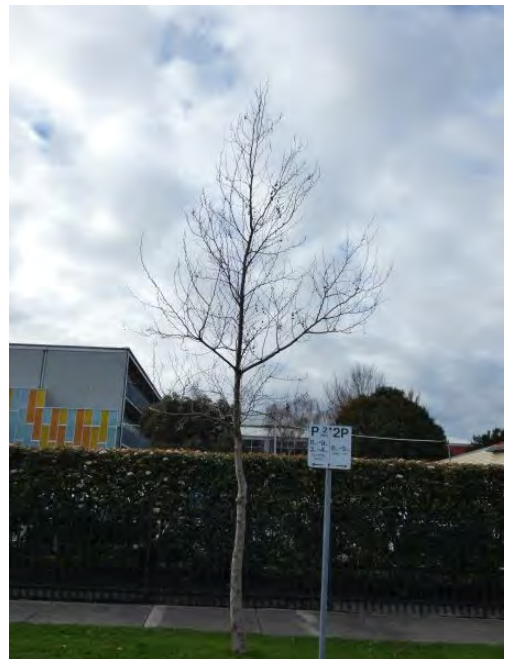
Tree ID: 15

Genus / species: *Platanus orientalis*
 Deciduous Plane
Height (m): 7 **Structure:** Good
Width (m): 3 **Health:** Good
DBH (cm): 10 Measured **Maturity:** Immature
Origin: Exotic **ULE (years)** > 60
Retained?: Retained **Form:** Good
Retention Value: Low
Removal / retention reason: Road reserve.
Amenity value: Very low
Works Required: N/A.

SRZ (m): 1.5 **Works priority:** N/A
TPZ (m): 2.0 **Construction Proximity:** 5.5
mTPZ (m) = TPZ

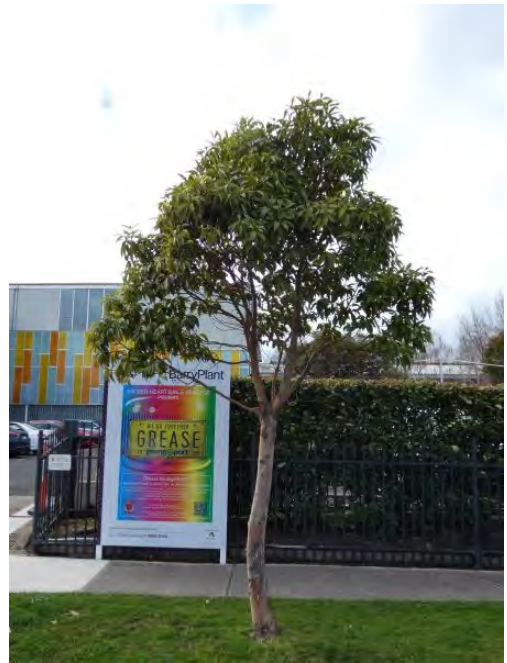
Tree ID: 16

Height (m): 5 **Structure:** Fair
Width (m): 3 **Health:** Good
DBH (cm): 12 Measured **Maturity:** Immature
Origin: Australian **ULE (years)** 30 - 60
Retained?: Retained **Form:** Good
Retention Value: Low
Removal / retention reason: Road reserve.
Amenity value: Low
Works Required: N/A.

SRZ (m): 1.5 **Works priority:** N/A
TPZ (m): 2.0 **Construction Proximity:** 5.7
mTPZ (m) = TPZ

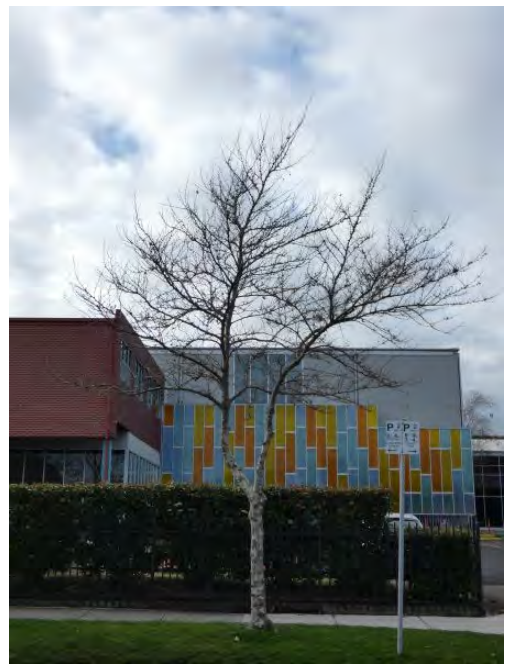
Tree ID: 17

Height (m): 8 **Structure:** Good
Width (m): 6 **Health:** Good
DBH (cm): 17 Measured **Maturity:** Immature
Origin: Exotic **ULE (years)** > 60
Retained?: Retained **Form:** Good
Retention Value: Moderate
Removal / retention reason: Road reserve.
Amenity value: Low
Works Required: N/A.

SRZ (m): 1.5 **Works priority:** N/A
TPZ (m): 2.0 **Construction Proximity:** 11.6
mTPZ (m) = TPZ
