# Feathertop Lodge, **Falls Creek**

Preliminary Geotechnica The Representation of the state o Assessment

13 July 2023

Project na	ame	Feathertop Lodge, Falls Creek - Preliminary Geotechnical Risk Assessment					
Documen	t title	Feathertop Lodge, Falls Creek   Preliminary Geotechnical Risk Assessment					
Project n	umber	12612126					
File name		12612126_Feather	topLodge_2023_	GRA.docx			
Status	Revision	Author	Reviewer		Approved for issue		
Code			Name	Signature	Name	Signature	Date
S4	0	A Quealy R Hayes	A Hunter	A.Hur	G Jones	But	14 June 2023
[Status code]							
[Status code]							
[Status code]							
[Status code]

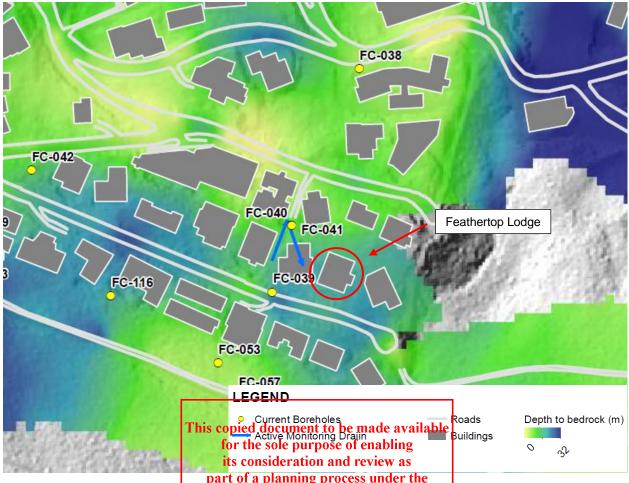
Figure 3 Extract from GHD (2012) showing borehole locations and depth to be drack model Figure 3 Extract from GHD (2012) showing borehole locations and depth to be drack model

Borehole FC-039 and drains FC-040 and FC-041 are located in the vicinity of Feathertop Lodge and undergo routine monitoring by Falls Creek Resort Management (refer to Figure 3). Figure 4 and Figure 5 below present groundwater levels and rainfall reported for FC-039 and drain flow rates and rainfall for FC-040 and FC-041, respectively.

The groundwater levels in FC-039, which is located in the Banool Lodge site to the south-west of the property, generally fluctuate between 1578 and 1572 m (AHD) (approximately 6 to 12 m below ground level) and are generally stable across the monitoring record and appear to reflect longer term rainfall trends. It is noted that the monitoring well is installed in the lower (rock) zone.

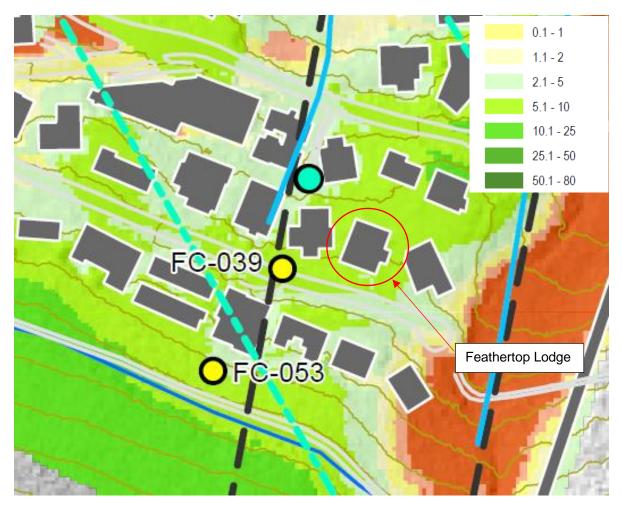
Figure 6 Extract from GHD (2022) showing lower aquifer groundwater level (m bgl) based on 2020-2021 spring average

Water table mapping which utilises groundwater monitoring data across Falls Creek Village undertaken as part of the GHD (2022) annual monitoring program is shown on Figure 6 and indicates a spring average groundwater level of 5.1 – 10.0 m below ground level on the slopes encompassing the site. During geotechnical investigation by GHD (2011) at Feathertop Lodge, soil was noted as moist, however groundwater was not encountered. It should be noted that intrusive works as part of this investigation consisted of two test pits to maximum depths of 1.8 m.

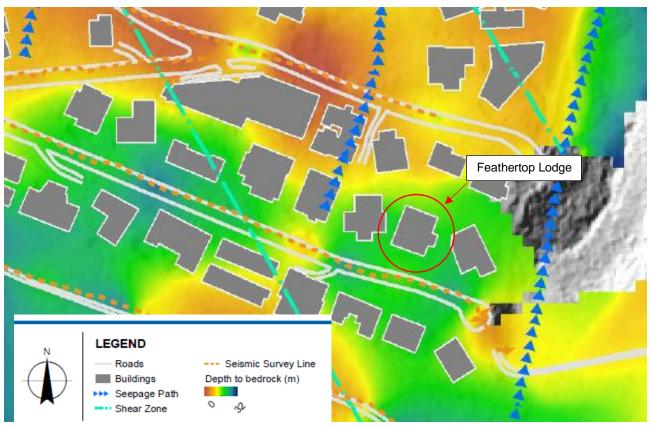
Extract of the interpreted depth to bedrock model from GHD (2012) Refinement of Geological and Hydrogeological Models – Falls Creek Geotechnical Risk Management Program

The anticipated subsurface conditions at Feathertop Lodge are based on a review of available desktop information including historical geotechnical investigations, geological mapping as well as observations made during the site assessment on 11 May 2023. The anticipated subsurface ground conditions are illustrated on the conceptual geological cross section Figure 14. Investigations by GHD (2011) and observations during the site assessment indicate subsurface conditions likely consist of up to 0.5 m of fill materials underlain by residual soil and extremely weathered rock of Migmatite and Granodiorite of silty to clayey sand whilst regional interpretations by GHD (2012) suggest these ground materials are underlain by granodiorite and migmatite rock at a depth of approximately 12 to 20 m below ground level (refer Figure 1).
