Appendix M

# Arborist Assessments

**RE: 013638 – Arboricultural Advice – Normanville Energy Park– Root sensitive electrical works**

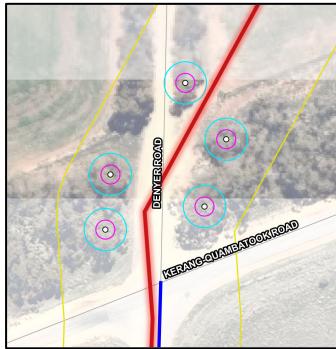
Figure 6. Section of external transmission line crossing Kerang-Quambatook Rd. The proposed route avoids TPZ incursion and is of low risk to existing trees.

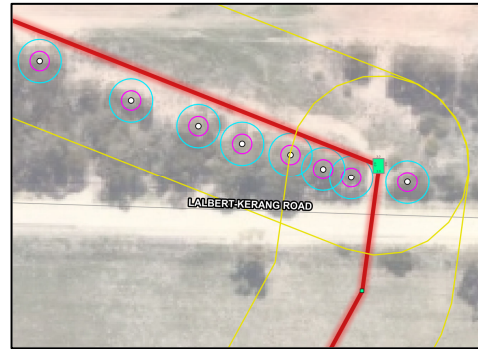
**Crossing Lalbert-Kerang Rd:** As seen in Figure 7, the route of the external transmission line is likely to avoid the TPZs of the surrounding trees, although the route could be moved slightly to the north to ensure this. Any form of excavation can be safely undertaken, assuming works can remain at least 6m from tree trunks and/or outside canopy driplines.

Figure 7. Section of external transmission line crossing Lalbert-Kerang Rd. The proposed route is of low risk to surrounding trees in terms of projected TPZs and likely boring pit locations.

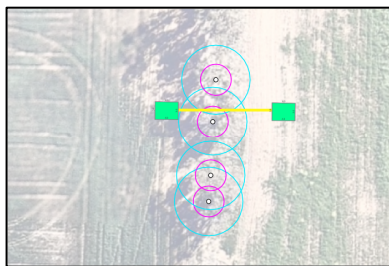
Seven (7) sections are proposed for HDD installation of the internal transmission line. As seen in Figures 8-14, the drilling will pass under the TPZs of trees in Sections 1, 2 & 7. It will pass relatively close to trees in Section 3, 4, 5 & 6. Boring pits can be safely excavated at either end of the HDD, although the pit may need to be moved slightly to ensure excavations are at least 6m back from tree trunks, and/or outside canopy driplines. Boring guidelines are provided on page 4.

Figure 8. Section 1. Passes under trees.

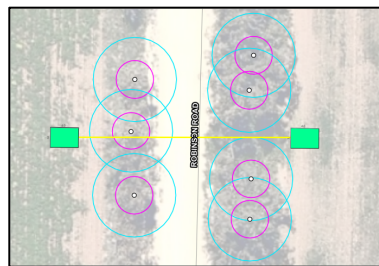
Figure 9. Section 2. Passes under trees.

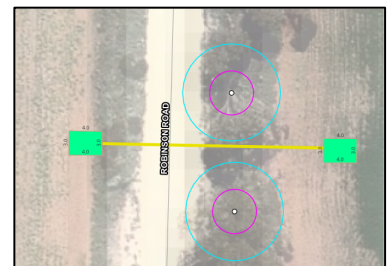
Figure 10. Section 3. Passes between trees.

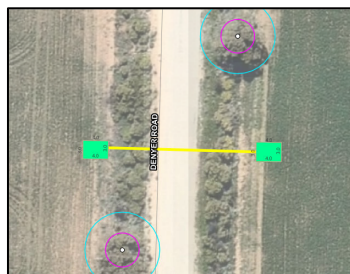
Figure 11. Section 4. Passes between existing trees.

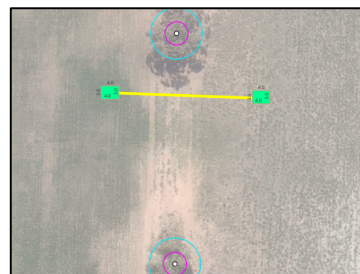
Figure 12. Section 5. Passes between trees.

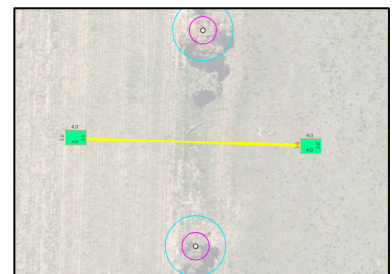
Figure 13. Section 6. Passes between trees.

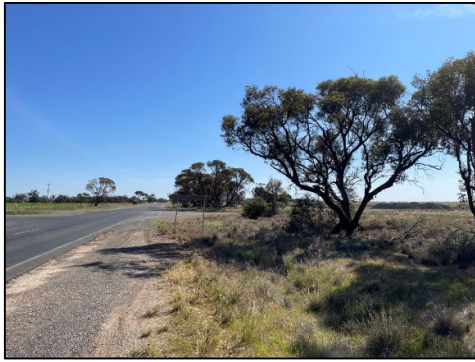
*Image 9. Tree 6 at Site 20 is within the swept path and would be lost.*

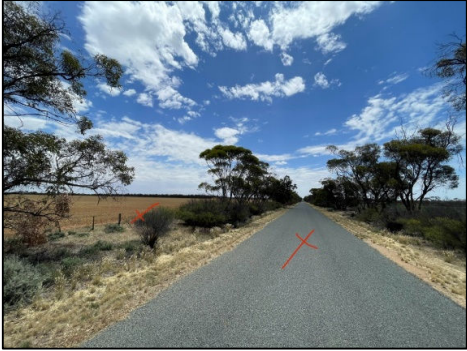
<p data-bbox="480 1518 902 1577">Image 1. Southern end of transmission line, approximate locations of 2x boring pits marked.</p> </div> <div data-bbox="977 1167 1442 1514">

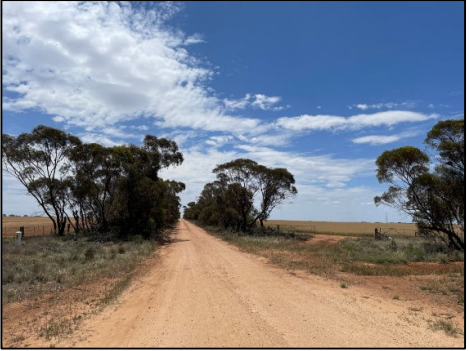
<p data-bbox="977 1528 1442 1619">Image 1. Location of Pit 21, approx. 50m north of the intersection of Kerang-Quambatook Rd and Denyer Road.</p> </div> </div>

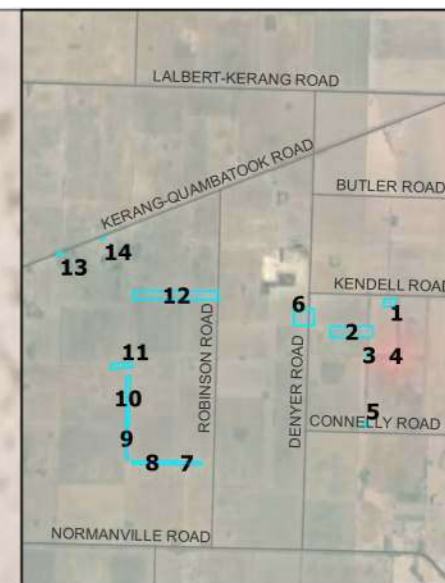
treeid	species	age_class	dbh_cm	hxw	arb_rating	TPZ	comments	habitat
22	Eucalyptus dumosa	Maturing	55	7x6	Low	6.6	Lost main leader.	Hollows - Main trunk
23	Eucalyptus oleosa	Maturing	35,20,14	9x12	Moderate	5.1	Fenced area. canopy over by <1m	Hollows - Primary limbs

**Canopy impact Major**  
**TPZ impact Major**  
**Mitigation:** Consider moving road between Trees 22 & 23. (23m gap between two trees).

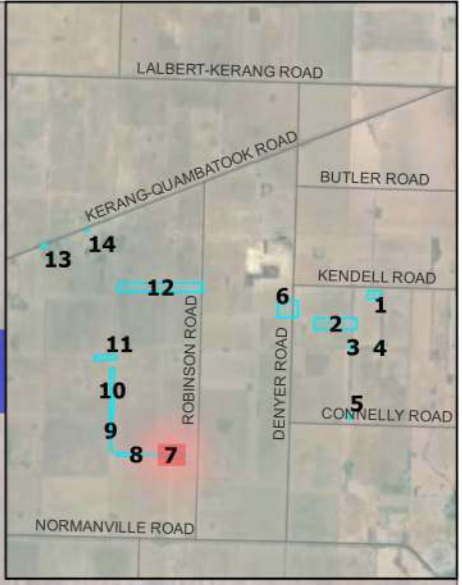
17

treeid	species	age_class	dbh_cm	hwx	arb_rating	TPZ	comments	habitat
1	Eucalyptus dumosa	Maturing	30,25,25,20,18	6x10	Moderate	6.4	Preserve dripline (5m).	Hollows - Primary limbs
G1	Eucalyptus dumosa	Maturing	40	6x10	Mod.C	4.8	dam wall sloping down to trees	Habitat hollows

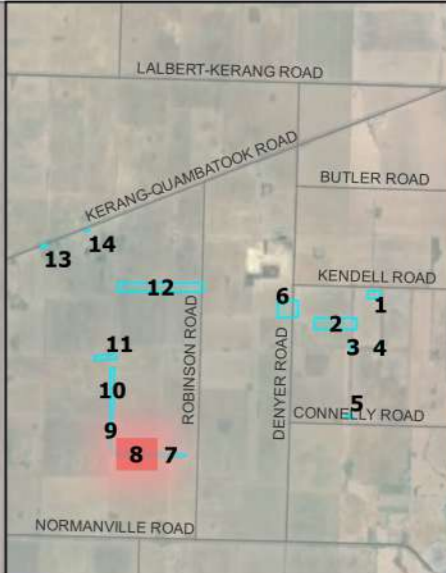
treeid	species	age_class	dbh_cm	hwx	arb_rating	TPZ	comments	habitat
2	Eucalyptus dumosa	Maturing	30,30,30,25,25	10x16	Moderate	7.5	Edge of cropping 7.5m from centre of trunk. preserve area in between	
G2	Eucalyptus dumosa	Maturing	50	10x15	Mod.B	6	deadwood. ground logs. Some branches overhang cropping area by up to 4m. lower canopies 3-7m.	Habitat hollows

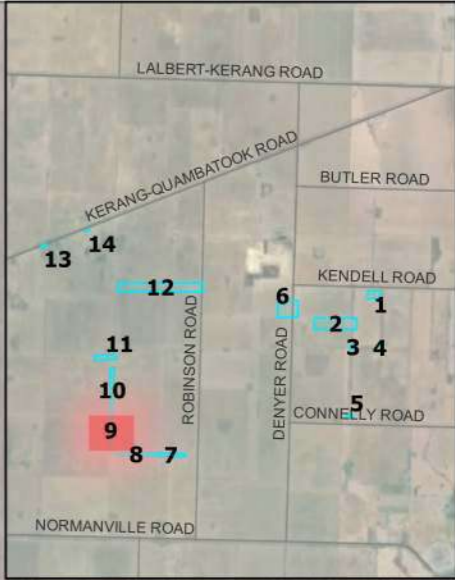
treeid	species	age_class	dbh_cm	hwx	arb_rating	TPZ	comments	habitat
3	Eucalyptus dumosa	Maturing	35,35,35,30,30	15x13	Moderate	8.9	5m from centre trunk to edge of cropping.	
G3	Eucalyptus dumosa;Eucalyptus oleosa	Maturing	40	9x9	Mod.C	4.8	oleosa dominant. coppicing. dead central leaders. some with hollows.

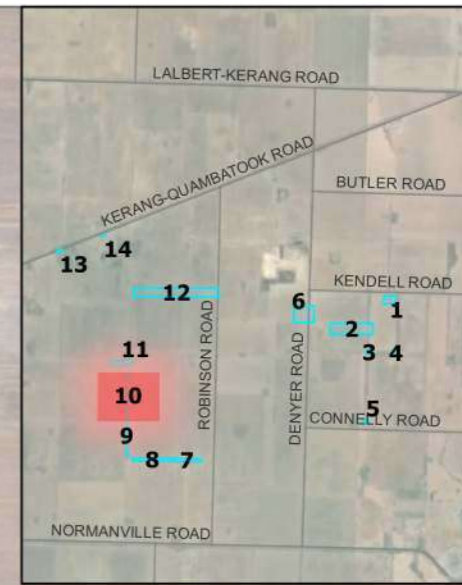
treeid	species	age_class	dbh_cm	hwx	arb_rating	TPZ	comments	habitat
4	Eucalyptus dumosa	Maturing	35,35	11x8	Moderate	5.9		
5	Eucalyptus leptophylla	Maturing	35,25,20	11x12	Moderate	5.7	Deadwood. 5m from centre of trunk to cropping	
G4	Eucalyptus dumosa;Eucalyptus leptophylla	Maturing	45	9x9	Mod.C	5.4		Habitat hollows

Canopy impact Minor  
 TPZ impact Minor to none  
 Mitigation: Clearance pruning may be required on 1-5 trees.

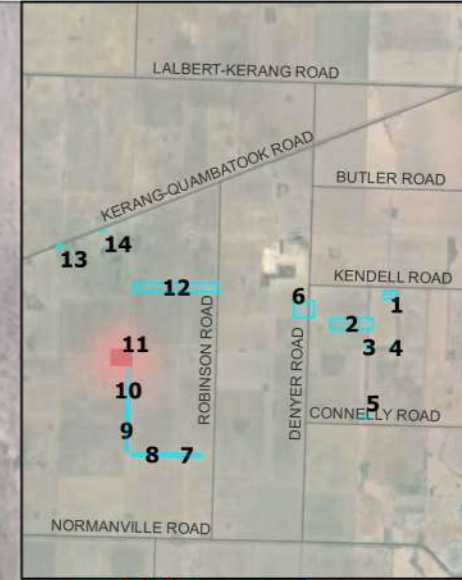
treeid	species	age_class	dbh_cm	hwx	arb_rating	TPZ	comments	habitat
6	Eucalyptus leptophylla	Over-mature	80	11x12	Low	9.6	Deadwood >50mm, habitat hollows, main leader dead.	Cracks/fissures
7	Eucalyptus leptophylla	Over-mature	55,35	15x16	Low	7.8	Basal wounds, habitat hollows.	Hollows - Primary limbs
8	Eucalyptus leptophylla	Early-mature	35,12,10,10,10	9x9	Moderate	4.9		No Hollows
9	Acacia salicina	Early-mature	50	9x10	Moderate	6	Only wattle in group.	
10	Eucalyptus leptophylla	Maturing	40,10,10,10	9x10	Low	5.2	Main leader dead. Basal shots.	Hollows - Main trunk

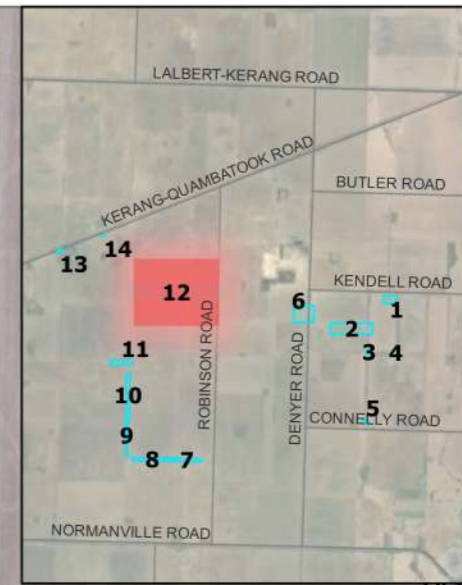
## Investigation Area 12

treeid	species	age_class	dbh_cm	hwx	arb_rating	TPZ	comments	habitat
13	Eucalyptus dumosa	Maturing	70,60	7x8	Low	11.1	3m centre of trunk to fence.	Hollows - Main trunk
14	Eucalyptus dumosa	Maturing	30,30,25,25	9x10	Moderate	6.6	Low canopy 3m over fence. typical size lf group.	Hollows - Main trunk
15	Eucalyptus dumosa	Maturing	35,35,30,30,25	9x15	Moderate	8.4	Canopy over fence 7m. low canopy height 4-5m.	Bird nest
16	Eucalyptus dumosa	Maturing	35,35	9x14	Moderate	5.9	Basal wounds.	Bird nest
G8	Eucalyptus dumosa	Maturing	35,35	8x12	Mod.C	5.9		Habitat hollows

Canopy impact Minor  
 TPZ impact Minor  
 Mitigation: Narrow road next to large trees (Trees 13 & 15)

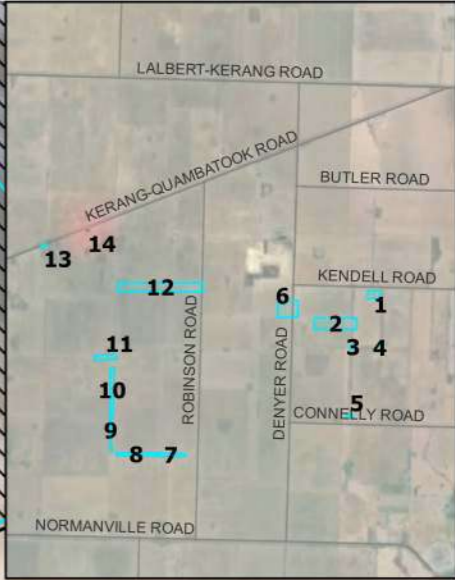
## Investigation Area 13

treeid	species	age_class	dbh_cm	hwx	arb_rating	TPZ	comments	habitat
G12	Eucalyptus dumosa	Early-mature	40	9x12	Mod.C	4.8

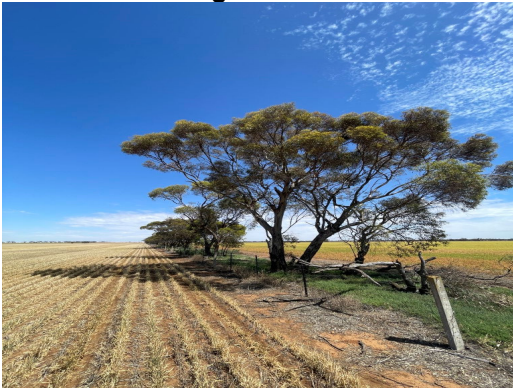
Investigation area 12

Tree ID: 16  
Species: *Eucalyptus dumosa*

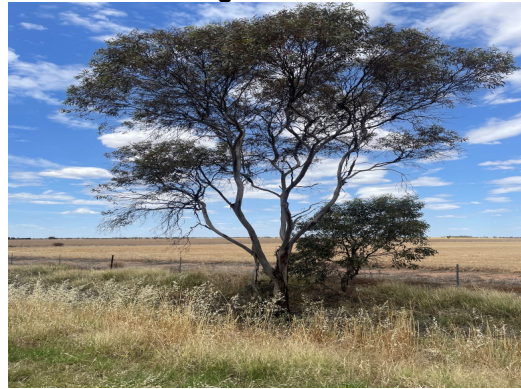
Investigation area 13

Tree ID: 30  
Species: *Eucalyptus dumosa*

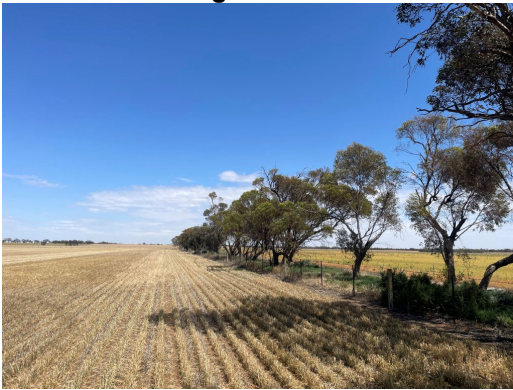
Investigation area 12

Tree ID: G8  
Species: *Eucalyptus dumosa*

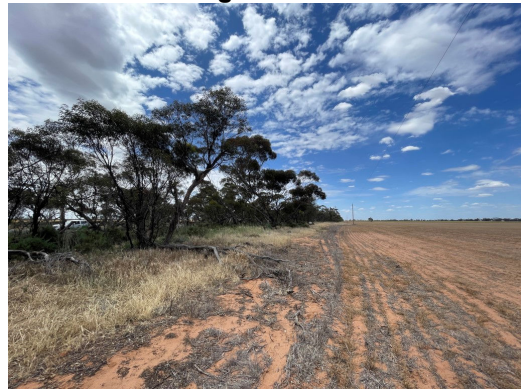
Investigation area 14

Tree ID: G12  
Species: *Eucalyptus dumosa*

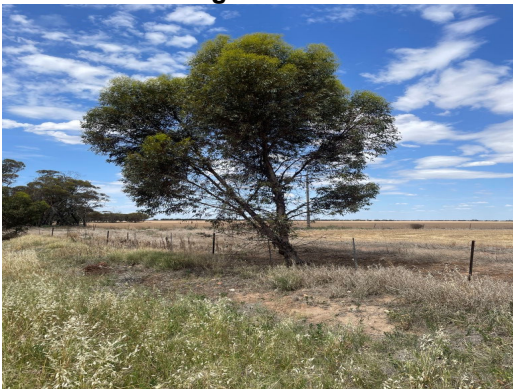
Investigation area 13

Tree ID: 29  
Species: *Eucalyptus dumosa*

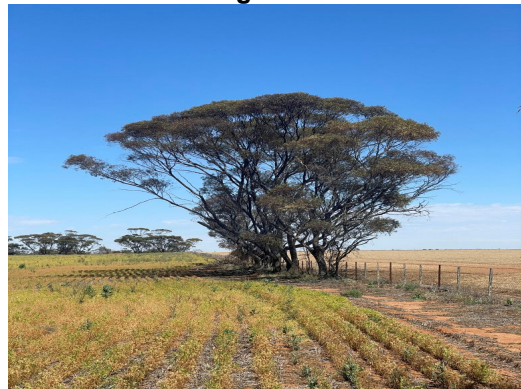
Investigation area

Tree ID: G7  
Species: *Eucalyptus dumosa*
