ARBORICULTURAL REPORT

10-12 LOFTS AVENUE, KEW

14 August 2024

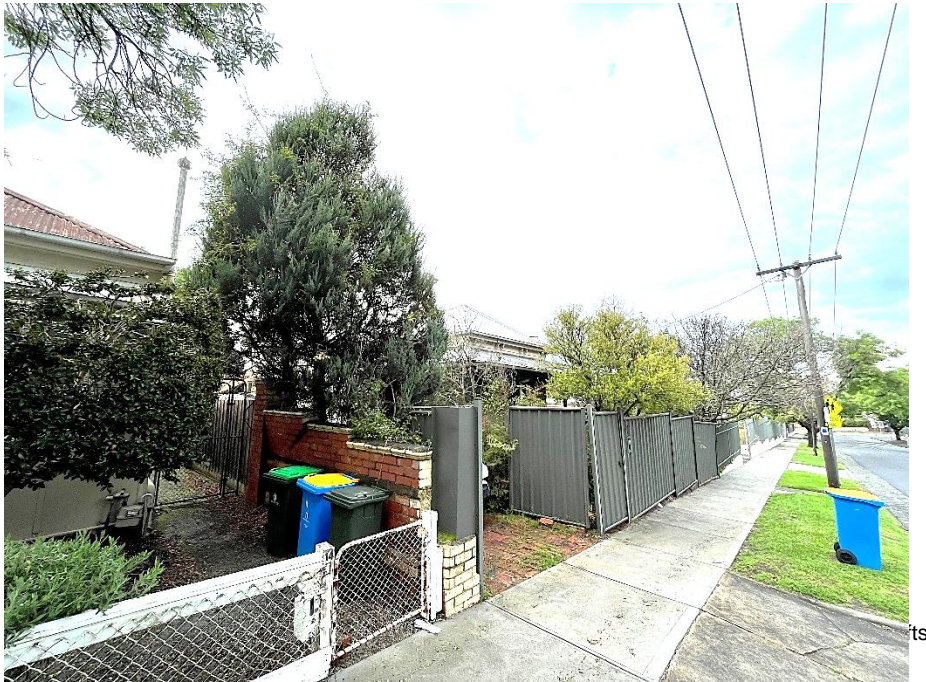
- 5.10 It is proposed to widen the existing crossover adjacent to Tree 11 a Desert Ash by approximately 1000mm and subsequently it will encroach to within approximately 3.4m from the tree. This is only an additional 2.4% encroachment to the 1.8% of the existing crossover.

- 5.11 A Telstra pit that is currently located within the TPZ of Tree 11 is proposed to be relocated to accommodate the extended crossover. Plans do not indicate where this will be relocated to, but it is recommended it be relocated outside the TPZ of this tree.
- 5.12 There are no proposed encroachments into the TPZ of Tree 6, a neighbouring Bottlebrush.
- 5.13 If any boundary fences are to be replaced, it is recommended that any section of the new fences that pass through the TPZ of trees to be retained be of light-weight construction with post holes hand dug and relocated if necessary to avoid major roots. It is also recommended that all landscape areas within the TPZ of trees to be retained be maintained at existing grades.
