# Arboricultural Impact Assessment

Aquinas College  
46 Great Ryrie St, Ringwood

Prepared for:  
Kosloff Architects

Submitted  
22/04/2025

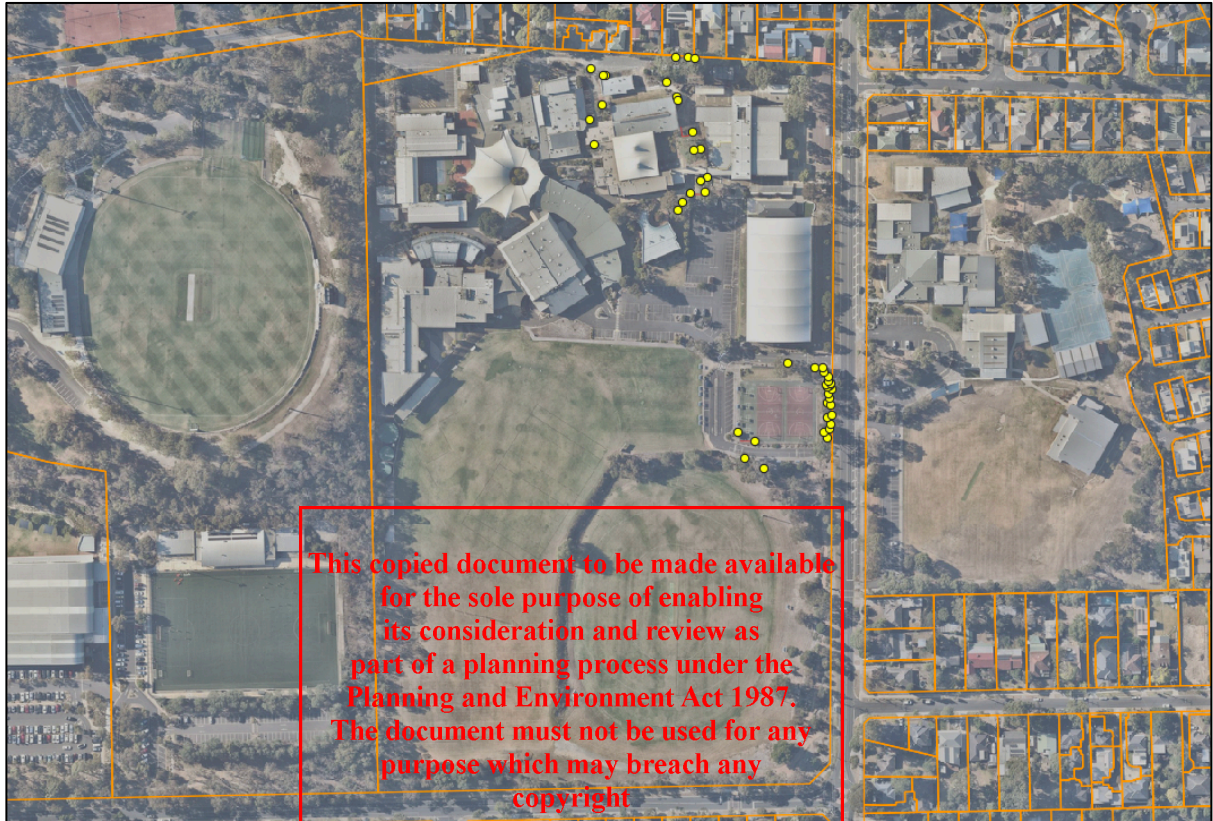
Figure 1. Site overview and tree locations.

A total of 46 individual trees were assessed for this report (Figure 1). Detailed observations for individual trees are listed in **Appendix A** and see **Appendix D** for glossary of terms.

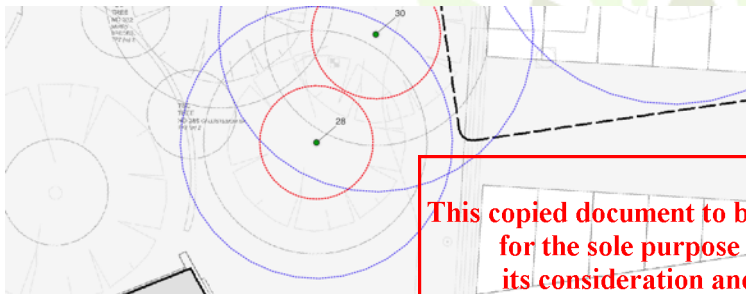
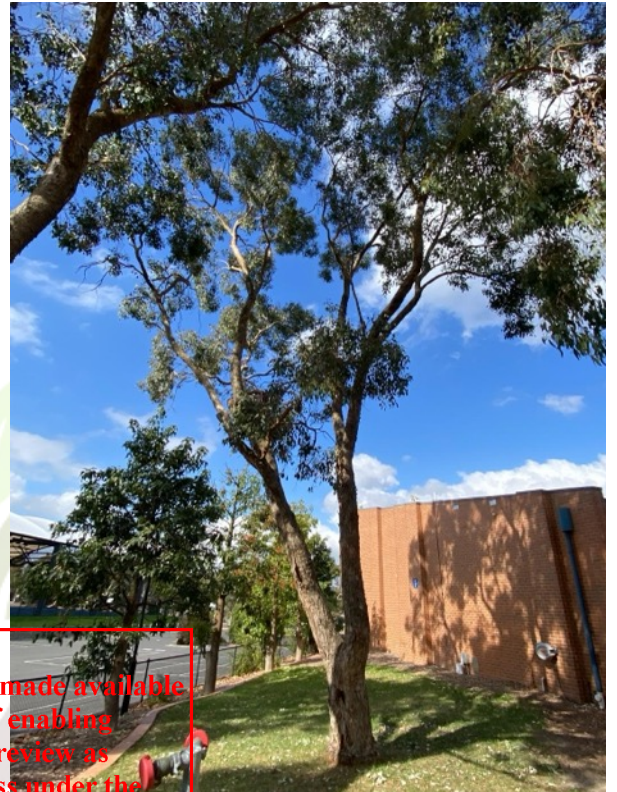
**Tree Id:** 30

**Observations:** Included codominant stems. Previous failures.

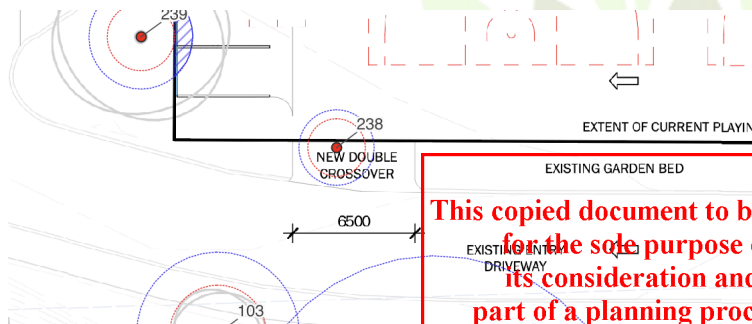
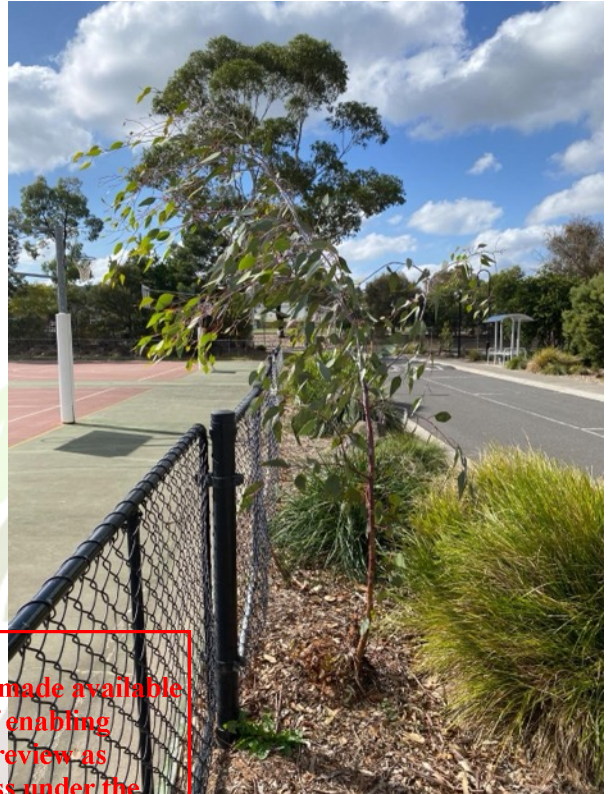
**Tree Id:** 239

- The TPZ of tree 239 will be encroached by >10% by the proposed basketball court resurfacing. While the proposed works are within the previous basketball court footprint and there is no encroachment to the SRZ, the tree is in poor health, has low retention value, and removal is recommended prior to the proposed development.

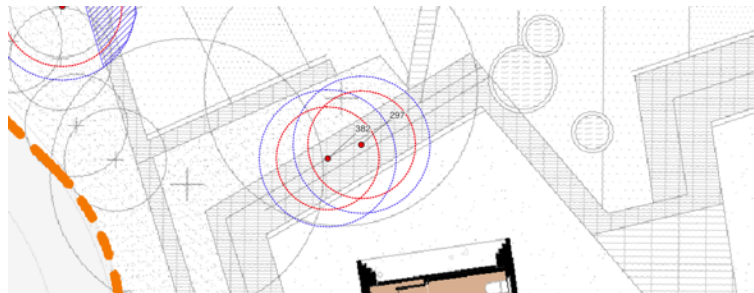
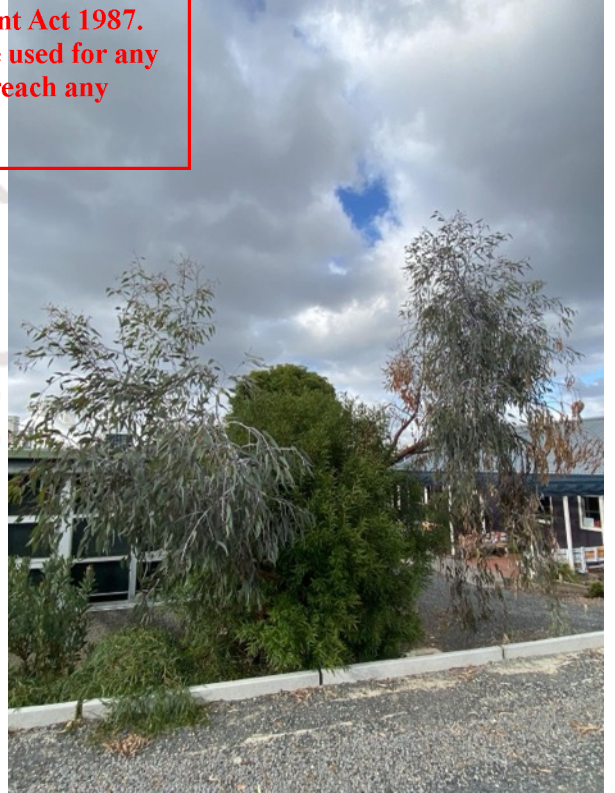
**Observations:** Root plate failure.

**Encroachment:** 100%

**Retention Status:** Remove

- Trees 238, 296, 297, and 382 are within the proposed construction envelope. As these trees have low retention value, removal is recommended prior to the proposed development.

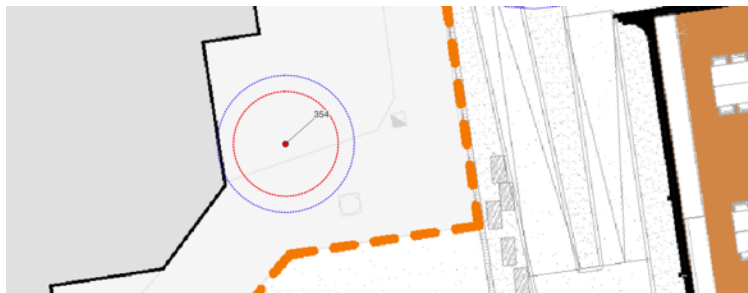
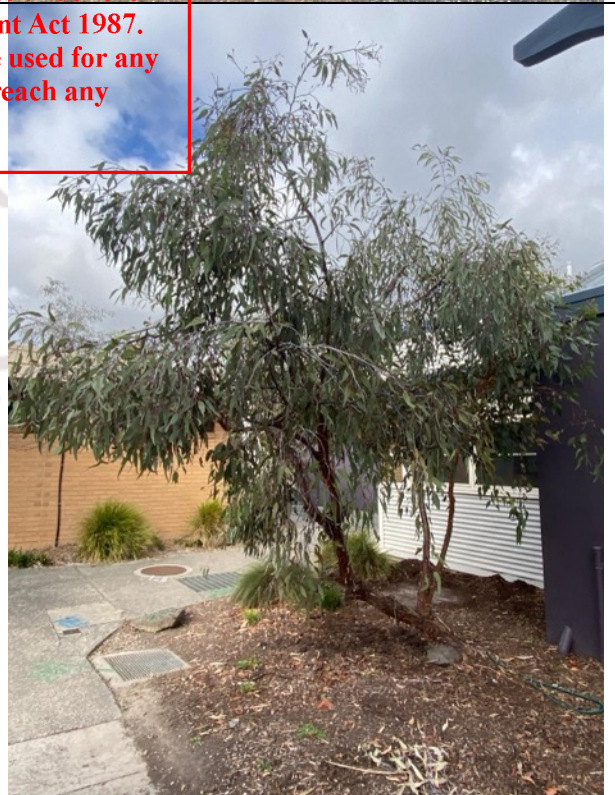
**Tree Id:** 354

**Observations:** Encroaching structure. Root plate failure.

**Encroachment:** None

**Retention Status:** Retain

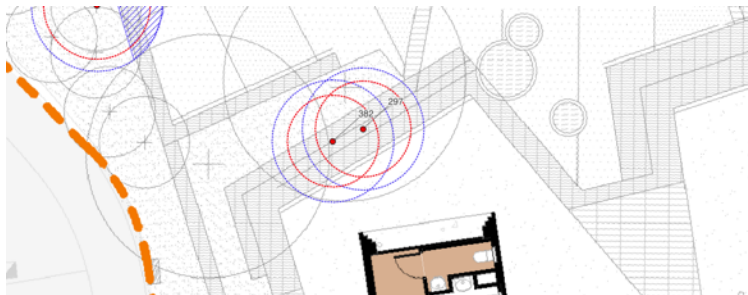
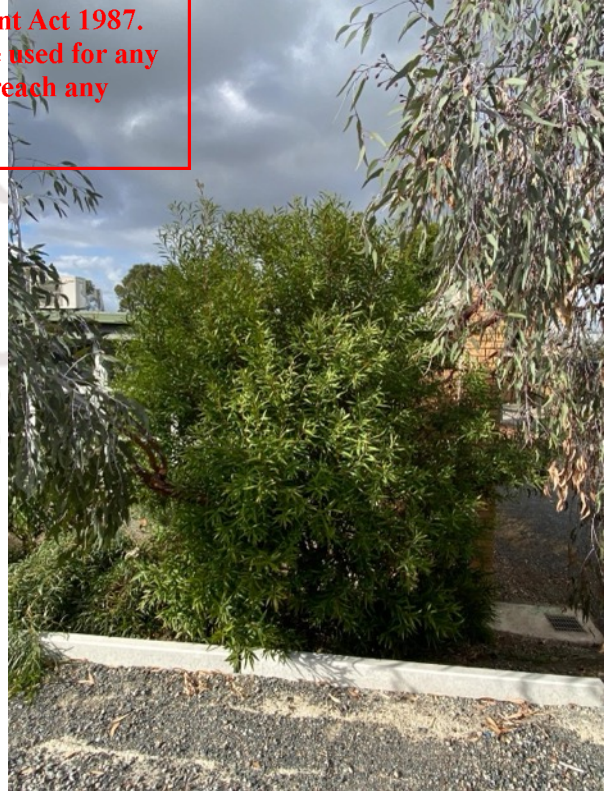
**Encroachment:** 100%

**Retention Status:** Remove

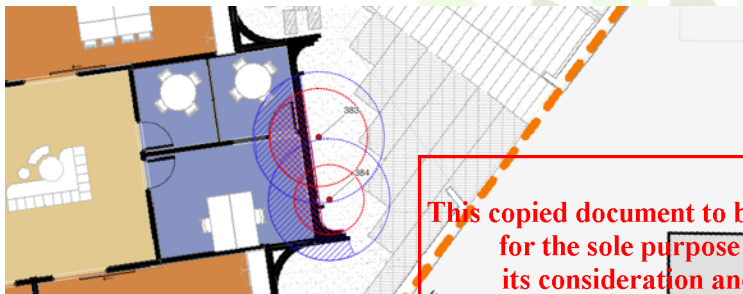
**Tree Id:** 383

**Observations:** Poor location. Coppice regrowth.

**Encroachment:** Major **Retention Status:** Remove

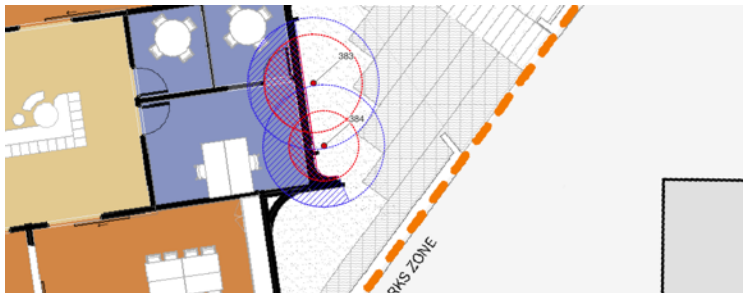
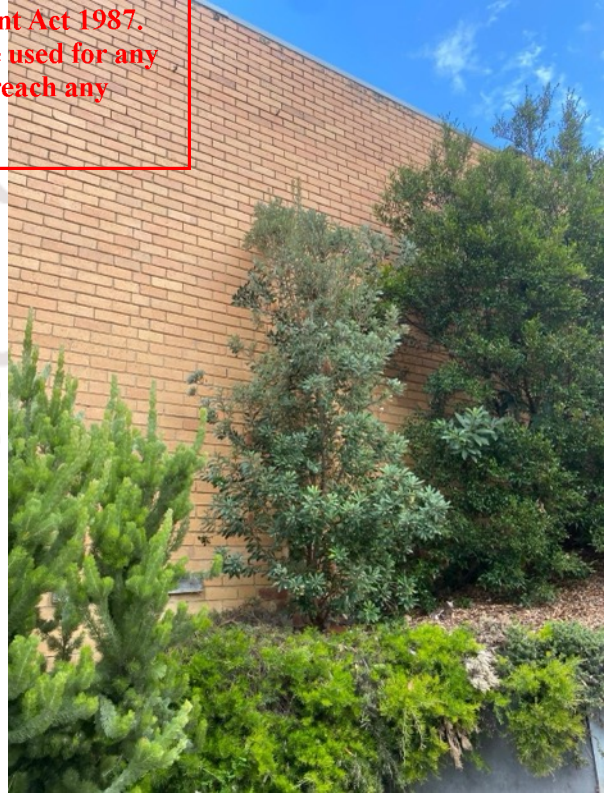
**Tree Id:** 384

**Observations:** Poor location.

**Encroachment:** Major **Retention Status:** Remove
