Arboricultural Assessment and Report

North Richmond Masterplan

29 July 2021
Tree Logic Ref. 011189

Prepared for MGS Architects
Prepared by Manori Senanayake – Consultant,
Tree Logic Pty. Ltd.

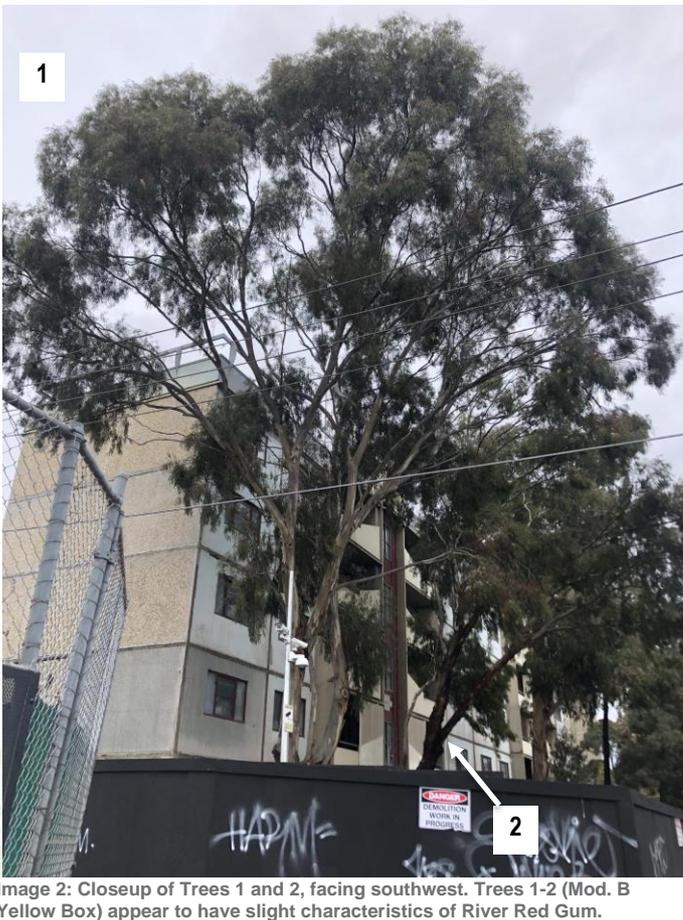
Image 2: Closeup of Trees 1 and 2, facing southwest. Trees 1-2 (Mod. B Yellow Box) appear to have slight characteristics of River Red Gum.

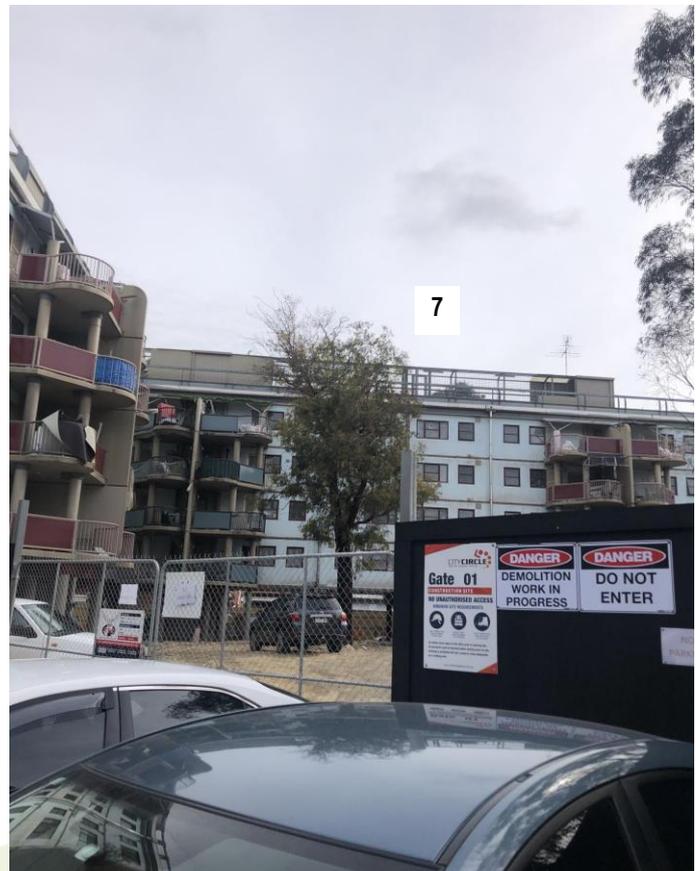
Tree 7 could be observed from a distance through the entry gate and the surrounding soil appeared compacted with vehicular parking on exposed soil within the TPZ and no tree protection measures visible (Image 3). It cannot be determined whether Trees 1-6 were in a similar situation and whether present construction measures may influence the trees' condition in relation to long-term retention considerations for master planning purposes.

Image 3: Tree 7 (Mod. C Red Ironbark) in demolition area with no tree protection and likely compacted soil. It is unclear if the tree is to be retained.

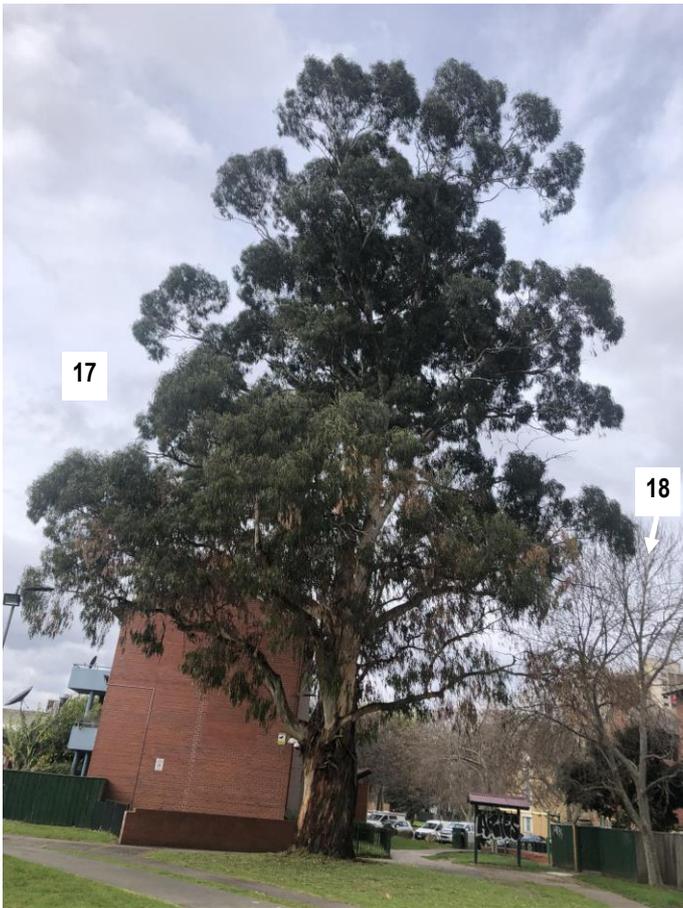
Image 4: Tree 17, Mod. A Manna Gum near Elizabeth Street flats, facing west. Significant landscape value although recent localized dieback in lower crown. Should be retained with ongoing management.

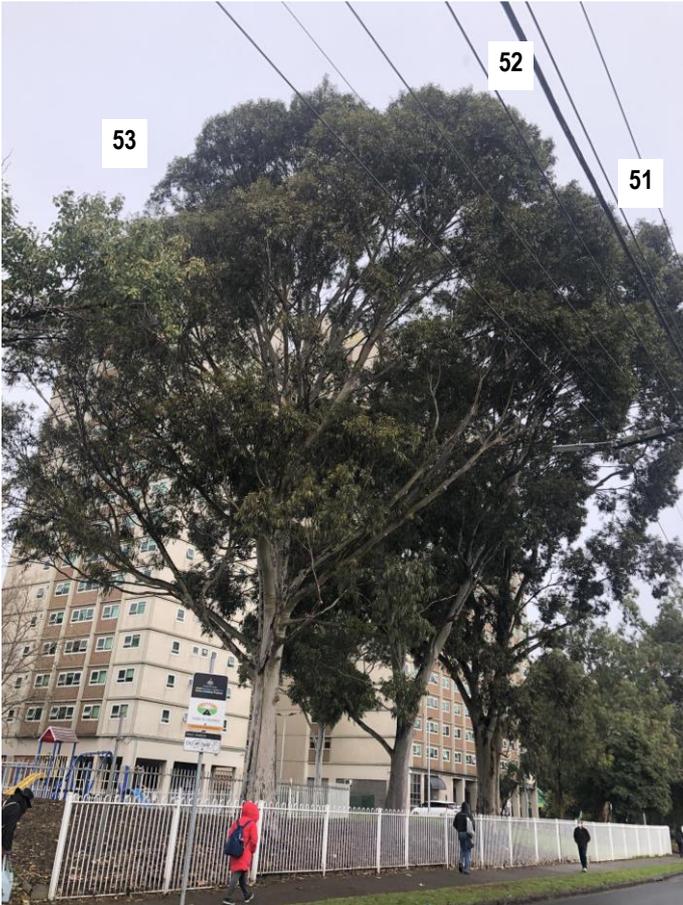
Image 10: Trees 51-53, Mod.B/Mod.A Spotted Gums northwest of towers along Lennox Street, facing south.

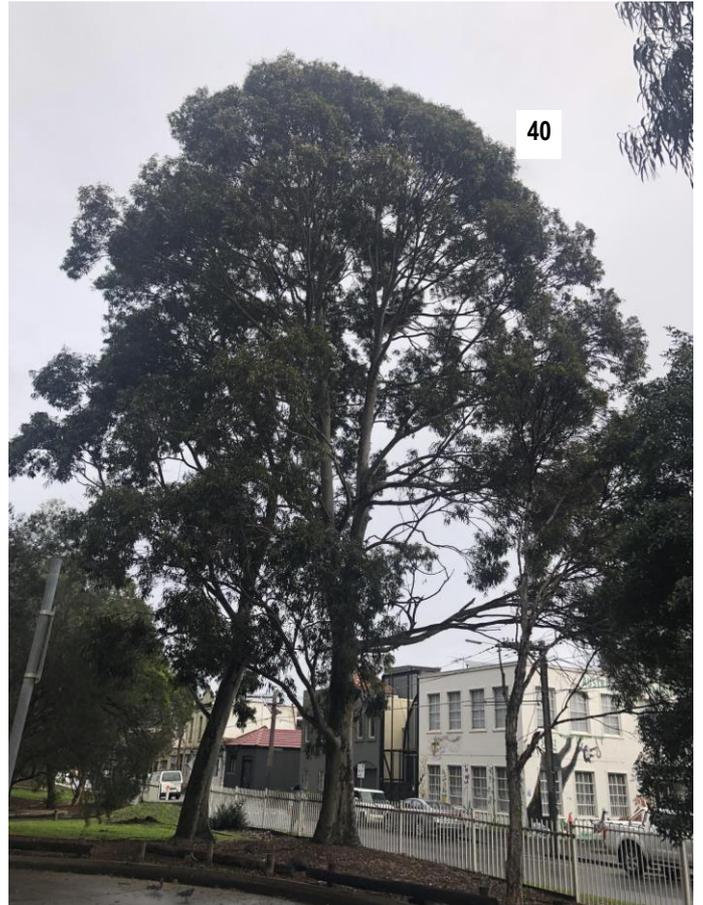
Image 11: Tree 40, Mod. A Spotted Gum along Lennox Street frontage facing southwest.

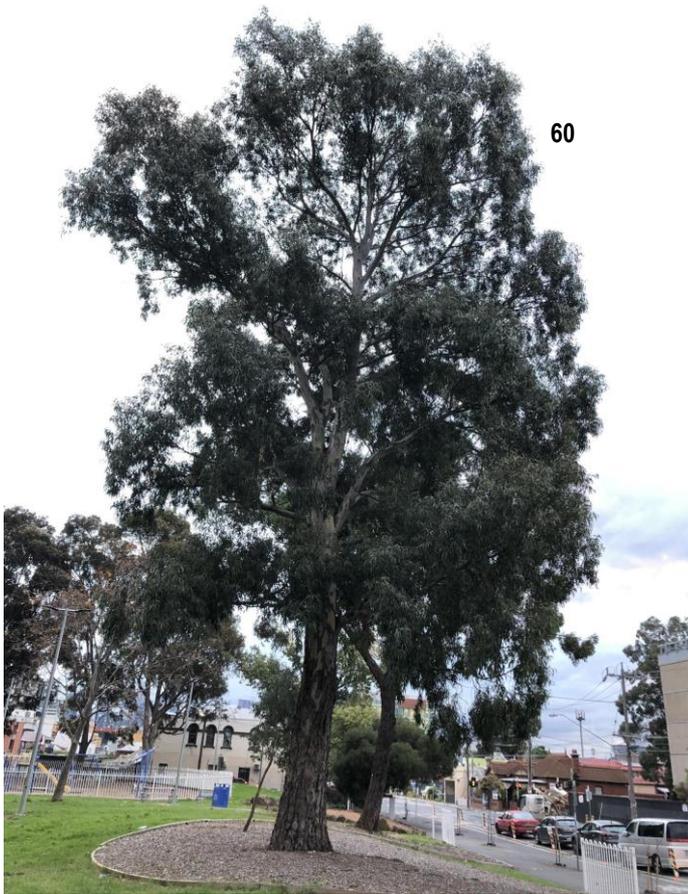
60

Image 13: Tree 60, Mod. A River Red Gum along Elizabeth Street frontage, facing west.

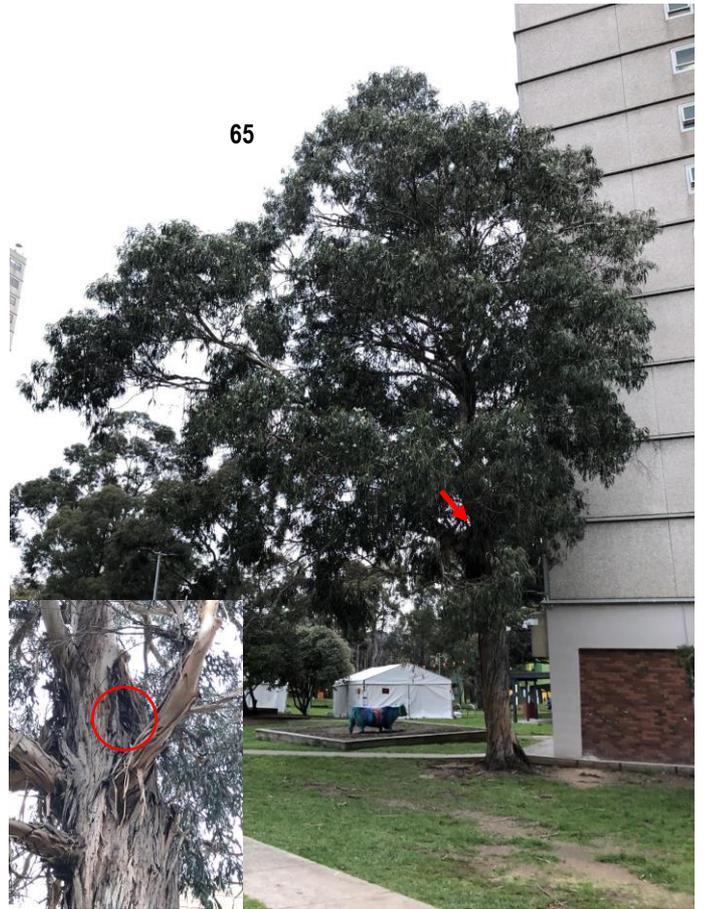
65

Image 14: Tree 65, Mod. C Southern Blue Gum adjacent to northwestern tower, facing south. Dense canopy despite fungal bracket (shown inset).

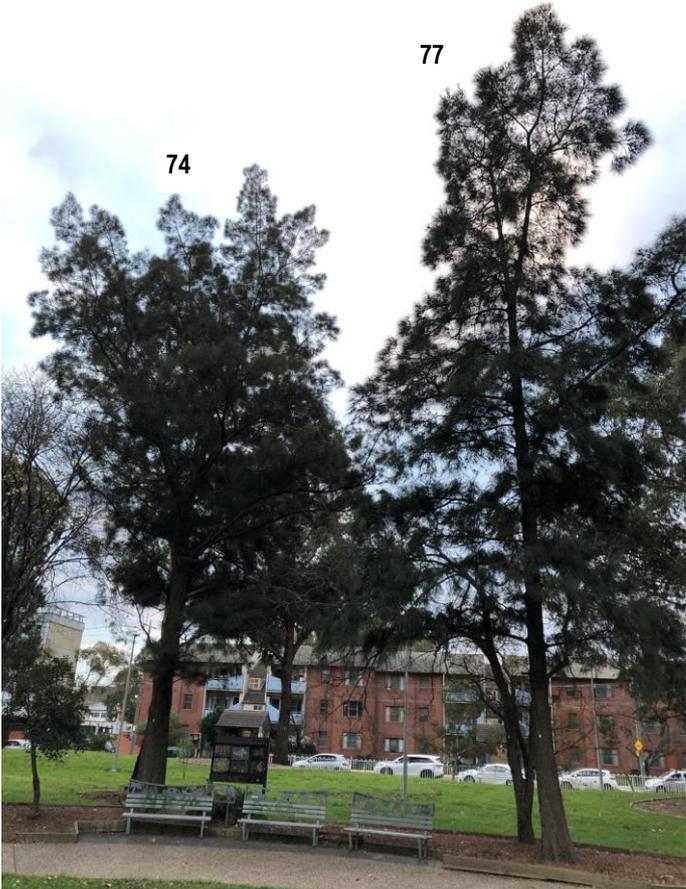
Image 18: Trees 74 and 77, Mod. B River She-oak near north-western seating area, facing north.

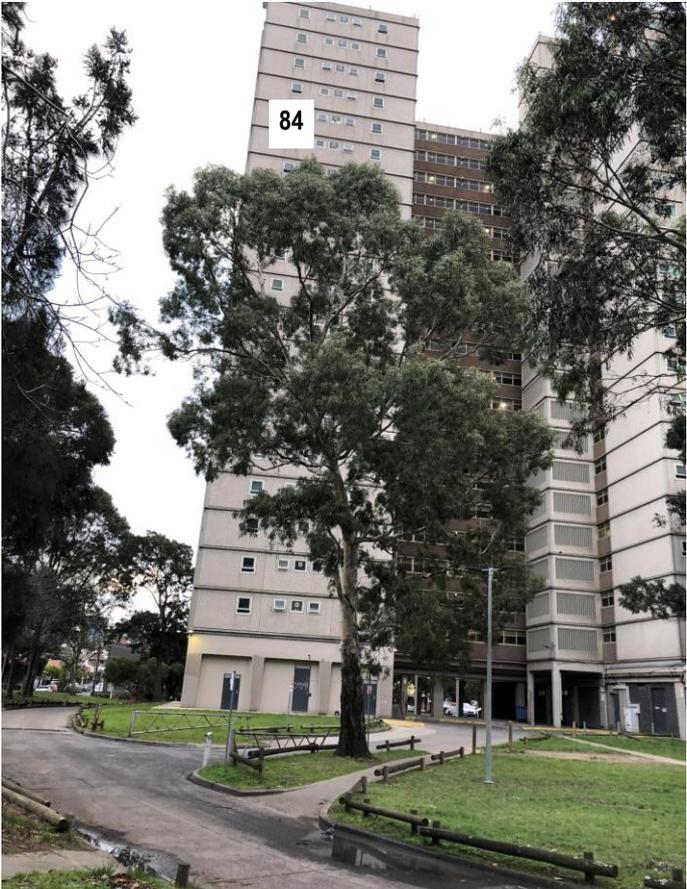
Image 19: Tree 84, Mod. A River Red Gum south-east of northwestern tower block towards multistorey carpark. Facing west.

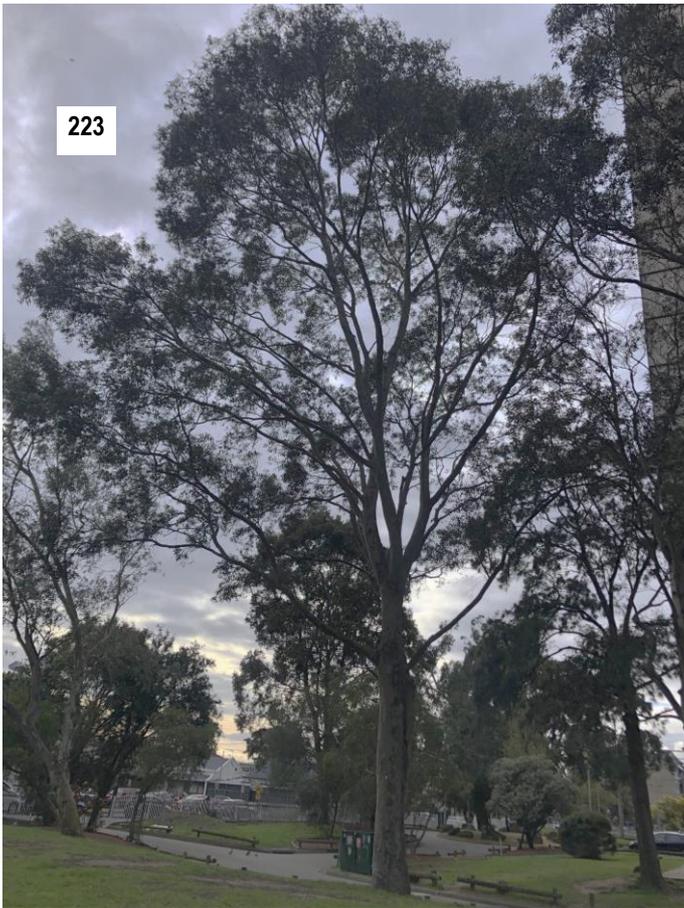
223

Image 20: Tree 223, Mod. A Spotted Gum south of northwestern tower block towards health centre. Facing northwest.

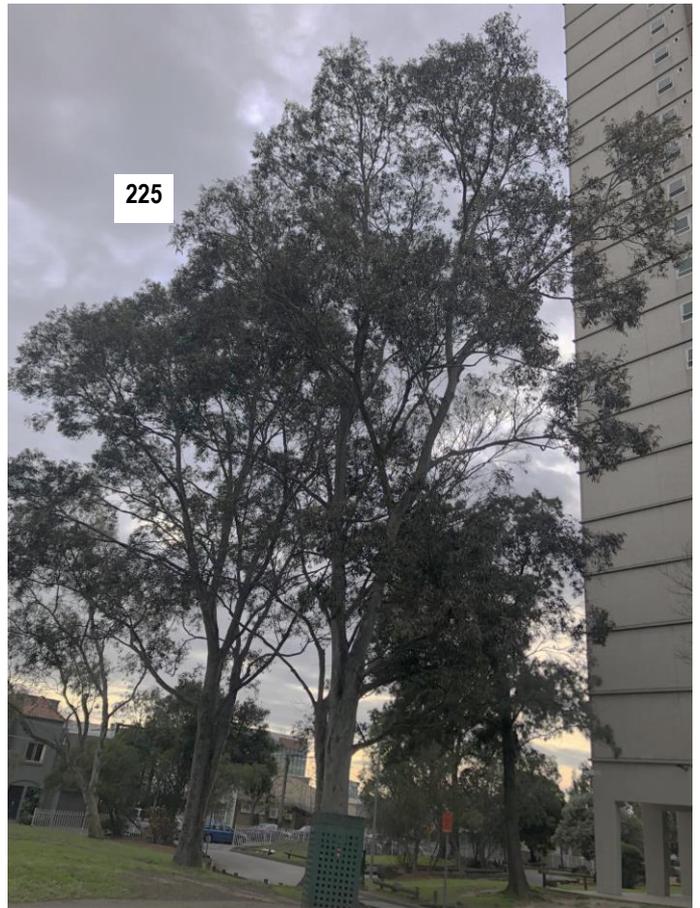
Image 21: Tree 225 Mod. A Spotted Gum south of northwestern tower block towards health centre. Facing northwest. Acute forks may require pruning or cabling over time.

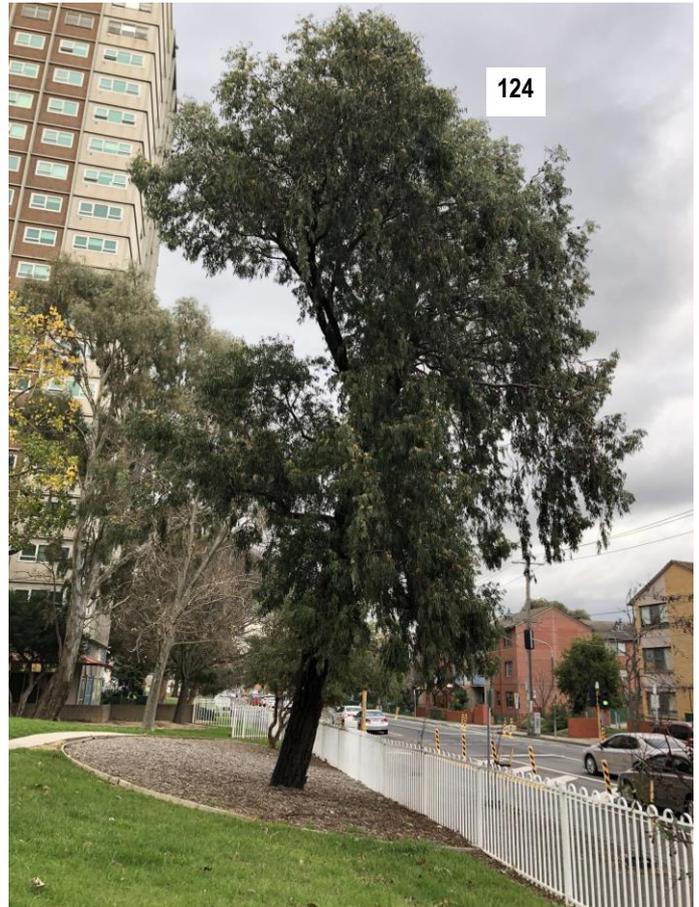
124

Image 26: Tree 124, Mod.B-rated Red Ironbark in north-central open space along Elizabeth Street frontage. Facing west.

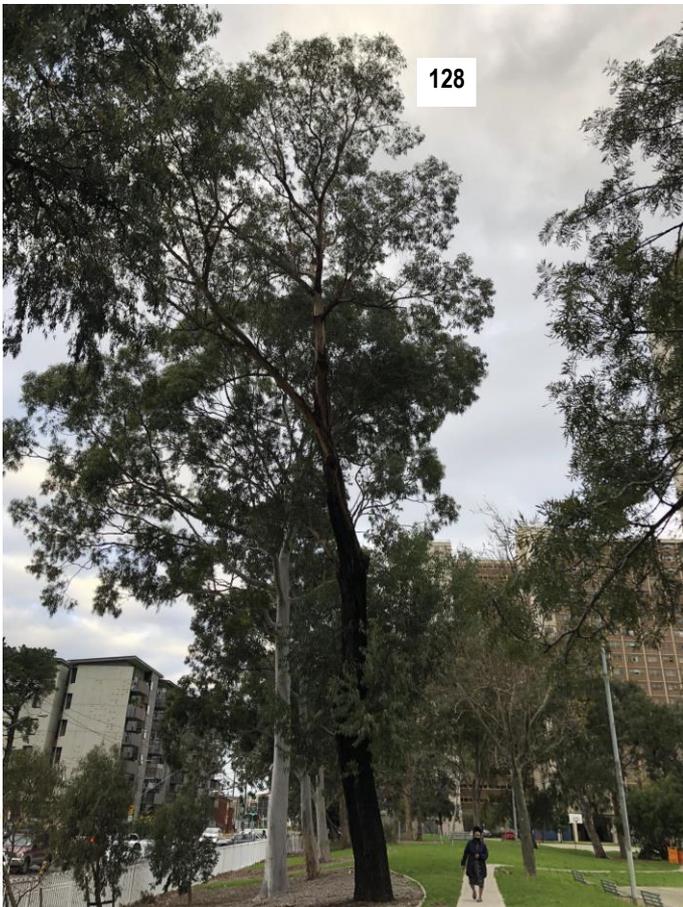
128

Image 27: Tree 128, Mod.B Red Ironbark in north-central open space along Elizabeth Street frontage, facing east.

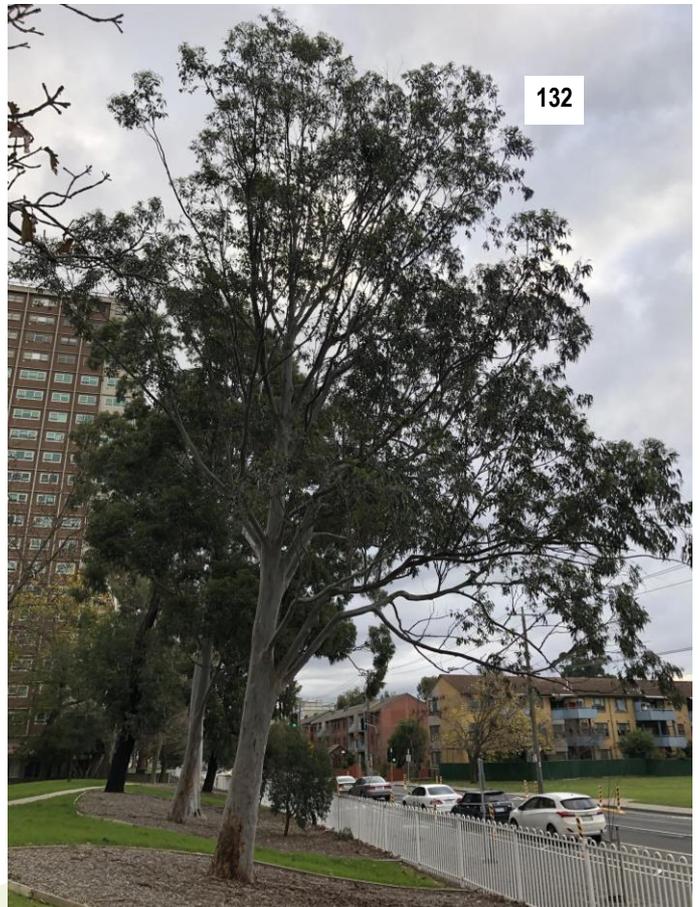
132

Image 28: Tree 132, Mod.B Sydney Blue Gum in north-central open space along Elizabeth Street frontage, facing west.

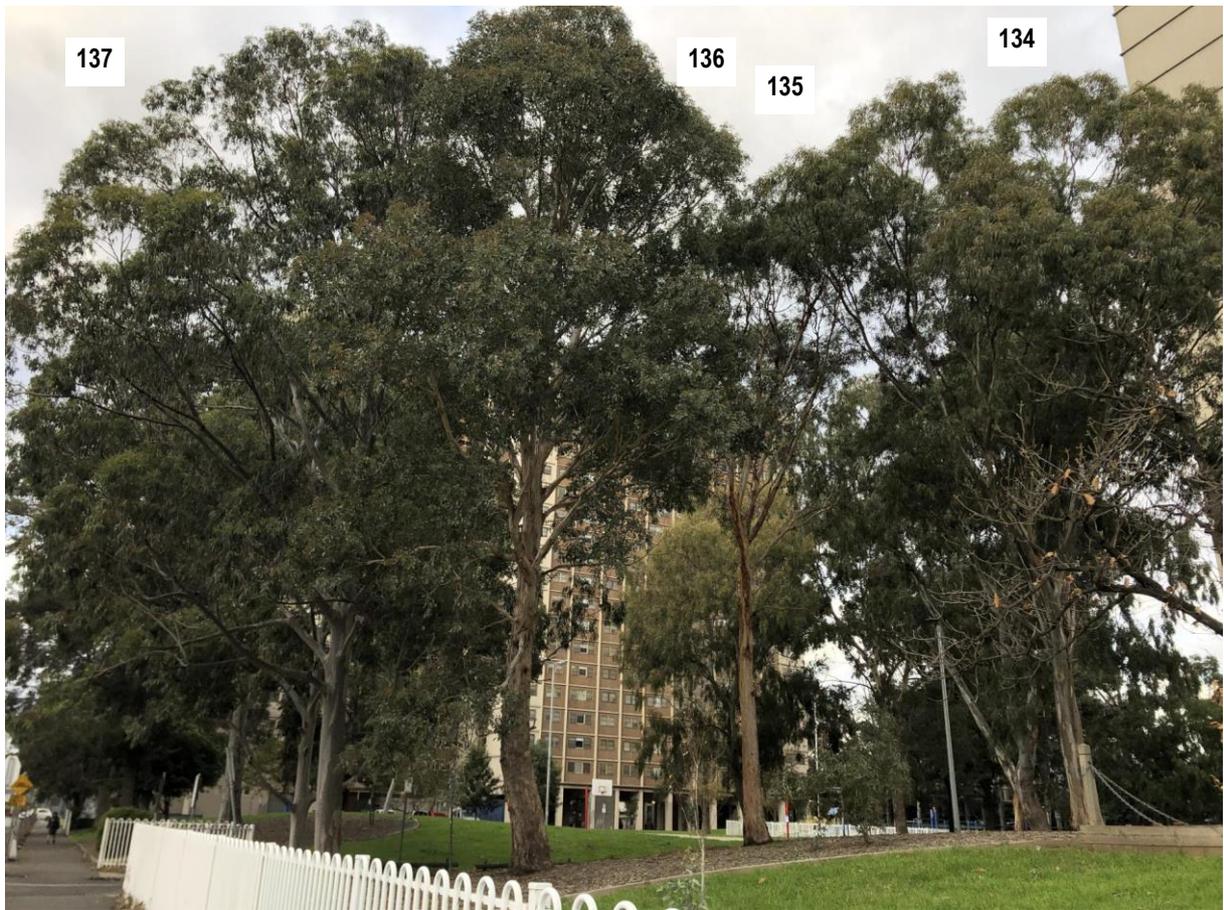
Image 29: Corridor of Mod. B trees north of north-central tower, facing west. Elizabeth Street to left of image. Trees 134 and 135 (River Red Gum), 136 (Yellow Box) and 137 (Sydney Blue Gum).

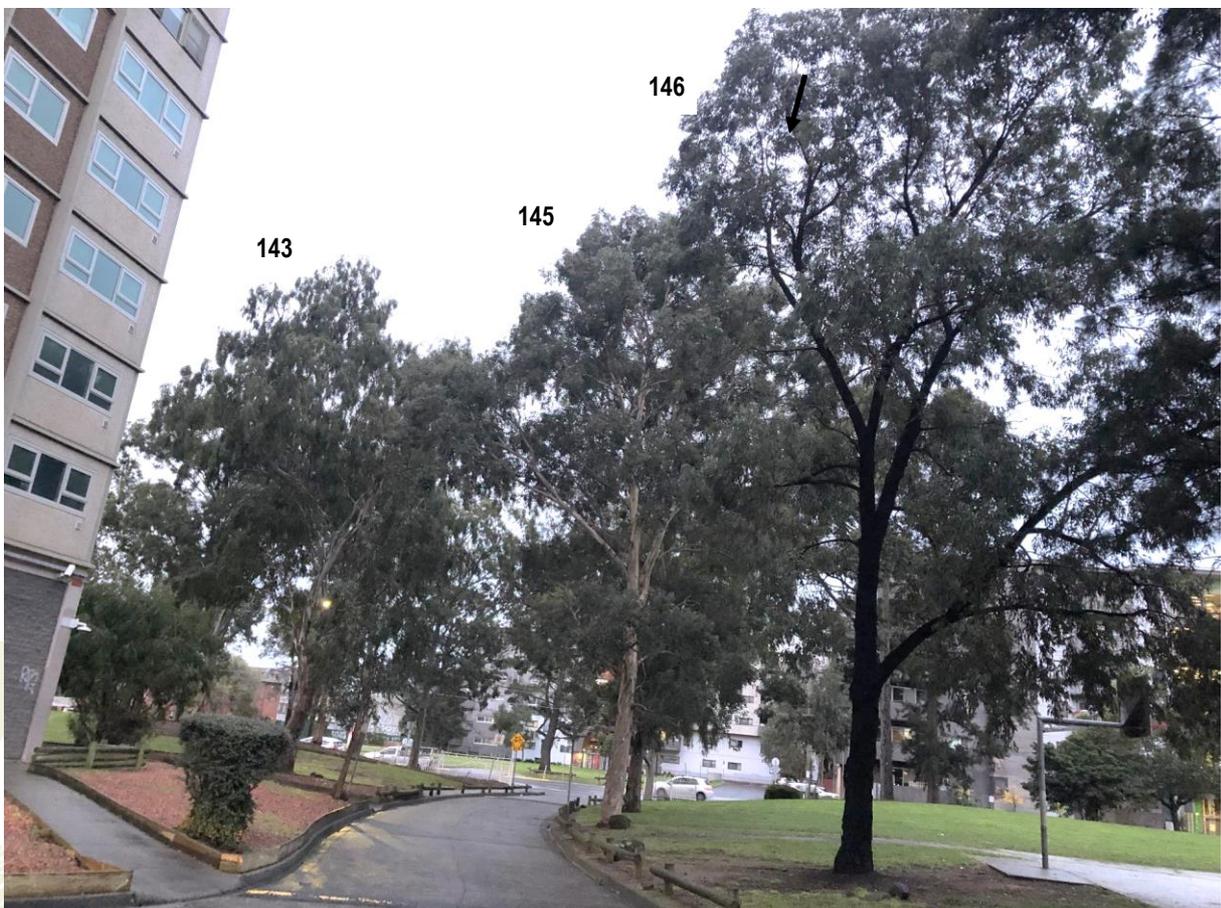
Image 30: Corridor of Mod. B trees northeast of north-central tower, facing north. Elizabeth Street to rear of image. Trees 143 (River Red Gum), 145 (Red Box) and 146 (Red Ironbark).

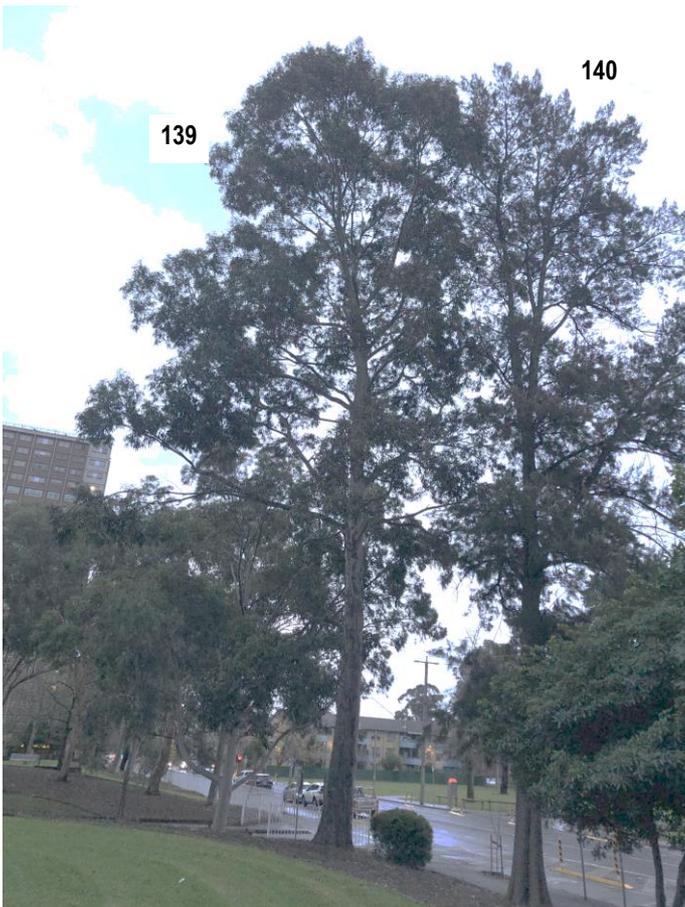
Image 31: Trees 139 (Mod. A Spotted Gum) and 140 (Mod. B River She-oak) along north-east Elizabeth Street frontage, facing northwest.

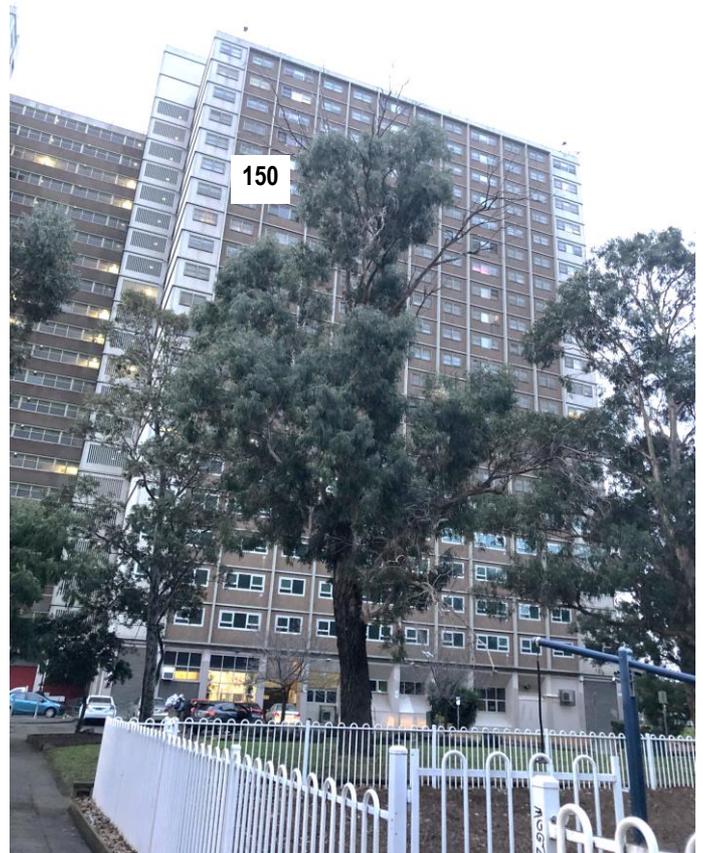
Image 32: Tree 150, Mod.C-rated Manna Gum with peripheral dieback and significantly reduced but otherwise dense crown. Tree appears to be senescing and could be retained with crown reduction.

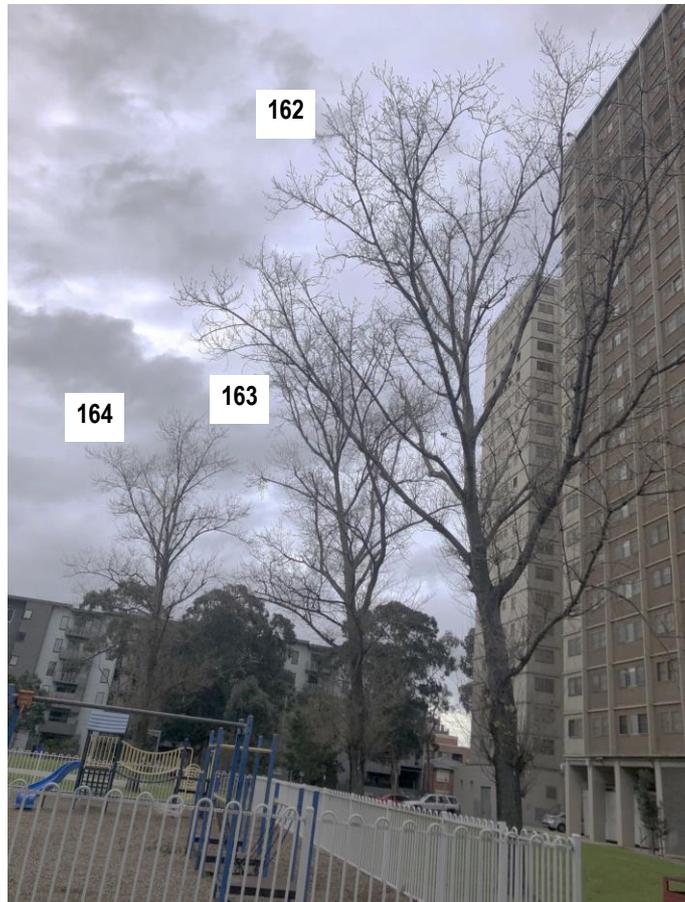
In this light it is anticipated that most of the Poplars on site are unlikely to be a long-term component of the landscape and further decline may be expected in this population, although several specimens with Fair health and structure (5 trees) could have a moderate useful life expectancy (e.g. Image 33).

Image 33: Trees 162-164, Mod.C Grey Poplars near north-eastern playground. While trees are better specimens the species is ultimately not ideal for long-term retention due to structural and heat tolerance concerns.

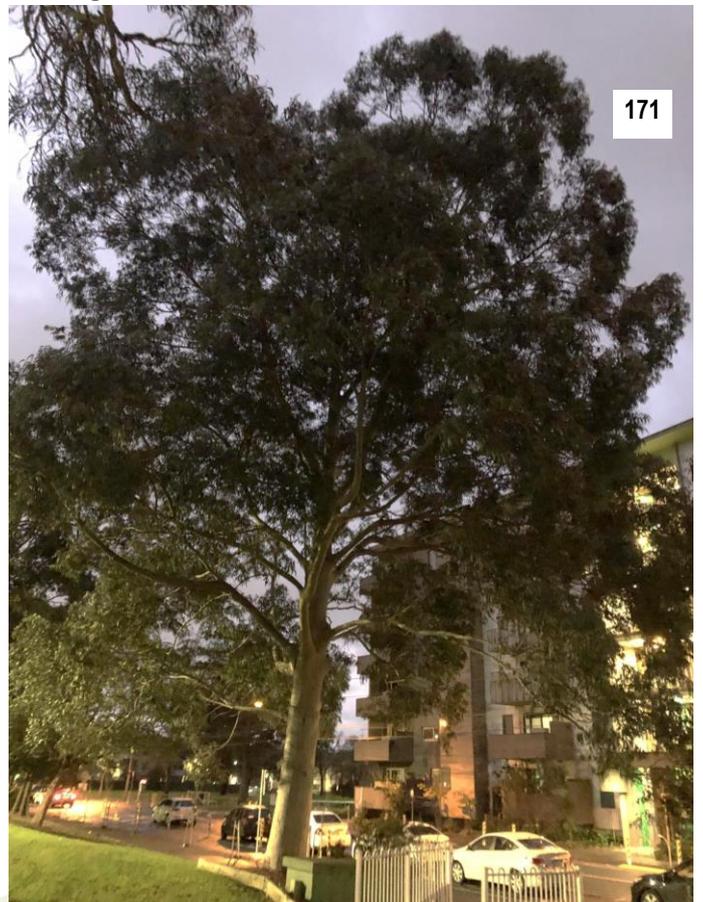
Image 34: Tree 171, High-rated Sydney Blue Gum along north-eastern Elizabeth Street frontage, facing northwest.

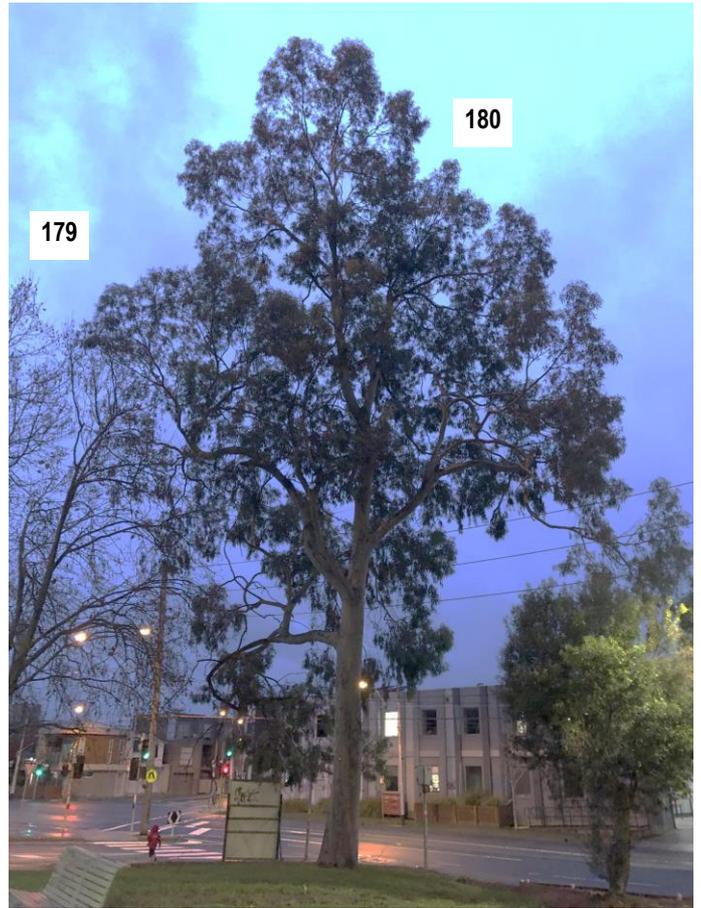
Image 36: Tree 180, Mod.A Spotted Gum on north-eastern corner of Elizabeth and Church Streets, facing northeast.

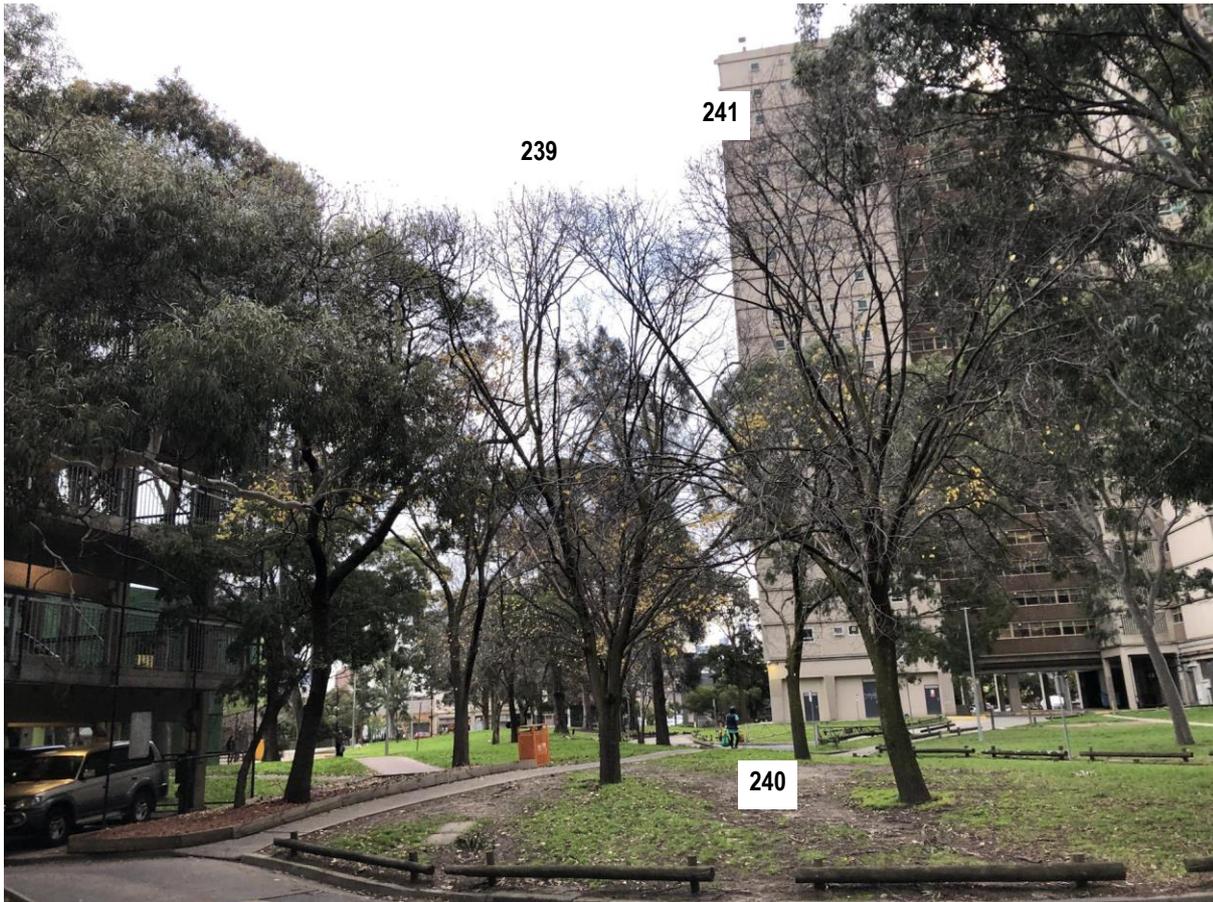
Image 39: Grove of Mod.B Golden Elms (including Trees 239-240) northwest of multistorey carpark, facing west.

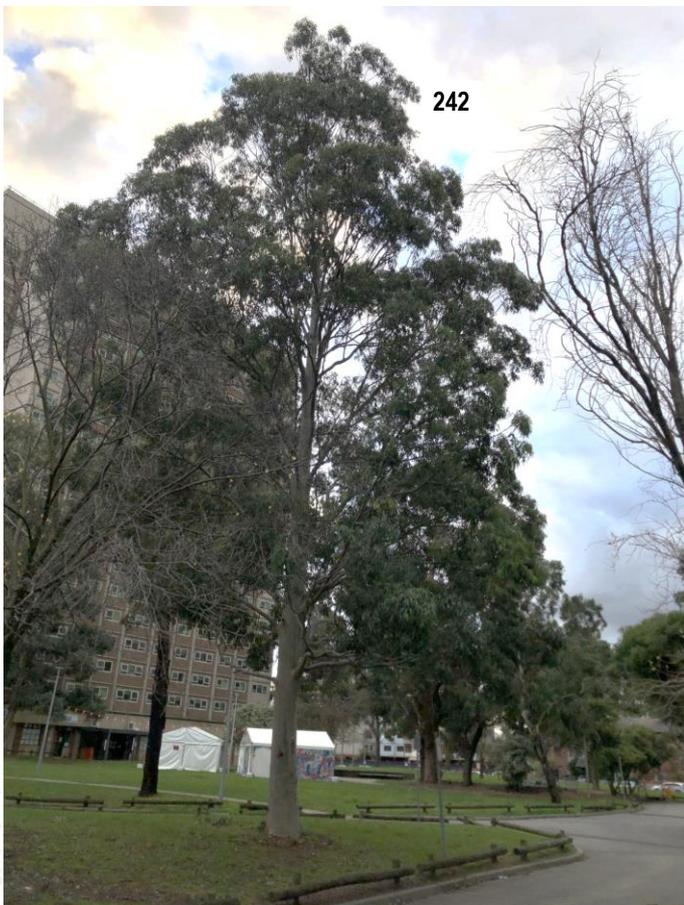
Image 40: Tree 242, Mod. A Spotted Gum north of multistorey carpark, facing west.

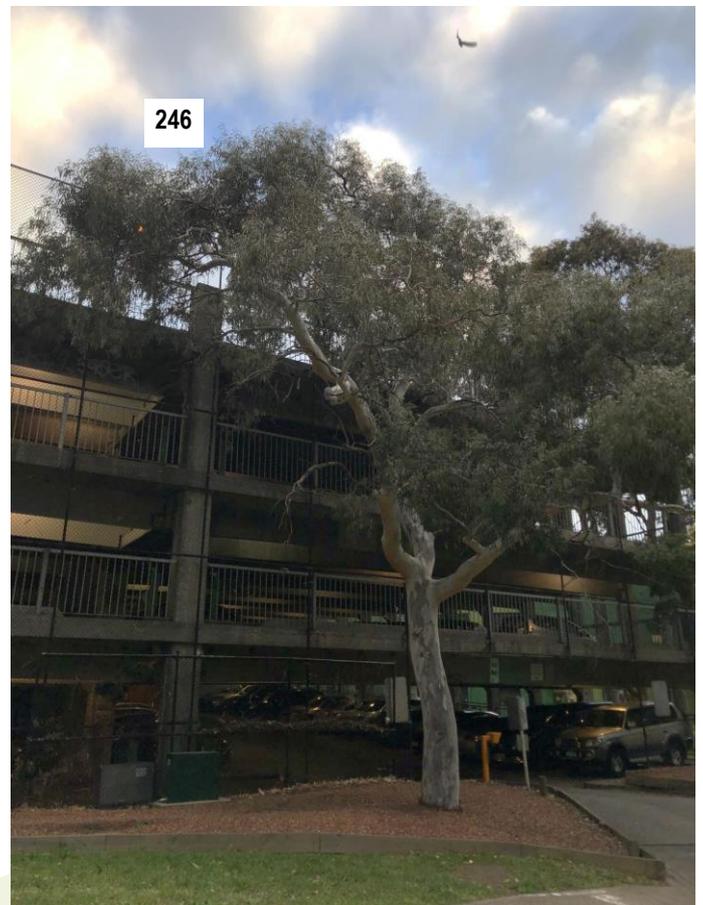
Image 41: Tree 246, Mod. B Brittle Gum north of multistorey carpark, facing southwest. Some canopy overhanging top floor of carpark.

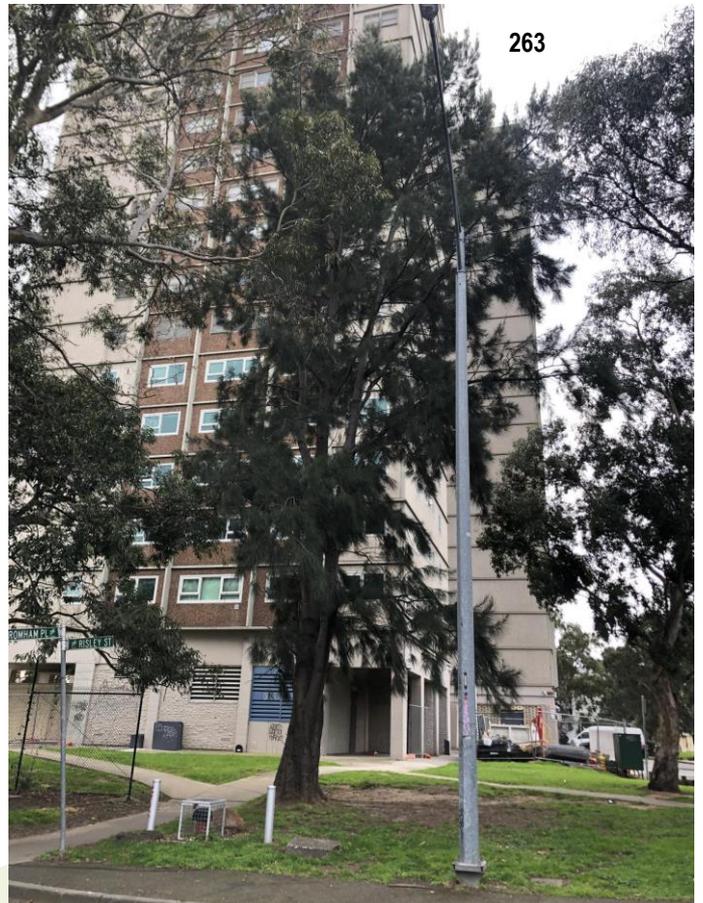
Image 44: Tree 263, Mod.A River She-oak west of multistorey carpark, facing north.

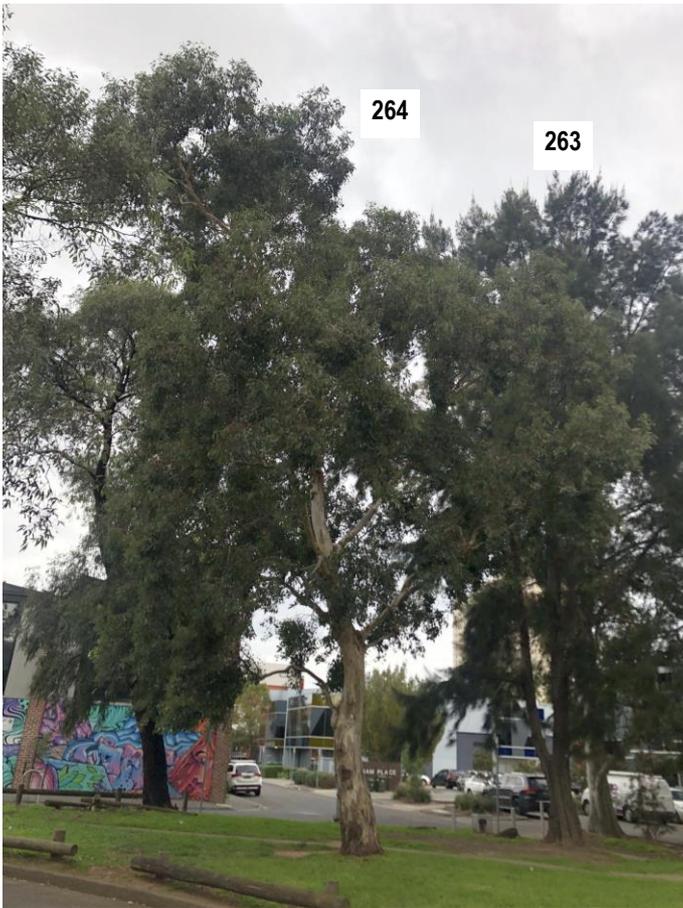
Image 45: Tree 264 Mod. B Red Box west of multistorey carpark, facing south.

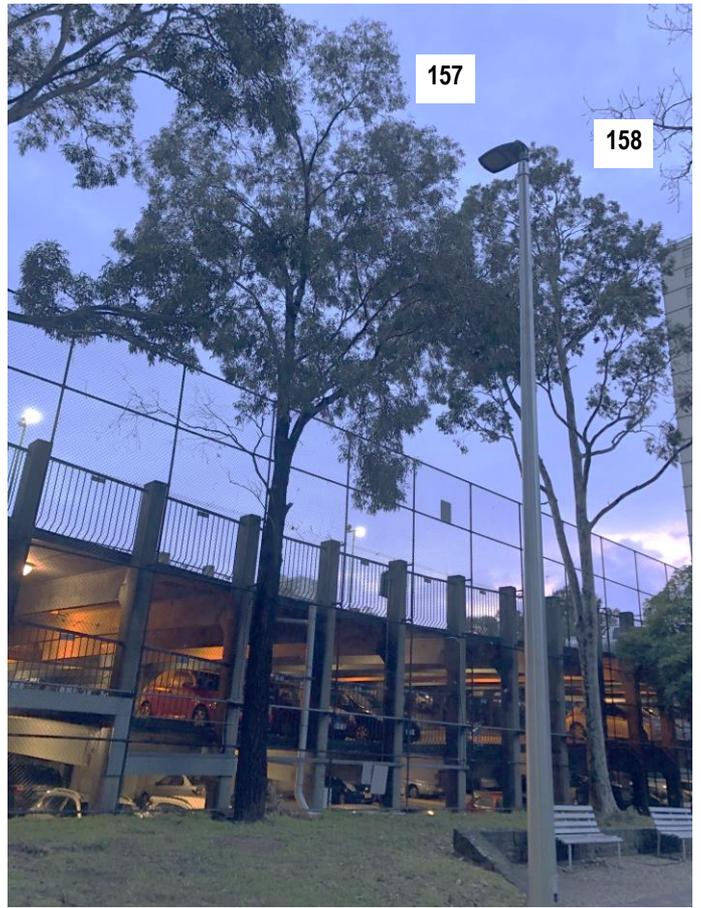
Image 46: Trees 157-158 Mod B Red Ironbark and Spotted Gum north of multistorey carpark, facing southwest.

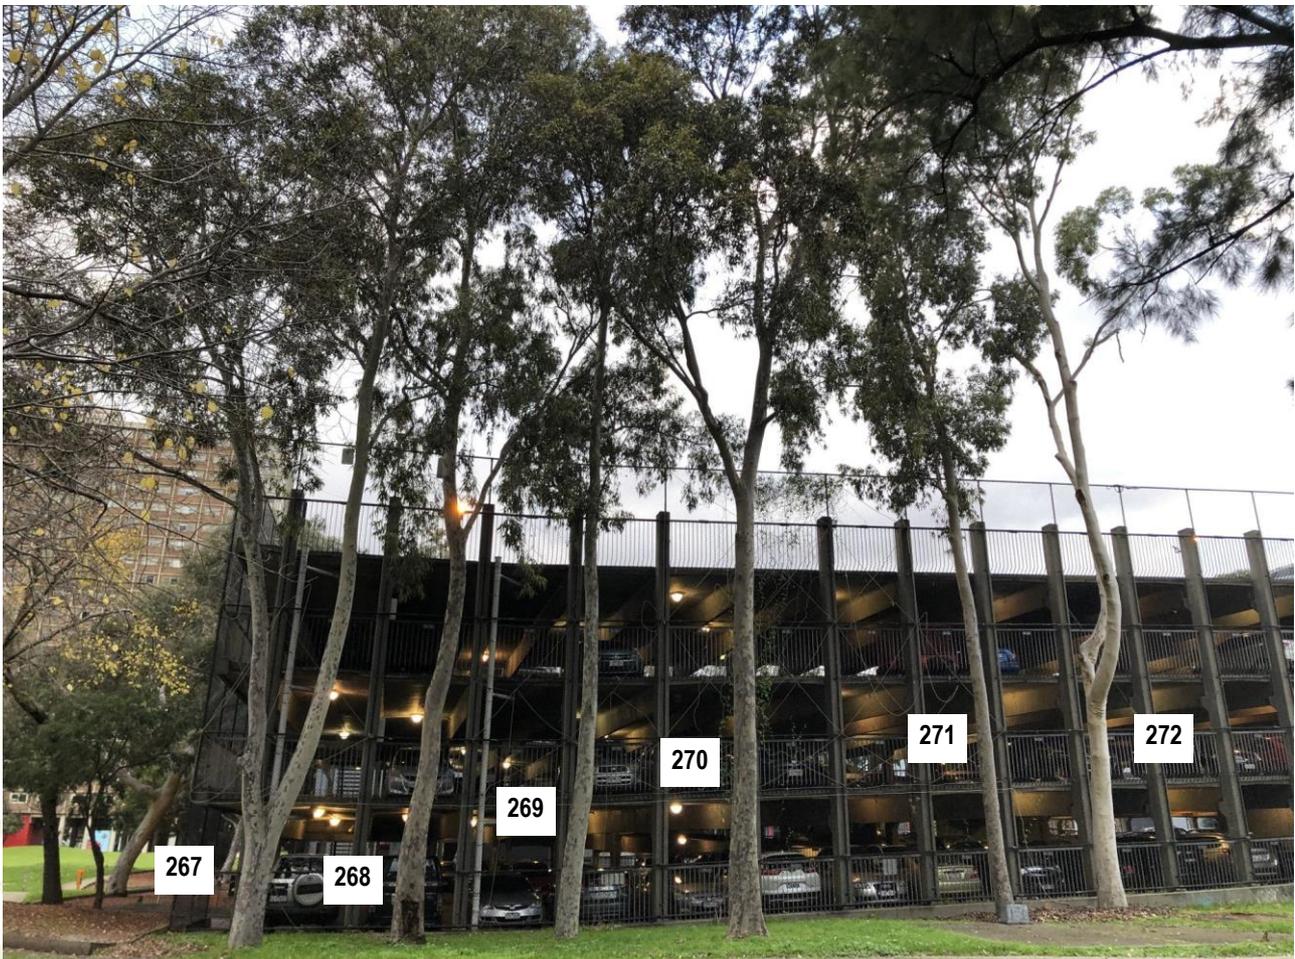
Image 47: Trees 267-272, mainly Mod.B Spotted Gums northwest of western multistorey carpark, east of health centre. Facing east.

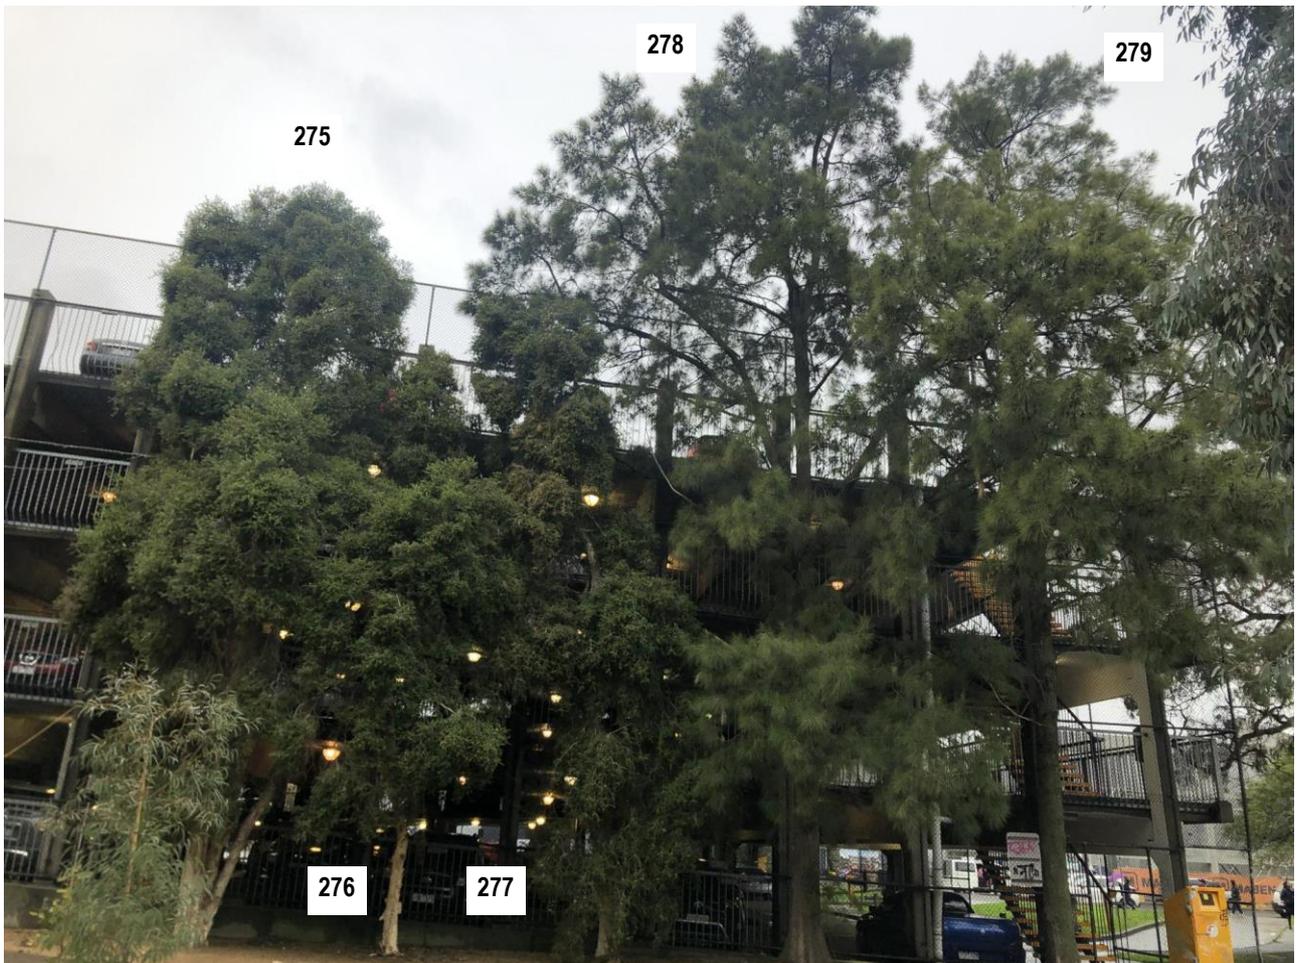
Image 48: Trees 275-279, row of trees southwest of western carpark, southeast of health centre. Including Mod. B trees 275 (Prickly-leaved Paperbark), 278 and 279 (River She-oak). Facing east.

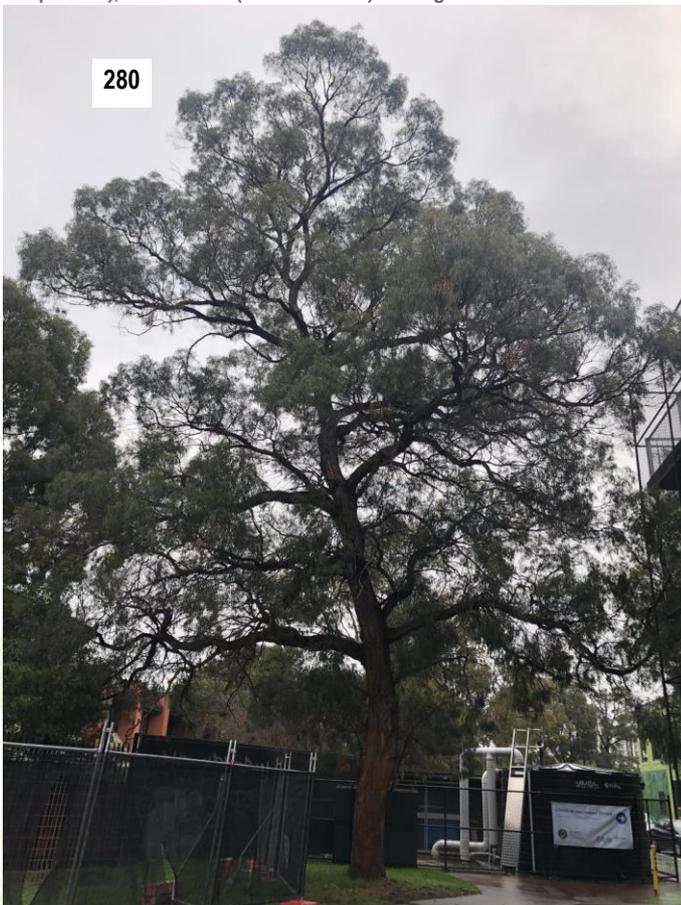
Image 49: Tree 280, Mod. A Narrow-leaved Black Peppermint south of western multistorey carpark, near periphery of primary school, facing west.
