Arboricultural Assessment and Report

North Richmond Masterplan

29 July 2021
Tree Logic Ref. 011189

Prepared for MGS Architects
Prepared by Manori Senanayake – Consultant,
Tree Logic Pty. Ltd.

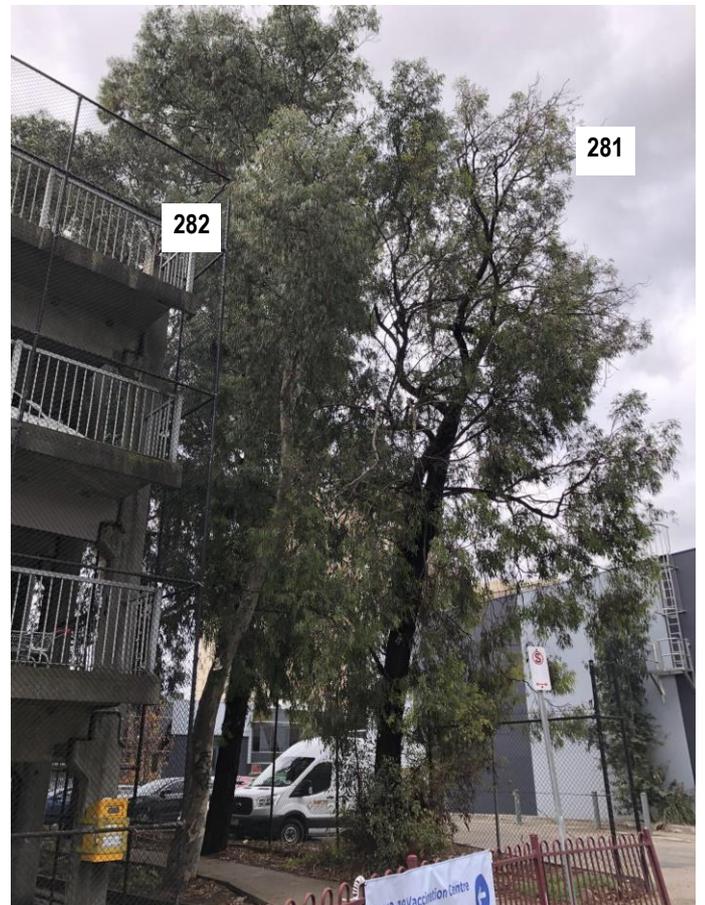
Image 50: Trees 281 (Mod.C Red Ironbark) and 282 (Mod.C Spotted Gum) southeast of western multistorey carpark in narrow site, facing northeast.

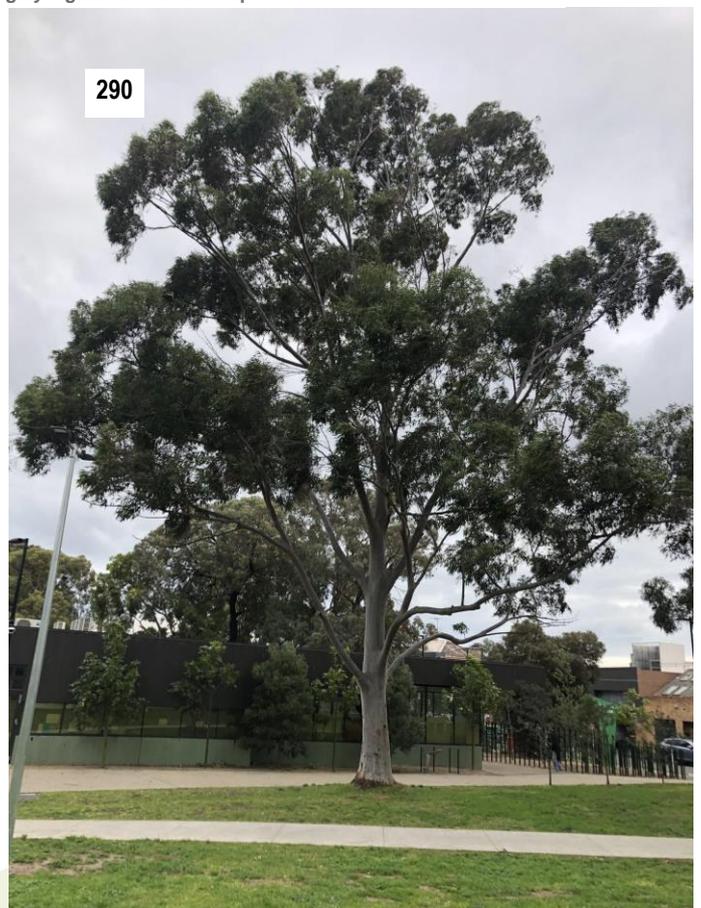
Image 57: Tree 290, Mod. A-rated Sydney Blue Gum northwest of Health Centre, facing south.

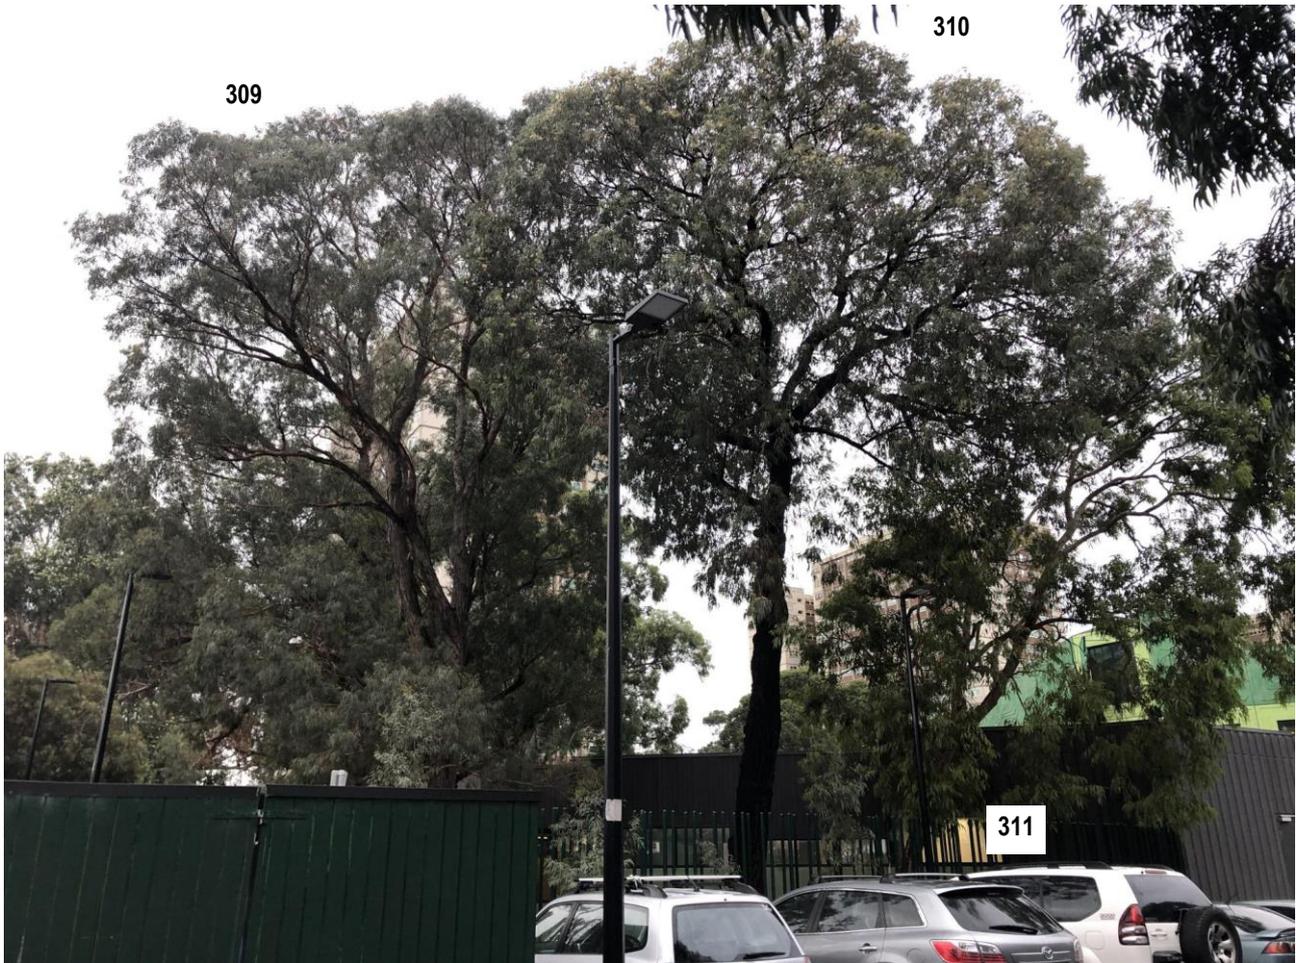
Image 58: Trees 309-310 (Mod. B Red Ironbark) and 311 (Mod. C Spotted Gum), cluster of trees west of Heath Centre. Facing north.

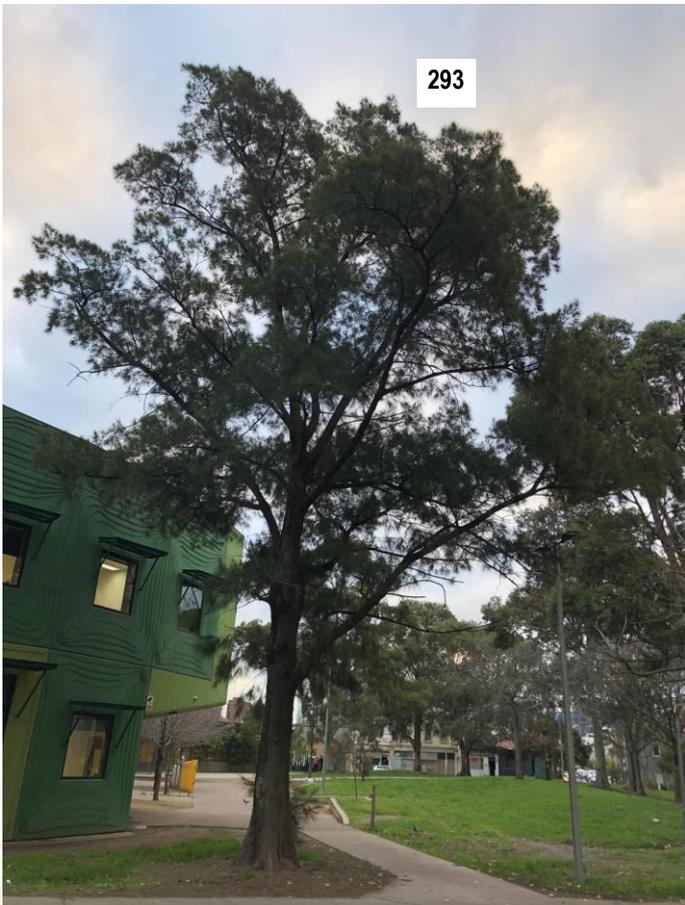
Image 59: Tree 293 (Mod. B River She-oak) northeast of Heath Centre, facing east.

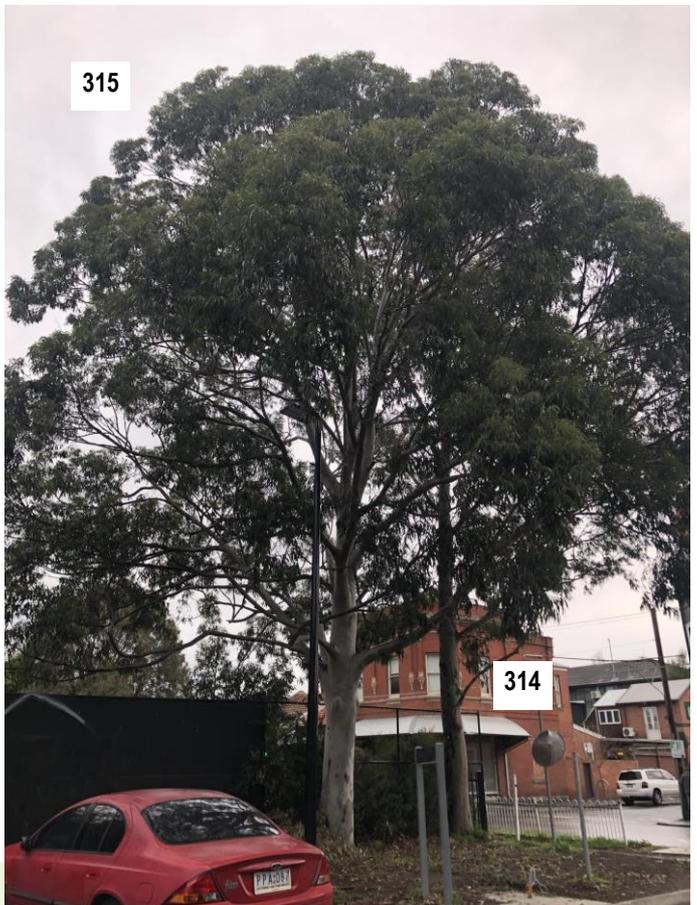
Image 60: Tree 315 (Mod. A Sydney Blue Gum) in Health Centre carpark and northern boundary of primary school, facing southwest.

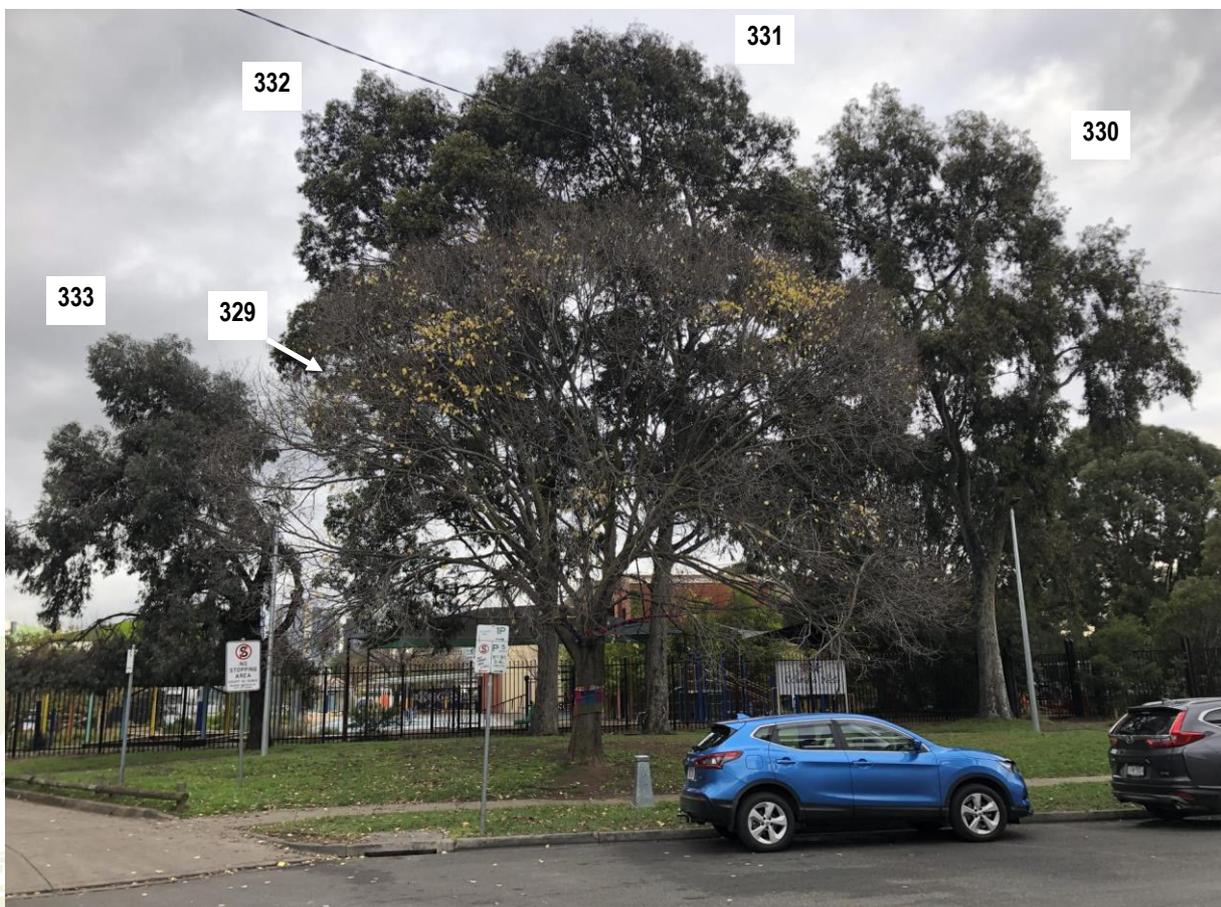
Image 64: Trees 329-333 northeast of primary school, including Mod. B Golden Elm in front (Tree 329), Mod. A Spotted Gums to rear (Trees 330-332) and Mod. C Red Ironbark (Tree 333). Facing west.

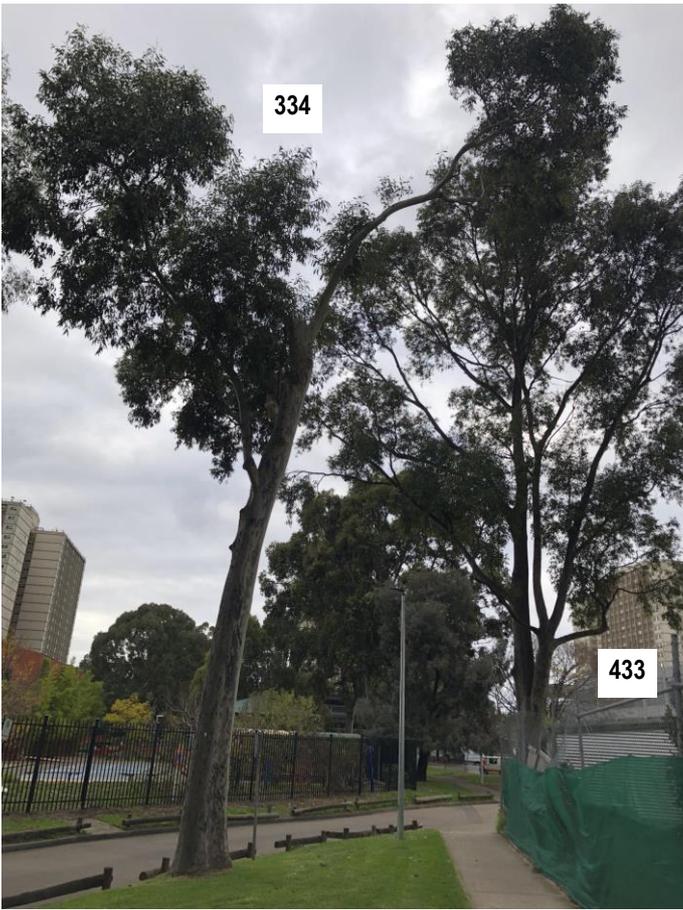
Image 65: Tree 334, Very Low-rated Spotted Gum east of school and west of community garden with snapped leader and limited management options. Facing north.

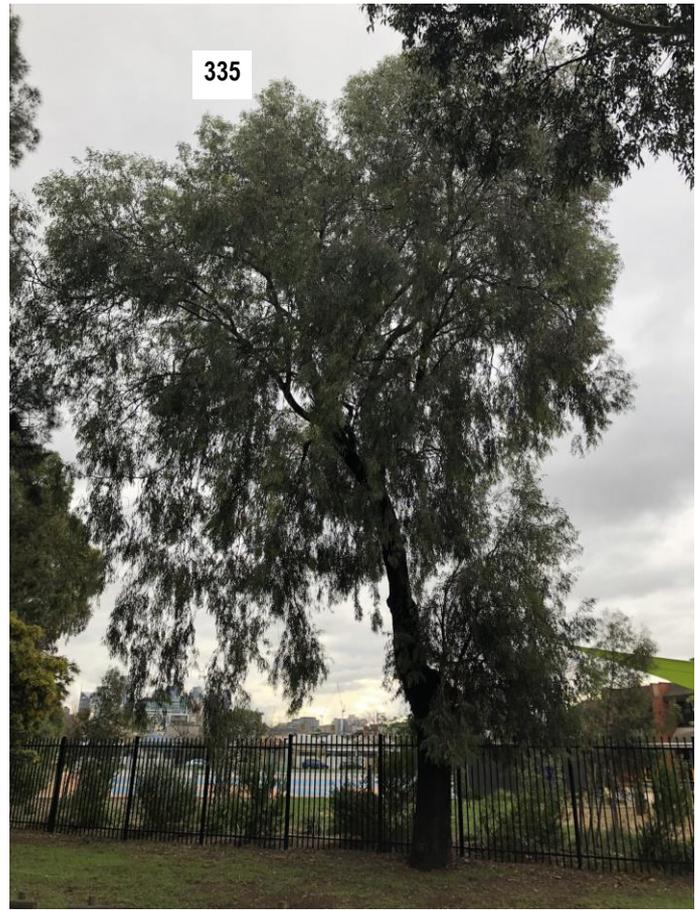
Image 66: Tree 335, Mod.B Red Ironbark east of school.

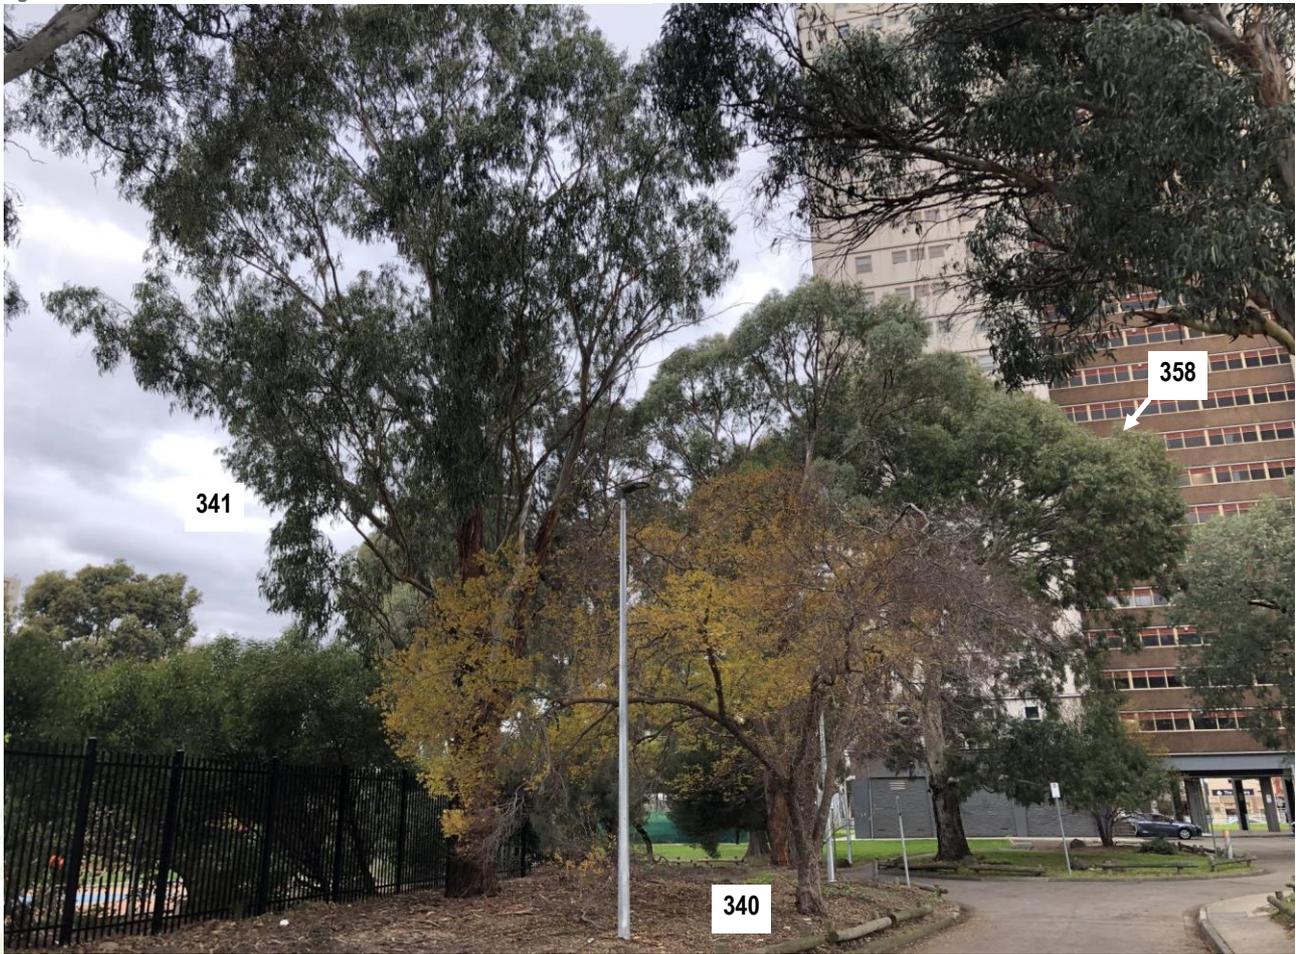
Image 67: Group of trees southeast of school, facing east, including Tree 340 (Mod. B Chinese Elm) and 341 (Mod. C Southern Blue Gum).

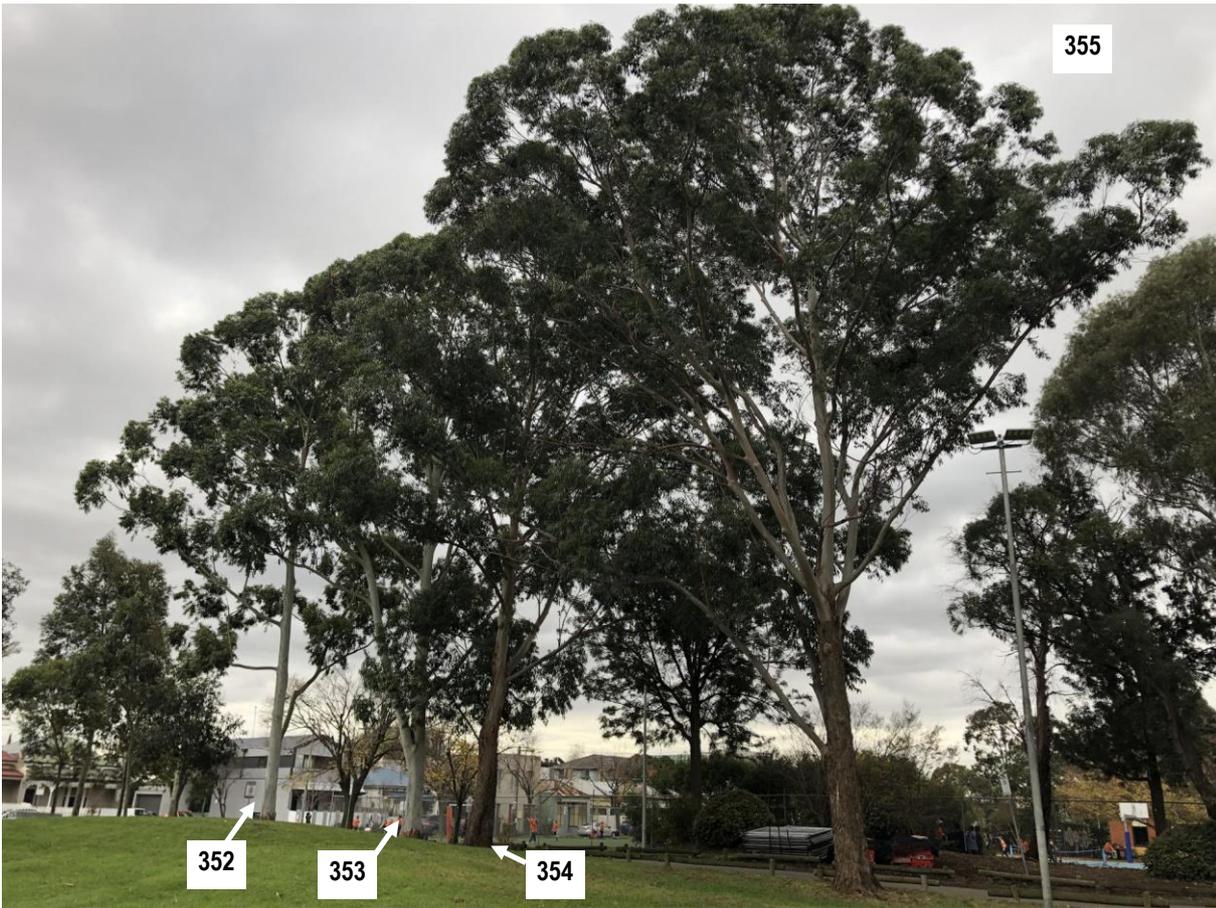
Image 68: Row of Sydney Blue Gums south of driveway along southern boundary of school, showing Trees 352 (Mod.C), 353 (Mod.B), 354 (Mod.A) and 355 (Mod.B). Facing northwest.

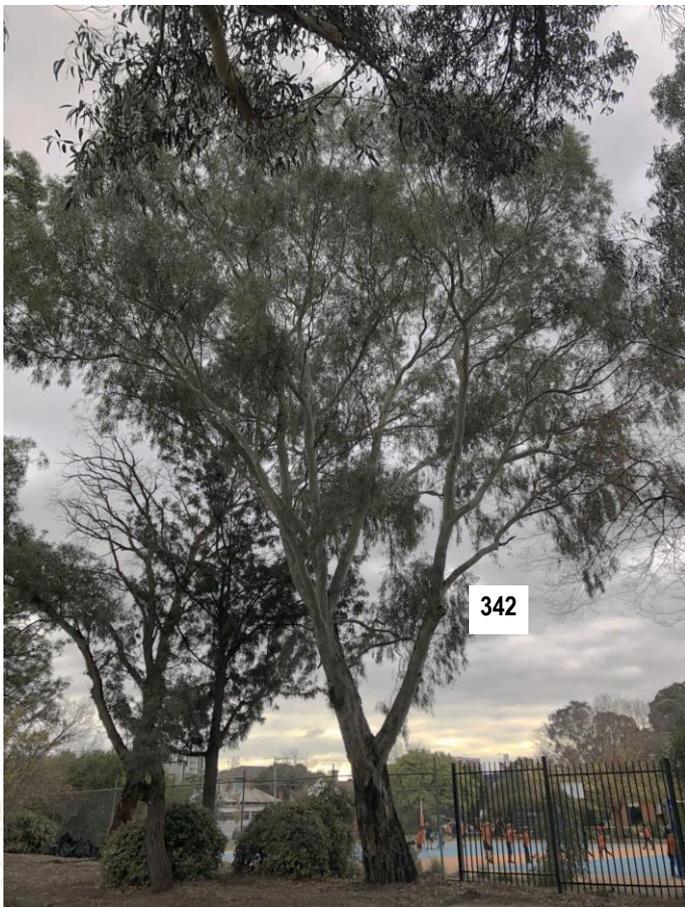
Image 69: Tree 342, Mod. A River Red Gum along southern boundary of primary school. Facing north.

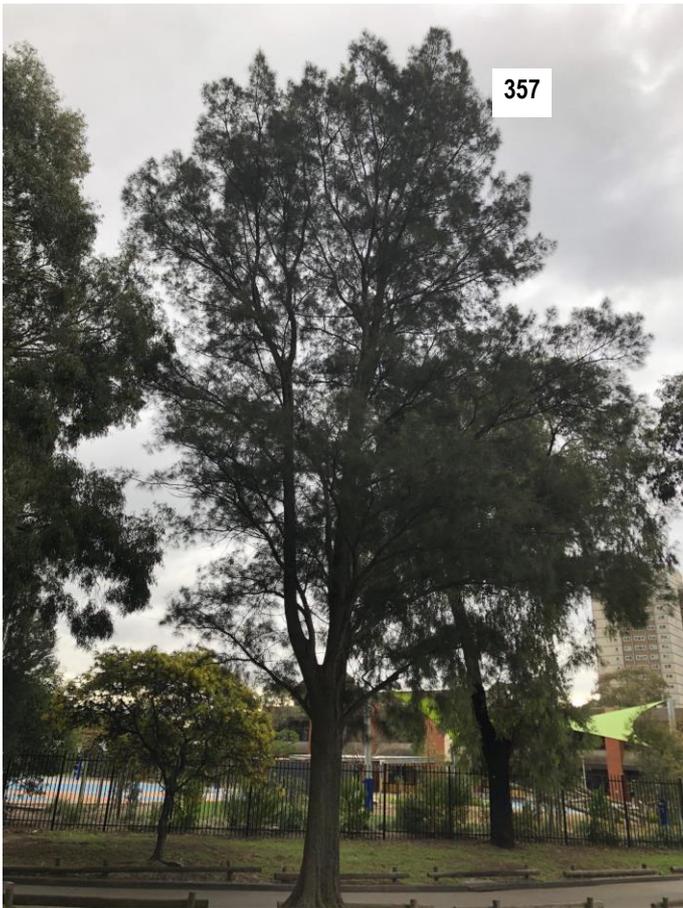
Image 71: Tree 357 (Mod. A River She-oak) southeast of primary school/northwest of southern tower, facing north.

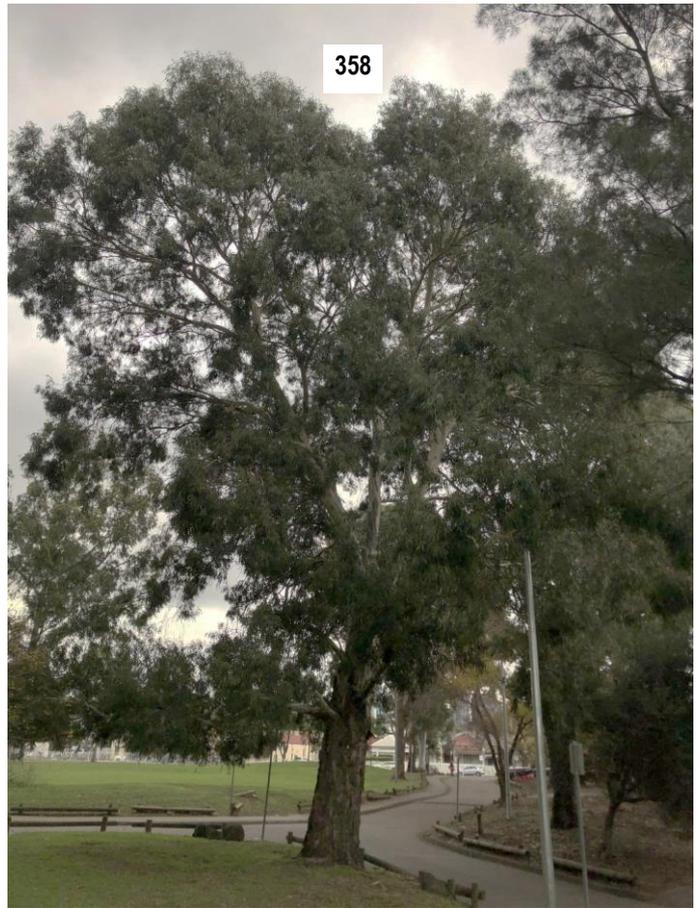
Image 72: Tree 358 (High-rated River Red Gum), southeast of primary school/northwest of southern tower, facing west.

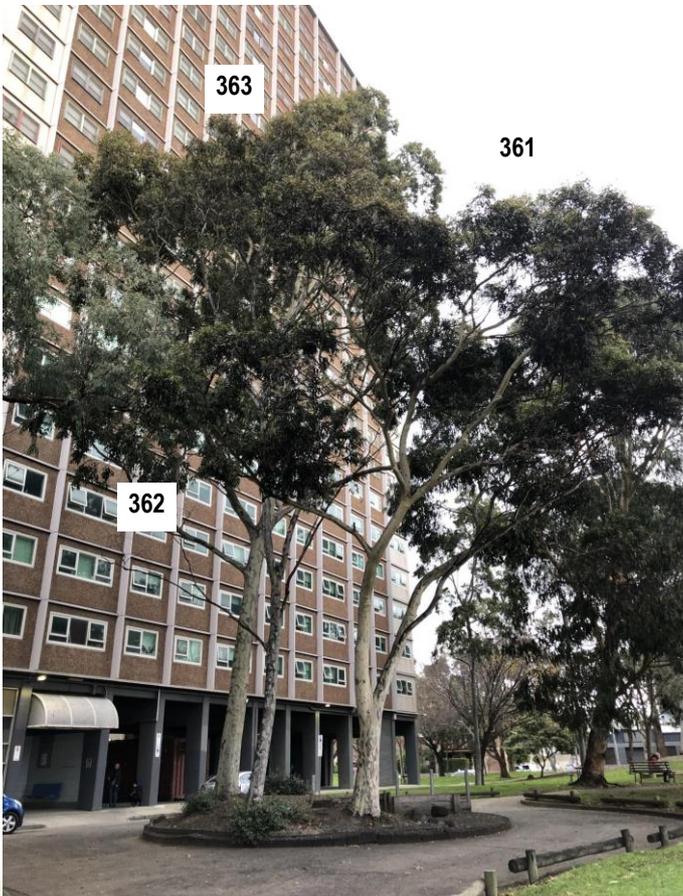
Image 73: Trees 361-363, Mod. B Spotted Gums west of southern tower, facing south.

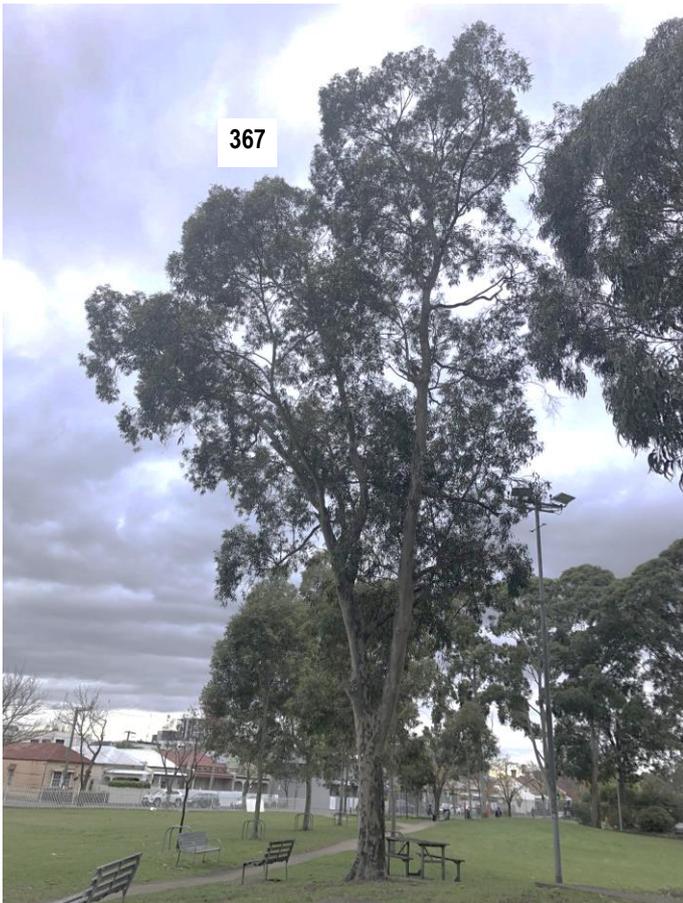
Image 75: Tree 367, Mod. B Spotted Gum in southern open space, facing north.

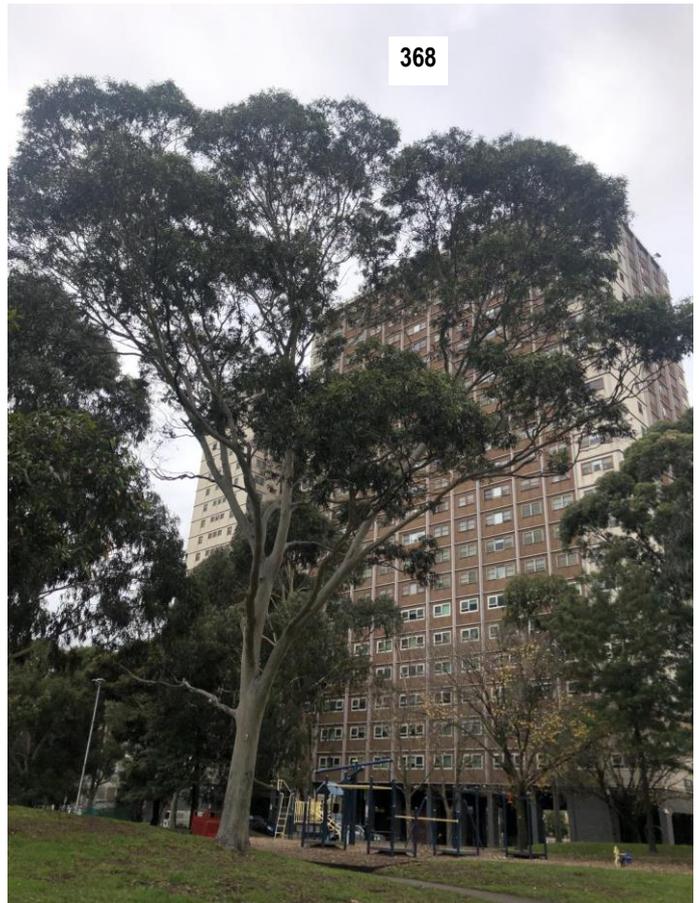
Image 76: Tree 368, Mod. C rated Spotted Gum in southern open space, facing northeast. Tree is significant in landscape in fair or better health however long-term canopy weight management may be an issue.

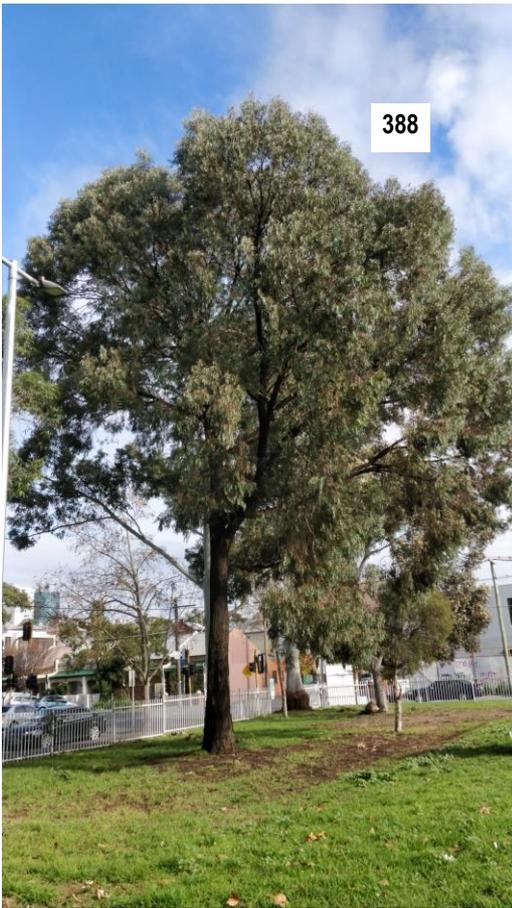
388

Image 79: Tree 388, Mod. B Red Ironbark in southwest open space near Highett Street frontage.

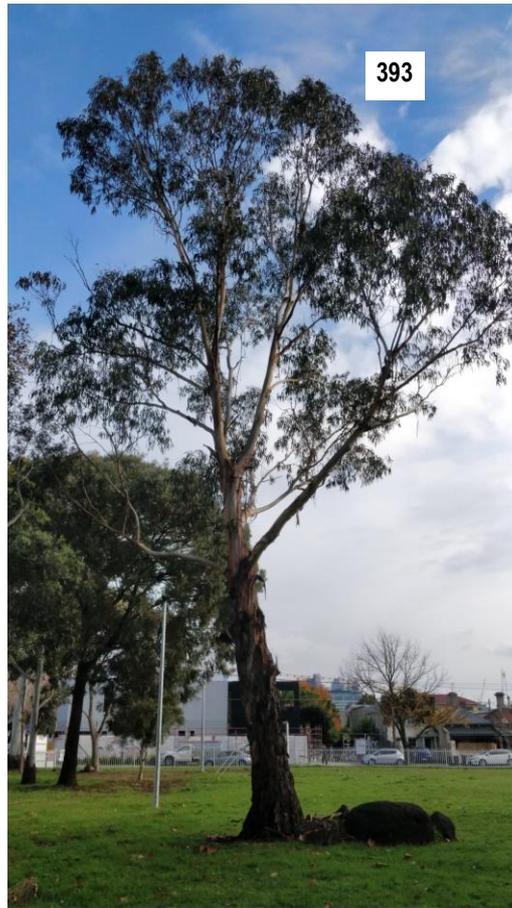
393

Refer to Images 16 and 56 for examples of Moderate A Southern Blue Gums, Images 15, 17, 23, 52, 74 (with fungal bracket) for Moderate B of the same, and Images 14, 25, 35, 37 for a range of Moderate C of the same. Images 70 and 80 show examples of Low-rated Southern Blue Gums in an advanced stage of decline, likely retained in the landscape due to small size (larger examples would have been removed).

Image 80: Tree 393, Low-rated Southern Blue Gum in southwest open space showing advanced fungal decay symptoms in the species.

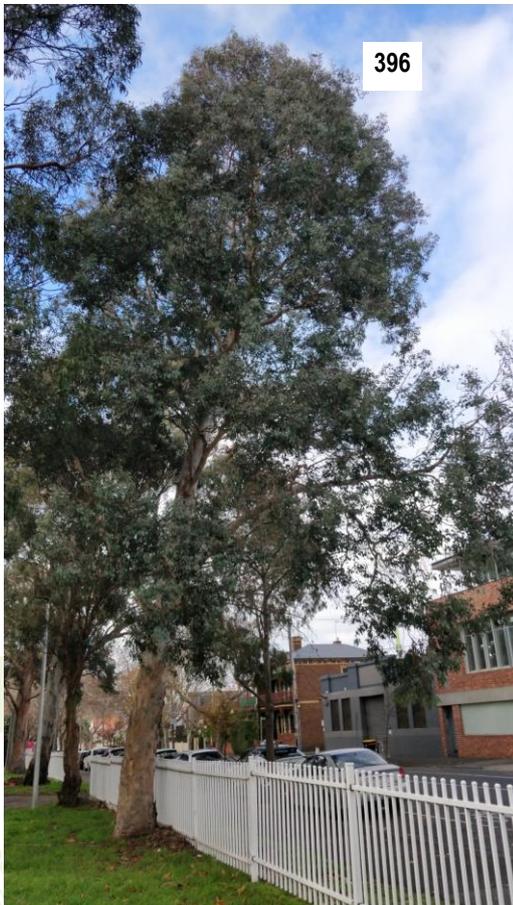
396

Image 81: Tree 396, Mod. A rated Red Box in southern open space along Highett Street frontage. Facing east.

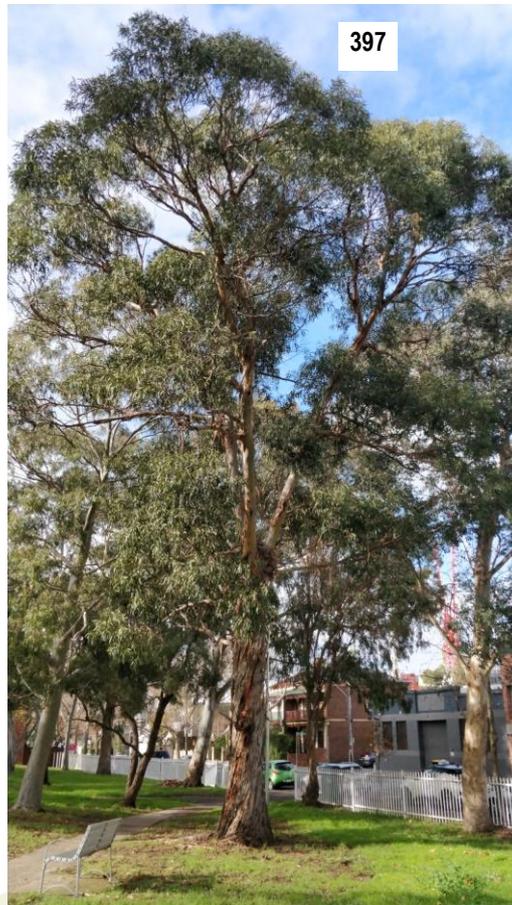
397

Image 82: Tree 397, Mod. C Southern Blue Gum in southern open space near Highett Street frontage. Fungal brackets at past failure point. Facing southeast.

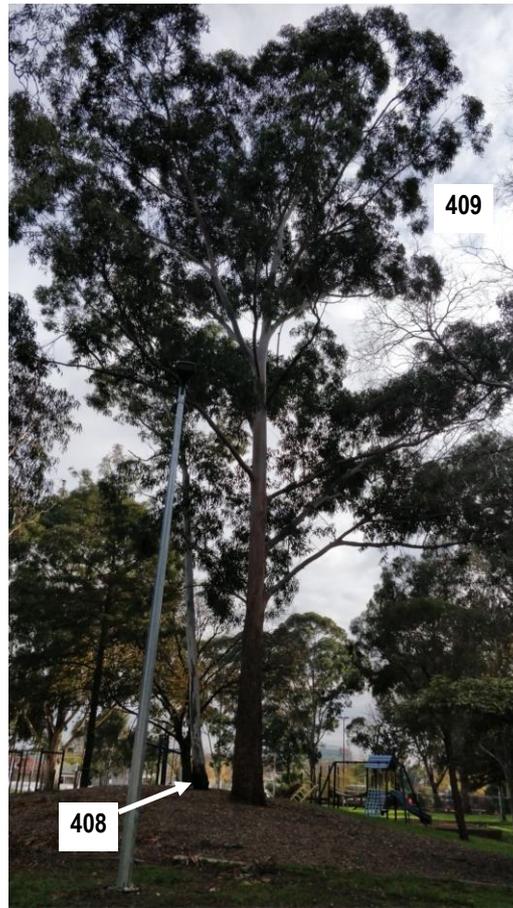
Image 84: Tree 409, Mod. B Sydney Blue Gum in southern open space, facing west.

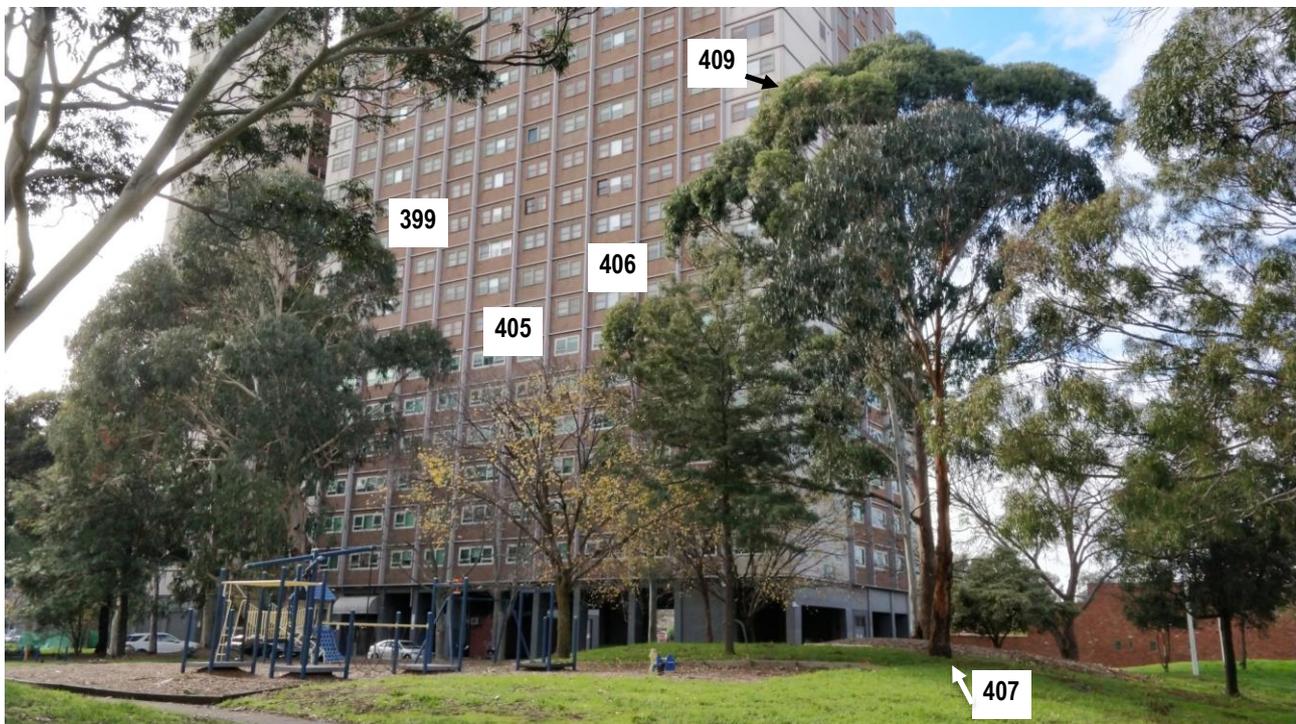
Image 85: Trees southwest of southern tower block around playground, including Tree 399 (Mod. B Southern Gum), 405 (Mod. B Golden Elm), 406 (Mod. C Silky Oak), 407 (Low-rated Southern Blue Gum) and 409 to rear (Mod. B Sydney Blue Gum).

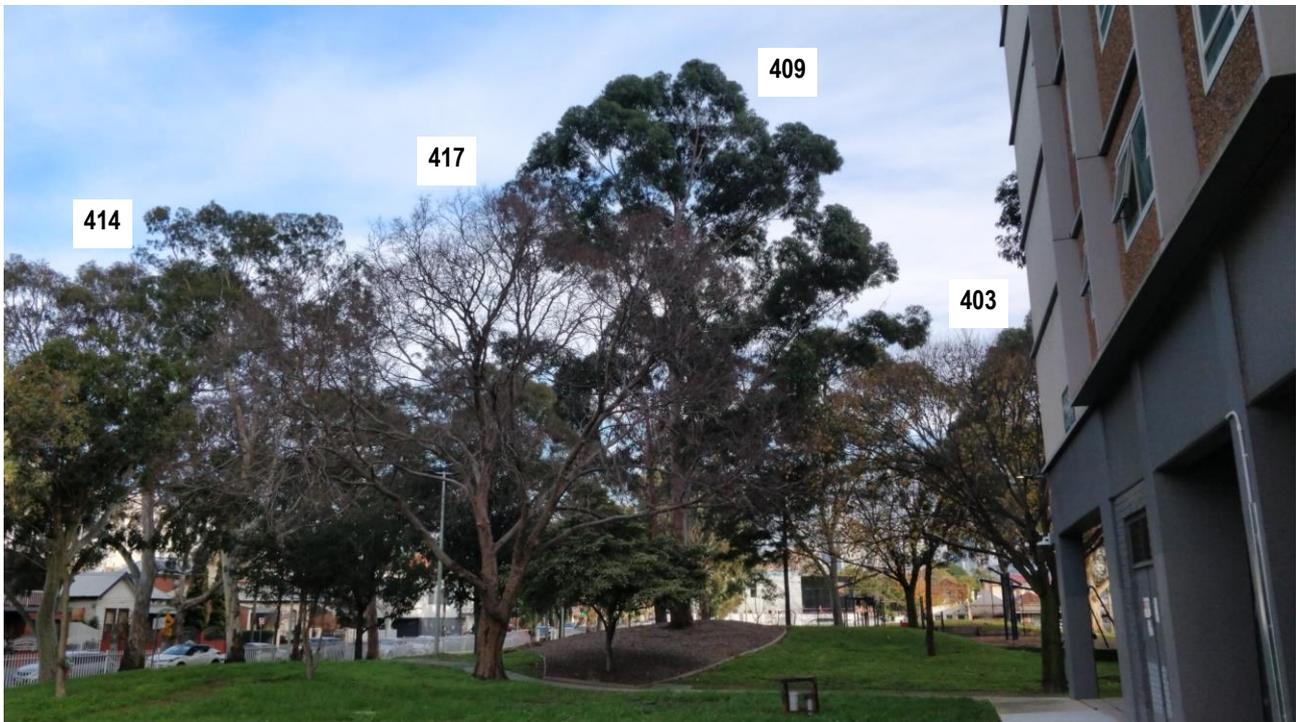
Image 88: Trees south of southern tower block, facing west, showing mixture of tree types and sizes. Including Tree 403 (Mod. B Golden Elm), 417 (Mod. B Chinese Elm), and 409 (Mod. B Sydney Blue Gum) and 414 (Mod. B River Red Gum) to rear.

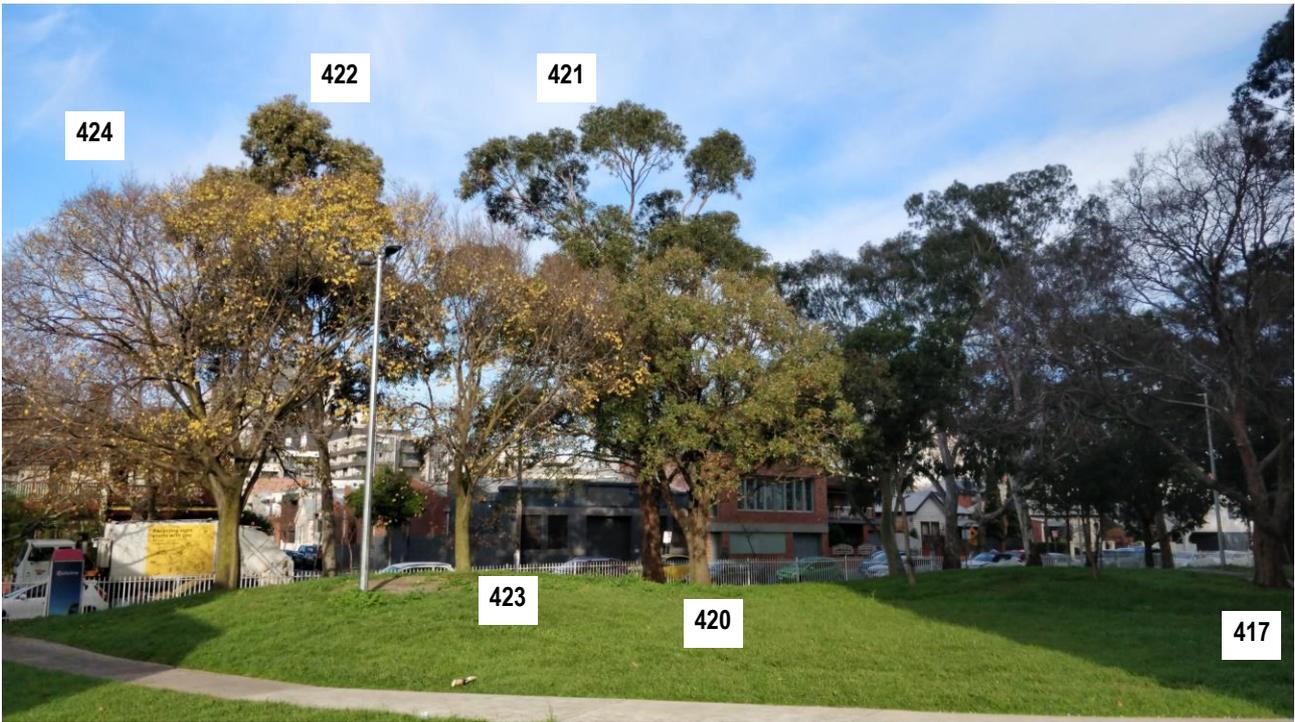
Image 89: Trees south of southern tower block along Highett Street frontage, facing southwest. Trees 420 (Mod. B English Oak), 423 (Mod. C Golden Elm), 424 (Mod. B Golden Elm), and to the rear, 421 (Mod. C Southern Blue Gum) and 422 (Mod. B Spotted Gum).

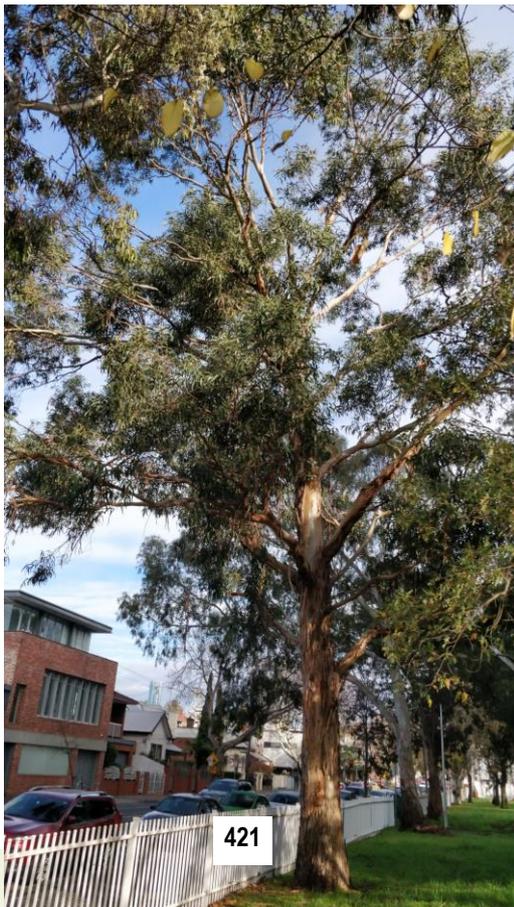
Image 90: Tree 421, Mod. C Southern Blue Gum along Highett Street frontage, facing west

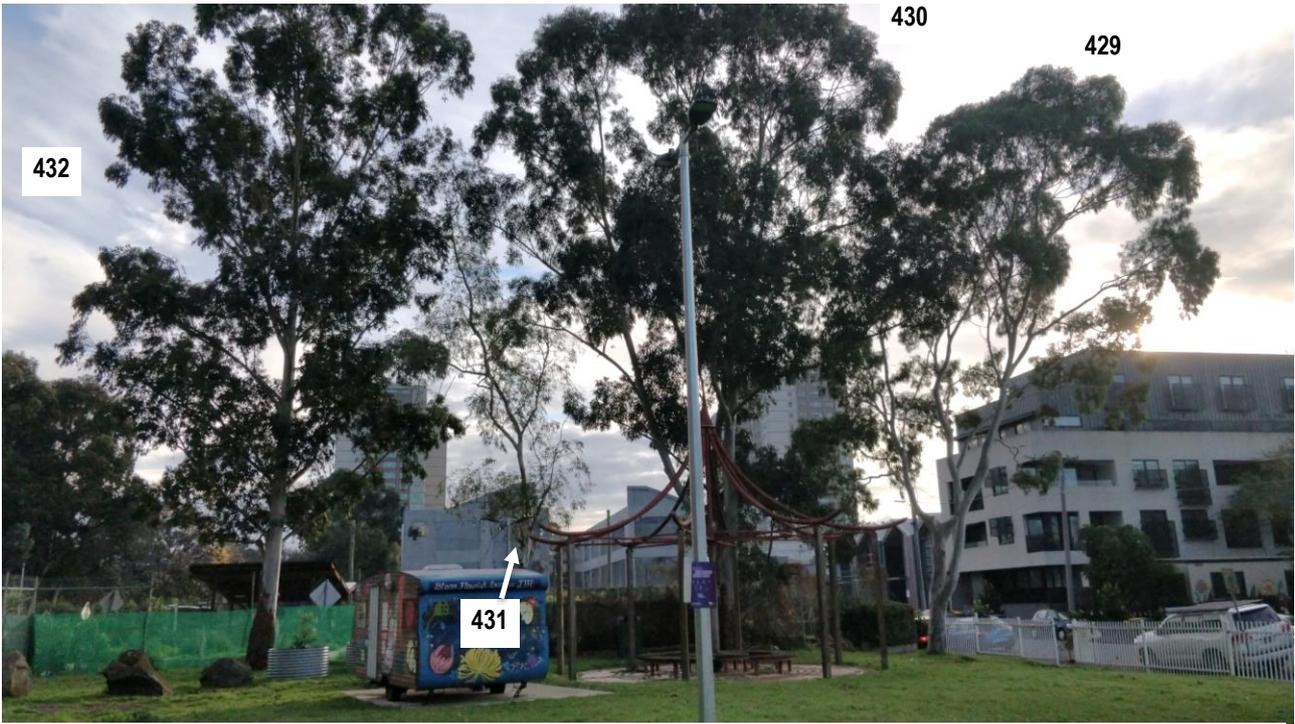
Image 92: Trees to south of community garden, west of Belgium Avenue, facing north. Mod. B trees include Tree 429 (Lemon-scented Gum), 430 and 431 (Sydney Blue Gum).

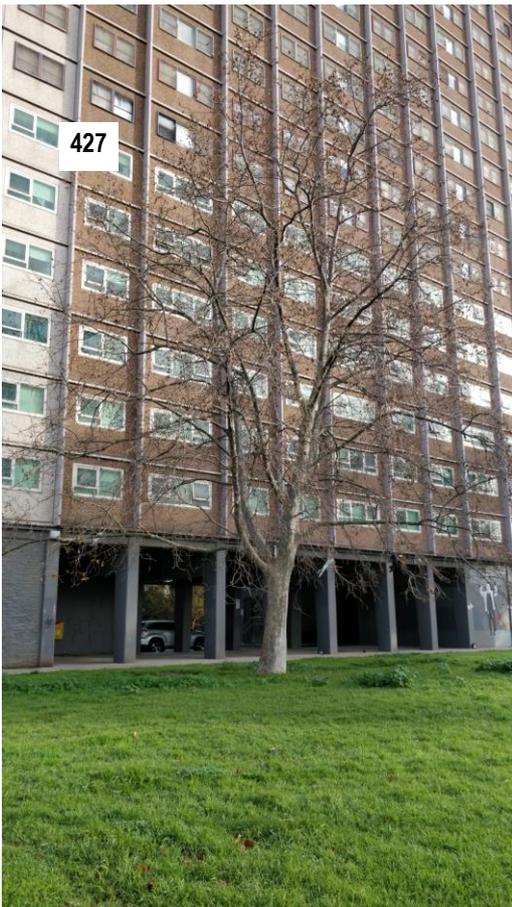
Image 93: Tree 427, Mod. B London Plane east of southern tower block, facing northwest.

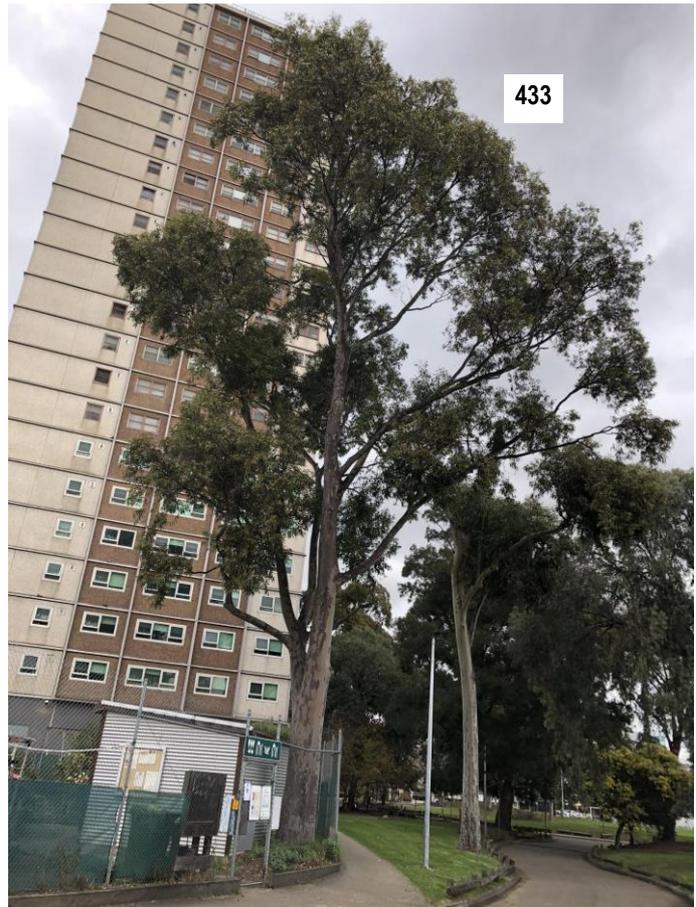
Image 94: Tree 433, Mod. B Spotted Gum at northwestern corner of community garden, north of southern tower block. Facing south.
