## **GEOTECHNICAL ASSESSMENT AND LANDSLIDE RISK ASSESSMENT REPORT**

Our Ref 20250524

Date 27 March 2026

**SITE: CABIN 1A WHITEHORSE VILLAGE ROAD, MOUNT BULLER.**

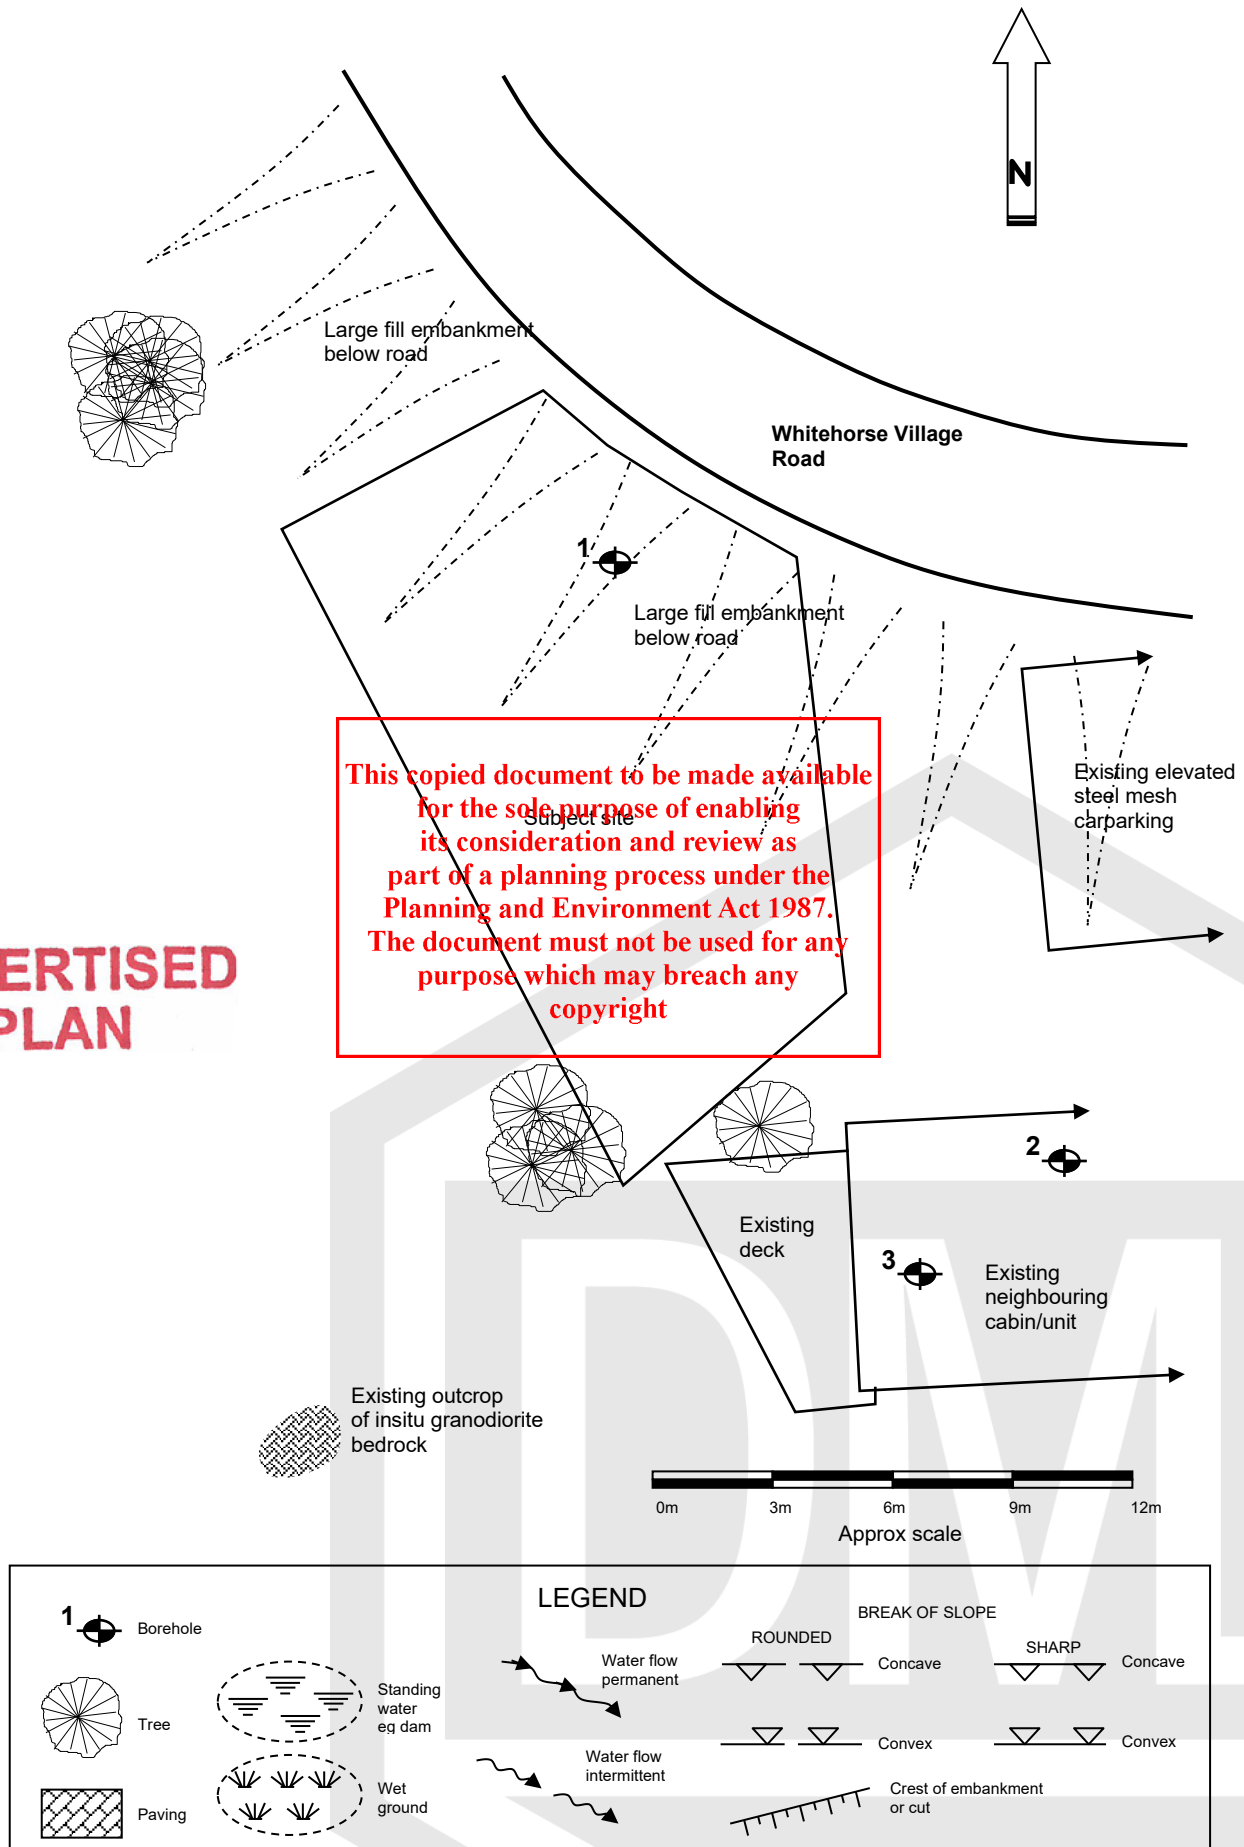
## SITE FEATURES PLAN

During our recent site investigation, it was noted that a large proportion of the site that fronts the low side of the road, has been filled. This filling appears to be associated with the lower fill embankment to facilitate the construction of Whitehorse Village Road. As can be seen from the photographs below, the depth of filling across the front of this site is likely to be in the order of 4.0 to 5.0 m deep.
