Proposed Zipline

Geotechnical Landslide Risk Assessment

Buller Ski Lifts

23 March 2026

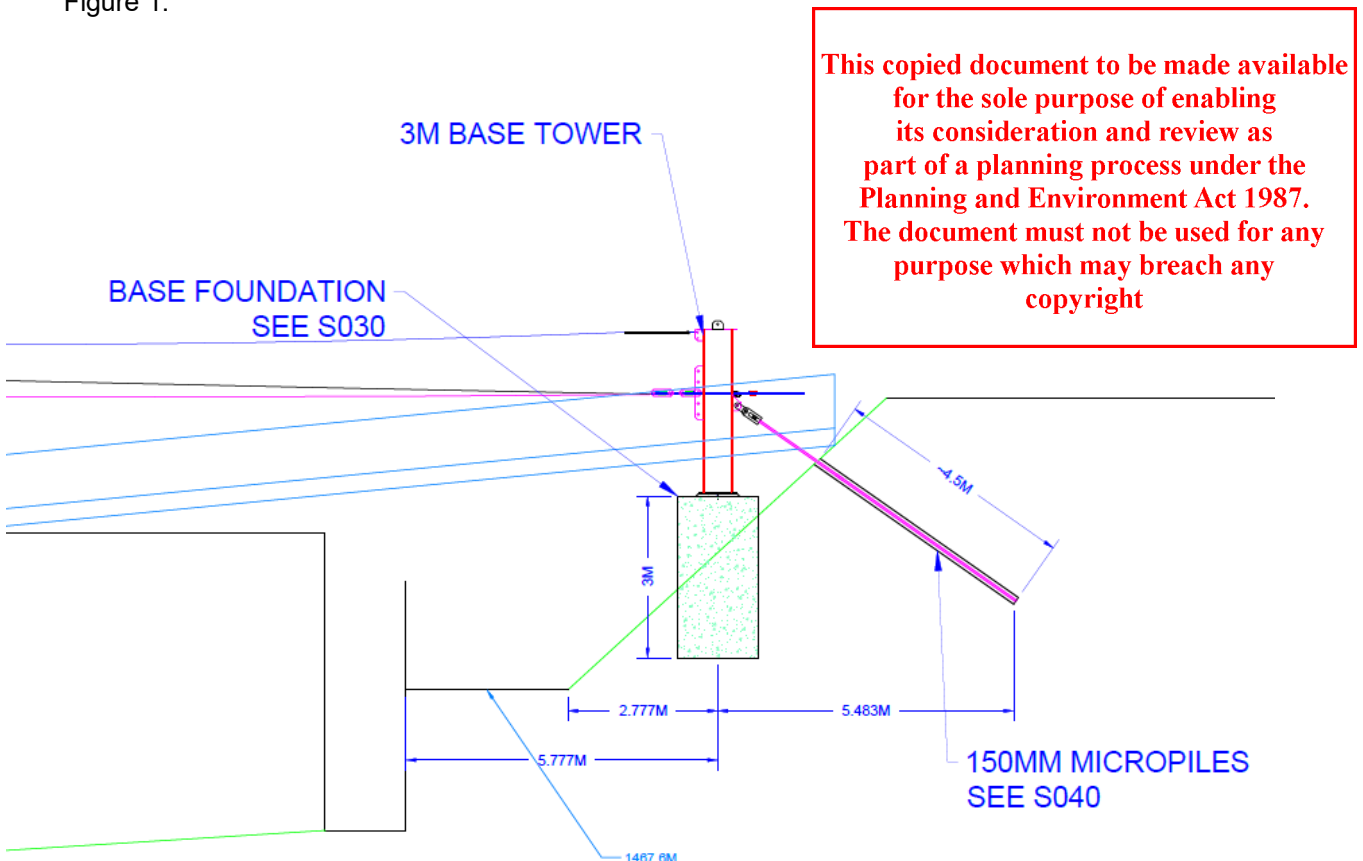
Figure 1 Extract from provided drawing A002 – illustrating construction plan for landing foundation and micropile anchors.

- DSI rod tie backs upslope of foundation, angled at 35°, embedded in 150mm micropiles. Embedded minimum 3500 mm into weathered rock
- Based on the design drawings provided, the required earthworks are assumed to involve excavation of the slope for the tower foundations, including estimated 3 m deep batter on the upslope side, as shown in Figure 1.

The construction drawings provided to GHD indicate a 3 m deep concrete foundation and specifies embedment of the foundation slab 200 mm into weathered rock. The excavation is therefore expected to encounter extremely weathered material and possible fill, and weathered granodiorite rock. Given the highly variable weathering profile and reporting of granodiorite corestones in soil strength material, a deeper embedment may be required to ensure that the foundations are embedded in competent bedrock and not a localised corestone.

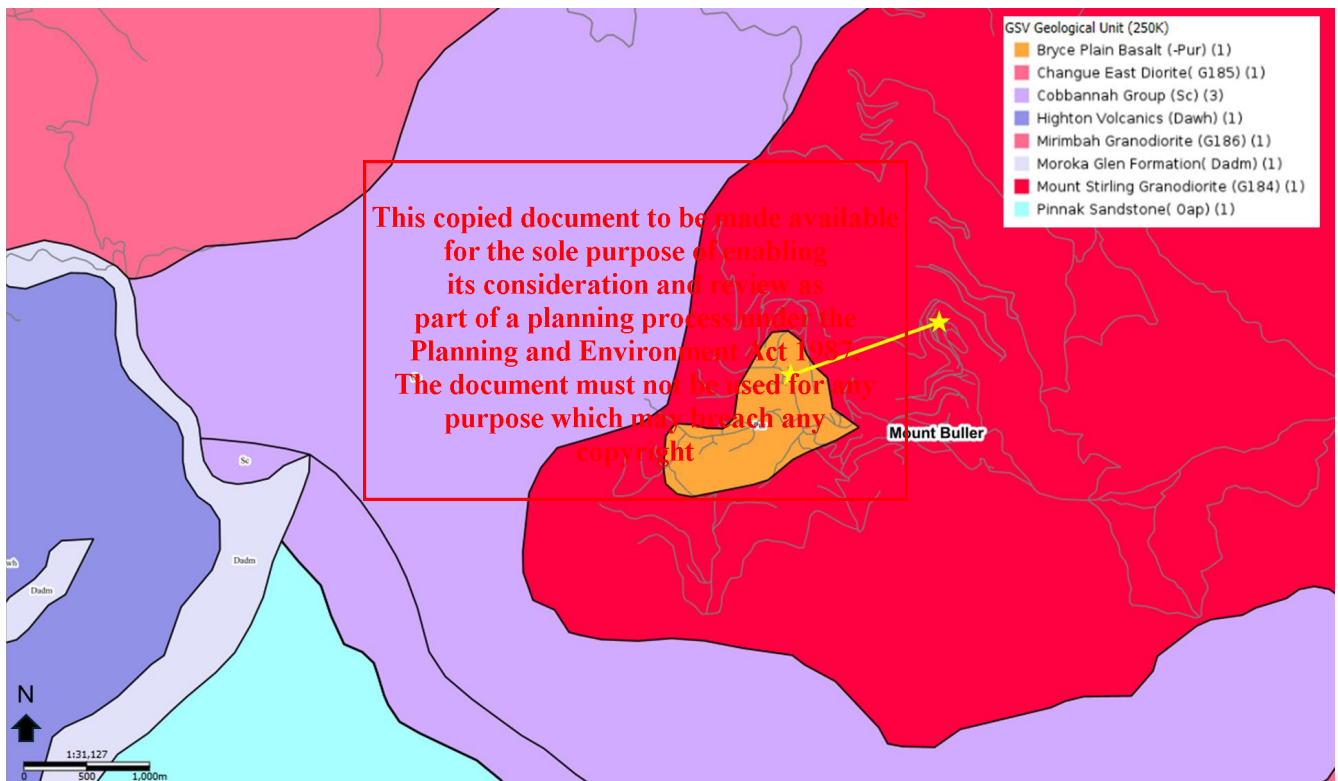
Figure 2 Regional geology of the Mount Buller region with Zipline alignment indicated by yellow markers (map excerpt from Earth Resources' GeoVic portal)

According to the Seamless Geology 1:250 000 scale map (produced by the Geological Survey of Victoria 2007-2014) (Figure 2), the upper zipline structure is situated within the Oligocene to Eocene aged Bryce Plain Basalt (Pur). The basalt is typically an olivine basalt, minor olivine tholeiite, minor hawaiite, lava flows and plugs, with interbedded sedimentary rocks.

The bottom structure is situated within the underlying Late to Middle Devonian aged Mount Stirling Granodiorite (G184), which is typically composed of a medium to coarse grained hornblende granodiorite, diorite, and gabbro. These granitic rocks intrude Ordovician Cobbannah Group (Sc) marine sandstone and mudstone which have developed a wide contact metamorphic aureole between intrusive margins. The contact rocks are typically comprised of quartzite and hornfels which are relatively resistant to erosion. These metamorphic rocks form steep slopes on the northern and western sides of the mountain. The granodiorite has formed flattened ridges and spurs on the east and south of the mountain. Figure 2 shows the granodiorite is locally overlain by remnants of formerly extensive basalt lava flows.

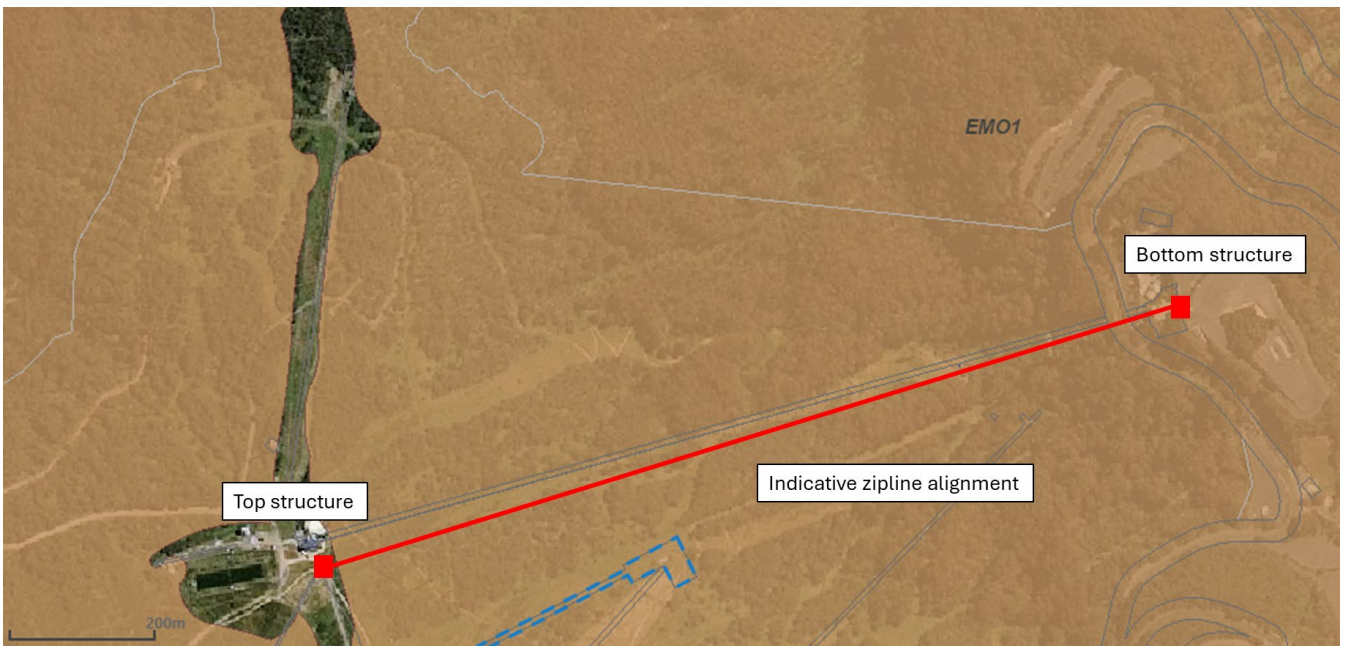
Figure 3 Location of proposed zipline structures relevant to the mapped EMO boundary.

The proposed zipline launch structure is situated on the slope adjacent to the top of the Northside Express Chairlift, outside of the EMO boundary (Figure 3) and therefore does not require a geotechnical and landslide risk assessment. During the site visit, the proposed launch structure location was inspected. The proposed location is positioned on a fill slope up to 20°, composed predominantly of non-engineered boulder fill likely sourced from local excavation works within the granodiorite. The fill depth at the proposed launch structure is expected to be approximately 5 m. No obvious signs of failures or instability in the fill slope were observed. The natural material immediately downslope showed no obvious indication of instability. Given the proposed position outside the EMO and no observed failures, further geotechnical and landslide risk assessment has not been undertaken for the top zipline structure.

The proposed zipline landing structure is situated inside the EMO boundary (Figure 3), and therefore requires a geotechnical and landslide risk assessment. The slope of the proposed construction is a cut and fill slope, located between the downslope Northside Express Chairlift and the upslope Horse Hill carpark (Figure 4). The slope has been altered by cut and fill activities for the carpark, chairlift, and access footpath. The carpark is understood to have been constructed in the early 1980s, followed by upgrades to the Northside Express Chairlift and presumed development of the slope around the same time period. The base of the slope is supported by a ~3.4 m tall crib

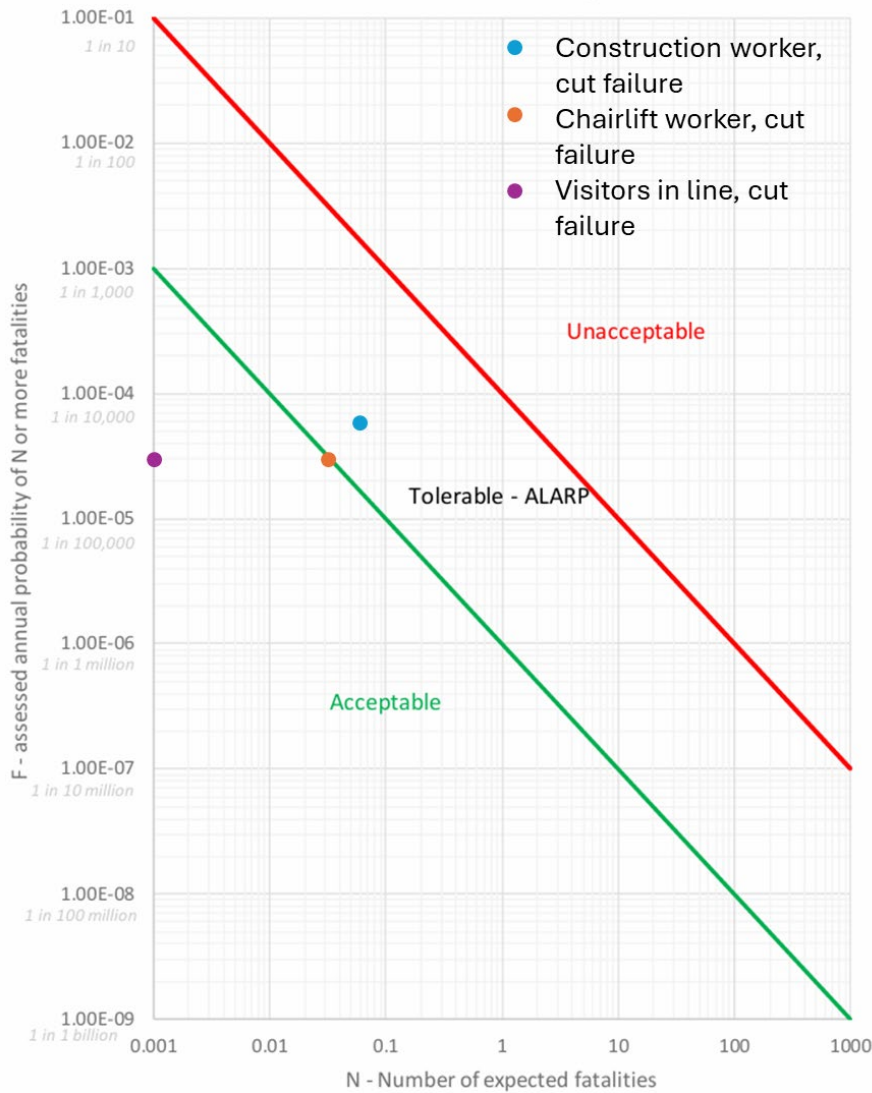
Figure 11 F-N plot for static elements at risk

The adopted N values for this assessment are presented in Table 14. The F-N chart for the elements at risk for each hazard are shown on Figure 11. The estimated societal risks for all elements at risk are within the “acceptable” or “tolerable” categories, as defined by NPWS (2023).
