29 June 2022

Arboricultural Impact Assessment Report regarding twenty-two (22) trees located within the vicinity of the proposed STEM Building at Loyola College

We are pleased to provide you with the following Arboricultural Impact Assessment Report for twenty-two (22) trees within the grounds of Loyola College, 32 Grimshaw Street, Watsonia.

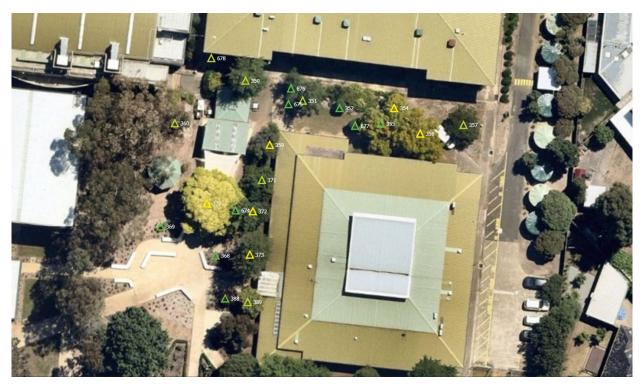
- 5.2.1 The subject trees (Figure 2) have been numbered in line with the existing ArborPlan tree numbering system. As these subject trees form part of a previous survey undertaken for the entire site the numbering may not be consecutive.
- 5.2.2 Trees can be identified on site using tree identification tags which are typically located at approximately 2m from ground level on the southern side of the trunk.
- 5.2.3 All trees were considered to be planted stock of exotic origins. The tree population was relatively young with 68% (15) of the identified subject trees rated as semi-mature specimens, with a further 22% (5) being in the juvenile category and just 3% (2) being classed as mature.

Figure 2. Site map showing subject trees. Note that icon colour indicates trees current risk rating (not Retention Value).
