Arboricultural Assessment and Report

3 Nortons Lane, Wantirna South

27 November 2025

Tree Logic Ref. 013990

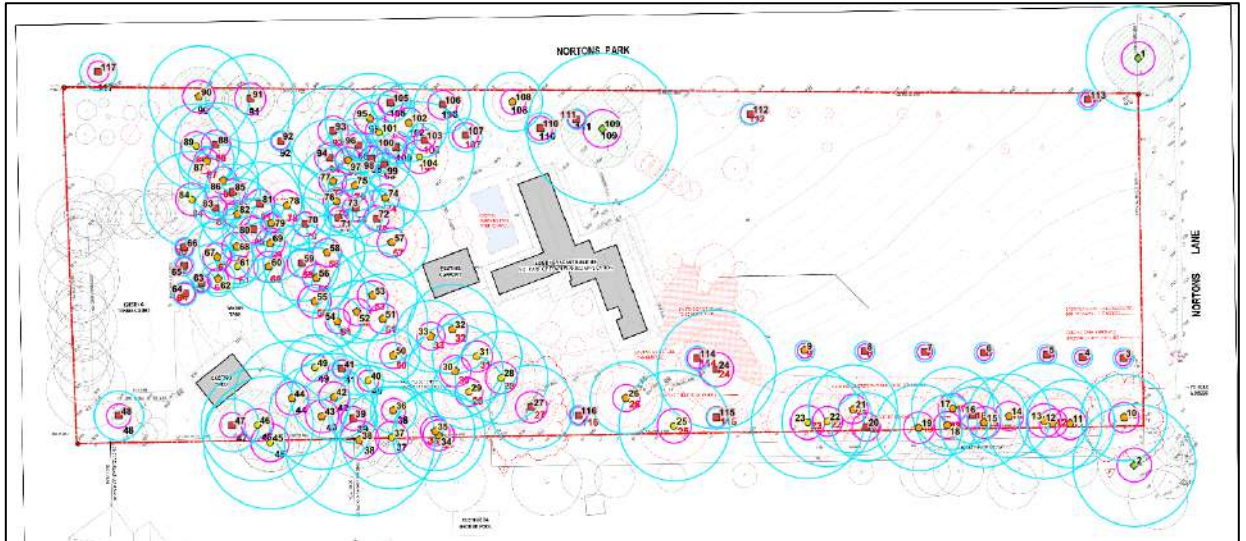
Plate 2. 1566_TP-02 [D] EXISTING CONDITIONS - DEMOLITION PLAN.

The demolition stage shows the removal of,

- The surrounding property brick wall, gate and fencing
- The eastern frontage brick paving and gravel driveway leading up to the main residence
- The southeastern water tank facility.
- Twenty-eight (28) trees and two (2) tree group features in the eastern frontage of the dwelling are slated for removal for construction works.

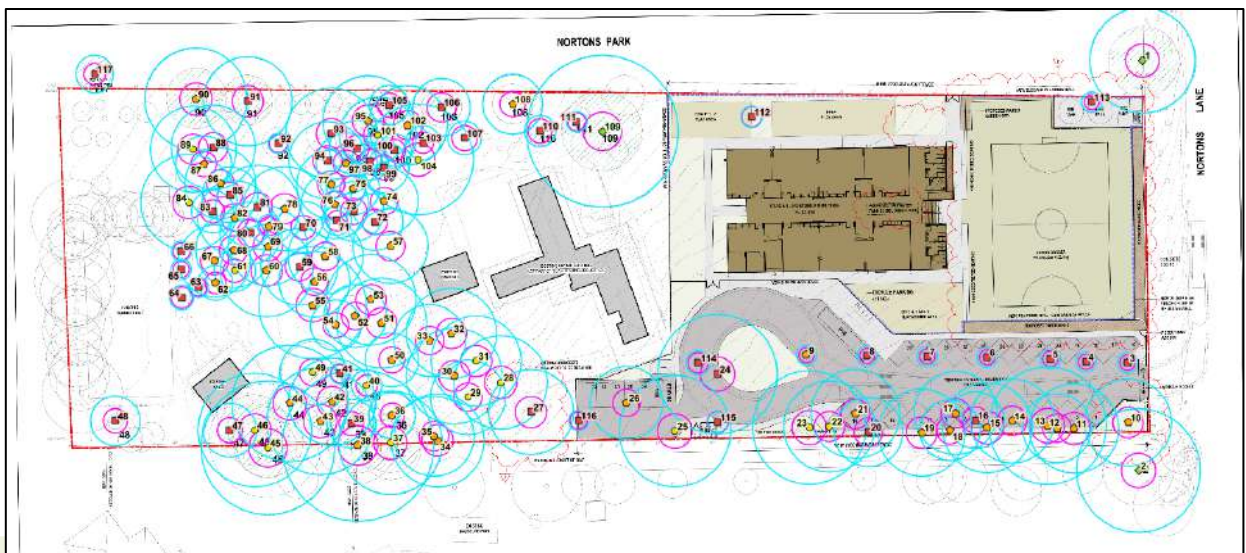
Stage 1 of the proposed development comprises of

- An internal roadway roundabout and car parking provisions

- Construction of a 40 meters long by 30 meters wide soccer field along the northeastern edges of the property
- A refuse area south of the existing dwelling structure
- A relocatable multi classroom facility west adjacent of the soccer field, north of the carpark
- Multiple landscaped play areas around the classroom facility.
- Tree 1, the Yellow Box at the northeastern exterior of the property will encounter minor encroachment from the proposed fencing and soccer field works. It is expected to survive the works with TPZ exclusion fencing.

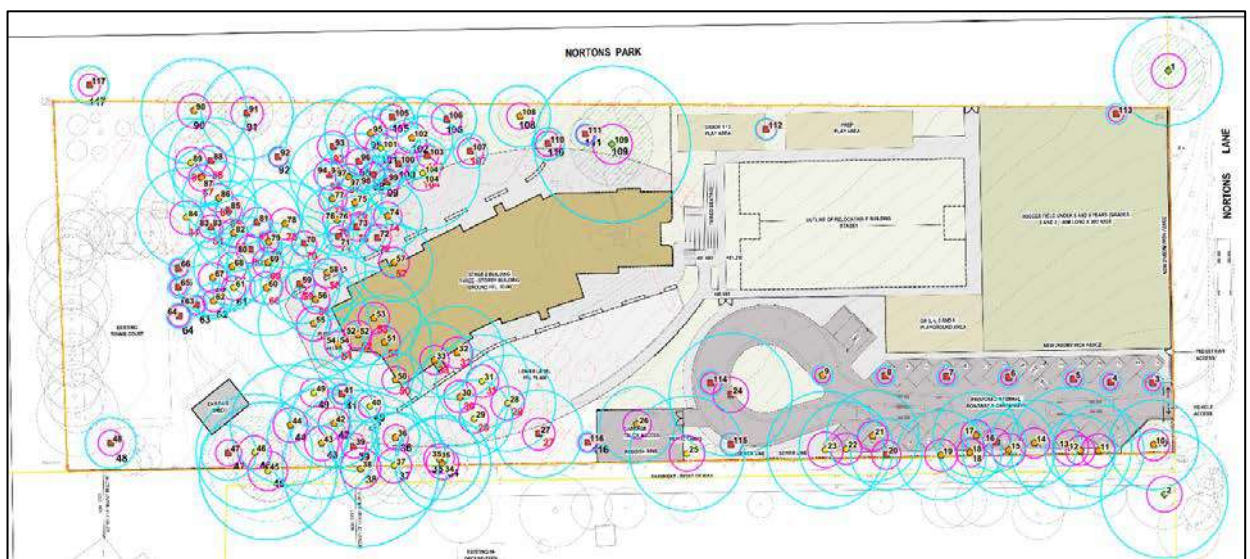
Stage 2 of the proposed development comprises of

- Construction of a multi-level education complex structure in place of the existing dwelling structure.
- Asphalt sectors bordering the north and south of the complex, with the south platform featuring a secondary lower level.
- New landscaping areas to the north and south of the asphalt sector. With level change construction works to occur in the south sector
- According to the proposed plan, forty-five (45) trees and four (4) tree group features are slated to be removal to cater to the construction works.

- Tree 109, the brittle gum located in the northern center of the property, will have TPZ and SRZ encroachment from the proposed works. Given the high arboricultural and amenity value of the tree, due consideration should be given to its retention through the development works. A Non-destructive root investigation (NDRI) should be undertaken prior to any work to establish the extent of the root structure. Root sensitive construction methods such as hydro excavation within the confines of the tree's TPZ are advised to minimize any damage to structural roots of the tree. The extent of the north asphalt sector should steer clear of the tree's SRZ to not compromise the structural integrity of the root plate. With these measures implemented, the tree is expected to survive the works.

- Trees 68-89 and 93-104 are Monterey Pines that were growing within proximity as a group. Groups of trees such as these should not be fragmented as this can expose remaining trees to new wind-loading and possibly increase the chances of tree or limb failure. In this case, where multiple trees within this cluster have been plan-marked for removal/ affected by the proposed works, they are all recommended for removal, with new canopy plantings as a replacement in alternative areas of the property.

- Trees 95, 108, and 109 will have their TPZs encroached by landscaping works to facilitate new planting. Landscaping design and construction should be sensitive to the site conditions and avoid soil level changes near retained trees. Changes in moisture levels, loss of tree roots and soil level changes can have detrimental effects on trees. It is recommended that with reference to the above trees, the proposed landscaping is to be tree sensitive, with garden beds or planter boxes / structures to be placed directly on ground or secured with individual footings instead of topping up existing soil level.
- It is also recommended that mulching and underplanting be part of the overall landscaping design to enhance the condition of root zones around retained trees.

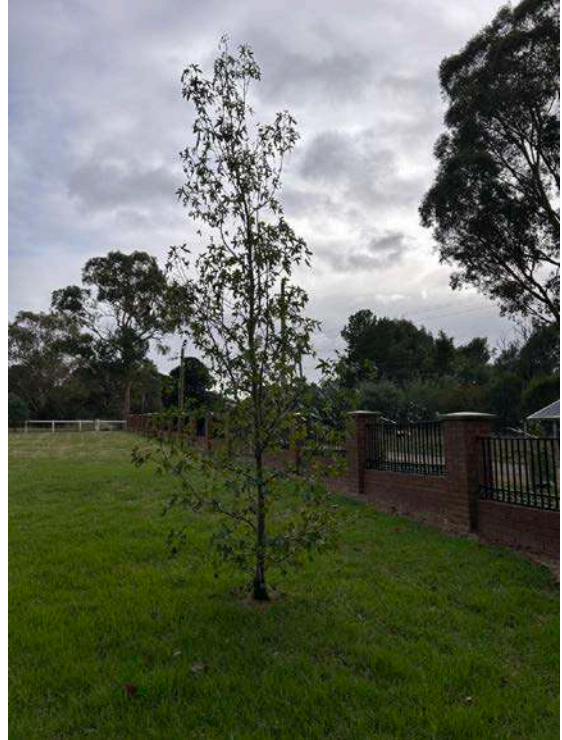
Tree ID: 4. *Acer rubrum* (Red Maple), Semi-mature Exotic deciduous.
DBH: 9cm. Arb. Rating: Low. 1m Adjacent to tap point.. TPZ (rad. m): 2. SRZ (rad. m): 1.5.

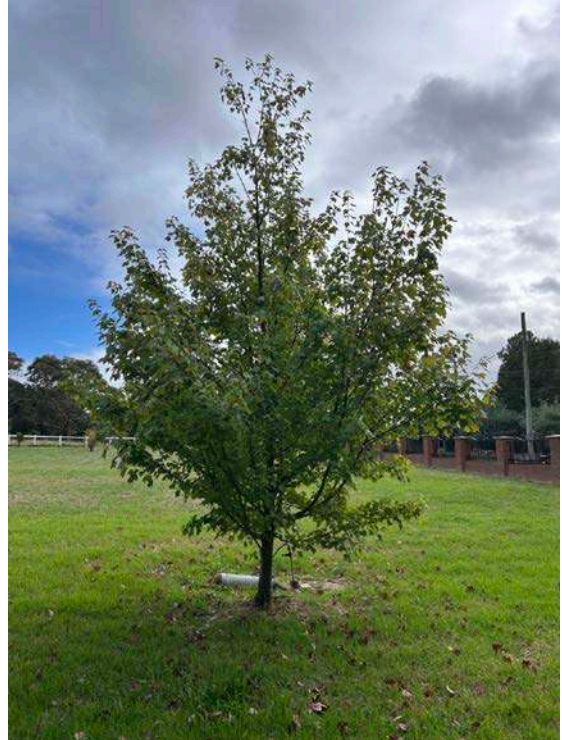
Tree ID: 5. *Acer rubrum* (Red Maple), Semi-mature Exotic deciduous.
DBH: 9,8cm. Arb. Rating: Low. Included bark forks.. TPZ (rad. m): 2. SRZ (rad. m): 1.5.

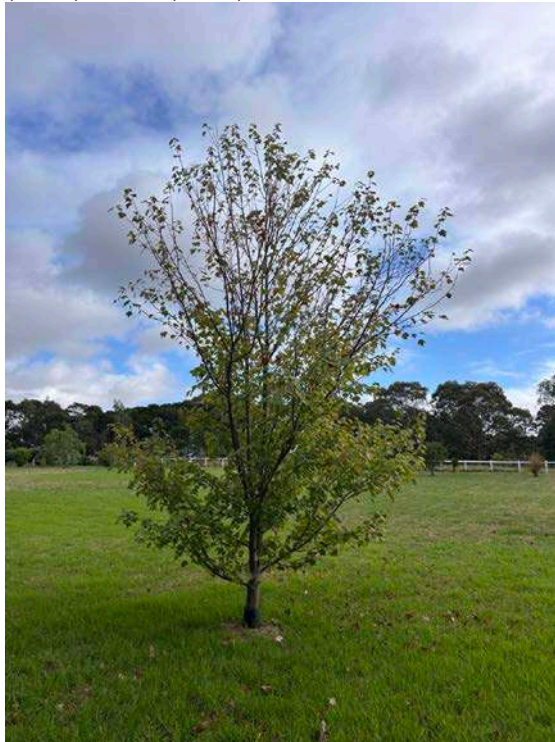
Tree ID: 7. *Acer rubrum* (Red Maple), Semi-mature Exotic deciduous.
DBH: 11cm. Arb. Rating: Low. Possible shedding.. TPZ (rad. m): 2. SRZ (rad. m): 1.5.

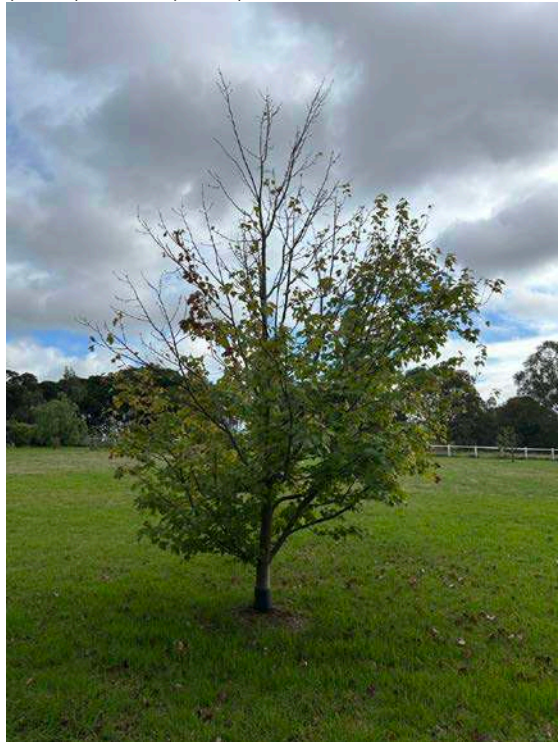
Tree ID: 6. *Liquidambar orientalis* (Oriental Sweet Gum), Semi-mature Exotic deciduous.
DBH: 9cm. Arb. Rating: Low. Reduced foliage density. Possible shedding.. TPZ (rad. m): 2. SRZ (rad. m): 1.5.

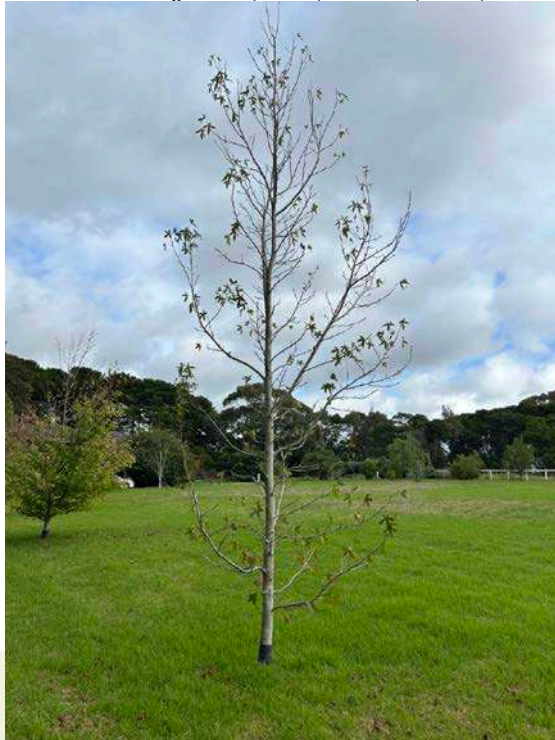
Tree ID: 8. *Acer rubrum* (Red Maple), Semi-mature Exotic deciduous.
DBH: 9cm. Arb. Rating: Low. Minor dieback. Possible shedding.. TPZ (rad. m): 2. SRZ (rad. m): 1.5.

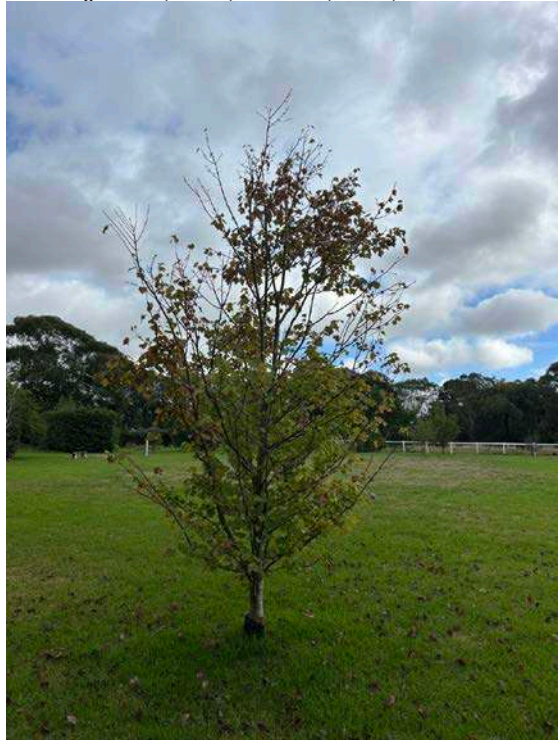
Tree ID: 9. *Liquidambar orientalis* (Oriental Sweet Gum), Semi-mature Exotic deciduous.
DBH: 13cm. Arb. Rating: Mod.C. Acute forks.. TPZ (rad. m): 2. SRZ (rad. m): 1.5.

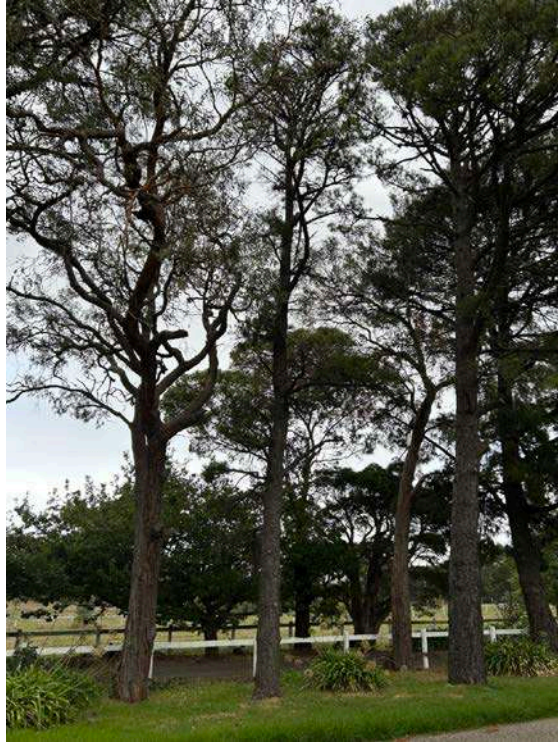
Tree ID: 17. *Pinus radiata* (Monterey Pine), Maturing Exotic conifer.
DBH: 68cm. Arb. Rating: Mod.C. Deadwood >50mm..
TPZ (rad. m): 8.2. SRZ (rad. m): 2.9.

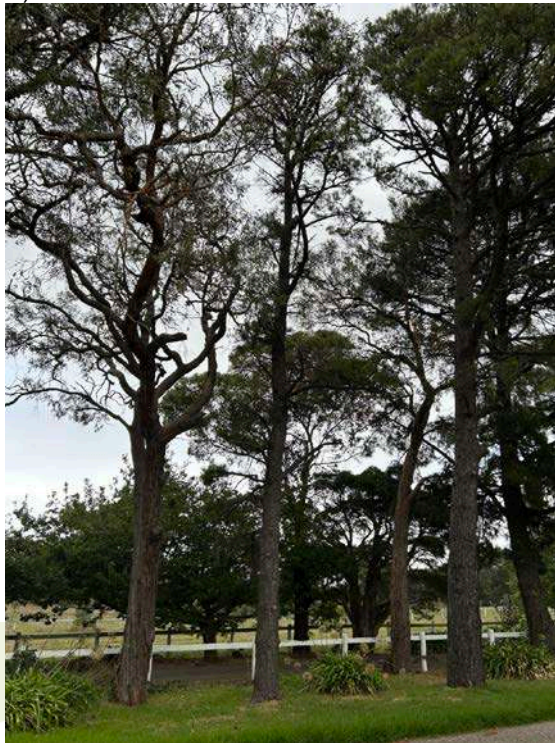
Tree ID: 19. *Pinus radiata* (Monterey Pine), Maturing Exotic conifer.
DBH: 72cm. Arb. Rating: Mod.C. Co-dominant stems..
TPZ (rad. m): 8.6. SRZ (rad. m): 3.1.

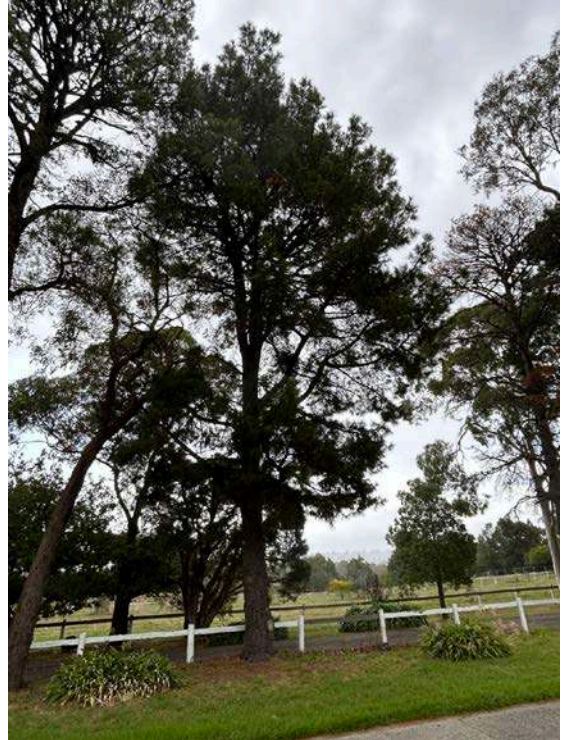
Tree ID: 20. *Pinus radiata* (Monterey Pine), Maturing Exotic conifer.
DBH: 57cm. Arb. Rating: Low. Deadwood >50mm, reduced foliage density.. TPZ (rad. m): 6.8. SRZ (rad. m): 2.8.

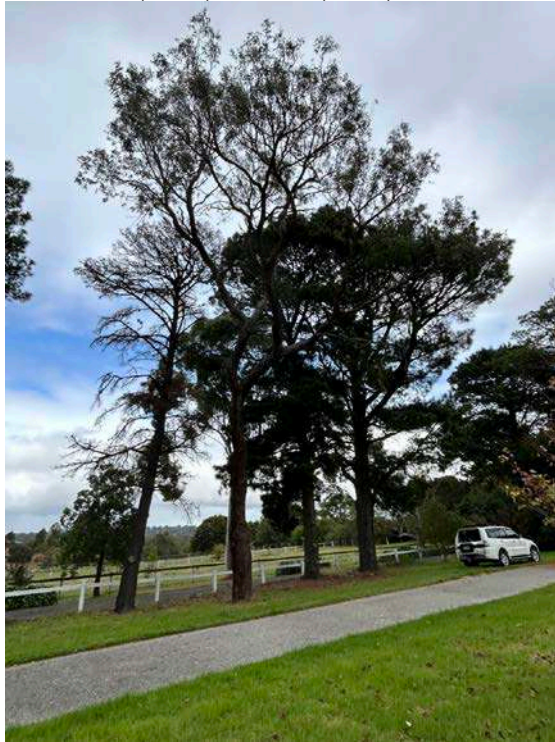
Tree ID: 22. *Pinus radiata* (Monterey Pine), Maturing Exotic conifer.
DBH: 75cm. Arb. Rating: Mod.B. Crown bias-e.. TPZ (rad. m): 9. SRZ (rad. m): 3.

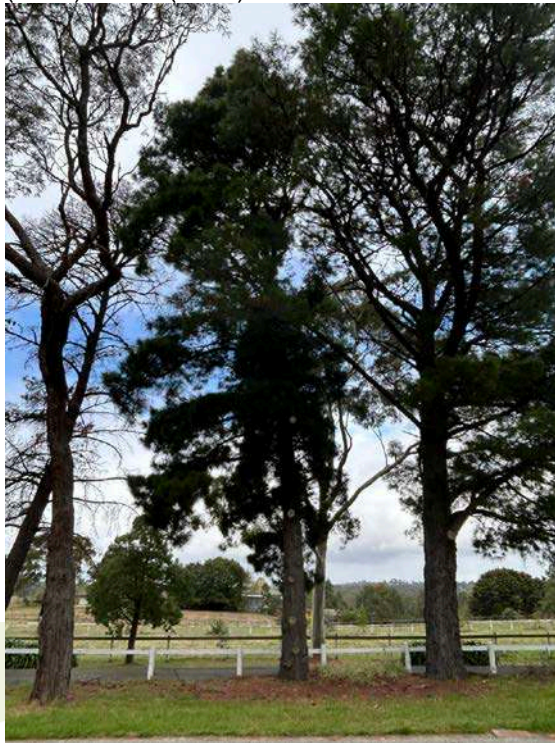
Tree ID: 23. *Pinus radiata* (Monterey Pine), Maturing Exotic conifer.
DBH: 93cm. Arb. Rating: Mod.B. Deadwood >50mm, over-extended limbs developing.. TPZ (rad. m): 11.2. SRZ (rad. m): 3.4.

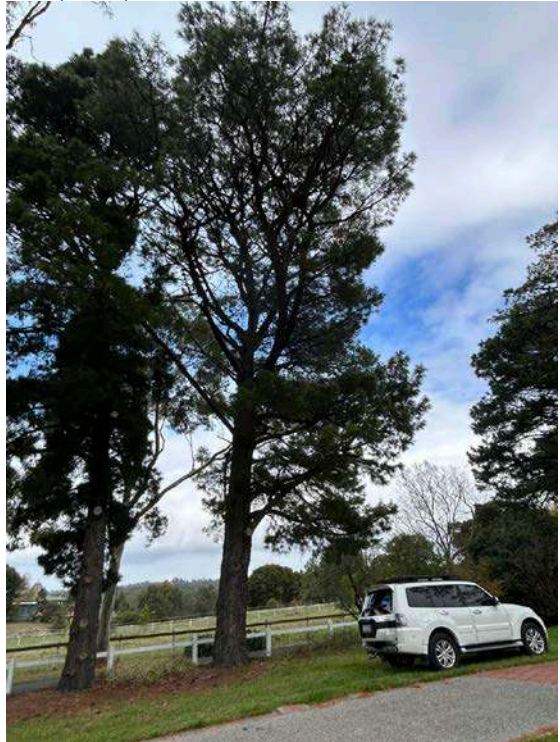
Tree ID: 24. *Pinus radiata* (Monterey Pine), Maturing Exotic conifer.
DBH: 98cm. Arb. Rating: Low. Deadwood >50mm, reduced foliage density, tip dieback. Poor pruning. Minor trunk lean - self corrected. 3227.. TPZ (rad. m): 11.8. SRZ (rad. m): 3.4.

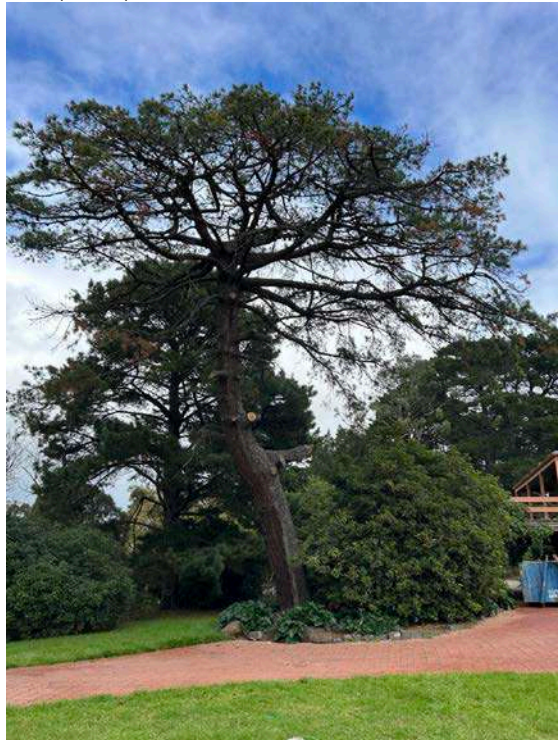
Tree ID: 25. *Pinus radiata* (Monterey Pine), Maturing Exotic conifer.
DBH: 92cm. Arb. Rating: Mod.B. Deadwood >50mm.
Check sp. *Pittosporum undulatum* in understorey.. TPZ (rad. m): 11. SRZ (rad. m): 3.4.

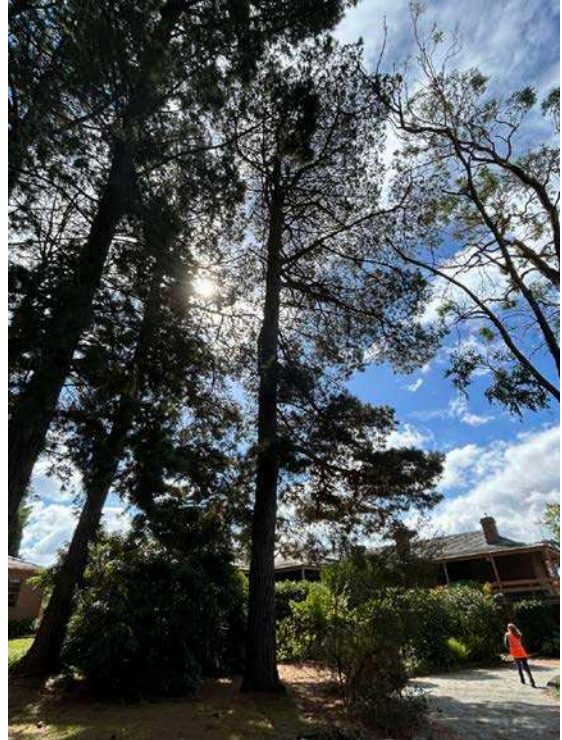
Tree ID: 29. *Pinus radiata* (Monterey Pine), Maturing Exotic conifer.
DBH: 62cm. Arb. Rating: Mod.B. Deadwood >50mm, crown bias-sw. Slight trunk lean to south. TPZ (rad. m): 7.4. SRZ (rad. m): 2.8.

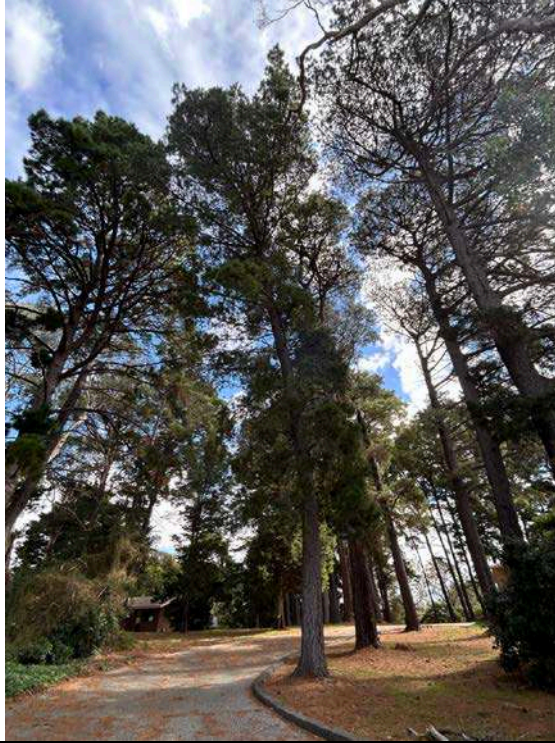
Tree ID: 30. *Pinus radiata* (Monterey Pine), Maturing Exotic conifer.
DBH: 79cm. Arb. Rating: Mod.C. Co-dominant stems, deadwood >50mm, over-extended limbs developing.. TPZ (rad. m): 9.5. SRZ (rad. m): 3.1.

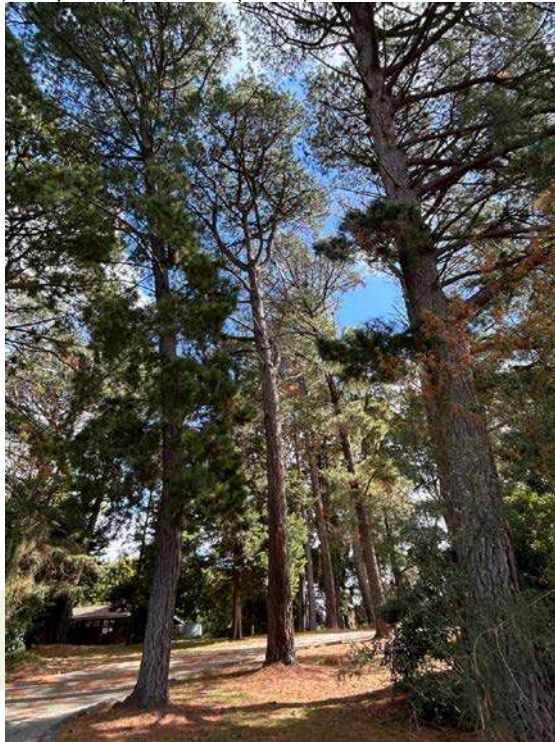
Tree ID: 31. *Pinus radiata* (Monterey Pine), Maturing Exotic conifer.
DBH: 74cm. Arb. Rating: Mod.B. Deadwood >50mm, crown bias-e.. TPZ (rad. m): 8.9. SRZ (rad. m): 3.1.

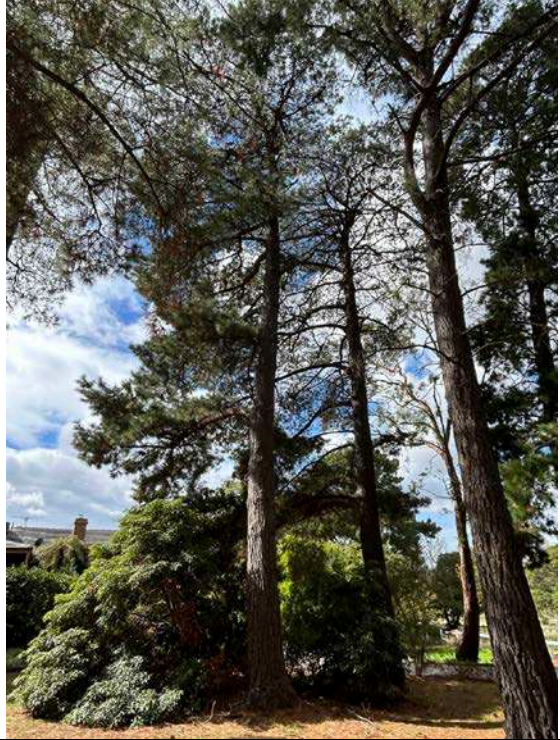
Tree ID: 32. *Pinus radiata* (Monterey Pine), Maturing Exotic conifer.
DBH: 74cm. Arb. Rating: Mod.C. Deadwood >50mm, reduced foliage density, crown bias-ne.. TPZ (rad. m): 8.9. SRZ (rad. m): 3.

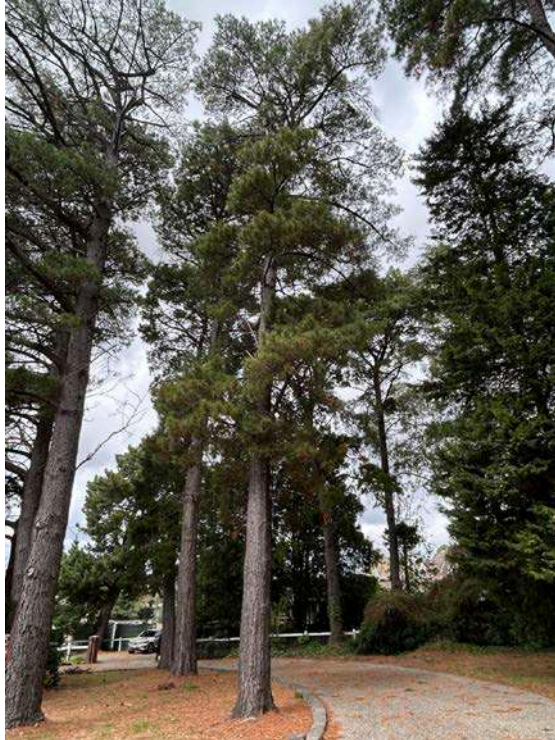
Tree ID: 34. *Pinus radiata* (Monterey Pine), Maturing Exotic conifer.
DBH: 77cm. Arb. Rating: Mod.C. Deadwood >50mm, ivy on trunk.. TPZ (rad. m): 9.2. SRZ (rad. m): 3.1.

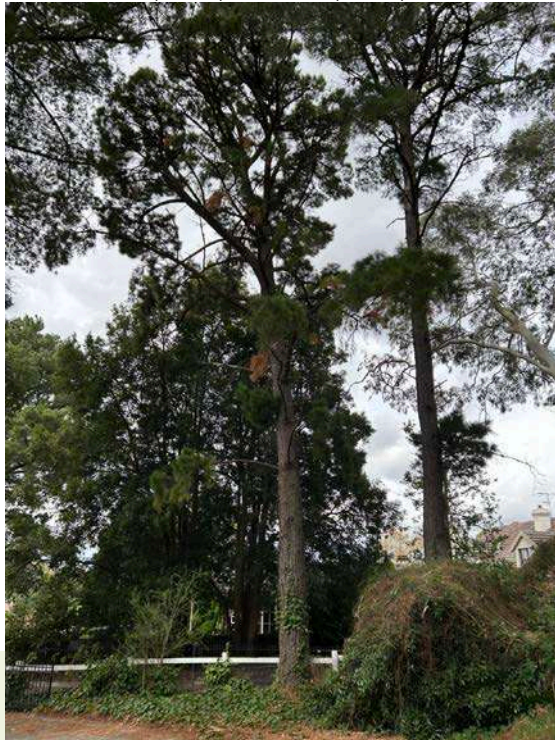
Tree ID: 35. *Pinus radiata* (Monterey Pine), Maturing Exotic conifer.
DBH: 66cm. Arb. Rating: Mod.C. Deadwood >50mm.. TPZ (rad. m): 7.9. SRZ (rad. m): 2.9.

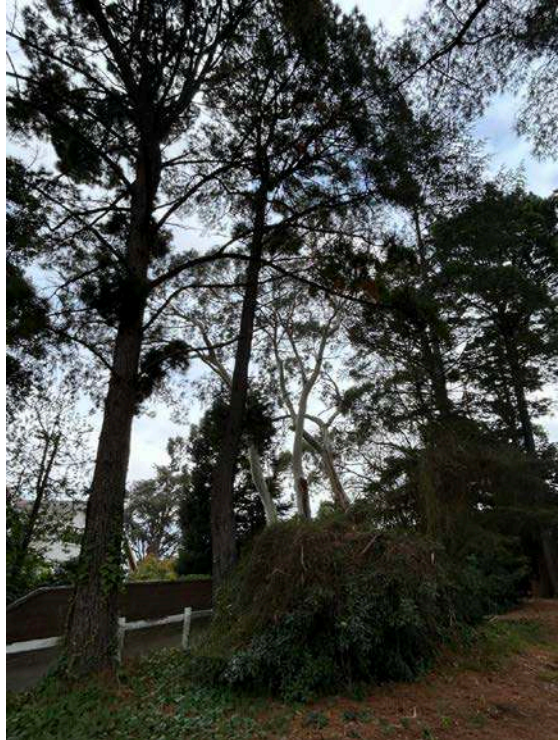
Tree ID: 36. *Cedrus deodara* (Deodar), Early-mature Exotic conifer.
DBH: 38cm. Arb. Rating: Mod.C. Ivy on trunk, reduced foliage density, vine infested.. TPZ (rad. m): 4.6. SRZ (rad. m): 2.4.

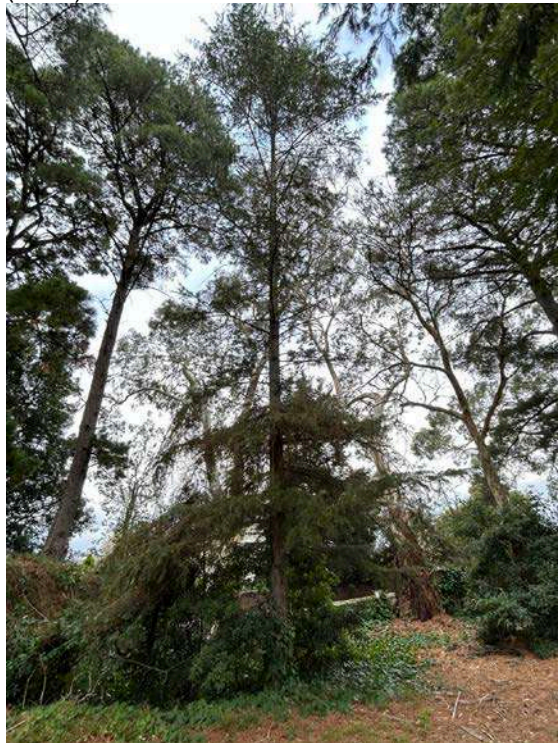
Tree ID: 37. *Eucalyptus viminalis* (Manna Gum),
 Maturing Victorian native.
 DBH: 64,56cm. Arb. Rating: Mod.B. Co-dominant stems,
 deadwood >50mm. Co-dom to south suppressed,
 co-dom to south on neighbouring property. TPZ (rad. m):
 10.2. SRZ (rad. m): 3.3.

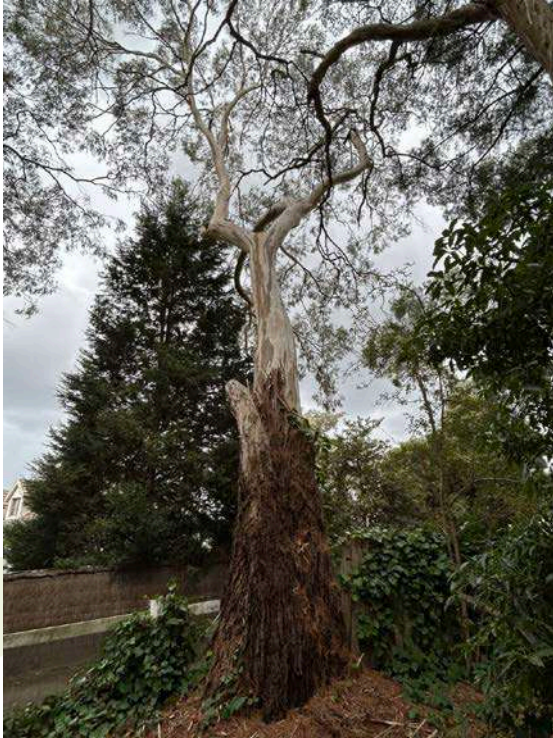
Tree ID: 39. *Eucalyptus melliodora* (Yellow Box), Early-
 mature Victorian native.
 DBH: 40cm. Arb. Rating: Low. Deadwood >50mm,
 epicormic shoots, reduced foliage density, suppressed..
 TPZ (rad. m): 4.8. SRZ (rad. m): 2.4.

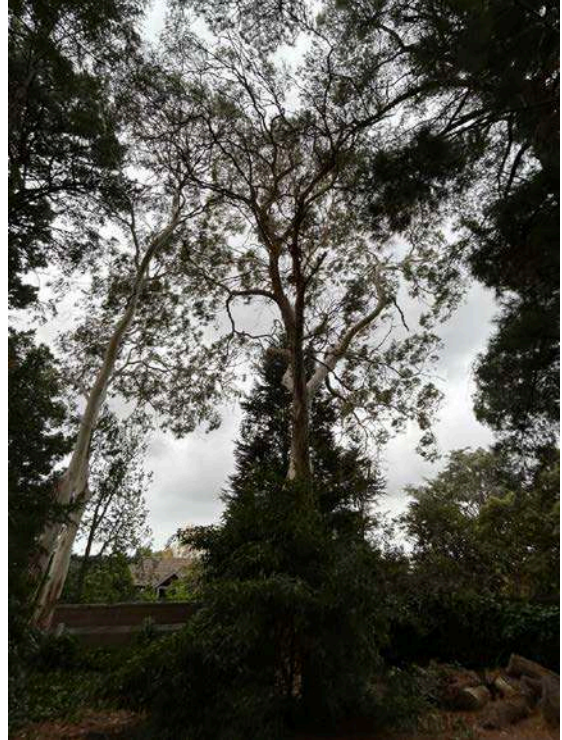
Tree ID: 40. *Grevillea robusta* (Silky Oak), Early-mature
 Australian native.
 DBH: 25cm. Arb. Rating: Mod.B. Minor trunk kink. TPZ
 (rad. m): 3. SRZ (rad. m): 2.1.

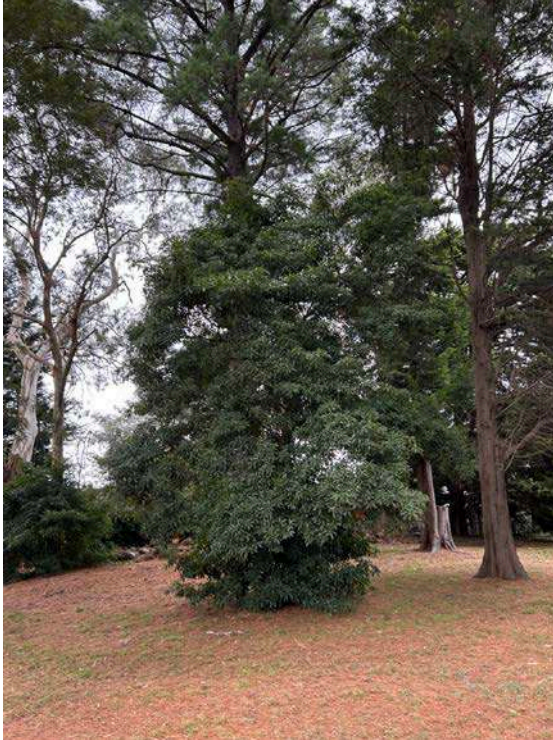
Tree ID: 42. *Pinus radiata* (Monterey Pine), Maturing Exotic conifer. DBH: 72cm. Arb. Rating: Mod.C. Deadwood >50mm.. TPZ (rad. m): 8.6. SRZ (rad. m): 3.

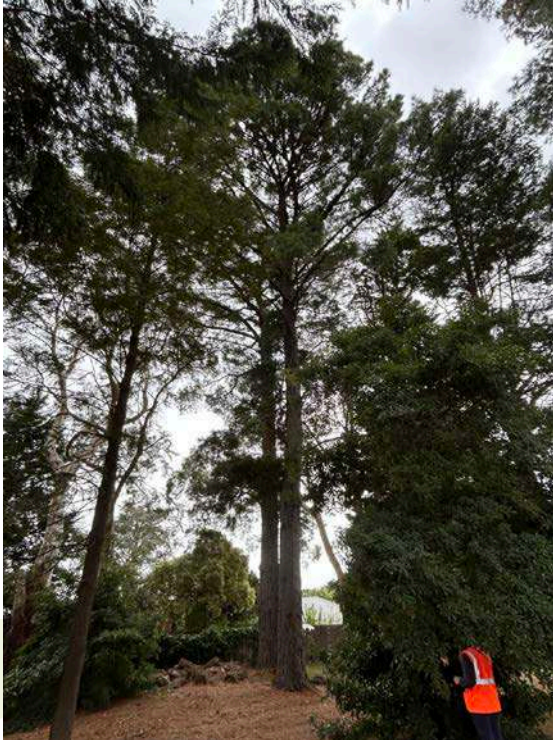
Tree ID: 43. *Pinus radiata* (Monterey Pine), Maturing Exotic conifer. DBH: 88cm. Arb. Rating: Mod.C. Deadwood >50mm, crown bias-s.. TPZ (rad. m): 10.6. SRZ (rad. m): 3.3.

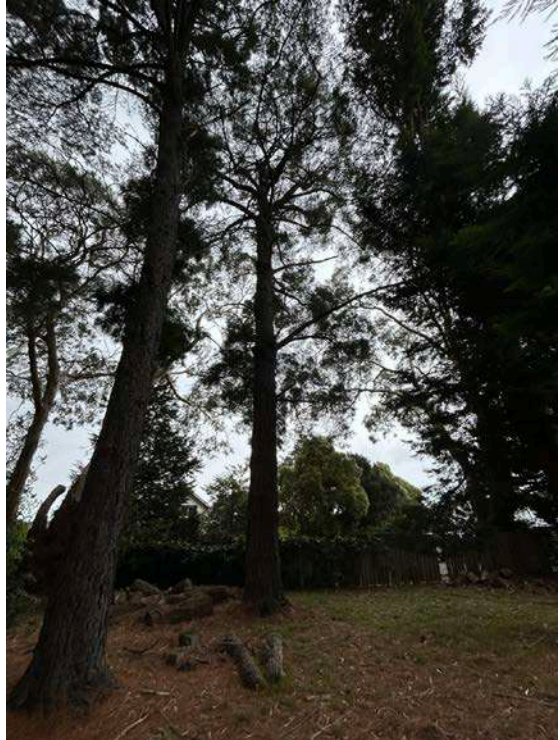
Tree ID: 44. *Cupressus sempervirens* 'Swanes Golden' (Swane's Golden Pencil Pine), Maturing Exotic conifer. DBH: 96cm. Arb. Rating: Mod.C. Co-dominant stems. Prev stem removal. TPZ (rad. m): 11.5. SRZ (rad. m): 3.3.

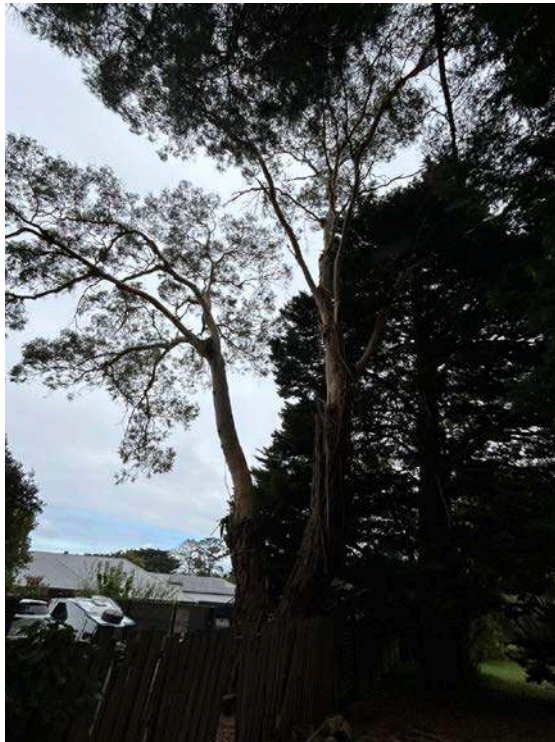
Tree ID: 45. *Eucalyptus viminalis* (Manna Gum),
Maturing Victorian native.
DBH: 80,75cm. Arb. Rating: Mod.B. Co-dominant stems,
deadwood >50mm, habitat hollows, neighbour's tree. Sth
co-dom suppressed. TPZ (rad. m): 13.2. SRZ (rad. m):
3.8.

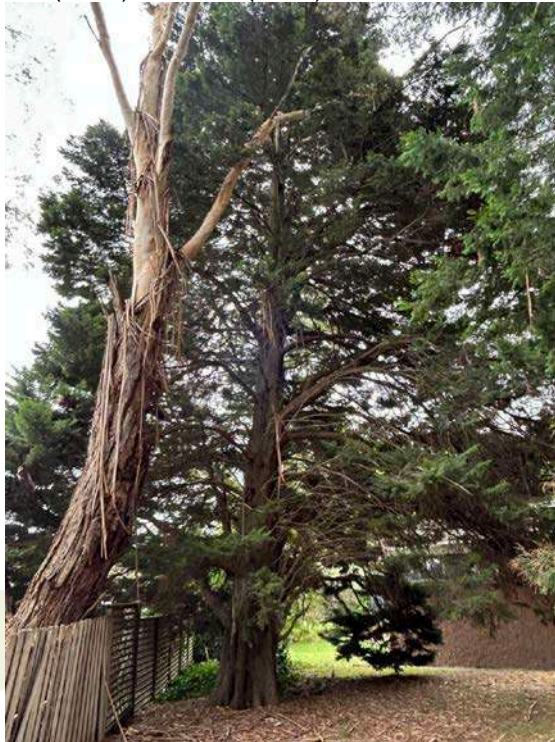
Tree ID: 46. *Cupressus sempervirens* 'Swanes Golden'
(Swane's Golden Pencil Pine), Maturing Exotic conifer.
DBH: 93cm. Arb. Rating: Mod.B. Deadwood >50mm..
TPZ (rad. m): 11.2. SRZ (rad. m): 3.2.

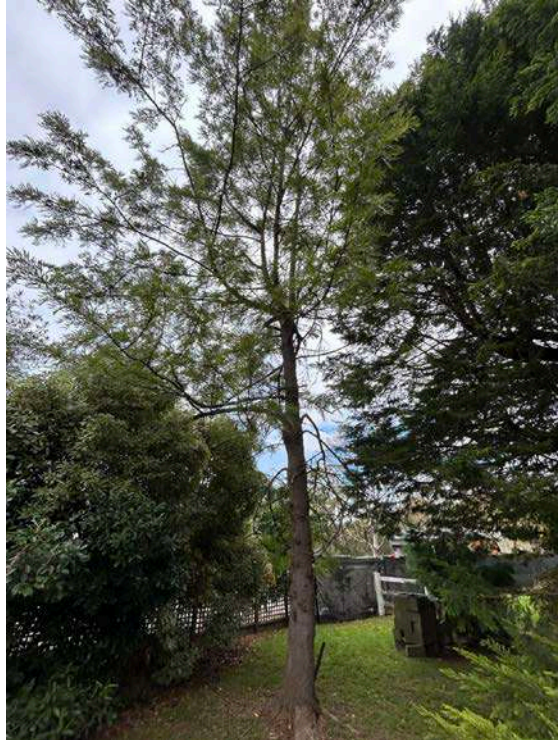
Tree ID: 48. *Grevillea robusta* (Silky Oak), Early-mature
Australian native.
DBH: 41cm. Arb. Rating: Low. Deadwood, exposed
roots, mower damage to surface roots. Possibly
previously lopped. TPZ (rad. m): 4.9. SRZ (rad. m): 2.4.

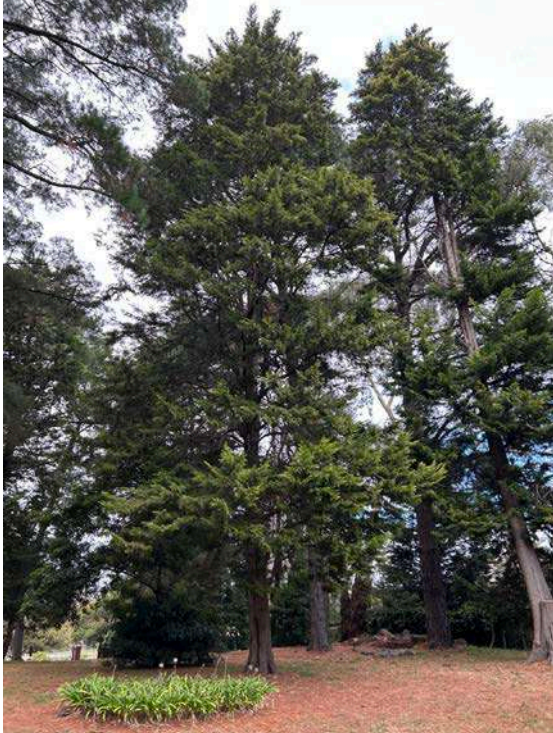
Tree ID: 49. *Cupressus sempervirens* 'Swanes Golden' (Swane's Golden Pencil Pine), Maturing Exotic conifer. DBH: 54cm. Arb. Rating: Mod.B. Crown bias- n.. TPZ (rad. m): 6.5. SRZ (rad. m): 2.7.

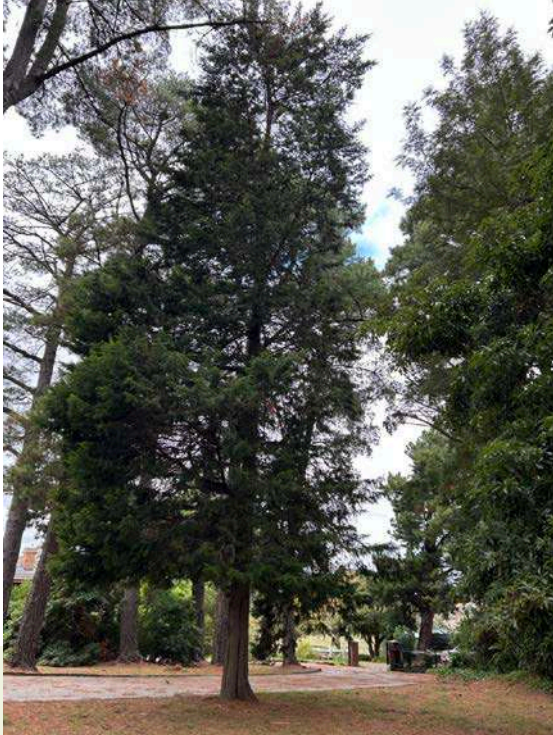
Tree ID: 50. *Cupressus sempervirens* 'Swanes Golden' (Swane's Golden Pencil Pine), Maturing Exotic conifer. DBH: 44cm. Arb. Rating: Mod.C. Co-dominant stems.. TPZ (rad. m): 5.3. SRZ (rad. m): 2.6.

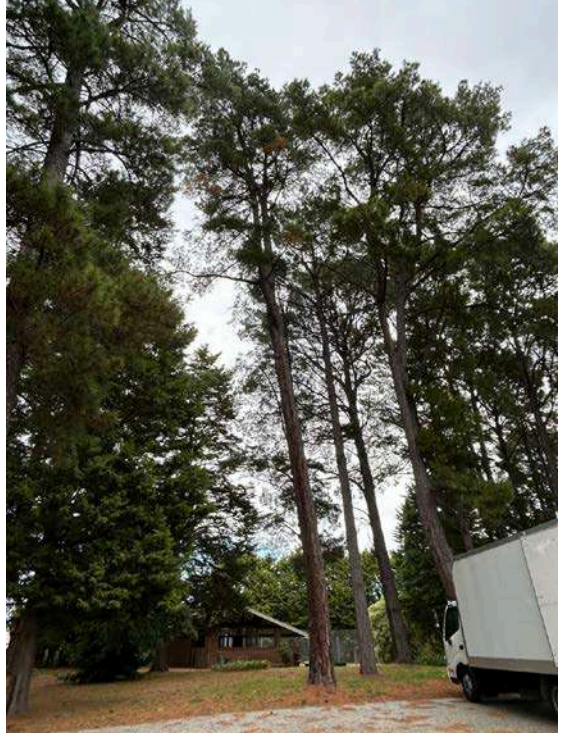
Tree ID: 51. *Pinus radiata* (Monterey Pine), Maturing Exotic conifer. DBH: 74cm. Arb. Rating: Mod.C. Co-dominant stems, deadwood >50mm.. TPZ (rad. m): 8.9. SRZ (rad. m): 3.

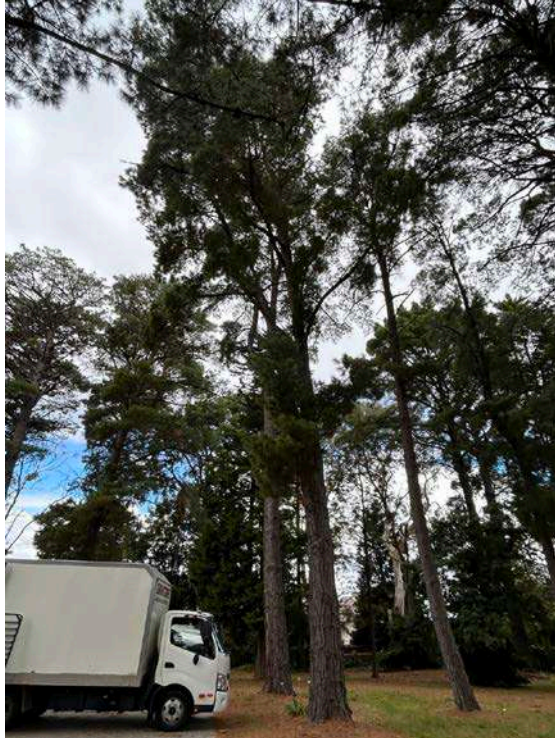
Tree ID: 53. *Pinus radiata* (Monterey Pine), Maturing Exotic conifer.
DBH: 74cm. Arb. Rating: Mod.C. Acute forks, co-dominant stems, included bark. Cabled- last inspection unknown. TPZ (rad. m): 8.9. SRZ (rad. m): 3.

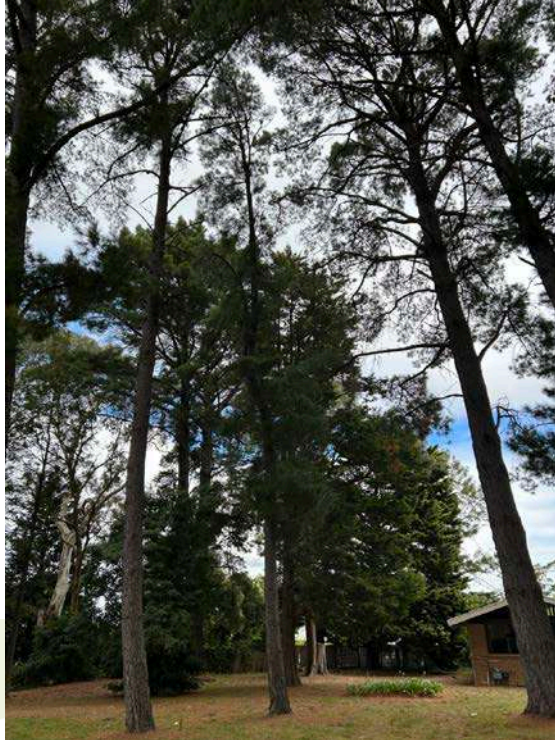
Tree ID: 54. *Pinus radiata* (Monterey Pine), Early-mature Exotic conifer.
DBH: 42cm. Arb. Rating: Mod.C. Kinked trunk - self corrected. TPZ (rad. m): 5. SRZ (rad. m): 2.5.

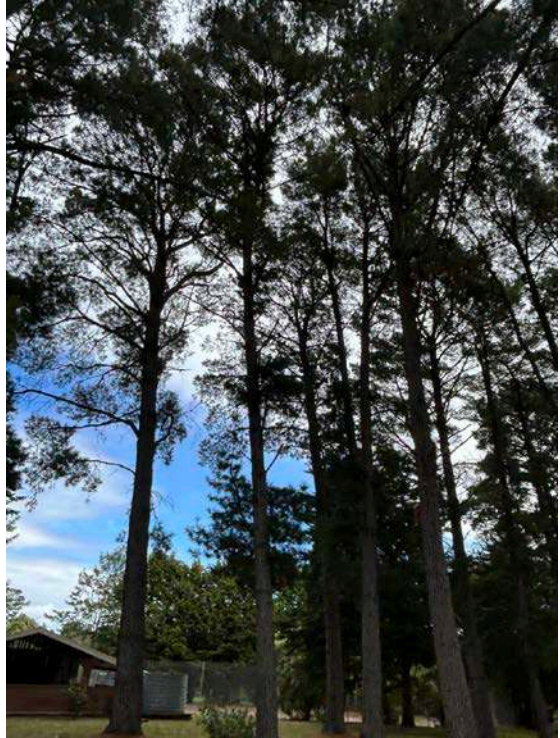
Tree ID: 56. *Pinus radiata* (Monterey Pine), Maturing Exotic conifer.
DBH: 58cm. Arb. Rating: Mod.C. Deadwood >50mm, partly suppressed - crown bias. Minor trunk lean to southeast. TPZ (rad. m): 7. SRZ (rad. m): 2.7.

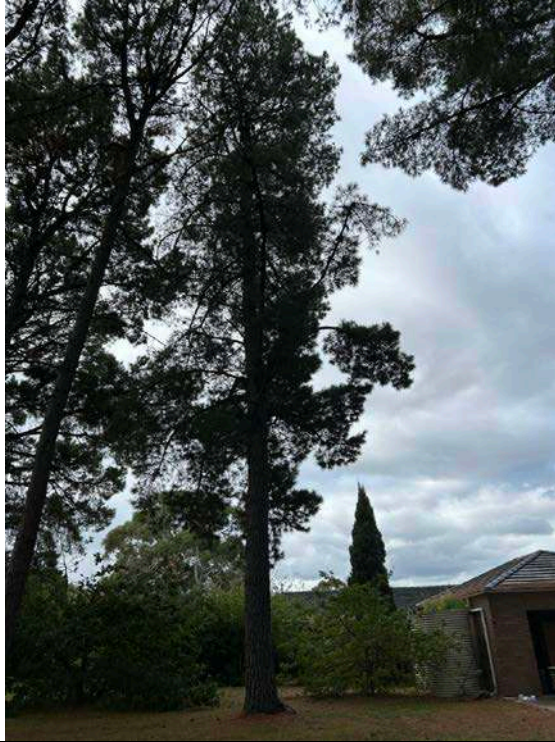
Tree ID: 57. *Pinus radiata* (Monterey Pine), Maturing Exotic conifer.
DBH: 62cm. Arb. Rating: Mod.C. Deadwood >50mm..
TPZ (rad. m): 7.4. SRZ (rad. m): 2.9.

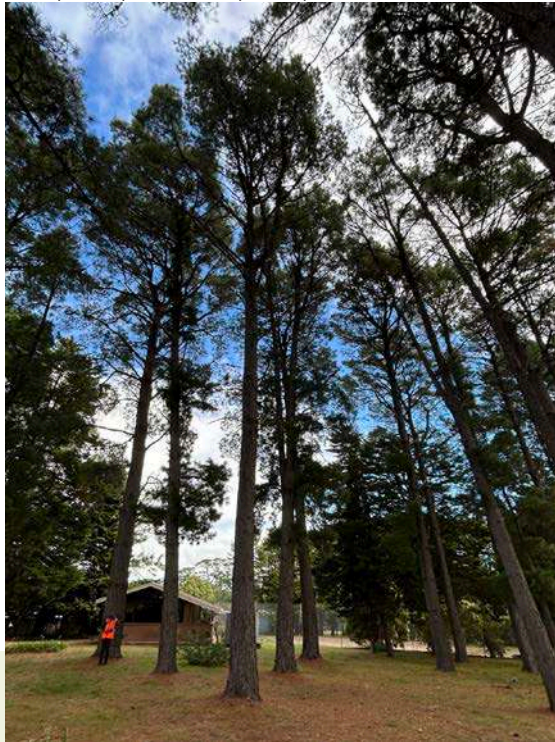
Tree ID: 58. *Pinus radiata* (Monterey Pine), Maturing Exotic conifer.
DBH: 62cm. Arb. Rating: Mod.C. Deadwood >50mm..
TPZ (rad. m): 7.4. SRZ (rad. m): 2.8.

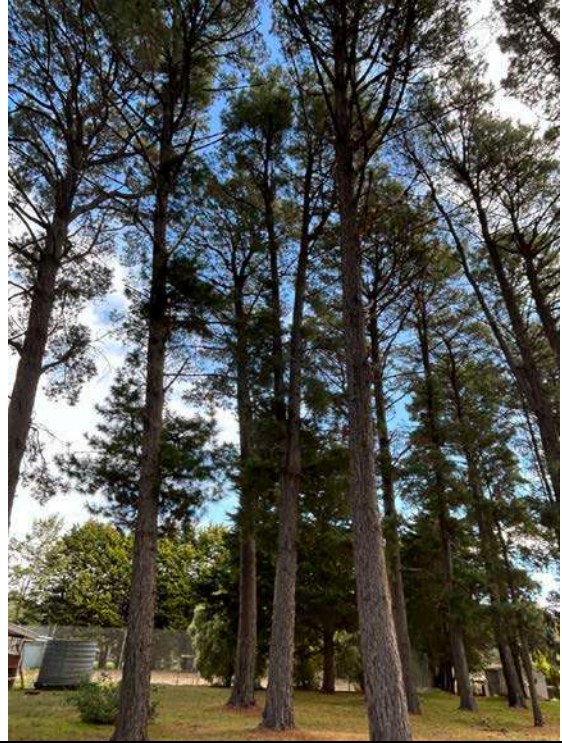
Tree ID: 59. *Pinus radiata* (Monterey Pine), Maturing Exotic conifer.
DBH: 63cm. Arb. Rating: Low. Acute forks, co-dominant stems, included bark..
TPZ (rad. m): 7.6. SRZ (rad. m): 2.8.

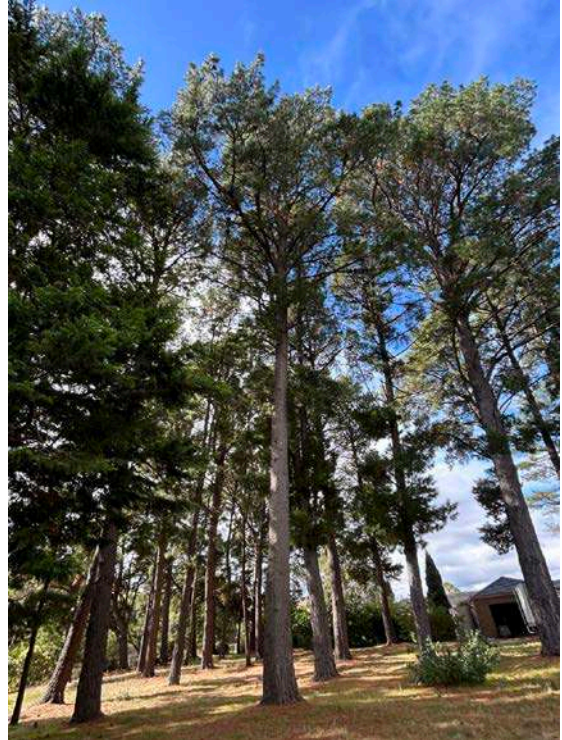
Tree ID: 60. *Pinus radiata* (Monterey Pine), Maturing Exotic conifer.
DBH: 76cm. Arb. Rating: Mod.C. Deadwood >50mm, mower damage to surface roots..
TPZ (rad. m): 9.1. SRZ (rad. m): 3.1.

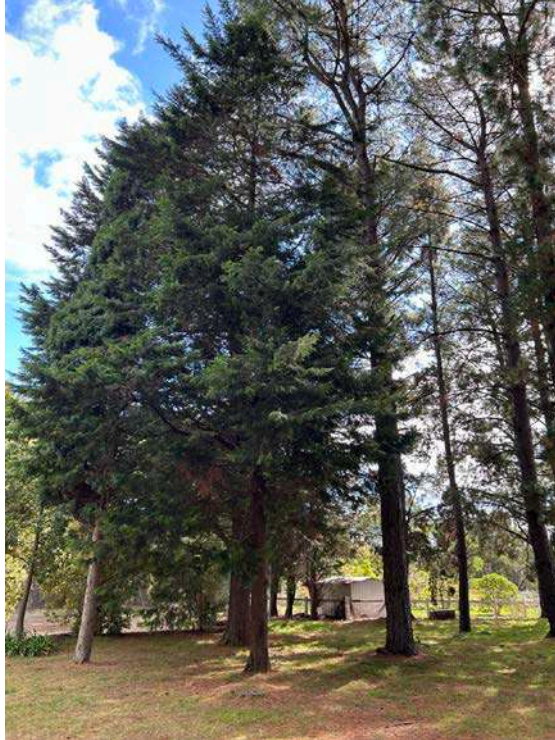
Tree ID: 61. *Cupressus sempervirens* 'Swanes Golden' (Swane's Golden Pencil Pine), Early-mature Exotic conifer.
DBH: 34cm. Arb. Rating: Mod.B. NA. TPZ (rad. m): 4.1. SRZ (rad. m): 2.3.

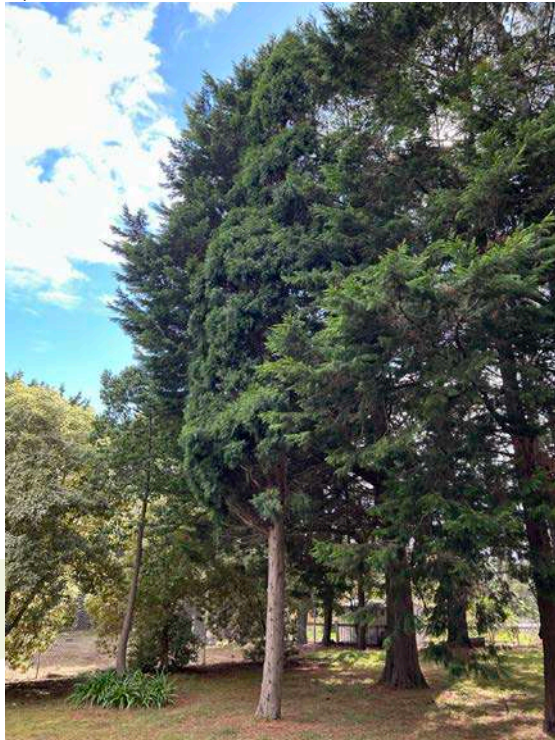
Tree ID: 62. *Cupressus sempervirens* 'Swanes Golden' (Swane's Golden Pencil Pine), Early-mature Exotic conifer.
DBH: 28cm. Arb. Rating: Mod.C. Acute forks, partly suppressed - crown bias.. TPZ (rad. m): 3.4. SRZ (rad. m): 2.1.

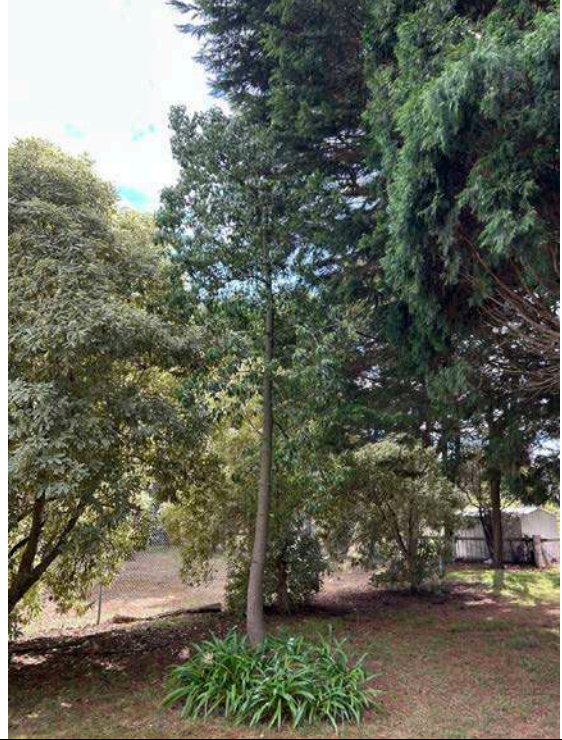
Tree ID: 63. *Brachychiton populneus* (Kurrajong), Semi-mature Victorian native.
DBH: 14cm. Arb. Rating: Low. Suppressed, crown bias-w. Bowed at base. TPZ (rad. m): 2. SRZ (rad. m): 1.7.
