Arboricultural Assessment and Report

3 Nortons Lane, Wantirna South

27 November 2025

Tree Logic Ref. 013990

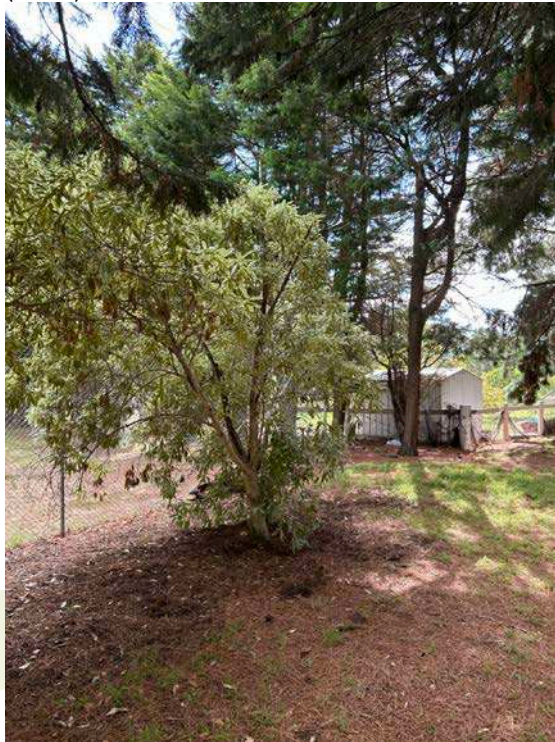
Tree ID: 66. *Pittosporum eugenioides* 'Variegatum' (Variegated Tarata), Early-mature Exotic evergreen. DBH: 9,8,6cm. Arb. Rating: Low. Borers, decay, epicormic shoots, limb wounds.. TPZ (rad. m): 2. SRZ (rad. m): 1.7.

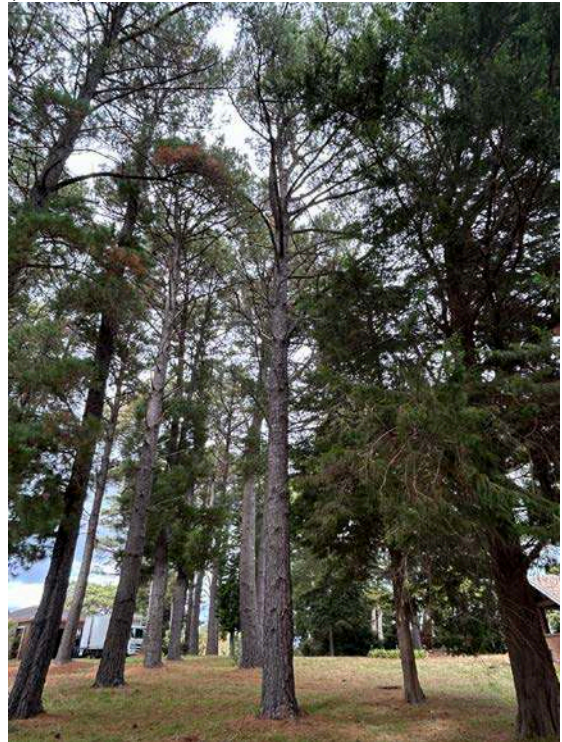
Tree ID: 68. *Pinus radiata* (Monterey Pine), Maturing Exotic conifer. DBH: 62cm. Arb. Rating: Mod.C. Co-dominant stems, deadwood >50mm, girdling root.. TPZ (rad. m): 7.4. SRZ (rad. m): 2.8.

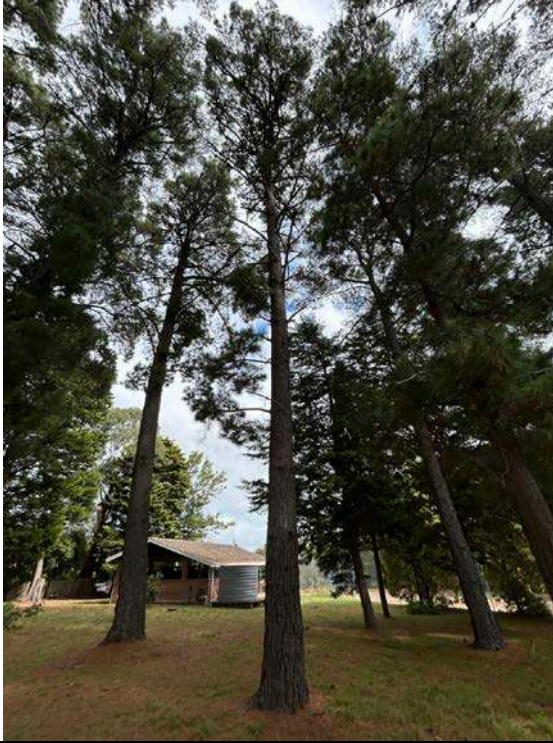
Tree ID: 69. *Pinus radiata* (Monterey Pine), Maturing Exotic conifer.
DBH: 65cm. Arb. Rating: Mod.C. Deadwood >50mm, mower damage to surface roots.. TPZ (rad. m): 7.8. SRZ (rad. m): 2.9.

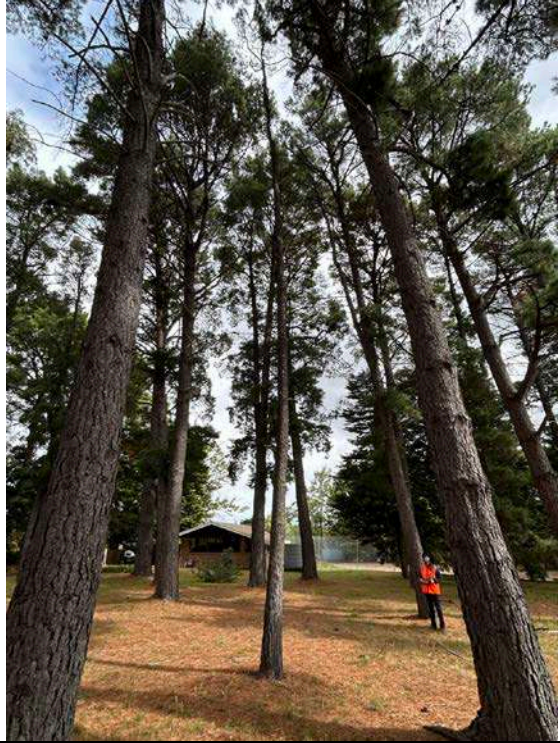
Tree ID: 71. *Pinus radiata* (Monterey Pine), Semi-mature Exotic conifer.
DBH: 24cm. Arb. Rating: Low. Poor taper, reduced foliage density, poor stem/height ratio.. TPZ (rad. m): 2.9. SRZ (rad. m): 2.

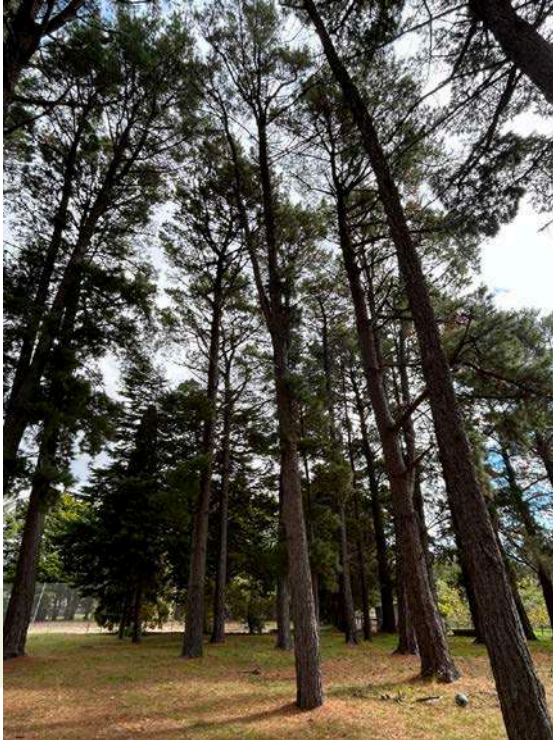
Tree ID: 70. *Pinus radiata* (Monterey Pine), Maturing Exotic conifer.
DBH: 43cm. Arb. Rating: Low. Acute forks, co-dominant stems, deadwood >50mm, included bark.. TPZ (rad. m): 5.2. SRZ (rad. m): 2.4.

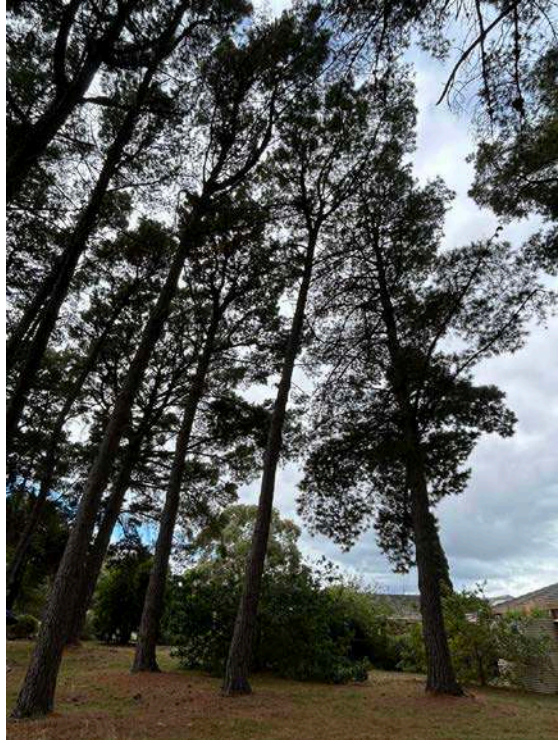
Tree ID: 72. *Pinus radiata* (Monterey Pine), Maturing Exotic conifer.
DBH: 47cm. Arb. Rating: Low. Co-dominant stems, deadwood >50mm, leaning trunk.. TPZ (rad. m): 5.6. SRZ (rad. m): 2.5.

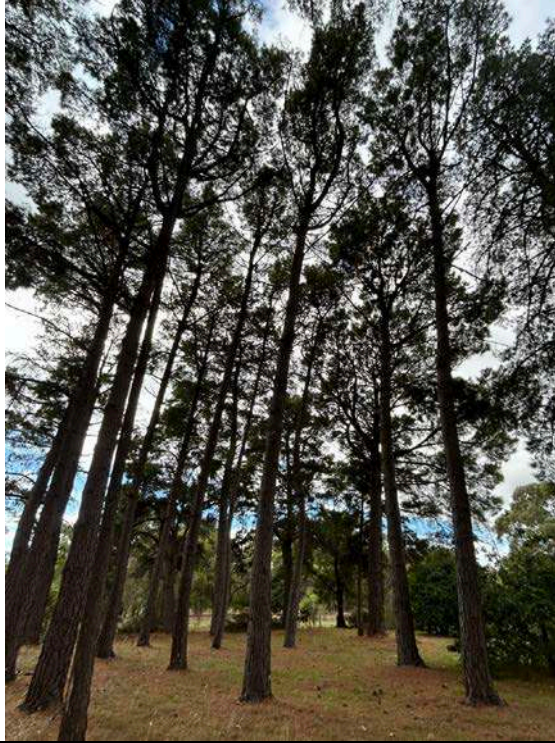
Tree ID: 73. *Pinus radiata* (Monterey Pine), Maturing Exotic conifer.
DBH: 49cm. Arb. Rating: Low. Deadwood >50mm. Minor trunk lean, limb competing for dominance. TPZ (rad. m): 5.9. SRZ (rad. m): 2.6.

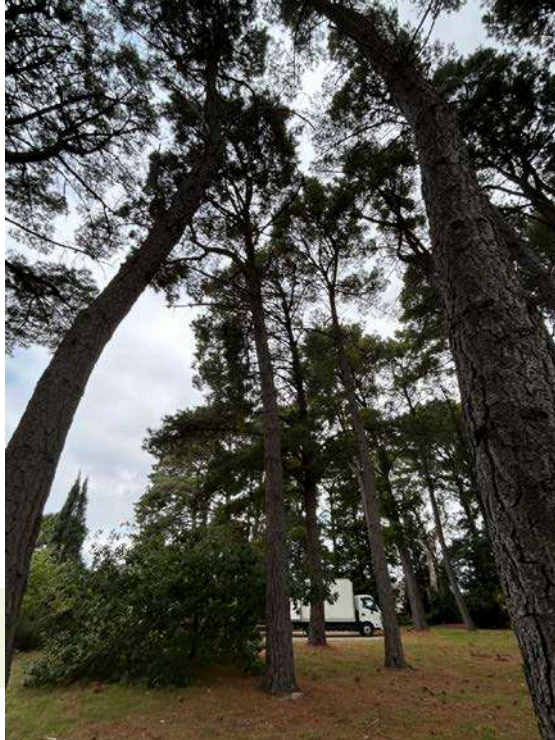
Tree ID: 74. *Pinus radiata* (Monterey Pine), Maturing Exotic conifer.
DBH: 56cm. Arb. Rating: Mod.C. Deadwood >50mm, mower damage to surface roots.. TPZ (rad. m): 6.7. SRZ (rad. m): 2.7.

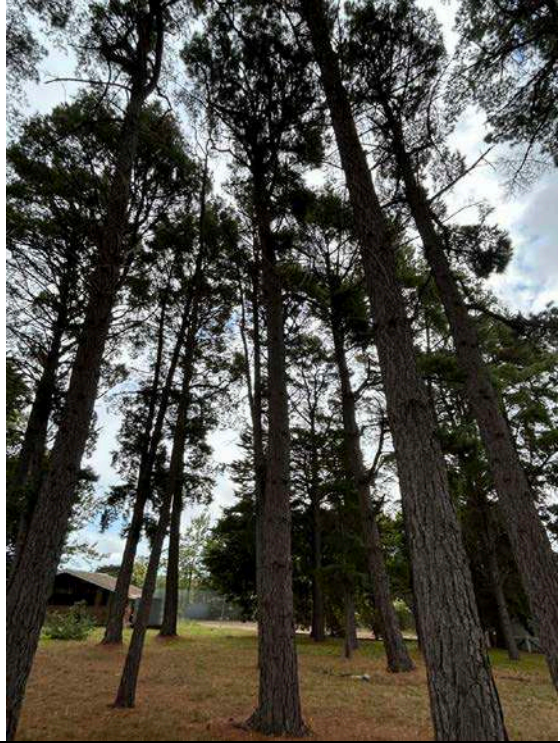
Tree ID: 75. *Pinus radiata* (Monterey Pine), Maturing Exotic conifer.
DBH: 43cm. Arb. Rating: Mod.C. Co-dominant stems, deadwood >50mm, included bark.. TPZ (rad. m): 5.2. SRZ (rad. m): 2.5.

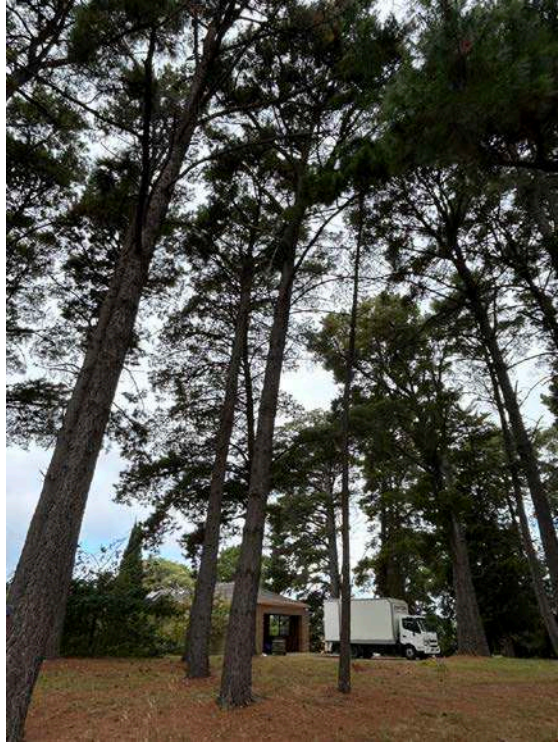
Tree ID: 76. *Pinus radiata* (Monterey Pine), Maturing Exotic conifer.
DBH: 56cm. Arb. Rating: Mod.C. Deadwood >50mm.. TPZ (rad. m): 6.7. SRZ (rad. m): 2.7.

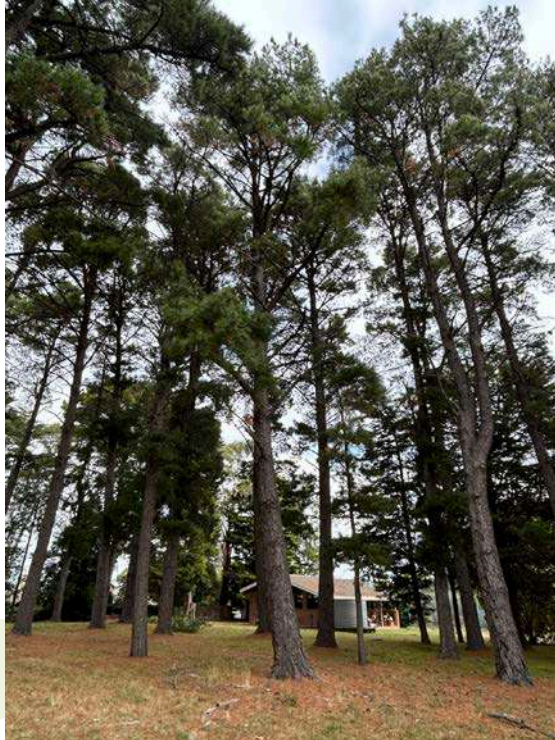
Tree ID: 78. *Pinus radiata* (Monterey Pine), Maturing Exotic conifer.
DBH: 69cm. Arb. Rating: Mod.C. Deadwood >50mm, leaning trunk, mower damage to surface roots.. TPZ (rad. m): 8.3. SRZ (rad. m): 3.

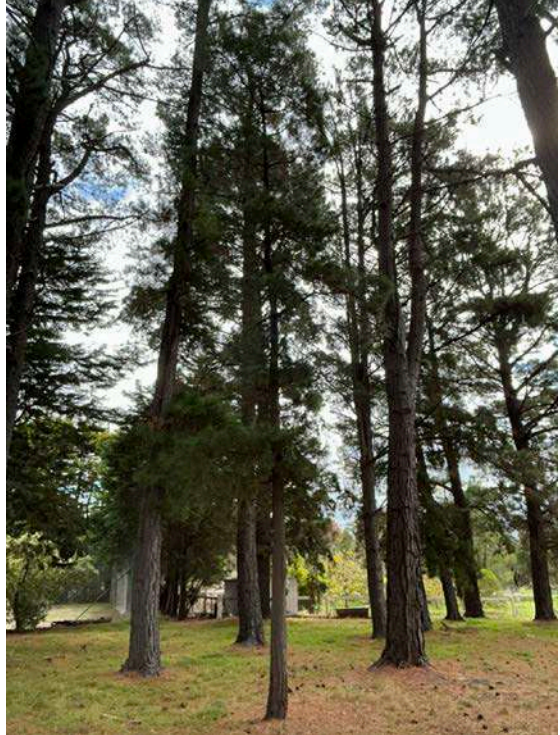
Tree ID: 79. *Pinus radiata* (Monterey Pine), Semi-mature Exotic conifer.
DBH: 19cm. Arb. Rating: Mod.C. NA. TPZ (rad. m): 2.3. SRZ (rad. m): 1.9.

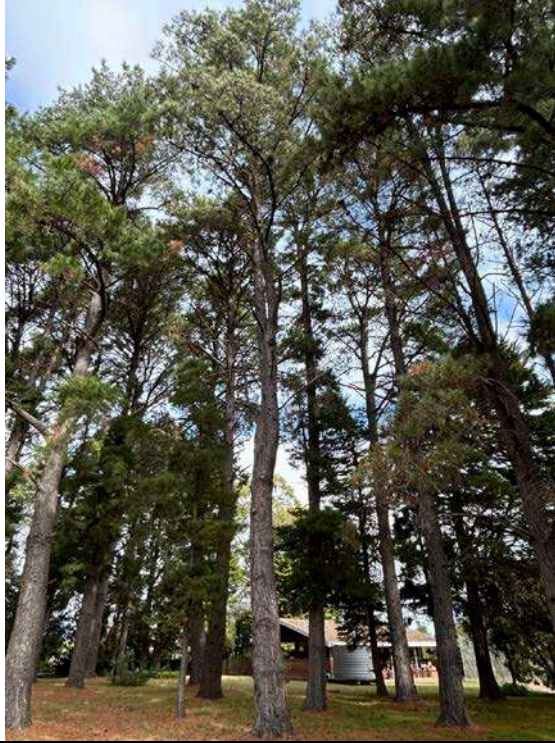
Tree ID: 81. *Pinus radiata* (Monterey Pine), Maturing Exotic conifer.
DBH: 69cm. Arb. Rating: Low. Co-dominant stems, deadwood >50mm, included bark, mower damage to surface roots.. TPZ (rad. m): 8.3. SRZ (rad. m): 2.9.

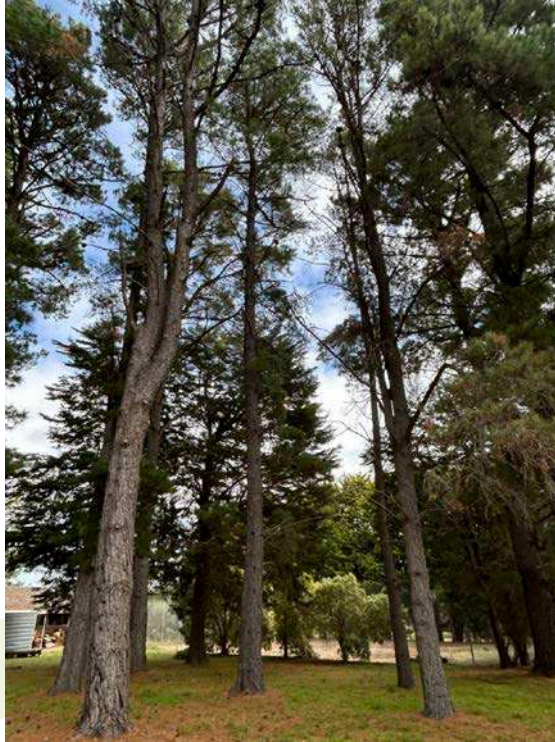
Tree ID: 82. *Pinus radiata* (Monterey Pine), Maturing Exotic conifer.
DBH: 61cm. Arb. Rating: Mod.C. Deadwood >50mm.. TPZ (rad. m): 7.3. SRZ (rad. m): 2.7.

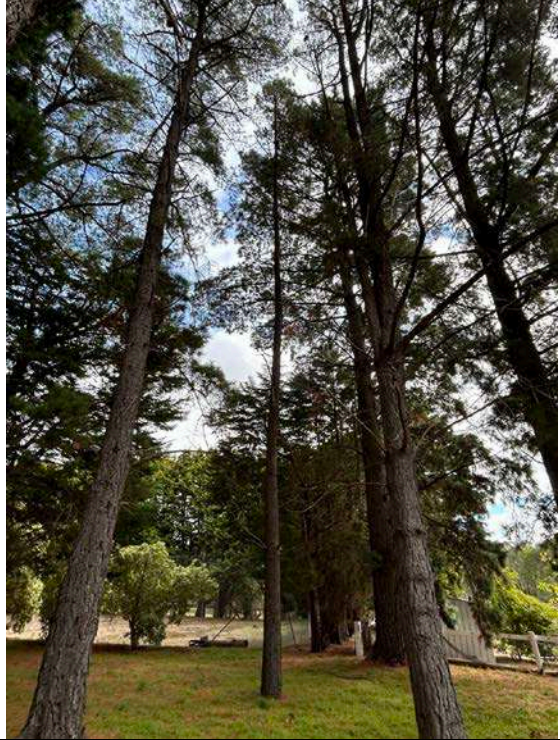
Tree ID: 83. *Pinus radiata* (Monterey Pine), Maturing Exotic conifer.
DBH: 35cm. Arb. Rating: Low. Deadwood >50mm, poor stem/height ratio.. TPZ (rad. m): 4.2. SRZ (rad. m): 2.3.

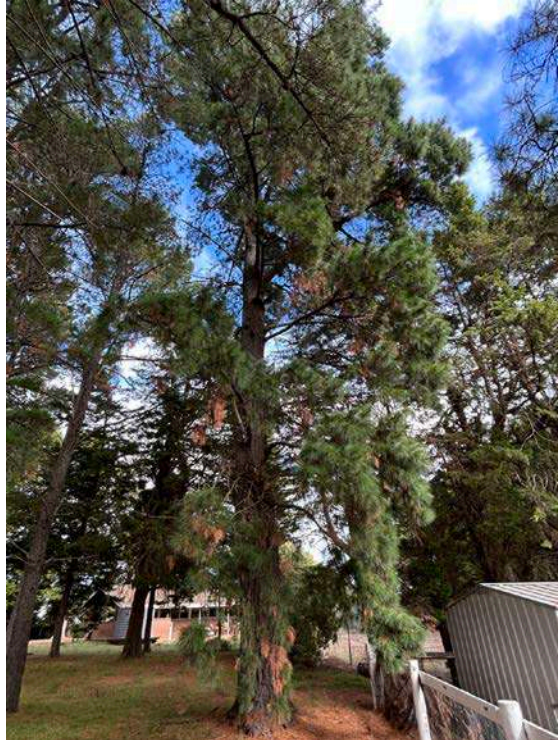
Tree ID: 84. *Pinus radiata* (Monterey Pine), Maturing Exotic conifer.
DBH: 79cm. Arb. Rating: Mod.B. Deadwood >50mm.. TPZ (rad. m): 9.5. SRZ (rad. m): 3.2.

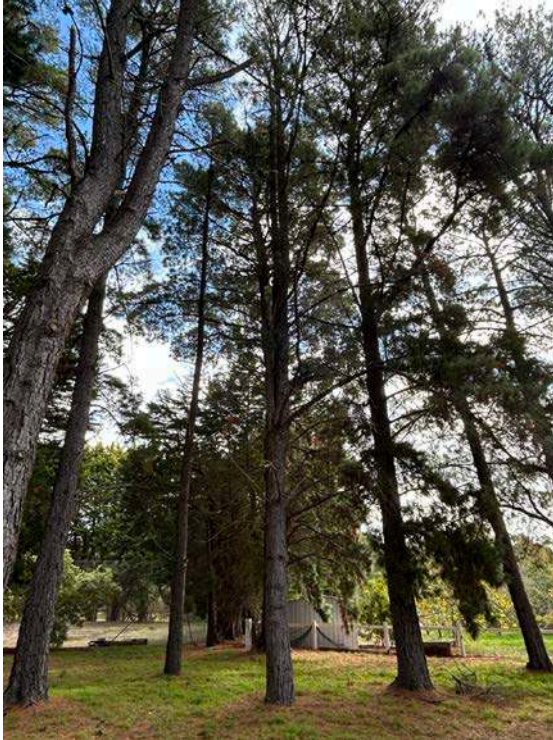
Tree ID: 85. *Pinus radiata* (Monterey Pine), Maturing Exotic conifer.
DBH: 46cm. Arb. Rating: Low. Acute forks, co-dominant stems, included bark, reduced foliage density.. TPZ (rad. m): 5.5. SRZ (rad. m): 2.5.

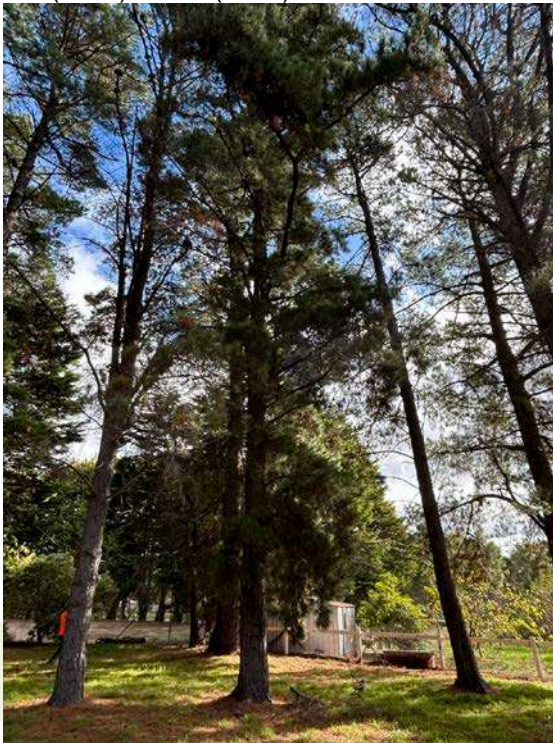
Tree ID: 86. *Pinus radiata* (Monterey Pine), Maturing Exotic conifer.
DBH: 58cm. Arb. Rating: Mod.C. Deadwood >50mm.. TPZ (rad. m): 7. SRZ (rad. m): 2.7.

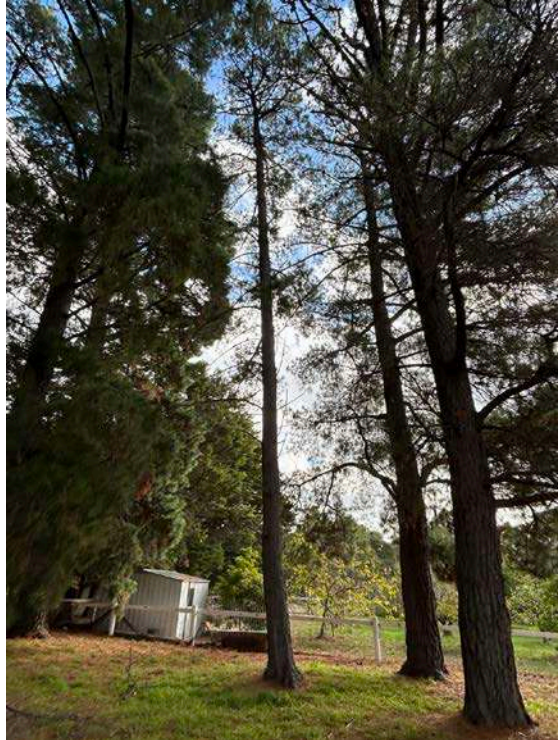
Tree ID: 87. *Pinus radiata* (Monterey Pine), Maturing Exotic conifer.
DBH: 46cm. Arb. Rating: Mod.C. Deadwood >50mm.. TPZ (rad. m): 5.5. SRZ (rad. m): 2.5.

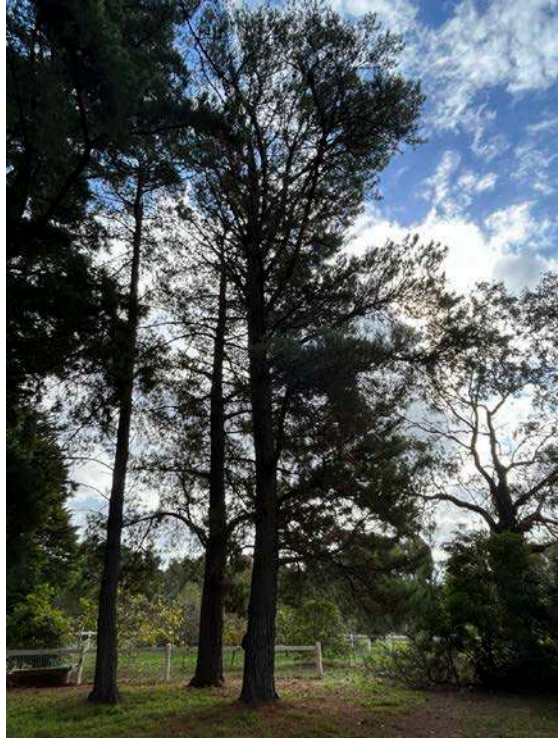
Tree ID: 88. *Pinus radiata* (Monterey Pine), Maturing Exotic conifer.
DBH: 69cm. Arb. Rating: Low. Deadwood >50mm, mower damage to surface roots, reduced foliage density, tip dieback, crown bias-ne.. TPZ (rad. m): 8.3. SRZ (rad. m): 2.9.

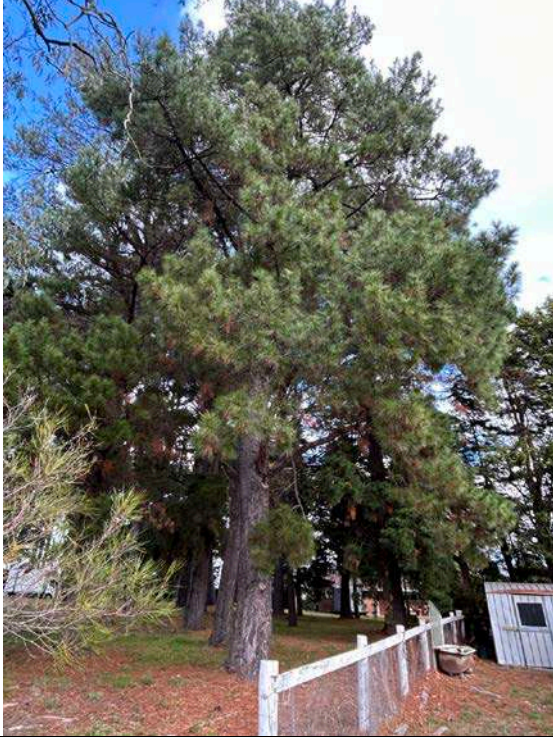
Tree ID: 89. *Pinus radiata* (Monterey Pine), Maturing Exotic conifer.
DBH: 71cm. Arb. Rating: Mod.B. Deadwood >50mm, hangers.. TPZ (rad. m): 8.5. SRZ (rad. m): 3.

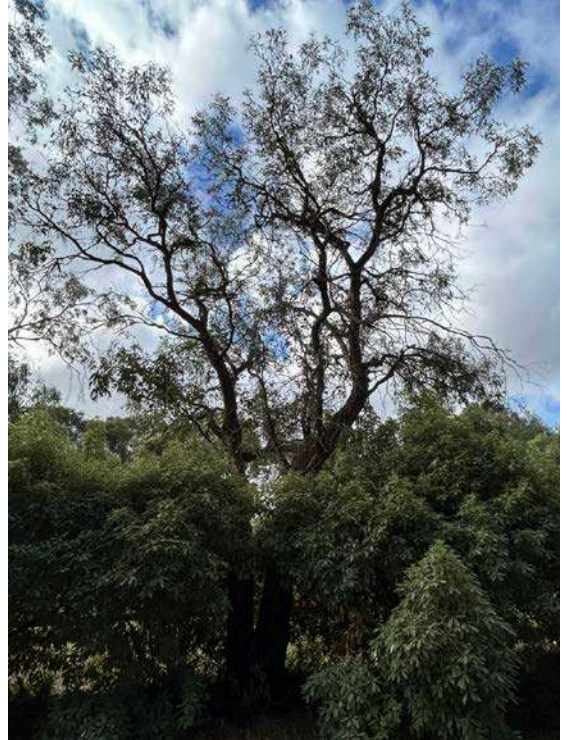
Tree ID: 91. *Eucalyptus cephalocarpa* (Mealy Stringybark), Maturing Australian native.
DBH: 55,48cm. Arb. Rating: Low. Bracket fungi, co-dominant stems, trunk wounds. Sp ?.. TPZ (rad. m): 8.8. SRZ (rad. m): 3.1.

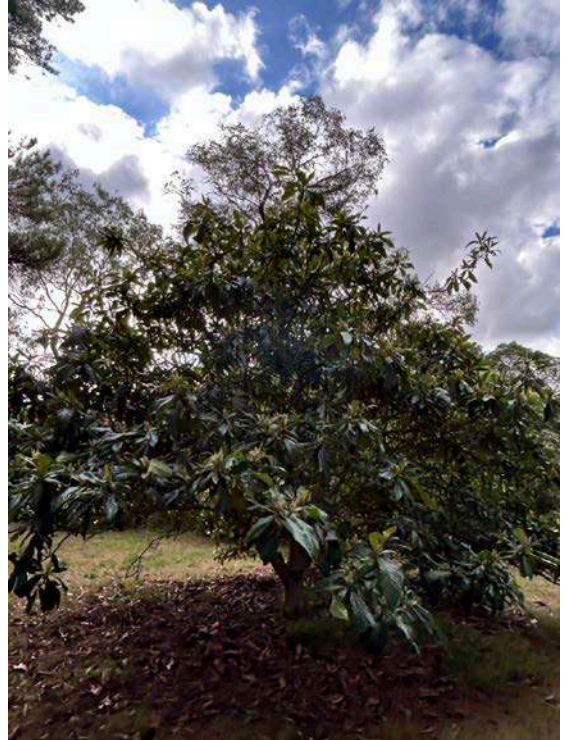
Tree ID: 92. *Eriobotrya japonica* (Loquat), Early-mature Exotic evergreen.
DBH: 14cm. Arb. Rating: Low. NA. TPZ (rad. m): 2. SRZ (rad. m): 1.8.

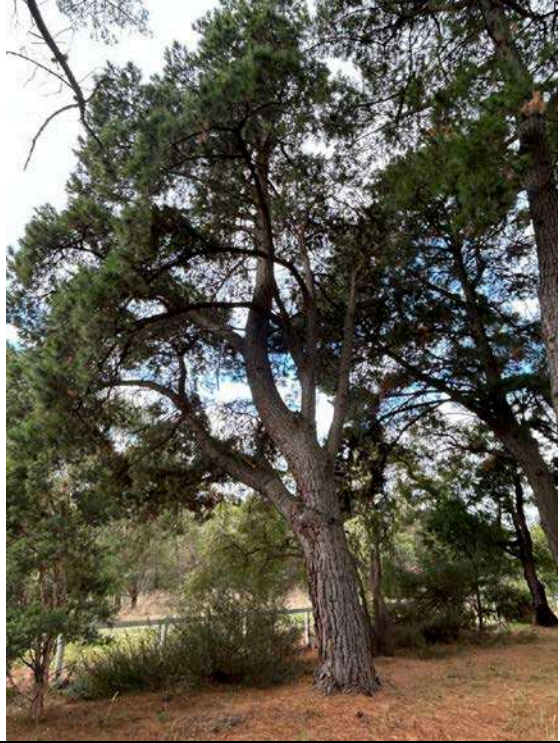
Tree ID: 95. *Pinus radiata* (Monterey Pine), Maturing Exotic conifer.
DBH: 74cm. Arb. Rating: Mod.C. Exposed roots, over-extended limbs developing, suppressed, crown bias- n.. TPZ (rad. m): 8.9. SRZ (rad. m): 3.1.

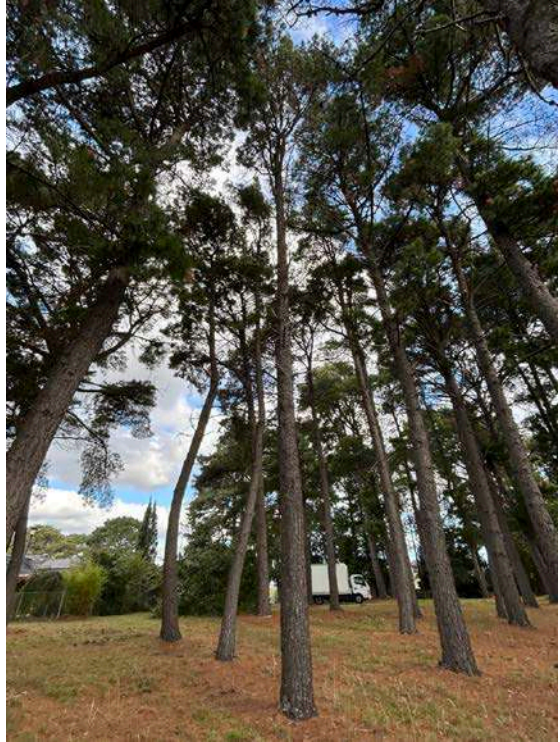
Tree ID: 96. *Pinus radiata* (Monterey Pine), Early-mature Exotic conifer.
DBH: 45cm. Arb. Rating: Low. Deadwood >50mm.. TPZ (rad. m): 5.4. SRZ (rad. m): 2.5.

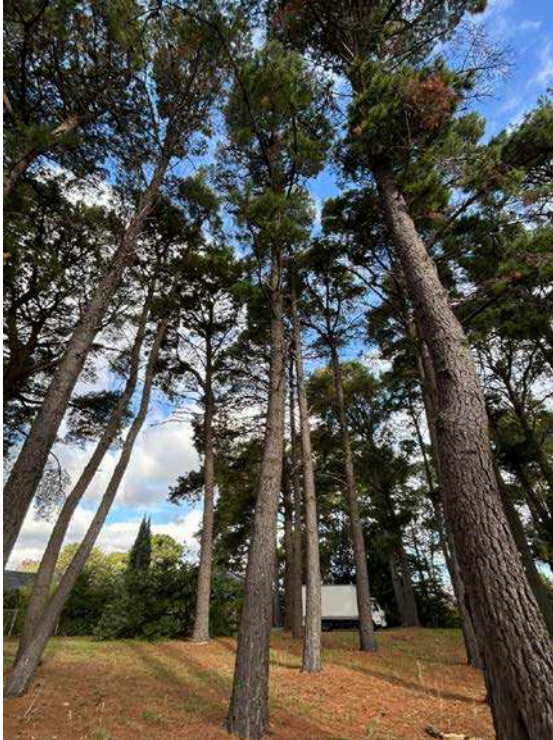
Tree ID: 97. *Pinus radiata* (Monterey Pine), Maturing Exotic conifer.
DBH: 50cm. Arb. Rating: Mod.C. Deadwood >50mm..
TPZ (rad. m): 6. SRZ (rad. m): 2.6.

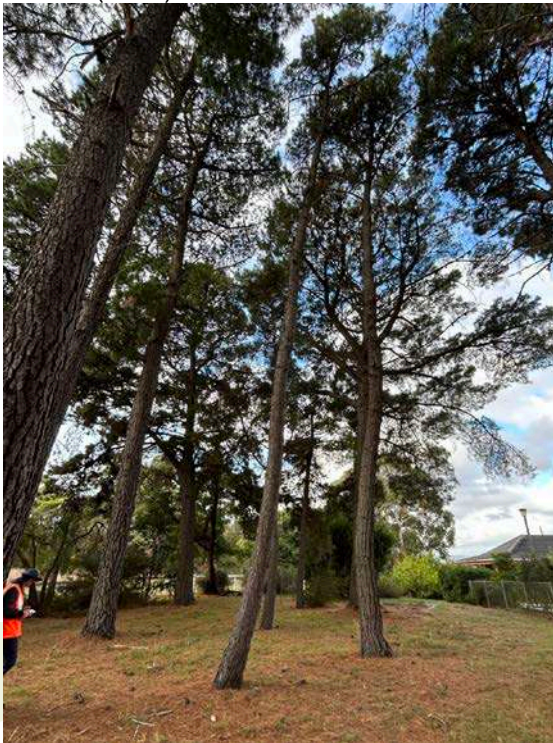
Tree ID: 98. *Pinus radiata* (Monterey Pine), Early-mature Exotic conifer.
DBH: 31cm. Arb. Rating: Low. Deadwood >50mm, poor stem/height ratio. Self-corrected trunk lean. TPZ (rad. m): 3.7. SRZ (rad. m): 2.3.

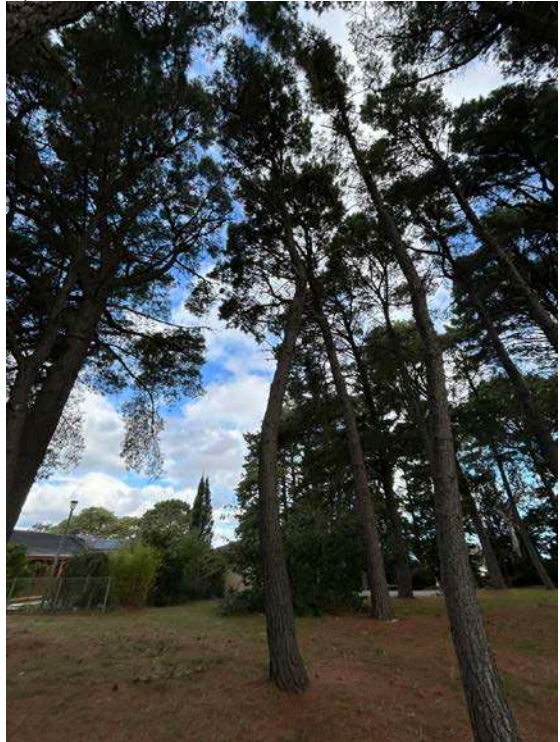
Tree ID: 99. *Pinus radiata* (Monterey Pine), Early-mature Exotic conifer.
DBH: 42cm. Arb. Rating: Low. Deadwood >50mm.
Bowed trunk -self corrected. TPZ (rad. m): 5. SRZ (rad. m): 2.4.

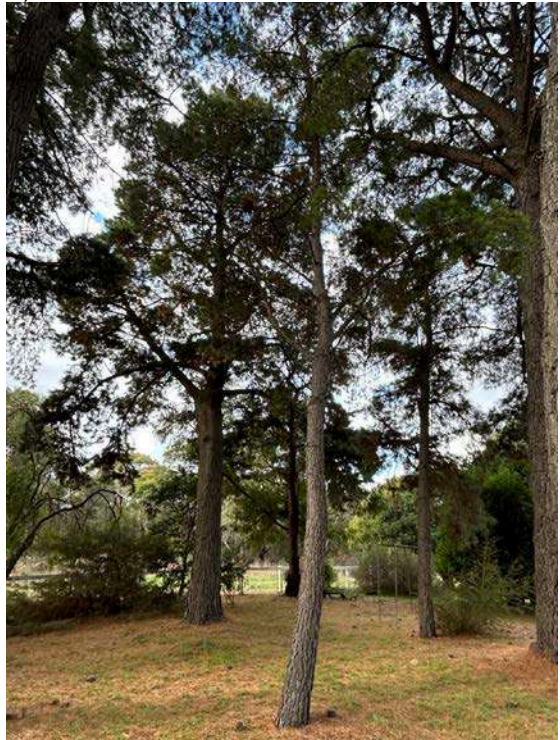
Tree ID: 100. *Pinus radiata* (Monterey Pine), Early-mature Exotic conifer.
DBH: 27cm. Arb. Rating: Low. Deadwood, suppressed.
Bowed trunk self-corrected. TPZ (rad. m): 3.2. SRZ (rad. m): 2.1.

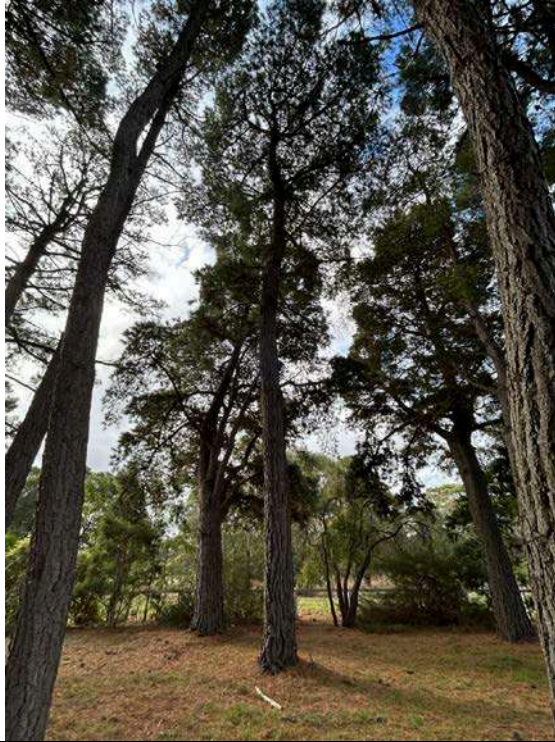
Tree ID: 101. *Pinus radiata* (Monterey Pine), Early-mature Exotic conifer.
DBH: 63cm. Arb. Rating: Mod.B. Deadwood >50mm..
TPZ (rad. m): 7.6. SRZ (rad. m): 2.9.

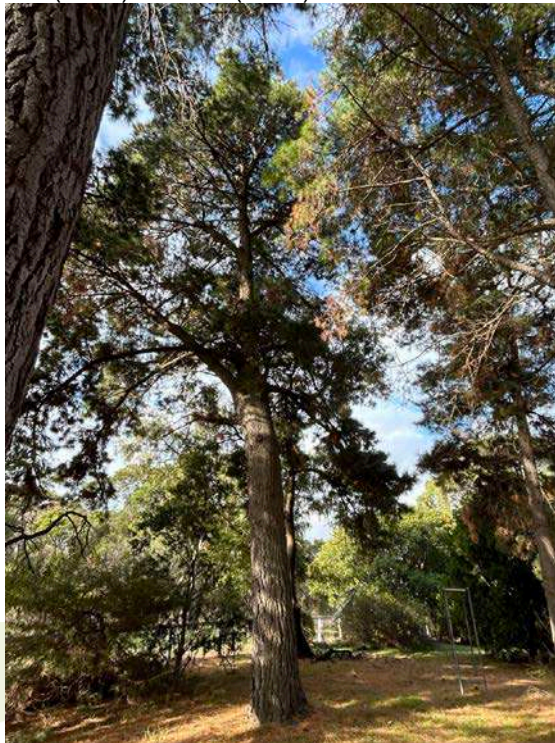
Tree ID: 102. *Pinus radiata* (Monterey Pine), Maturing Exotic conifer.
DBH: 65cm. Arb. Rating: Mod.C. Partly suppressed - crown bias, crown bias-ne. Bowed trunk self corrected.
TPZ (rad. m): 7.8. SRZ (rad. m): 2.9.

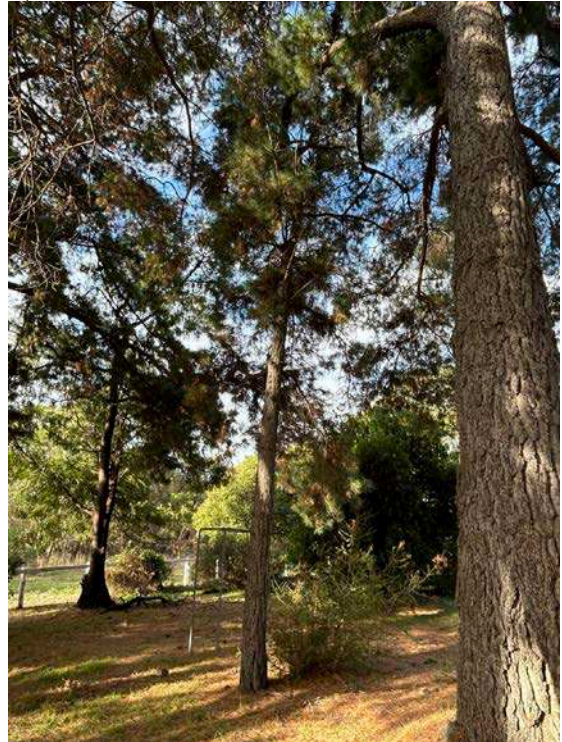
Tree ID: 103. *Pinus radiata* (Monterey Pine), Early-mature Exotic conifer.
DBH: 28cm. Arb. Rating: Low. Over-extended limbs developing, suppressed..
TPZ (rad. m): 3.4. SRZ (rad. m): 2.1.

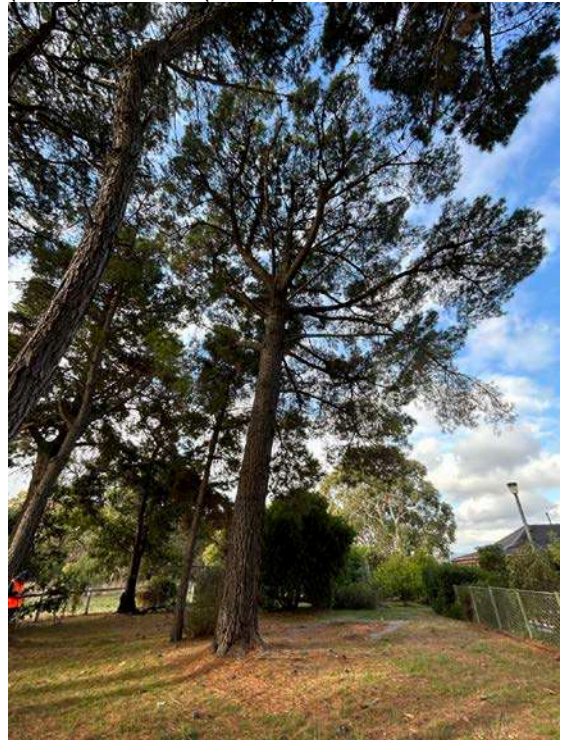
Tree ID: 104. *Pinus radiata* (Monterey Pine), Maturing Exotic conifer.
DBH: 91cm. Arb. Rating: Mod.B. Deadwood >50mm, exposed roots, mower damage to surface roots..
TPZ (rad. m): 10.9. SRZ (rad. m): 3.3.

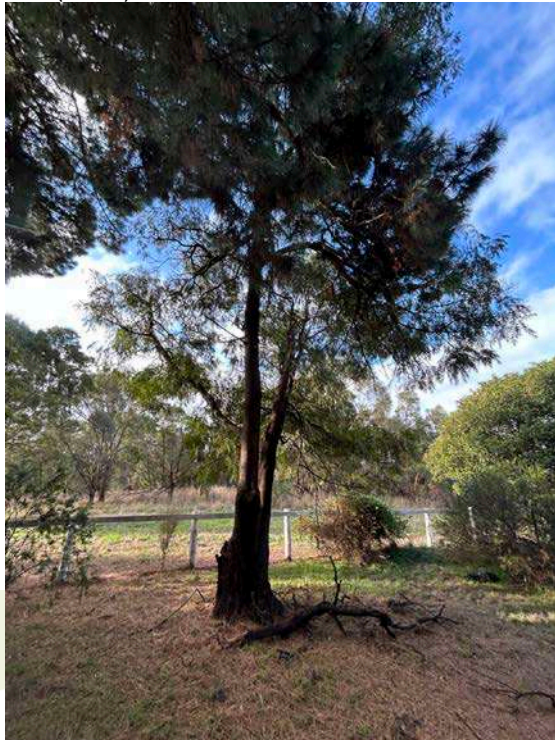
Tree ID: 106. *Acacia elata* (Cedar Wattle), Maturing Australian native.
DBH: 38,28cm. Arb. Rating: Low. Borers, co-dominant stems, past branch failure, past limb failure.
Delaminating bark, trunk exudation. TPZ (rad. m): 5.7. SRZ (rad. m): 2.9.

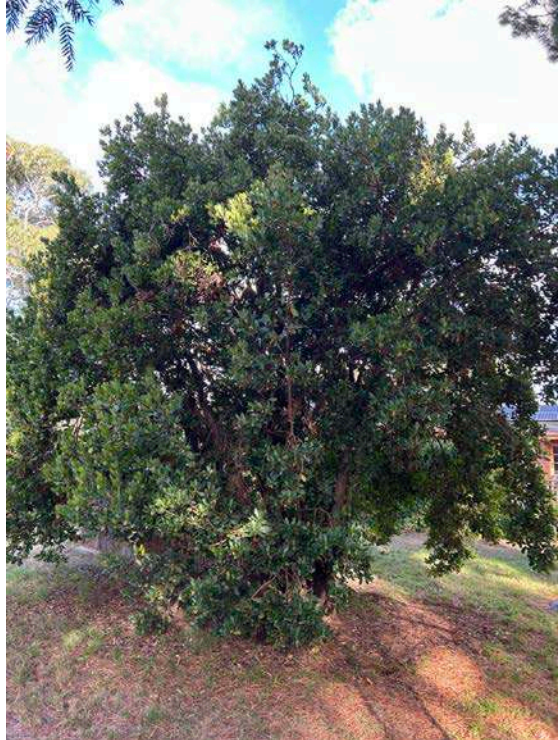
Tree ID: 107. *Arbutus unedo* (Irish Strawberry Tree), Early-mature Exotic evergreen.
DBH: 14,12,12,12,12cm. Arb. Rating: Low. Multi-stemmed at base.. TPZ (rad. m): 3.3. SRZ (rad. m): 2.5.

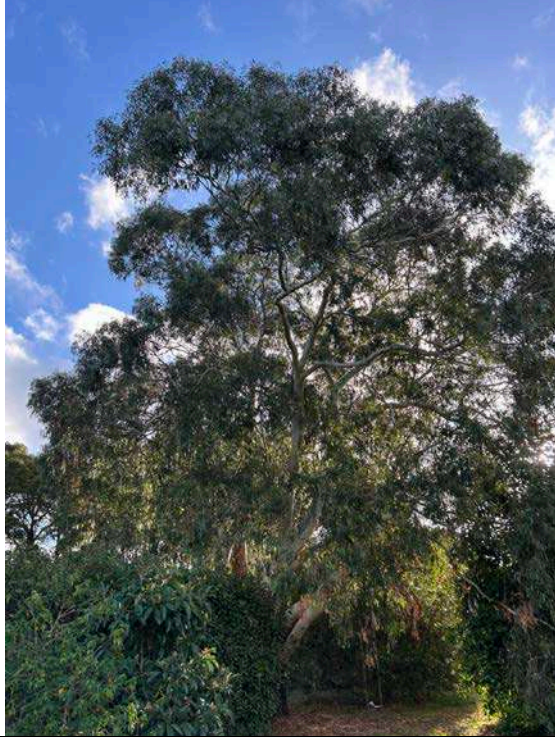
Tree ID: 109. *Eucalyptus mannifera* (Brittle Gum),
Maturing Australian native.
DBH: 140cm. Arb. Rating: Mod.A. Deadwood >50mm,
past branch failure.. TPZ (rad. m): 15. SRZ (rad. m): 3.8.

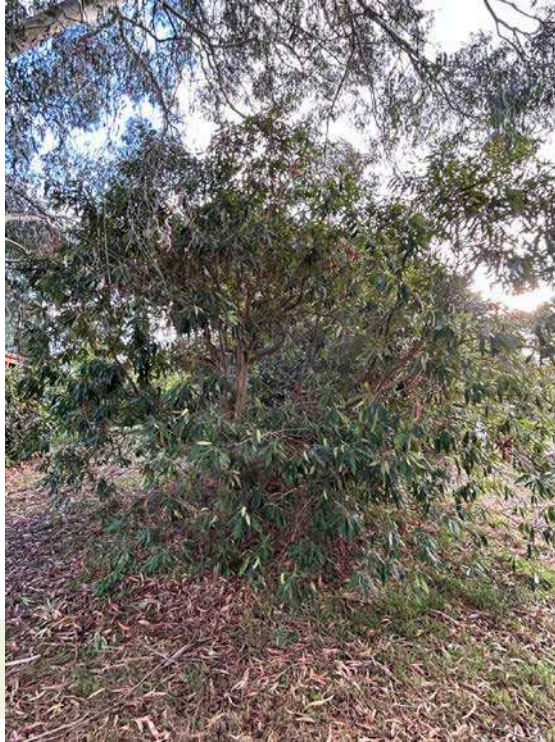
Tree ID: 110. *Tristaniopsis laurina* (Kanooka), Early-
mature Australian native.
DBH: 14,12,12,10,10cm. Arb. Rating: Low. Multi-
stemmed at base, suppressed.. TPZ (rad. m): 3.1. SRZ
(rad. m): 2.4.

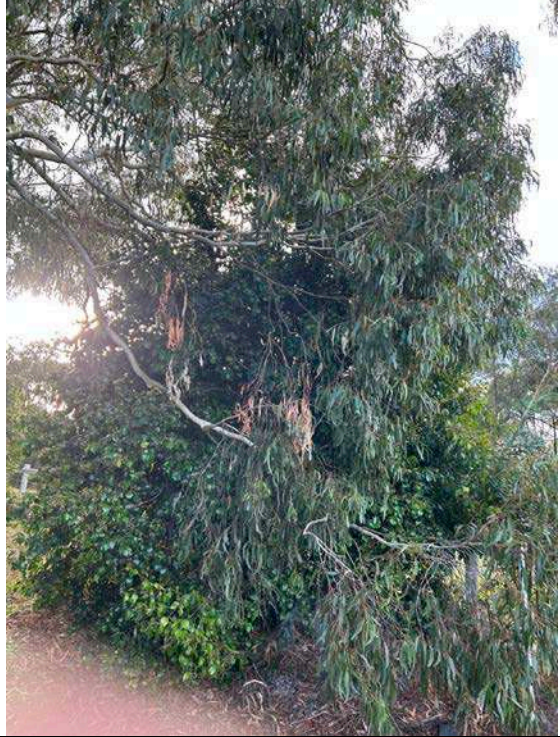
Tree ID: 111. *Syzygium sp.* (Lilly Pilly), Early-mature
Australian native.
DBH: 9,9,9,8,8cm. Arb. Rating: Low. Multi-stemmed at
base, suppressed.. TPZ (rad. m): 2. SRZ (rad. m): 1.8.

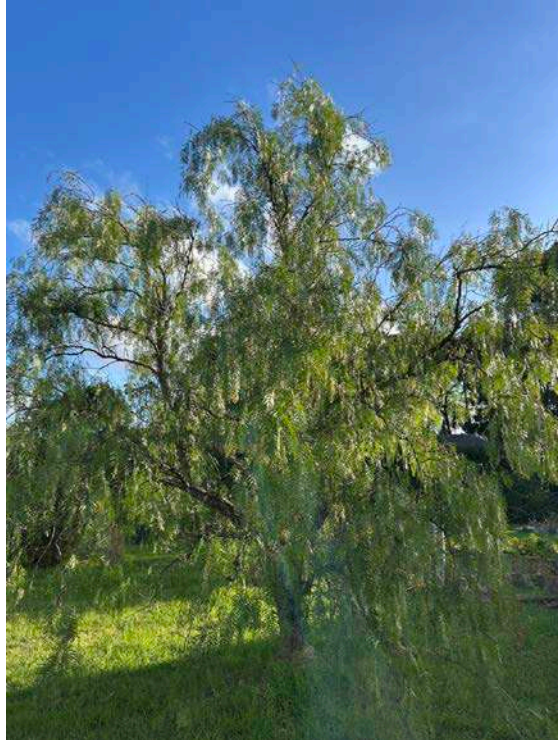
Tree ID: 112. *Schinus areira* (Peppercorn Tree), Semi-
mature Exotic evergreen.
DBH: 13,12,7cm. Arb. Rating: Low. NA. TPZ (rad. m):
2.1. SRZ (rad. m): 2.

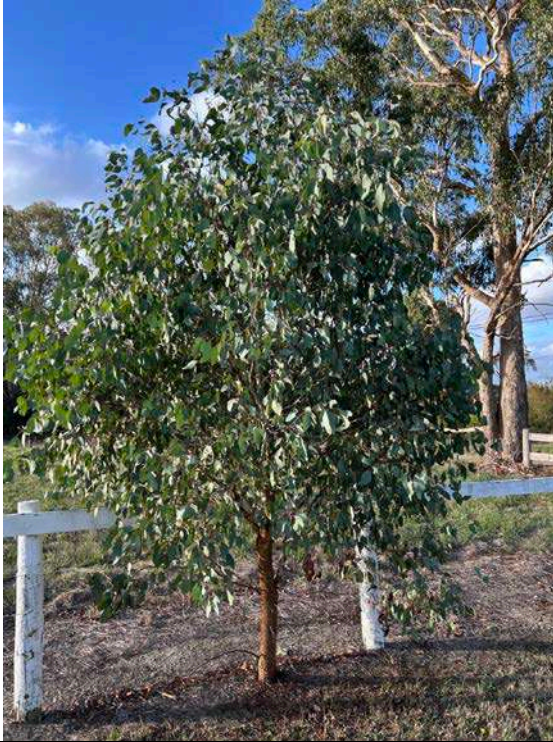
Tree ID: 113. *Eucalyptus melliodora* (Yellow Box), Semi-mature Victorian native.
DBH: 7,7cm. Arb. Rating: Low. NA. TPZ (rad. m): 2. SRZ (rad. m): 1.5.

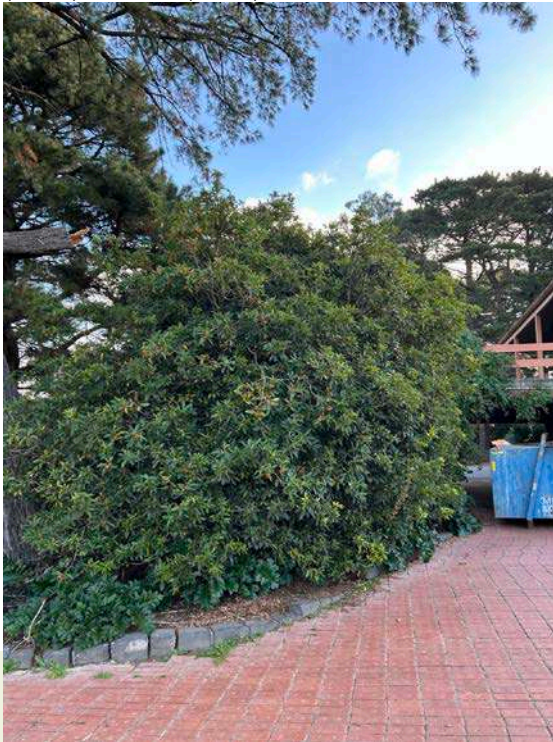
Tree ID: 114. *Pittosporum undulatum* (Sweet Pittosporum), Early-mature Victorian native.
DBH: 20cm. Arb. Rating: Low. Environmental Weed. TPZ (rad. m): 2.4. SRZ (rad. m): 2.

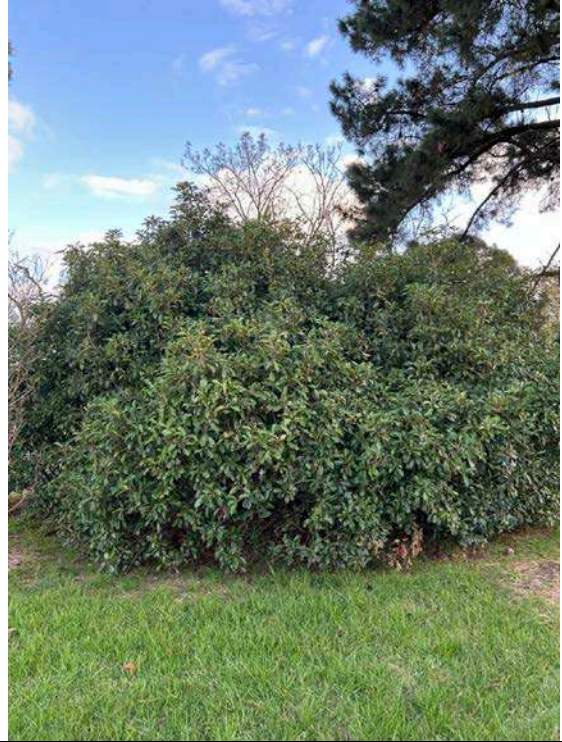
Tree ID: 115. *Photinia serratifolia* (Chinese Hawthorn), Early-mature Exotic evergreen.
DBH: 5,5,5,5cm. Arb. Rating: Low. Multi-stemmed at base.. TPZ (rad. m): 2. SRZ (rad. m): 2.1.

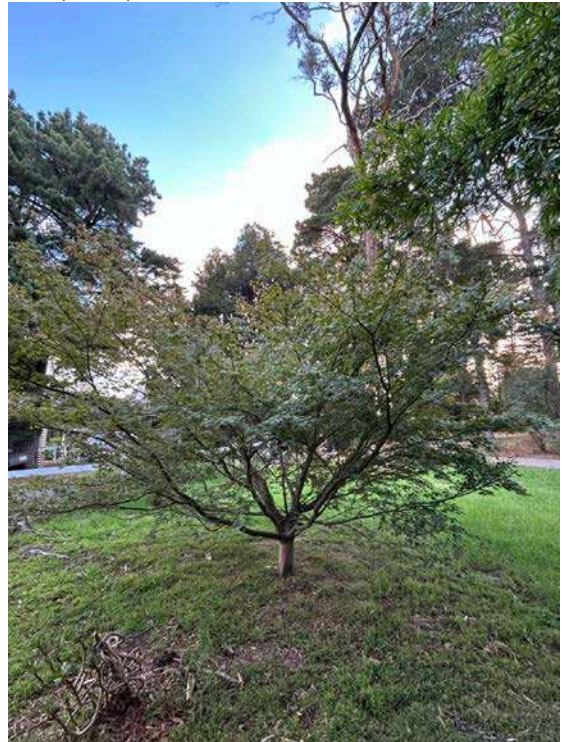
Tree ID: 116. *Acer palmatum* (Japanese Maple), Semi-mature Exotic deciduous.
DBH: 6,4,4,4cm. Arb. Rating: Low. NA. TPZ (rad. m): 2. SRZ (rad. m): 1.7.

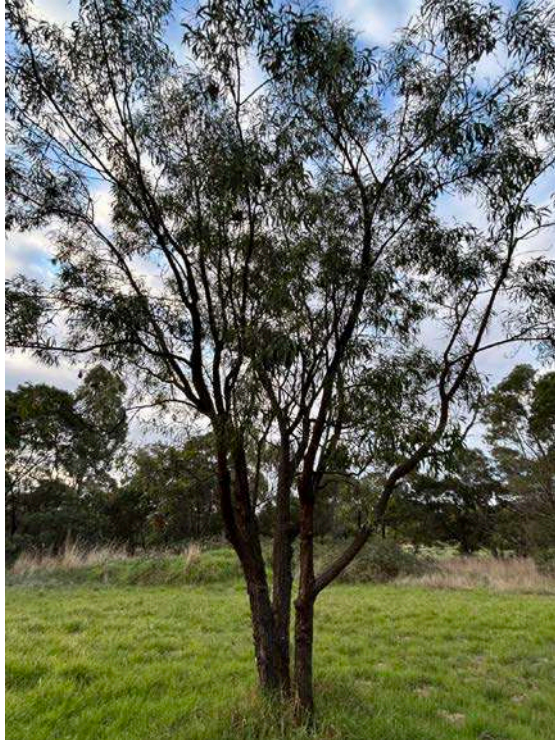
Tree ID: 117. *Acacia implexa* (Lightwood), Semi-mature Victorian native.
 DBH: 20,18,15cm. Arb. Rating: Low. NA. TPZ (rad. m): 3.7. SRZ (rad. m): 2.1.

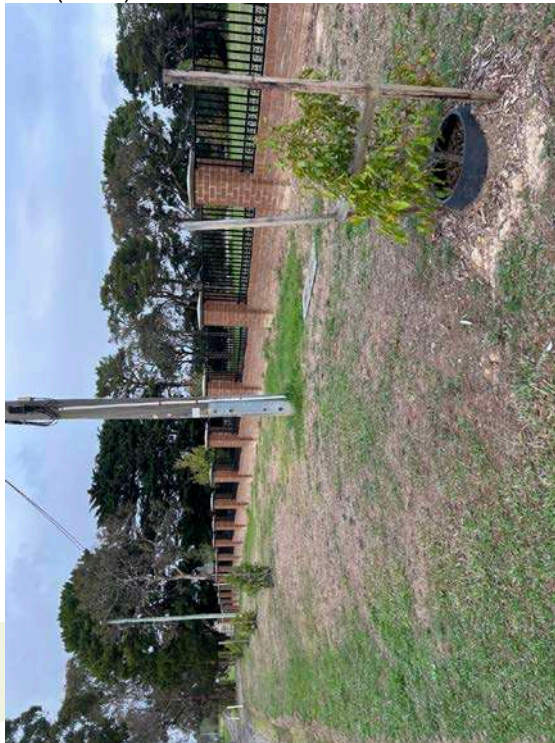
Tree ID: G1. *Syzygium sp.*; *Waterhousea floribunda* (Lilly Pilly; Weeping Lilly Pilly), Young Australian native; Australian native.
 DBH: 2cm. Arb. Rating: Low. 6 Stems. TPZ (rad. m): 2. SRZ (rad. m): 1.5.

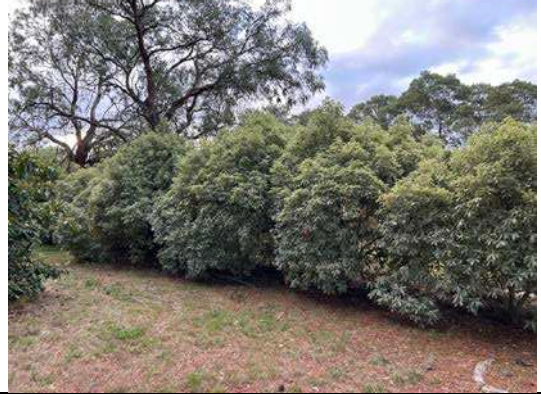
Tree ID: G10. *Pittosporum eugenioides* 'Variegatum' (Variegated Tarata), Semi-mature Exotic evergreen.
 DBH: 10cm. Arb. Rating: Low. 14 Stems. TPZ (rad. m): 2. SRZ (rad. m): 1.5.

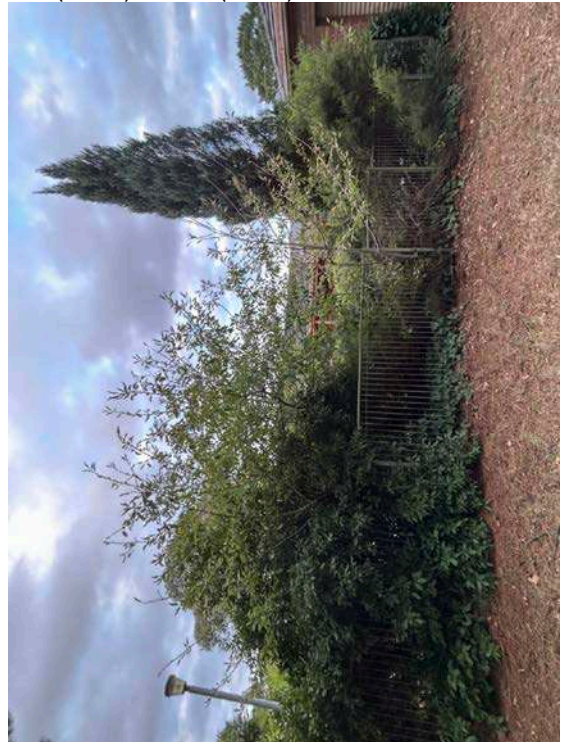
Tree ID: G11. *Juniperus sp.*; *Viburnum sp.* (Juniper; Wayfaring Tree), Semi-mature Exotic conifer; Exotic deciduous.
 DBH: 8cm. Arb. Rating: Low. 14 Stems, Amenity shrubs.. TPZ (rad. m): 2. SRZ (rad. m): 1.5.

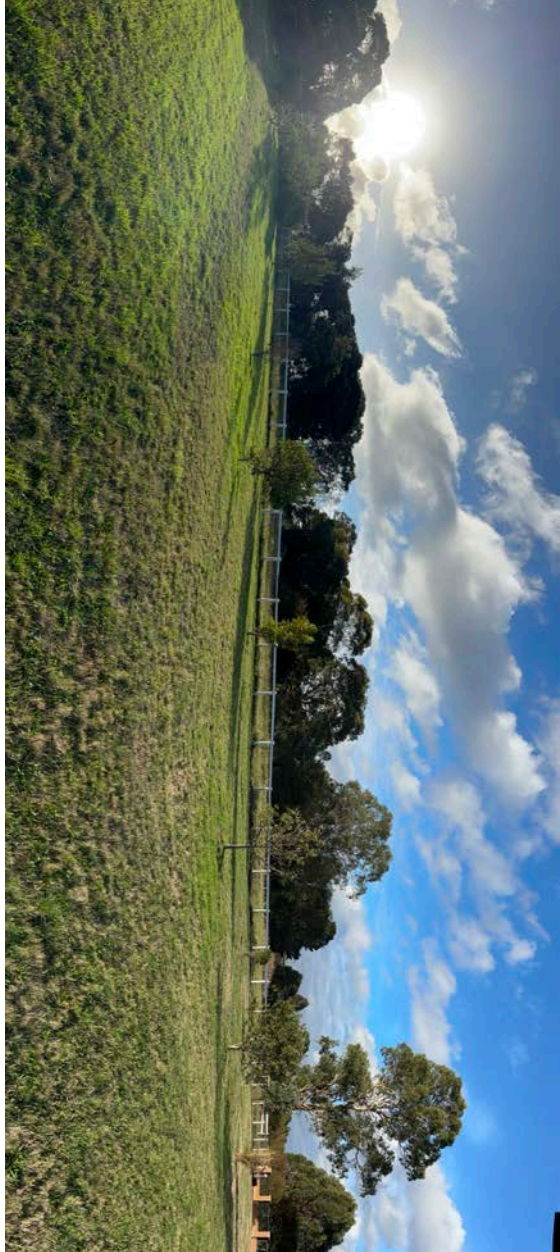
Tree ID: G2. *Citrus sp.*; *Ficus carica*; *Macadamia tetraphylla*; *Malus sp.*; *Prunus sp.*; *Punica granatum* (Citrus Tree; Common Fig; Macadamia Nut; Apple; Almond, Cherry, Peach, Plum), Early-mature Exotic evergreen; Exotic deciduous; Australian native; Exotic deciduous; Exotic deciduous.
 DBH: 10cm. Arb. Rating: Low. 8 Stems, Amenity hedge..
 TPZ (rad. m): 2. SRZ (rad. m): 1.5.

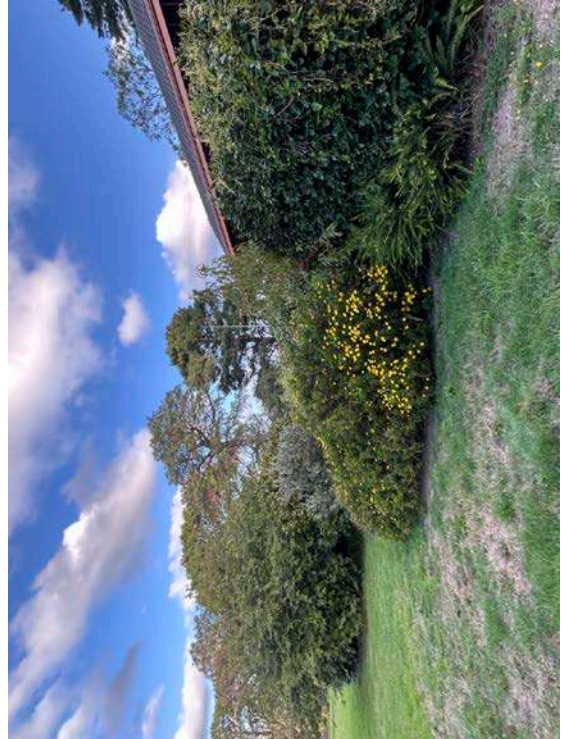
Tree ID: G3. *Betula pendula*; *Camellia japonica*; *Ligustrum sp.*; *Malus sp.* (Silver Birch; Camellia; Privet; Apple), Semi-mature Exotic deciduous; Exotic evergreen; Exotic evergreen; Exotic deciduous.
 DBH: 7cm. Arb. Rating: Low. 20 stems. TPZ (rad. m): 2.
 SRZ (rad. m): 1.5.
