Arboricultural Assessment and Report

3 Nortons Lane, Wantirna South

27 November 2025

Tree Logic Ref. 013990

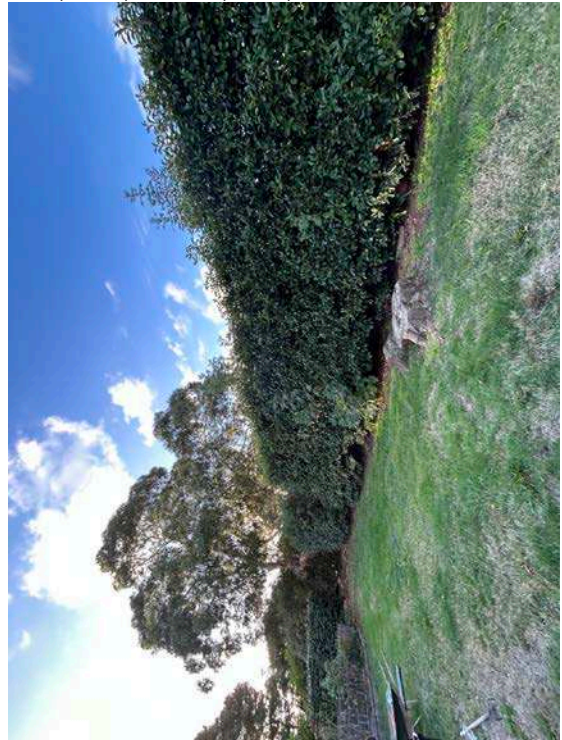
Tree ID: G4. *Fraxinus angustifolia*; *Photinia serratifolia* (Narrow-leaved Ash; Chinese Hawthorn), Early-mature Exotic deciduous; Exotic evergreen.
 DBH: 10cm. Arb. Rating: Low. 8 stems, Amenity shrubs..
 TPZ (rad. m): 2. SRZ (rad. m): 1.5.

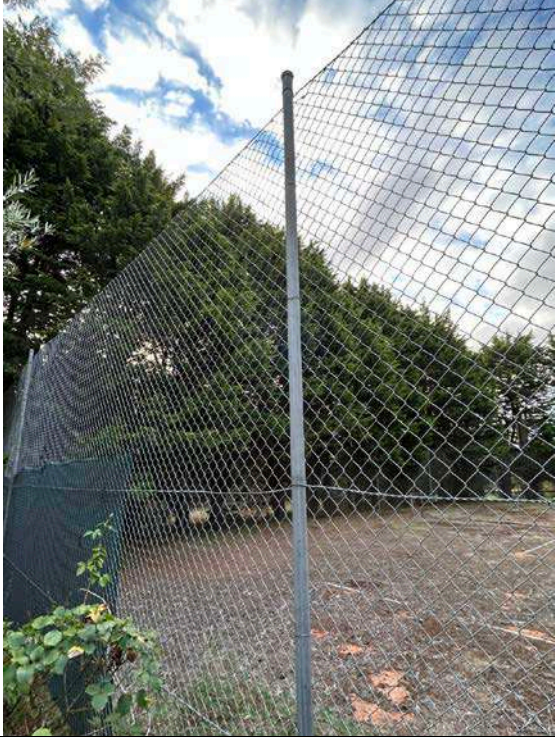
Tree ID: G7. *Cupressus lusitanica* (Mexican Cypress), Early-mature Exotic conifer.
DBH: 35cm. Arb. Rating: Mod.C. 17 stems. Fruit trees amenity planted,.. TPZ (rad. m): 4.2. SRZ (rad. m): 2.4.

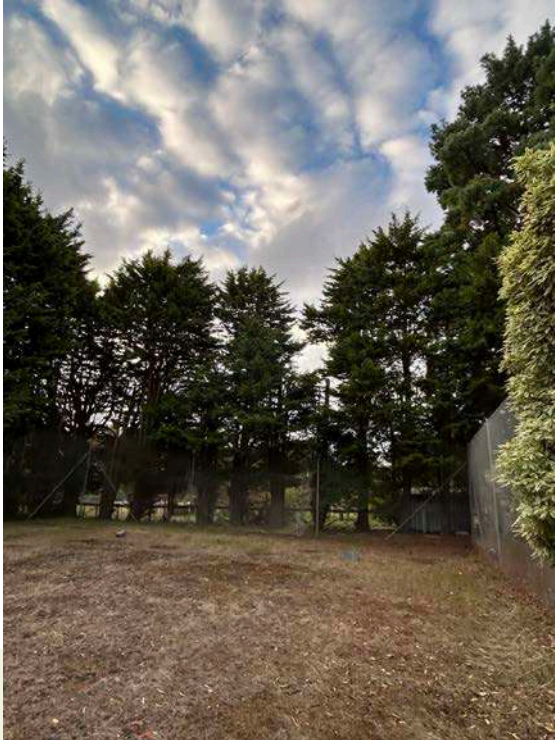
Tree ID: G8. *Cupressus lusitanica* (Mexican Cypress), Early-mature Exotic conifer.
DBH: 25cm. Arb. Rating: Low. 16 stems. Amenity hedge.. TPZ (rad. m): 3. SRZ (rad. m): 2.3.

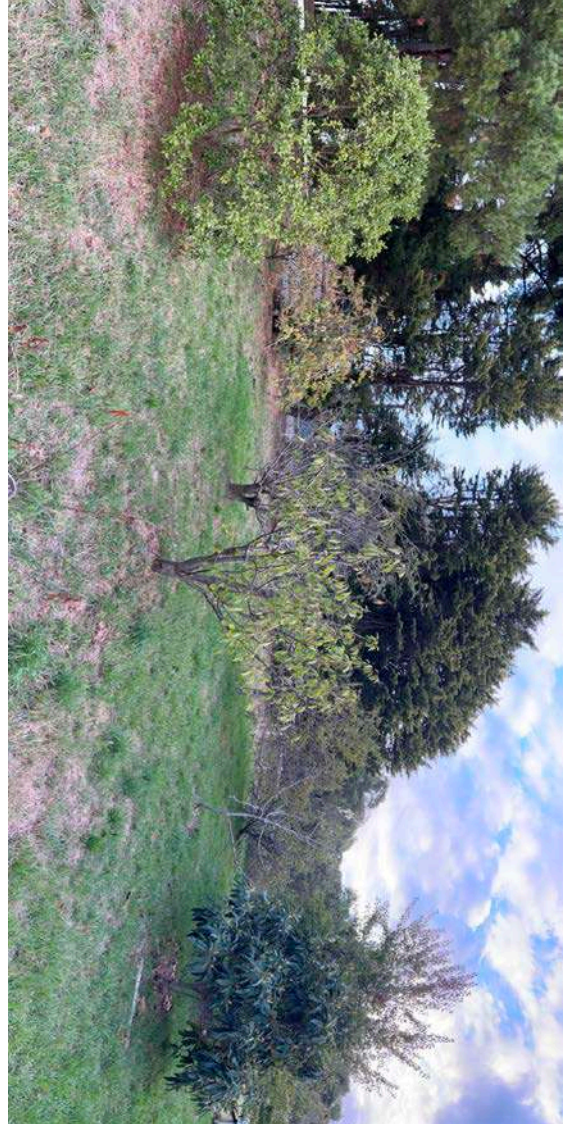
Tree ID: G9. *Diospyros kaki*; *Eriobotrya japonica*; *Ficus carica*; *Malus sp.*; *Pittosporum undulatum*; *Prunus sp.* (Persimmon; Loquat; Common Fig; Apple; Sweet Pittosporum), Semi-mature Exotic deciduous; Exotic evergreen; Exotic deciduous; Exotic deciduous; Victorian native.
DBH: 8cm. Arb. Rating: Low. 17 stems. TPZ (rad. m): 2. SRZ (rad. m): 1.5.

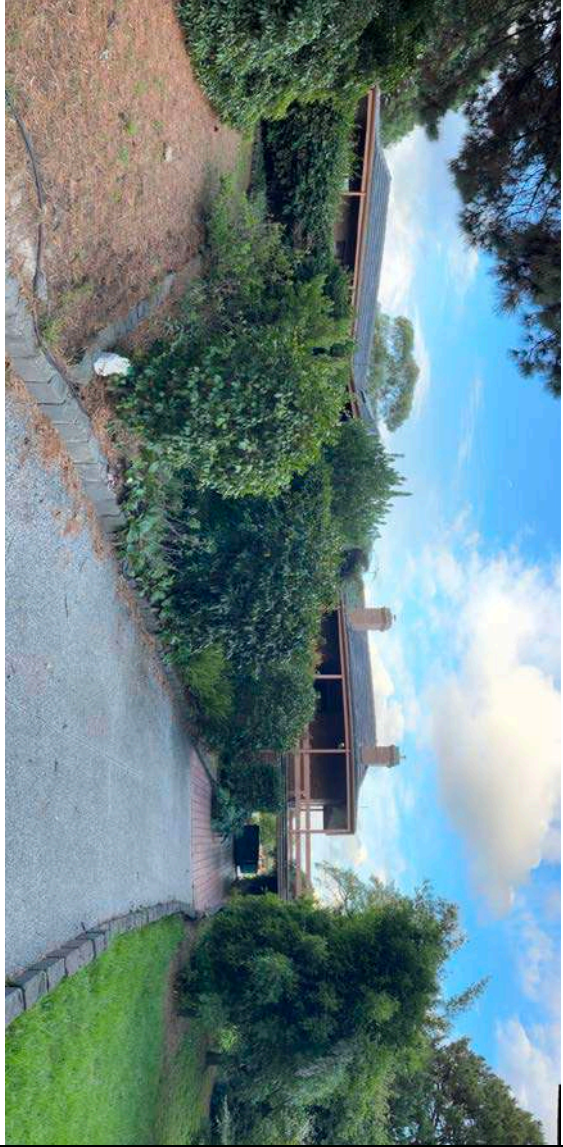
Tree ID: G5. *Arbutus sp.*; *Bambusa sp.*; *Camellia japonica*; *Dicksonia antarctica*; *Fagus sylvatica*; *Viburnum tinus* (Strawberry Tree; Bamboo; Camellia; Soft Tree Fern; European Beech), Semi-mature Exotic evergreen; Exotic grass; Exotic evergreen; Victorian native; Exotic deciduous.
 DBH: 10cm. Arb. Rating: Low. 16 stems. Window hedge.. TPZ (rad. m): 2. SRZ (rad. m): 1.5.

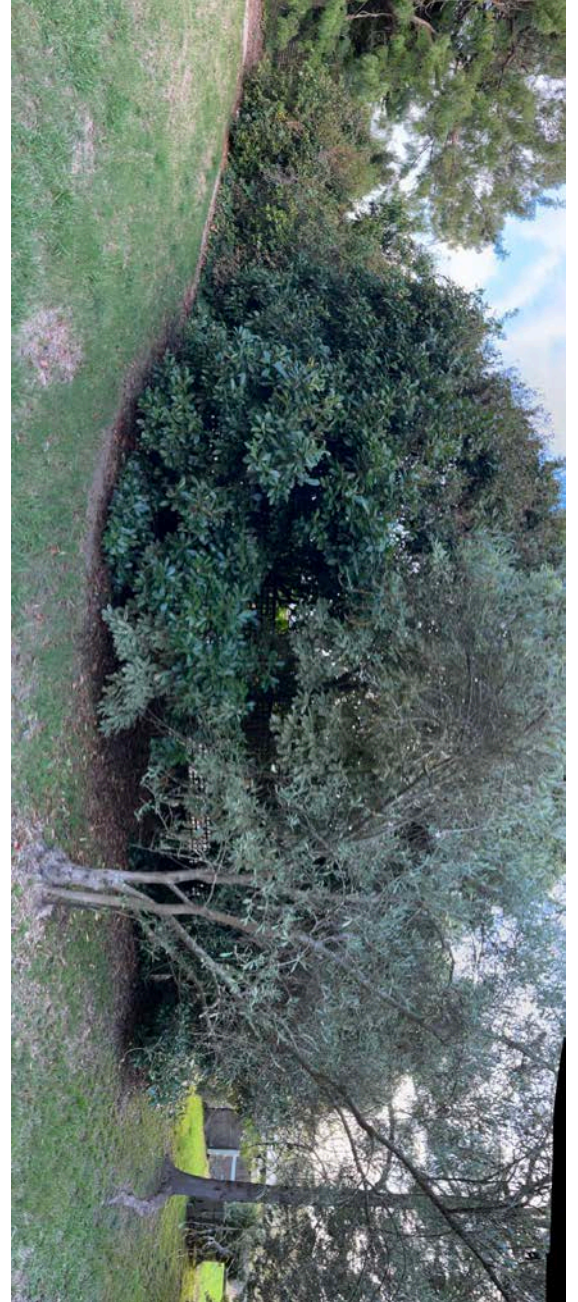
Tree ID: G6. *Camellia japonica*; *Olea europaea*; *Pittosporum eugenioides* 'Variegatum' (Camellia; Olive; Variegated Tarata), Semi-mature Exotic evergreen; Exotic evergreen; Exotic evergreen.
 DBH: 10cm. Arb. Rating: Low. 12 stems. Past branch failure, past limb failure.. TPZ (rad. m): 2. SRZ (rad. m): 1.5.
