A19 ARBORIST REPORT
St Kilda

Assessment of trees as part of proposed tramstop upgrades at Park Street, St Kilda

Arboricultural Impact Assessment

14 February 2024

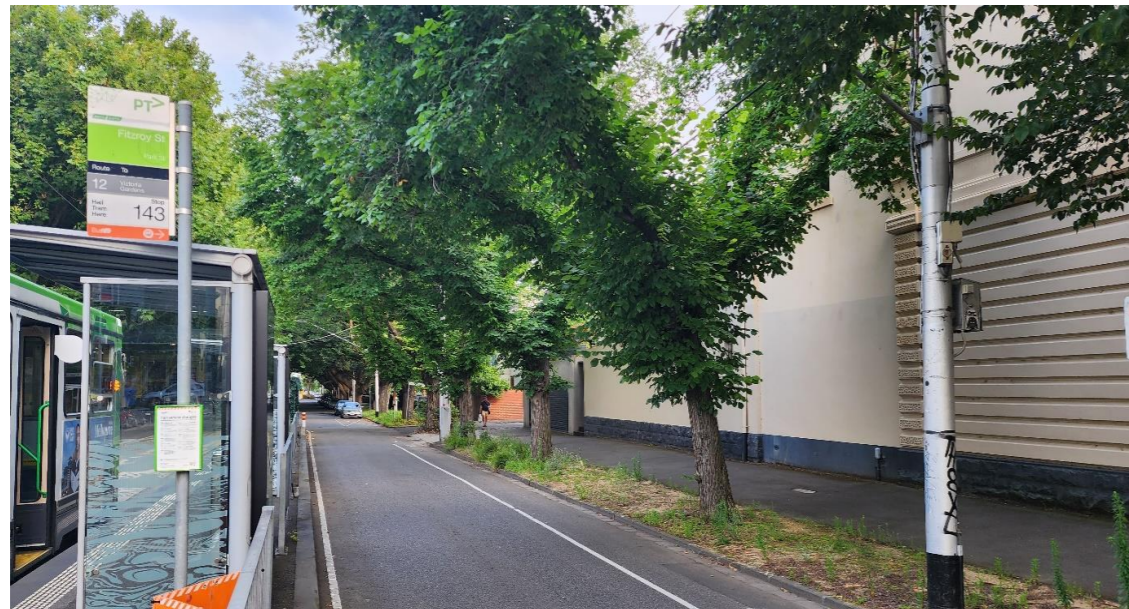
The subject site is Park Street near the intersection with Fitzroy Street in St Kilda (Figure 2). The street is characterised by large, mature, deciduous trees comprising elms *Ulmus* spp. and London Plane *Platanus xacerifolia*. Works are proposed on the north-east side of the road.

Figure 2: The subject site with Tree 4 in the foreground.
