Arboricultural Report

Holy Spirit Catholic Primary
School, 83 Minerva Road
Manifold Heights

9/12/2023

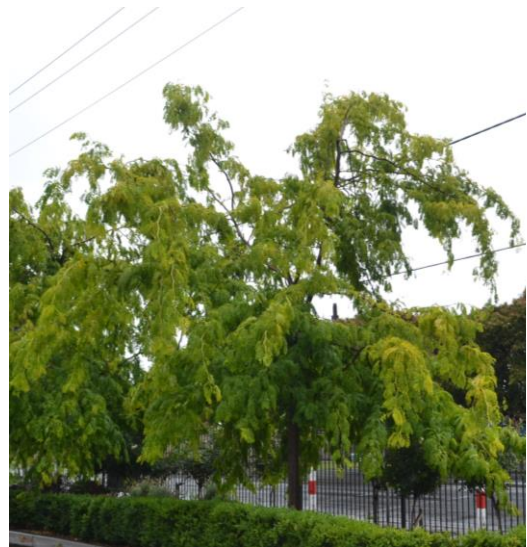
8.1 Tree 1 *Robinia pseudoacacia frisia*

Common Name	Golden Robinia
Health/Condition	Good
Structure	Fair
Height (m)	6 Meters
Width	6 Meters
Age	Semi-mature
Hazard	Medium
ULE	Medium
Retention	Moderate
Risk Rating	Low Risk
Priority	Urgent

FIGURE 1, UPLIFT OVER DRIVEWAY

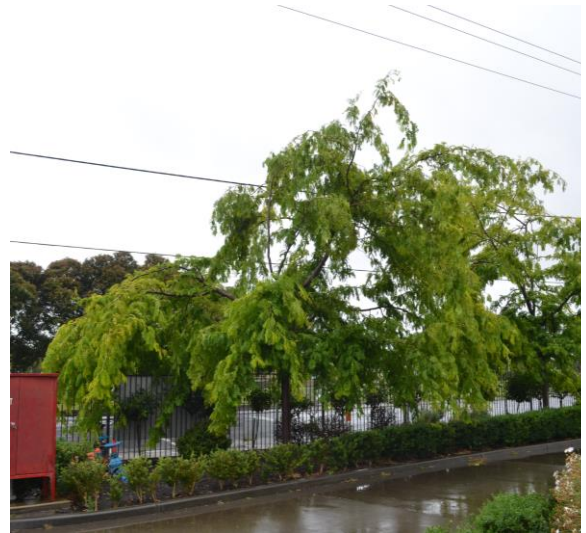
8.2 Tree 2 *Robinia pseudoacacia frisia*

Common Name	Golden Robinia
Health/Condition	Good
Structure	Fair
Height (m)	7 Meters
Width	6 Meters
Age	Semi-mature
Hazard	Medium
ULE	Medium
Retention	Moderate
Risk Rating	Low Risk
Priority	Urgent

FIGURE 1, UPLIFT OVER DRIVEWAY

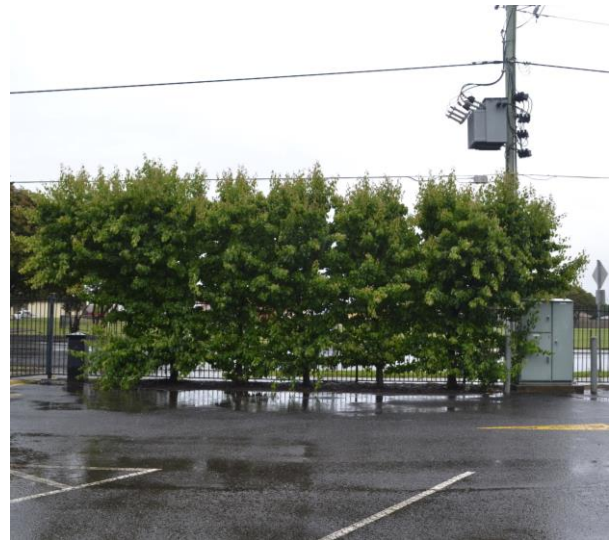
Plantation 1

Common Name	Ornamental Pear
Health/Condition	Good
Structure	Fair
Height (m)	5 Meters
Width	3 Meters
Age	Semi-mature
Hazard	Medium
ULE	Medium
Retention	Low
Risk Rating	Low Risk
Priority	N/A

FIGURE 1, FOLIAGE OVER FOOTPATH

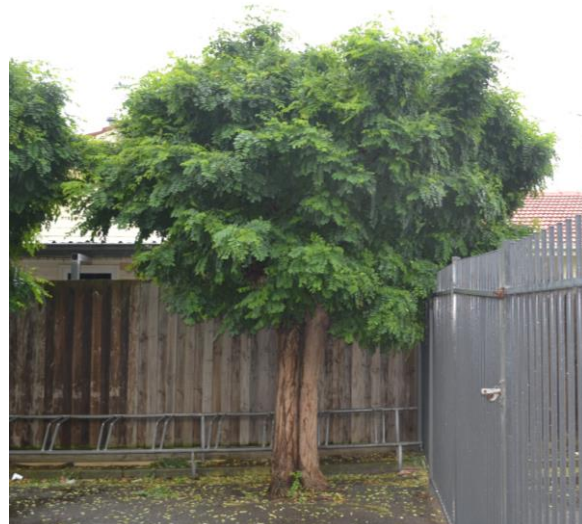
8.4 Tree 8 *Robinia pseudoacacia umbracaulifera*

Common Name	Mop Top
Health/Condition	Good
Structure	Fair
Height (m)	5 Meters
Width	5 Meters
Age	Semi-mature
Hazard	Medium
ULE	Medium
Retention	Moderate
Risk Rating	Low Risk
Priority	High

FIGURE 1, CLEAR OF FENCE

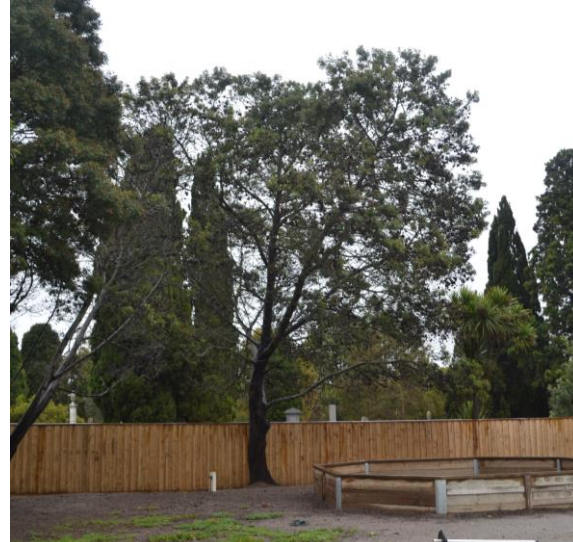
8.15 Tree 32 *Acacia mearnsii*

Common Name	Black Wattle
Health/Condition	Good
Structure	Fair
Height (m)	13 Meters
Width	9 Meters
Age	Semi-mature
Hazard	Medium
ULE	Long
Retention	Moderate
Risk Rating	Low Risk
Priority	Urgent

FIGURE 1, DEADWOOD

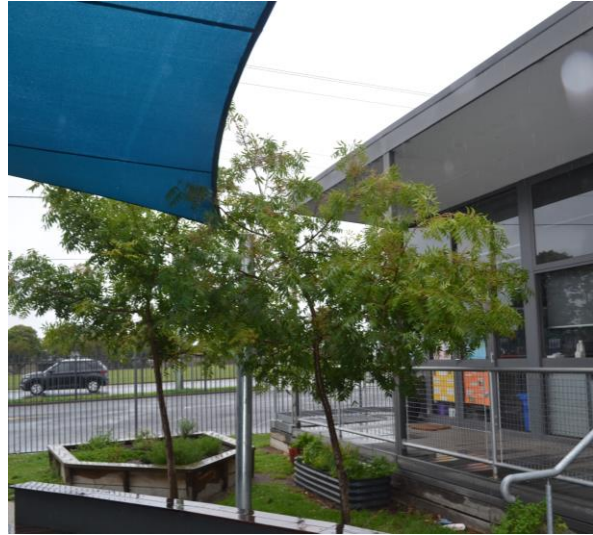
8.23 Tree 40 *Robinia pseudoacacia frisia*

Common Name	Golden Robinia
Health/Condition	Good
Structure	Good
Height (m)	5 Meters
Width	3 Meters
Age	Semi-mature
Hazard	Medium
ULE	Long
Retention	Moderate
Risk Rating	Low Risk
Priority	High

FIGURE 1, FOLIAGE ON SHADE SAIL
