Selected Mature Tree Health and Condition Assessment

Prepared for: Melbourne Montessori School - Brighton East Campus

Site Address: 741 Hawthorn Rd Brighton East

Date Prepared: April 2024

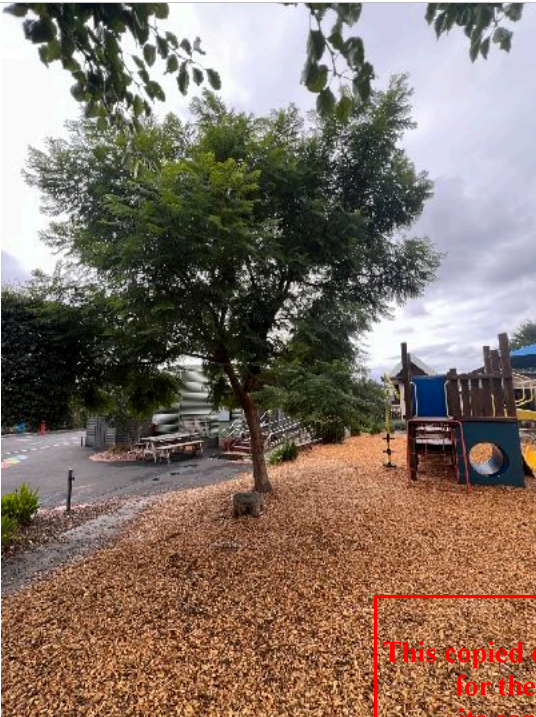
T13: *Jacaranda mimosifolia*

12	<i>Pyrus ussuriensis</i>	Manchurian Pear	5	2	N.R.	N.R.	N.R.	N.R.	Young	Under 5 years	Poor	Good	Fair	Appears to have poor branch attachments	Prune away from building	Low
13	<i>Jacaranda mimosifolia</i>	Jacaranda	10	7	23	2.8	31.8	2.0	Semi - mature	5 - 20 years	Fair	Fair	Fair	Damage on south side of trunk Low branches - potential hazard to students	Uplift canopy to minimum 2.2m	High
14	<i>Acacia</i>	Wattle	7	7	26	3.1	N.R.	N.R.	Mature	5 - 20 years	Poor	Good	Fair	Included bark present at main union Tree on a lean Dense canopy Deadwood present in canopy	Prune branches back from overhanging playground Reduce end weight of branches growing to the north west Remove deadwood greater than 30mm in diameter	Medium
15	<i>Grevillea robusta</i>	Silky Oak	7	5	11	2.0	N.R.	N.R.	Young	Over 50 years	Good	Good	Good	Good health and condition	No works	No works
16	<i>Pyrus ussuriensis</i>	Manchurian Pear	6	5	N.R.	N.R.	N.R.	N.R.	Mature	5 - 20 years	Fair	Good	Good	Good health and condition Small unions with included bark	No works	No works

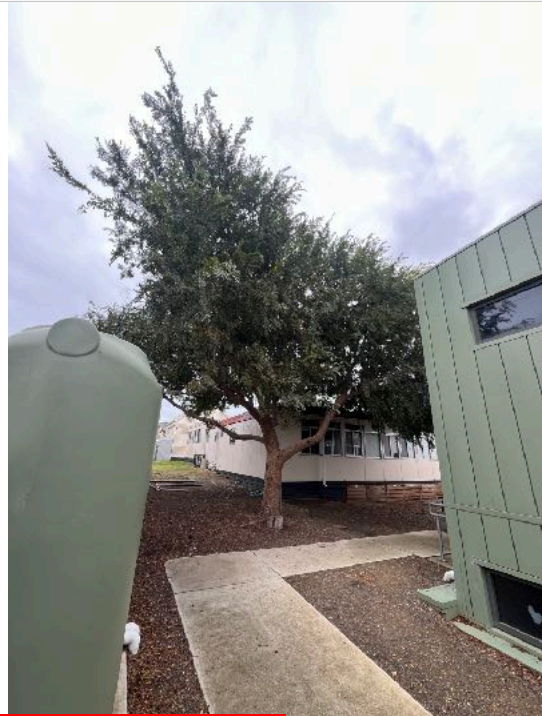
T17: *Pyrus ussuriensis*

17	<i>Pyrus ussuriensis</i>	Manchurian Pear	6	6	22	2.6	22	1.8	Mature	5 - 20 years	Poor	Good	Fair	Rubbing branches in canopy Included bark present at several unions Branches close to adjacent building Low branches - potential hazard to students	Uplift canopy to minimum 2.2m	High
18	<i>Ficus</i>	Fig	5	37	N.R.	N.R.	N.R.	N.R.	N.R.	N.R.	N.R.	N.R.	N.R.	Hedge of Ficus trees	No works	No works
19	<i>Ulmus parvifolia</i>	Chinese Elm	13	16	49	5.9	60.5	2.7	Mature	5 - 20 years	Fair	Good	Poor	History of poor pruning evident Branches touching adjacent building Appears that neighbours have lopped the tree back to fence line recently Exposed roots to the north	Remove to base Grind stump	High
20	<i>Populus nigra</i>	Poplar	NR	NR	NR	NR	NR	NR	NR	NR	NR	NR	NR	Tree is located in the neighbours property and is in the north east corner of the school Previously pruned hard, resulting in epidermic shoots From a ground based visual inspection with assistance of a drone, tree appears to be in good health and the structure appears be to good	Continue to monitor annually	Monitor
