Fire Hazard and Risk Assessment

Elaine Battery Energy Storage System (BESS)

Report Name: Fire Hazard and Risk Assessment

NJM Design has been engaged by Akaysha Energy to undertake a fire hazard and risk assessment for the Battery Energy Storage System (BESS) located at Elaine Victoria (225 Elaine-Blue Bridge Road). The site is adjacent to the existing Elaine Terminal Station. The new BESS will comprise Tesla Megapacks.

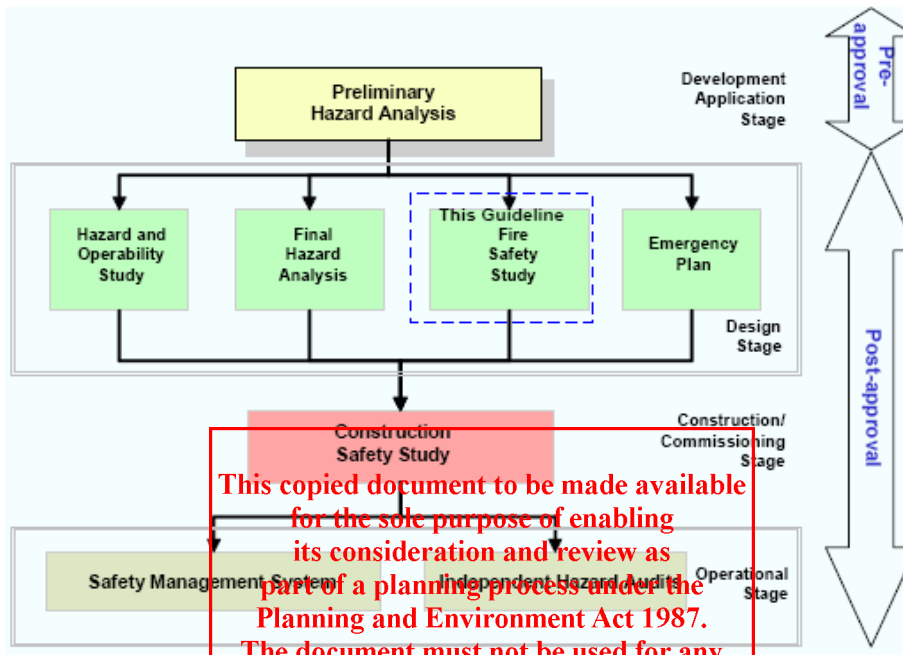
Figure 2: The Hazards-Related Assessment Process

The process is shown diagrammatically in Figure 2.

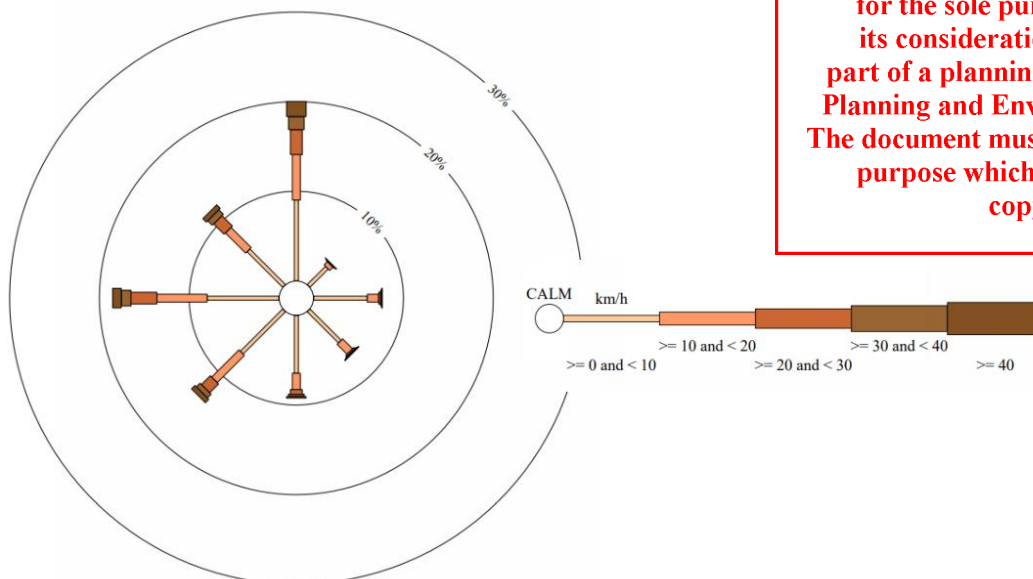
Figure 10: Wind Rose for Durdidwarrah weather station.

- The average temperature is 17°C and the highest mean maximum temperature is 24.1°C for the month of January.
- The mean relative humidity is 74%.
- Wind statistics (Figure 10):
 - Wind is calm 10% of the time.
 - The strongest wind comes from the north with a speed of more than 40 km/hr (11.1m/s), approximately 2% of the time.
 - Wind from the north most of the time (20% of the time), from the west 19% of the time, from the south 9% of the time, and from the east 6% of the time.
 - Average speed of the wind is 3.24 m/s.

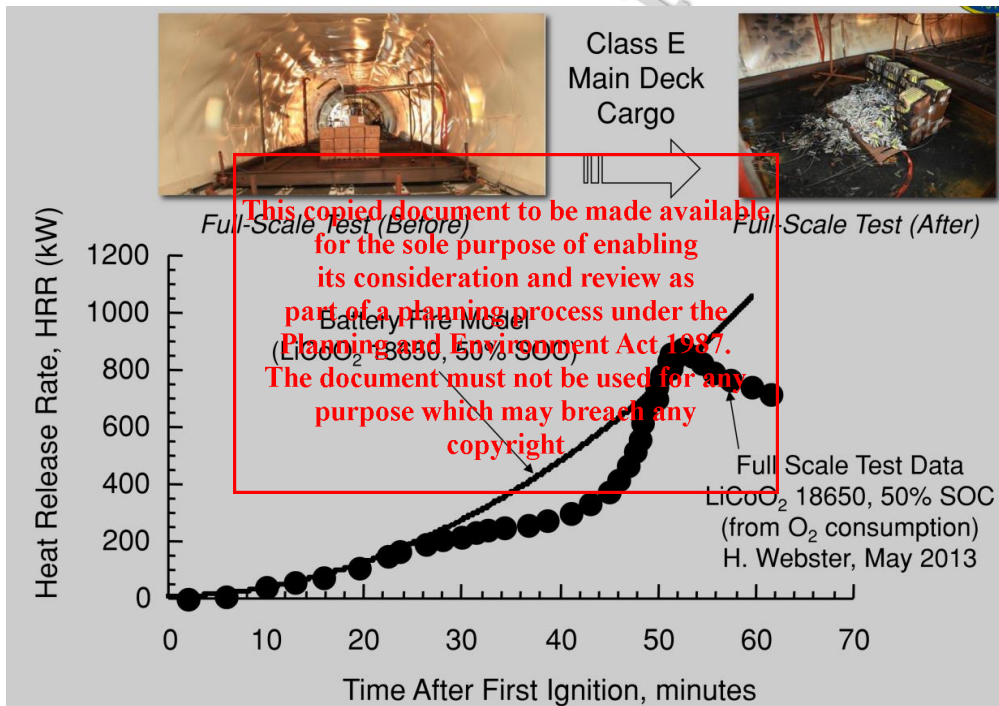
Figure 18: Results of full-scale tests on 18650 batteries

The peak heat release rate is approximately 1MW.

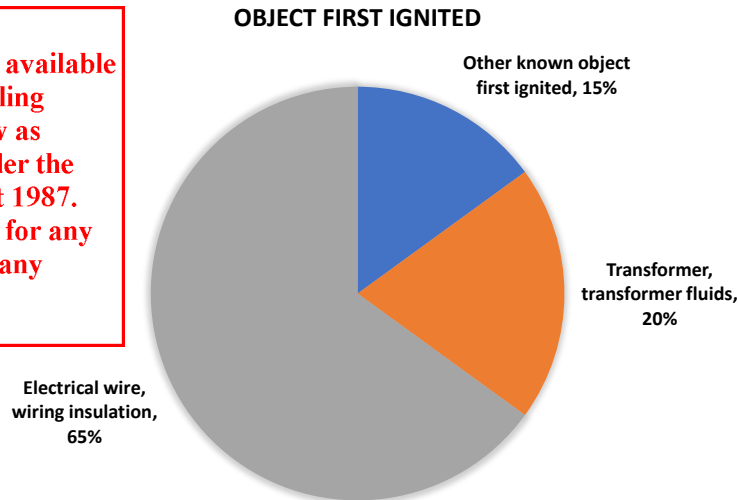
Figure 20: Substation fires distribution.

The Ministry of Economic Development (MED) provides annual statistics reports in New Zealand. In accordance with MED, from the substation's fires in New Zealand between 1946 and 1995, 65% of these fires had the electrical wire or cable insulation as the object first ignited (Figure 20). Compared to the cable insulation, the probability of having transformer or transformer fluid as the object first ignited is much lower (20%).

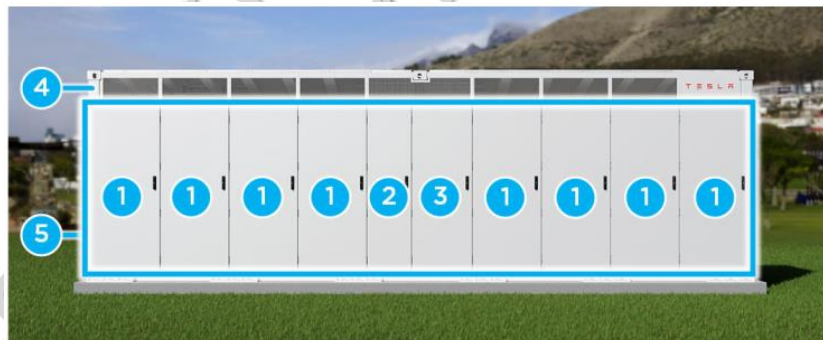
Figure 34: Megapack overview [5].

The batteries that will be used on site will be based on a Tesla Megapack design. It consists of a modular design with battery module bays, a thermal cabinet, a customer interface bay, a thermal roof and an IP66 enclosure [5].

1. Battery module bays ([Battery Modules on page 11](#))
2. Thermal cabinet ([Thermal System on page 12](#))
3. Customer Interface Bay ([Customer Interface Bay on page 13](#))
4. Thermal roof ([Thermal System on page 12](#))
5. IP66 enclosure ([Enclosure on page 13](#))

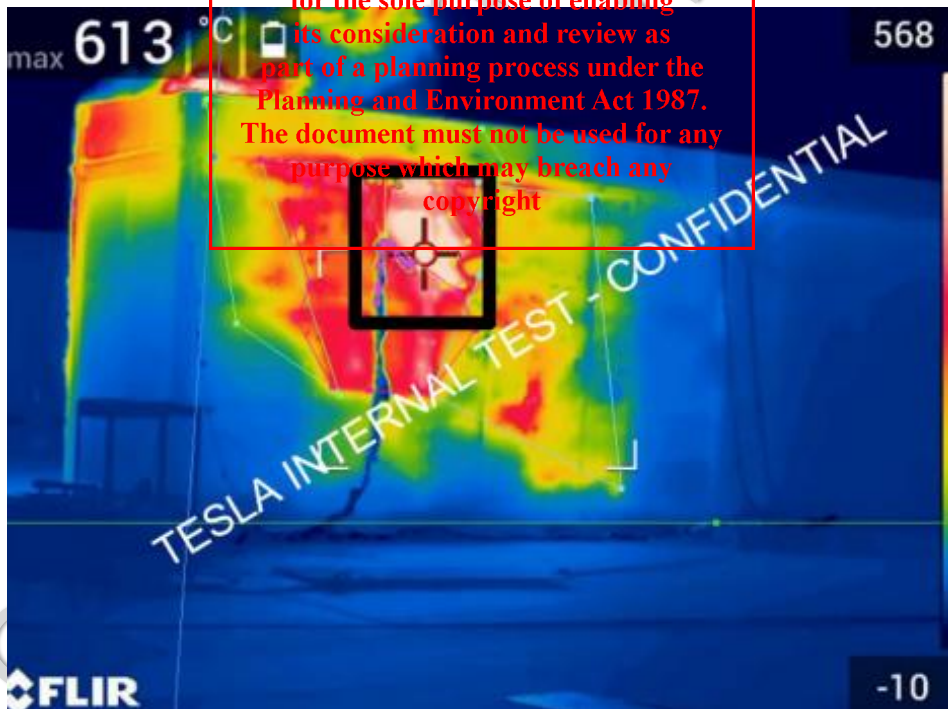
Figure 38: Fire spread between Tesla module bays.

- Although fire spread is not expected between Megapacks, fire may spread to maximum 1 energy module bay to each side of the fire-origin energy module bay (Figure 38) based on results of the Test as per UP9540A.

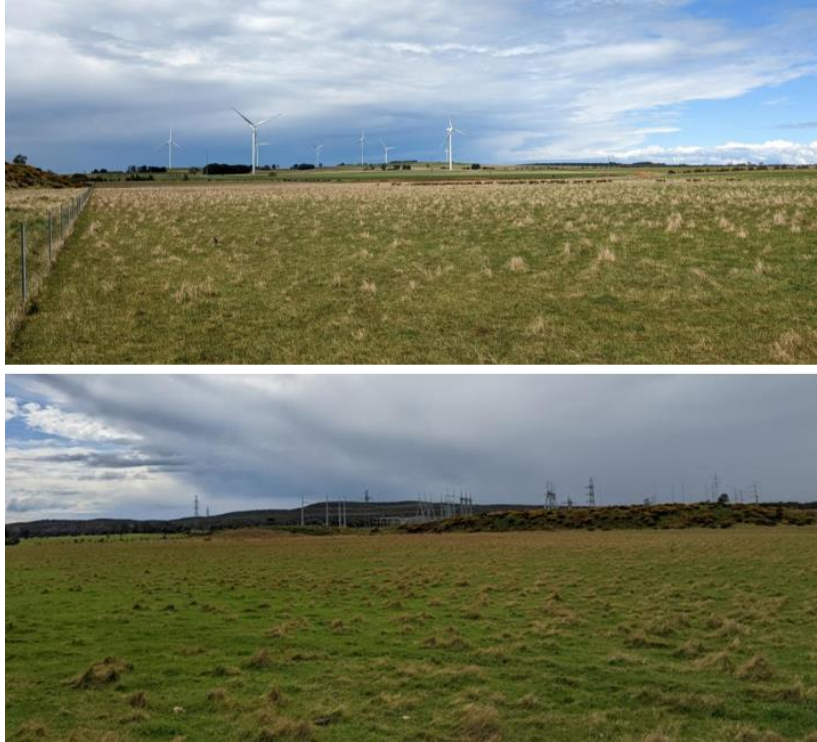
Figure 39: Vegetation in the adjoining agricultural allotments.

The adjoining allotments located approximately 10m from the relevant equipment are agricultural areas that have managed grassland, as shown in Figure 39 taken from the Red Flag Assessment.

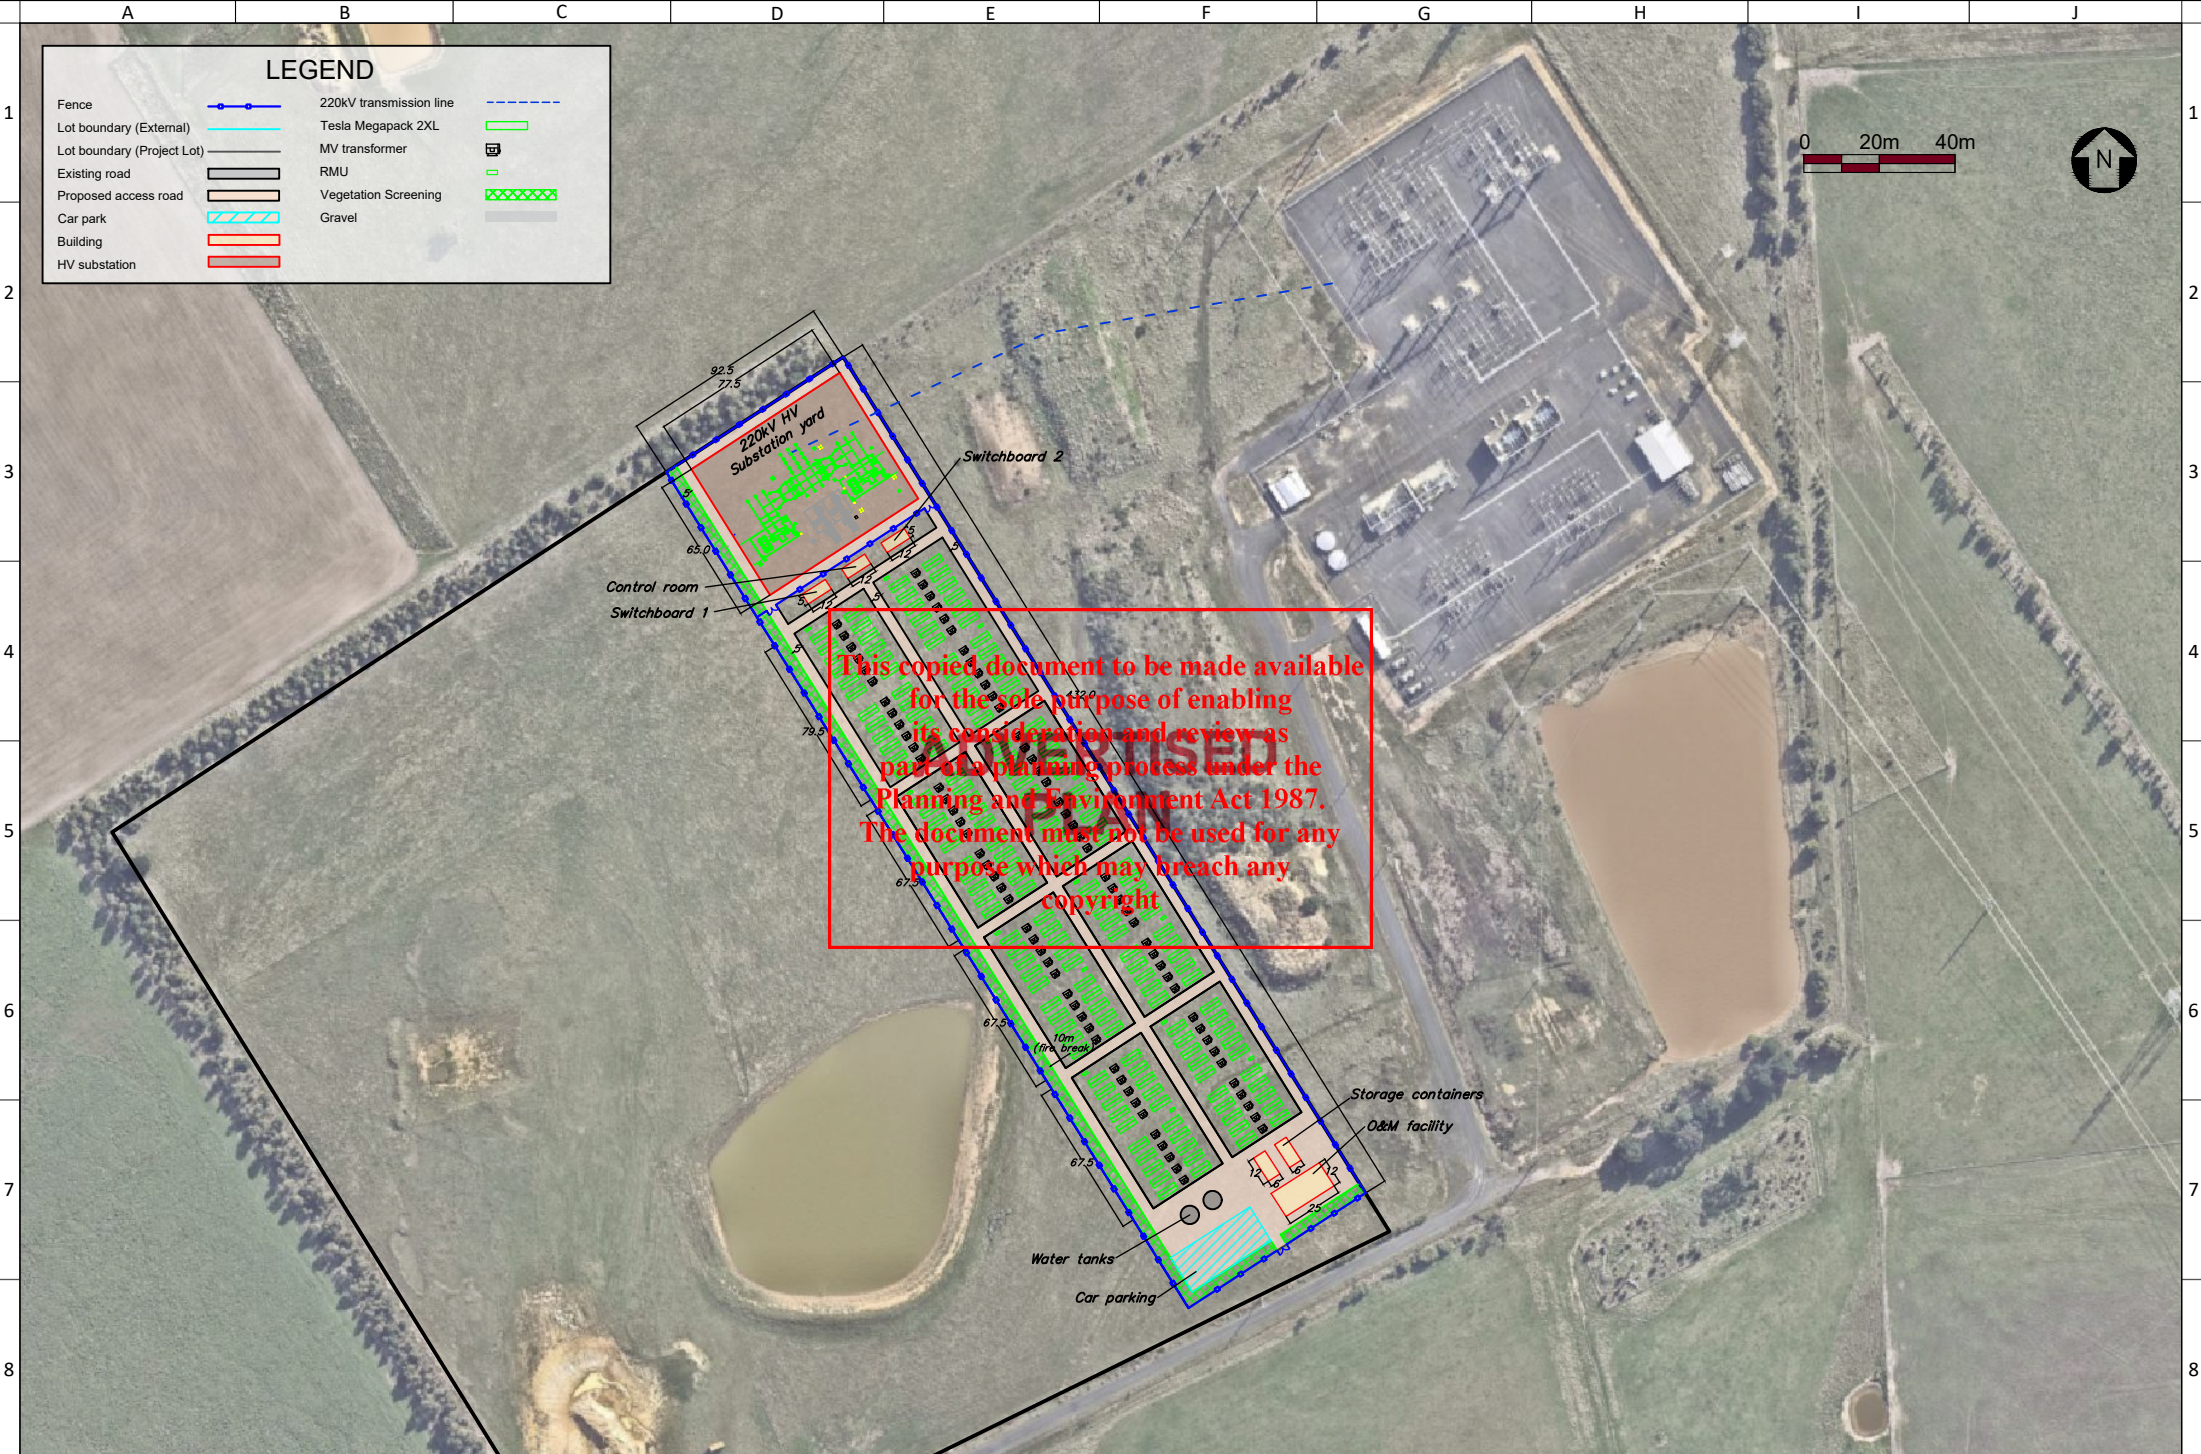
AKAYSHA ENERGY PTY. LTD. 11-13 PEARSON ST CREMORNE, VIC, AUS	NOTES: 1. 300 MW / 1200 MWh 2. BESS: 336 x TESLA MEGAPACK 2XL 3. PCS:	PROJECT ***** BATTERY ENERGY STORAGE SYSTEM ADDRESS/COORDS CITY, STATE, COUNTRY, POSTAL	DRAWN DESIGNER	DRAWING TITLE GENERAL LAYOUT	SHEET GA2
				REVIEWED REVIEWER	PROJECT # AE-XXX	CREATED DD MONTH YYYY
					APPROVED APPROVER	REV 1
