**REPORT No.** : 1191040-5 Issue 3

**PROJECT** : Lysterfield Lake College  
19-23 Horswood Road  
NARRE WARREN NORTH

**PROPOSAL** : It is proposed to develop this site with a multipurpose sports field.

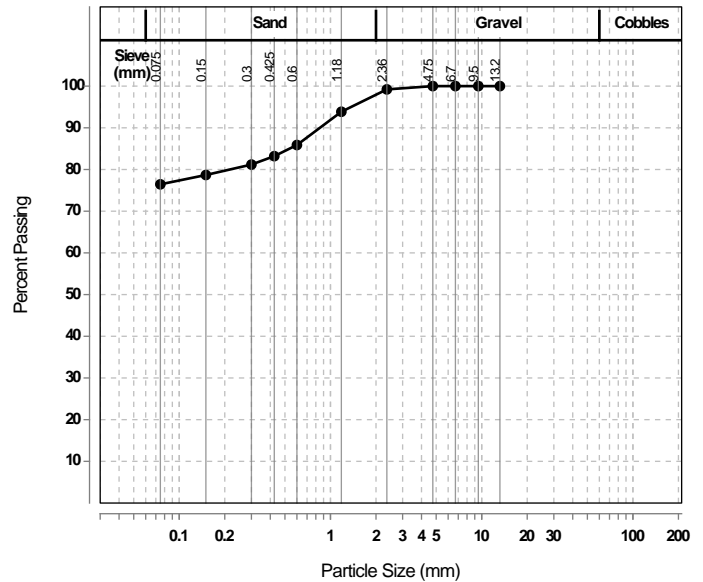
Particle Size Distribution

Min	Max
Linear Shrinkage (%)	14.5	
Cracking Crumbling Curling	Curling

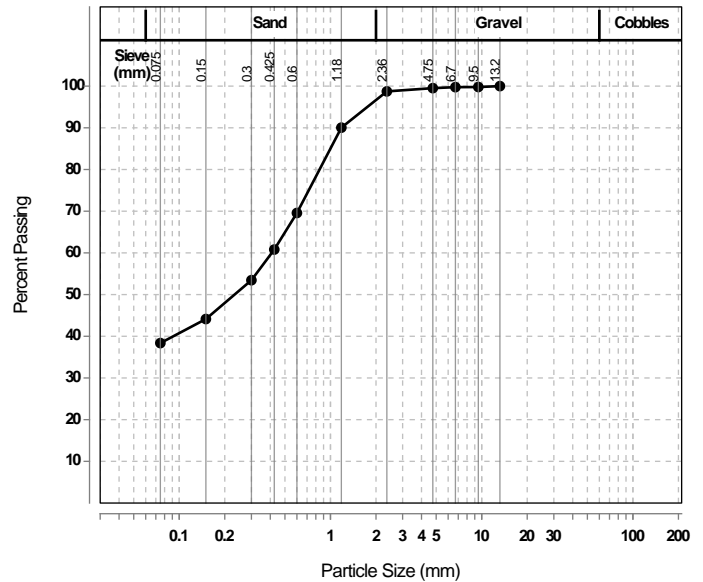
**Particle Size Distribution**

Min	Max
Linear Shrinkage (%)	4.0	
Cracking Crumbling Curling	None

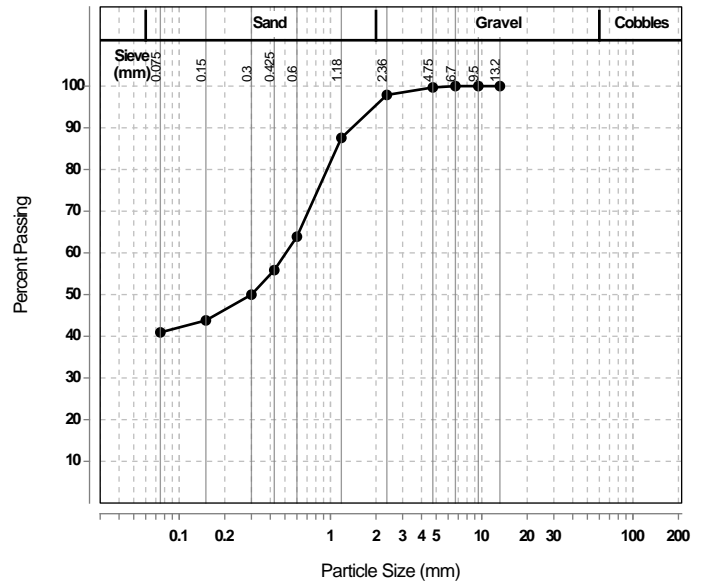
Particle Size Distribution

Min	Max
Linear Shrinkage (%)	9.0	
Cracking Crumbling Curling	Curling

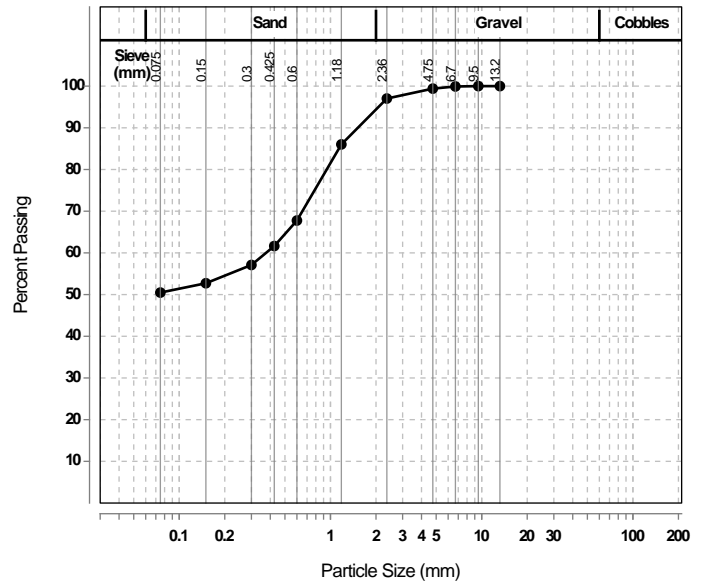
Particle Size Distribution

Min	Max
Linear Shrinkage (%)	10.0	
Cracking Crumbling Curling	Curling

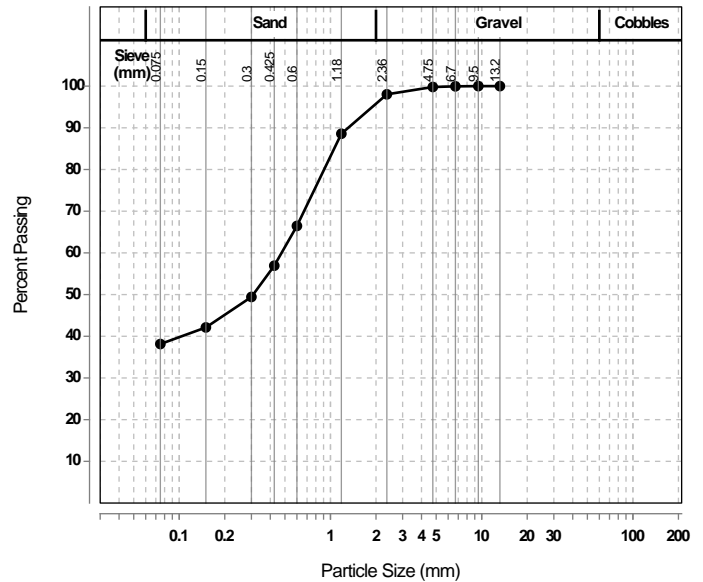
Particle Size Distribution

Min	Max
Linear Shrinkage (%)	2.5	
Cracking Crumbling Curling	None

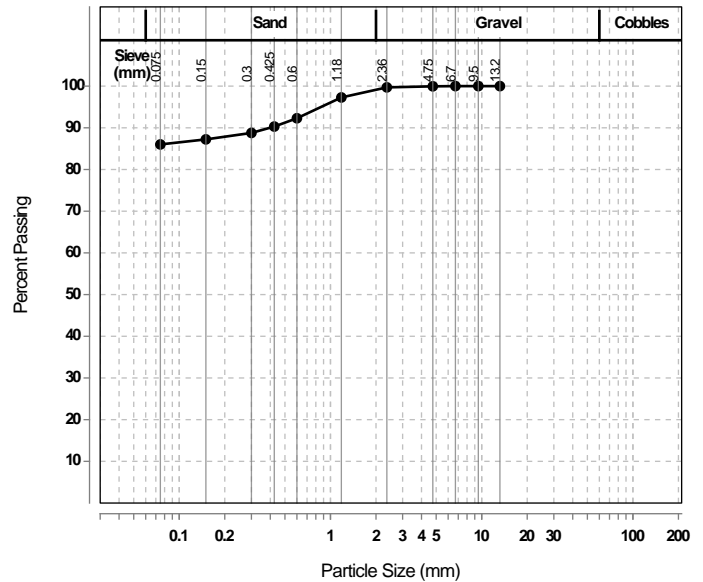
Particle Size Distribution

Min	Max
Linear Shrinkage (%)	17.0	
Cracking Crumbling Curling	Curling

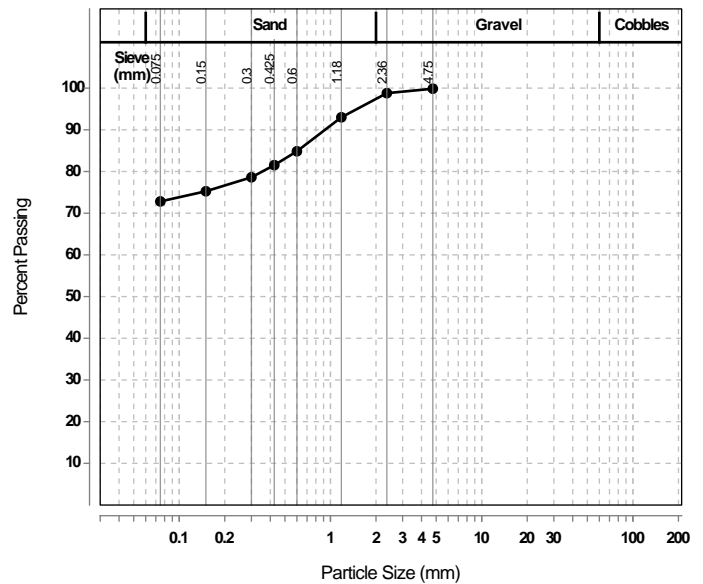
Particle Size Distribution

Min	Max
Linear Shrinkage (%)	13.0	
Cracking Crumbling Curling	Curling

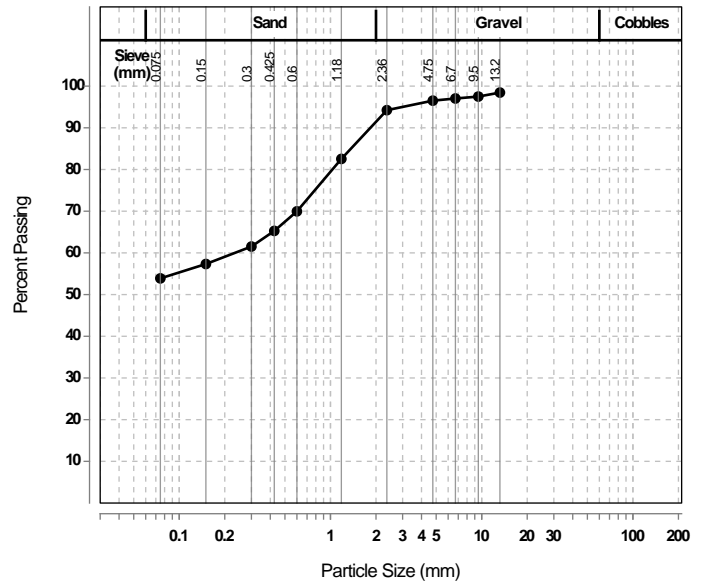
Particle Size Distribution

Min	Max
Linear Shrinkage (%)	14.0	
Cracking Crumbling Curling	Curling

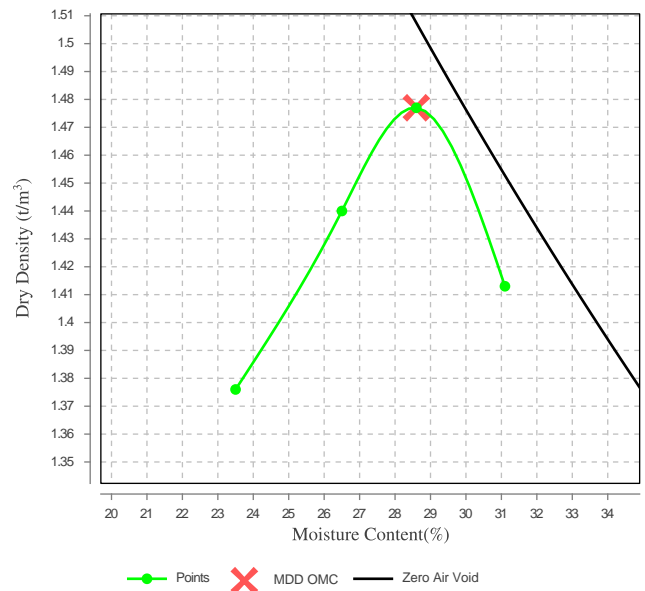
Moisture Density Relationship

## Dry Density - Moisture Relationship (AS 1289 5.1.1 & 2.1.1)

Mould Type	1 LITRE MOULD A
Compaction	Standard
No. Layers	3
No. Blows / Layer	25
Maximum Dry Density (t/m <sup>3</sup> )	1.48
Optimum Moisture Content (%)	28.5
Retained on 19mm (%)	
Oversize Sieve (mm)	19
Oversize Material Wet (%)	
Oversize Material Dry (%)	
Dry Oversize density (t/m <sup>3</sup> )	
Method used to Determine Plasticity	Visual
Curing Hours	168

Moisture Content (%)	32.3
----------------------	------

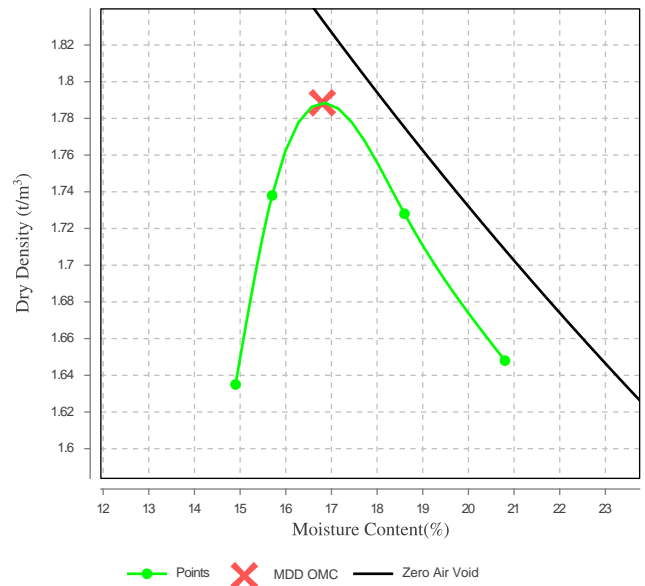
Moisture Density Relationship

### Dry Density - Moisture Relationship (AS 1289 5.1.1 & 2.1.1)

Mould Type	1 LITRE MOULD A
Compaction	Standard
No. Layers	3
No. Blows / Layer	25
Maximum Dry Density ( $t/m^3$ )	1.79
Optimum Moisture Content (%)	17.0
Retained on 19mm (%)	
Oversize Sieve (mm)	19
Oversize Material Wet (%)	
Oversize Material Dry (%)	
Dry Oversize density ( $t/m^3$ )	
Method used to Determine Plasticity	Visual
Curing Hours	168

Moisture Content (%)	20.2
----------------------	------

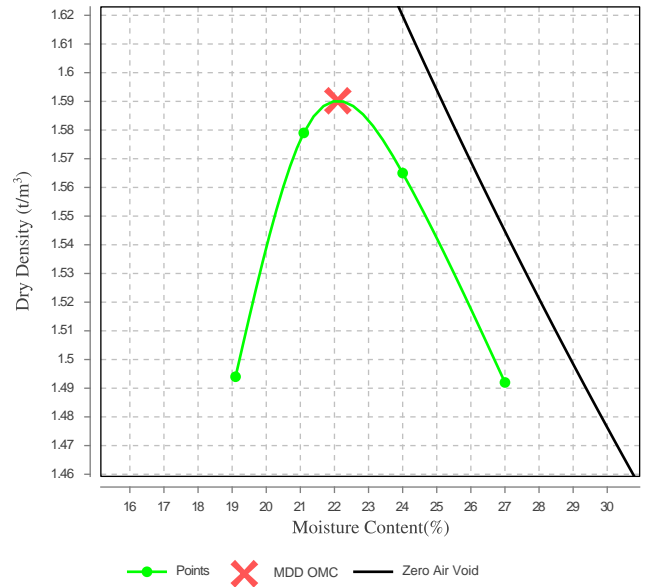
Moisture Density Relationship

## Dry Density - Moisture Relationship (AS 1289 5.1.1 & 2.1.1)

Mould Type	1 LITRE MOULD A
Compaction	Standard
No. Layers	3
No. Blows / Layer	25
Maximum Dry Density (t/m <sup>3</sup> )	1.59
Optimum Moisture Content (%)	22.0
Retained on 19mm (%)	
Oversize Sieve (mm)	19
Oversize Material Wet (%)	
Oversize Material Dry (%)	
Dry Oversize density (t/m <sup>3</sup> )	
Method used to Determine Plasticity	Visual
Curing Hours	116

Moisture Content (%)	24.2
----------------------	------
