**Approved Cultural Heritage Management
Plan**

RRON Facility, Black Rock Water Reclamation Plant, Connewarre, Victoria

Cultural Heritage Management Plan 19285

Barwon Water

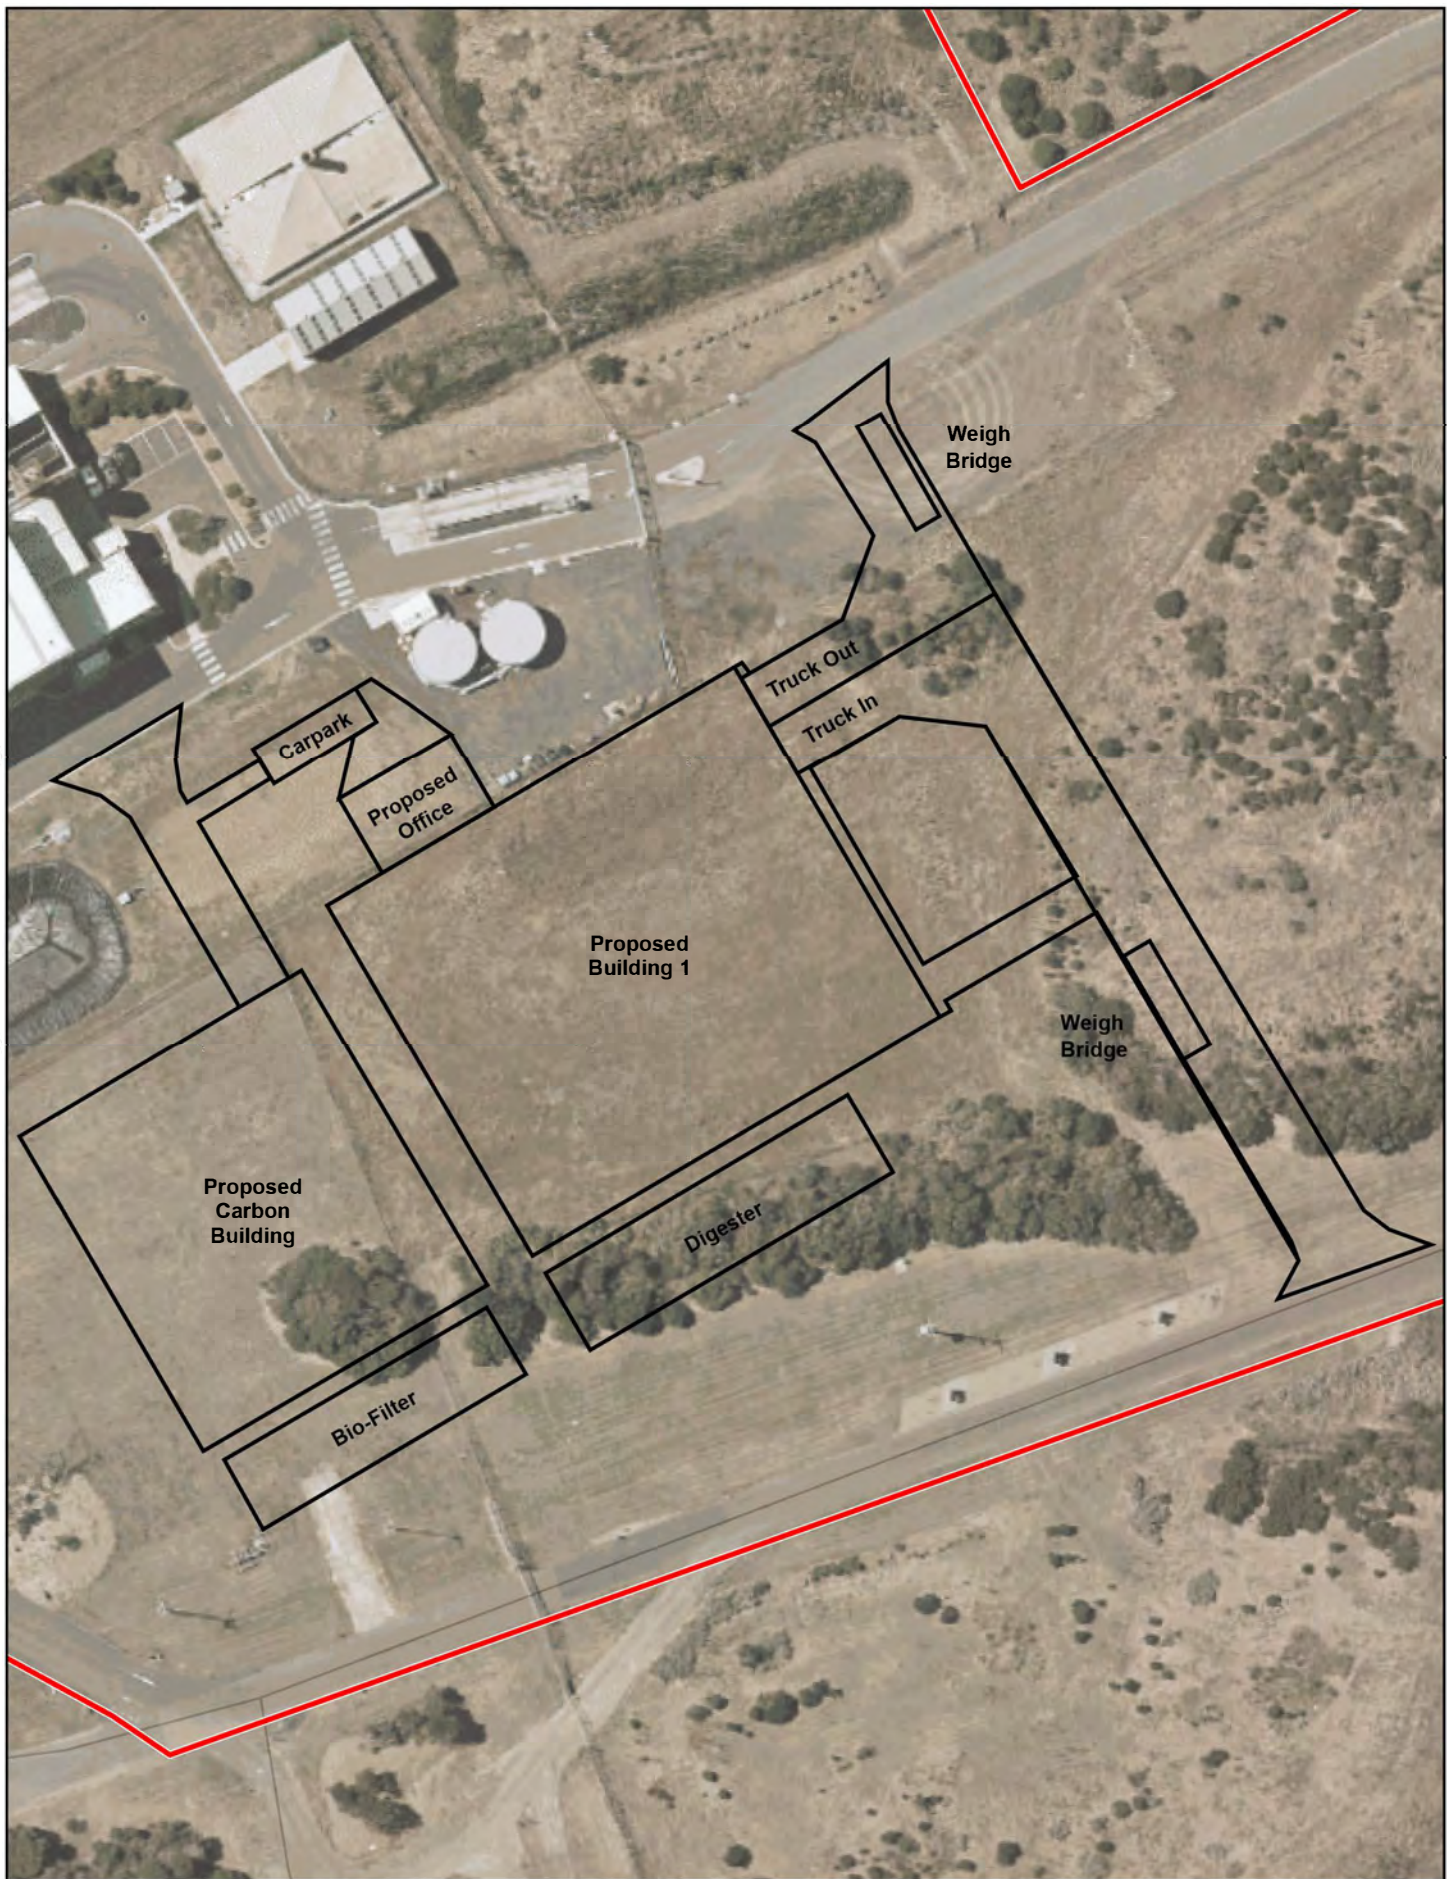
FIGURE 1

A preliminary lay out of the RRON facility that was used in the development of this CHMP, can be seen in Figure 1. The most recent design plans can be seen in Appendix H.

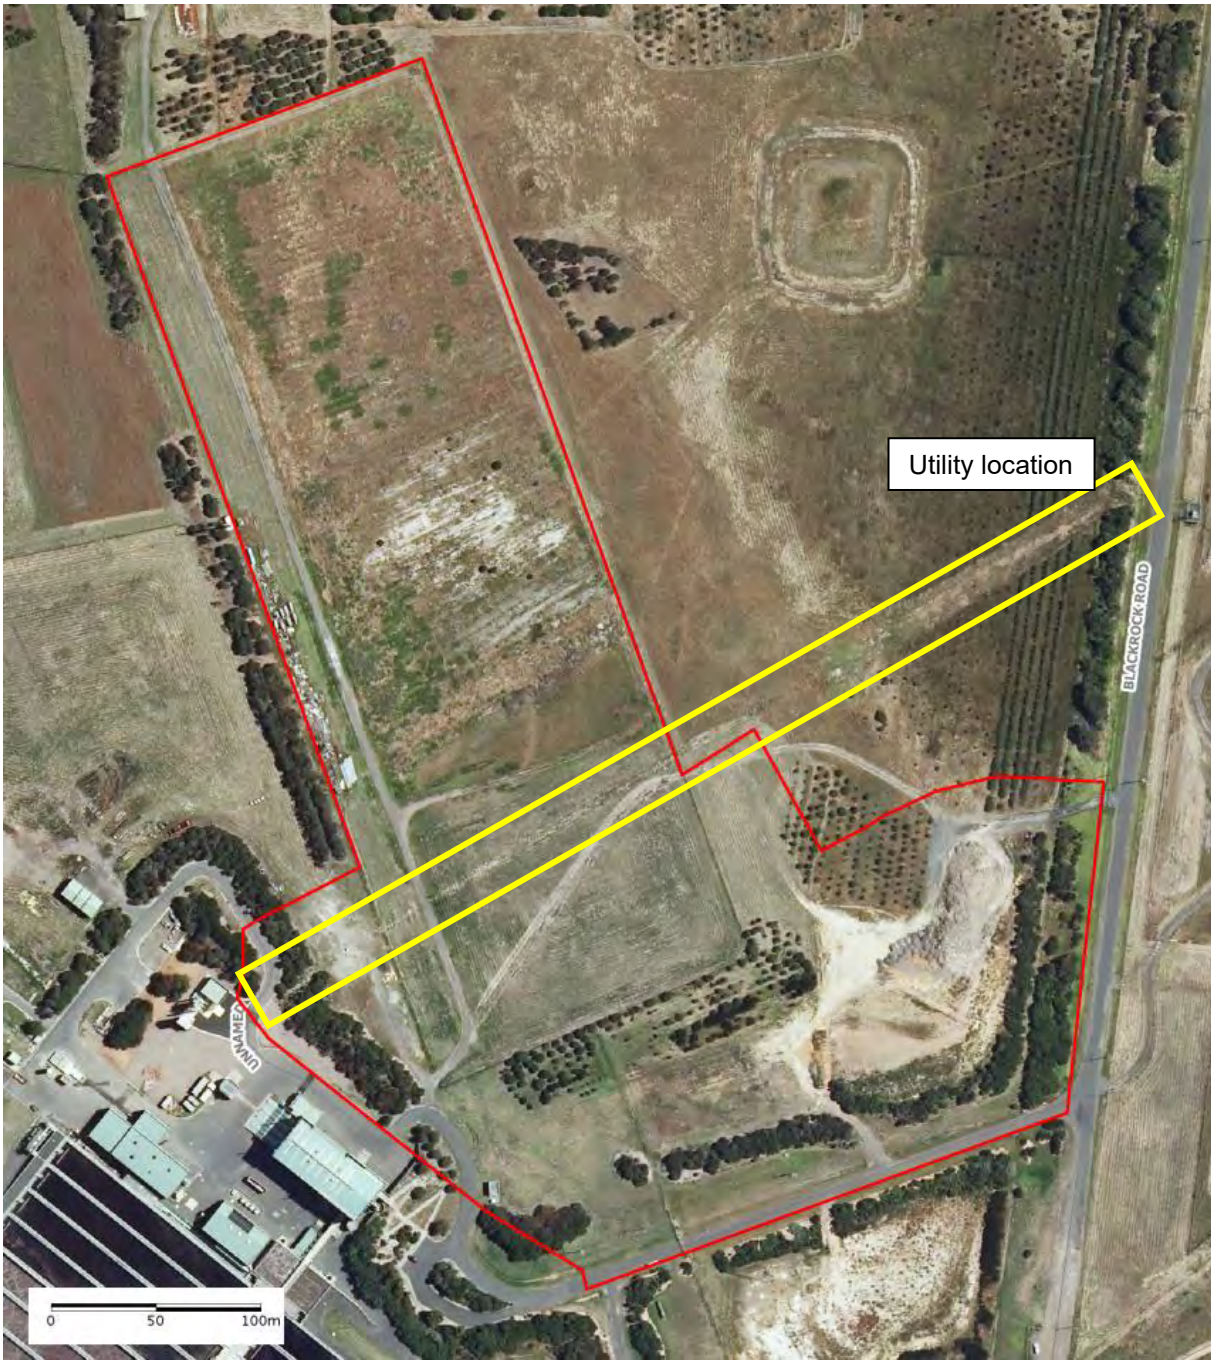
Plate 8 2007 aerial image (DEECA, 2023), Activity Area in red

In 2007 (Plate 8) a large mound was constructed in the eastern edge of Activity Area. This construction is a stockpile of soils from elsewhere within the facility. Access tracks to the mound can be seen from Black Rock Road in the east and the visitors entrance road to the south, with cleared areas around the northern base of the mound. An underground utility can also be seen running from east to west across the north of the Activity Area.

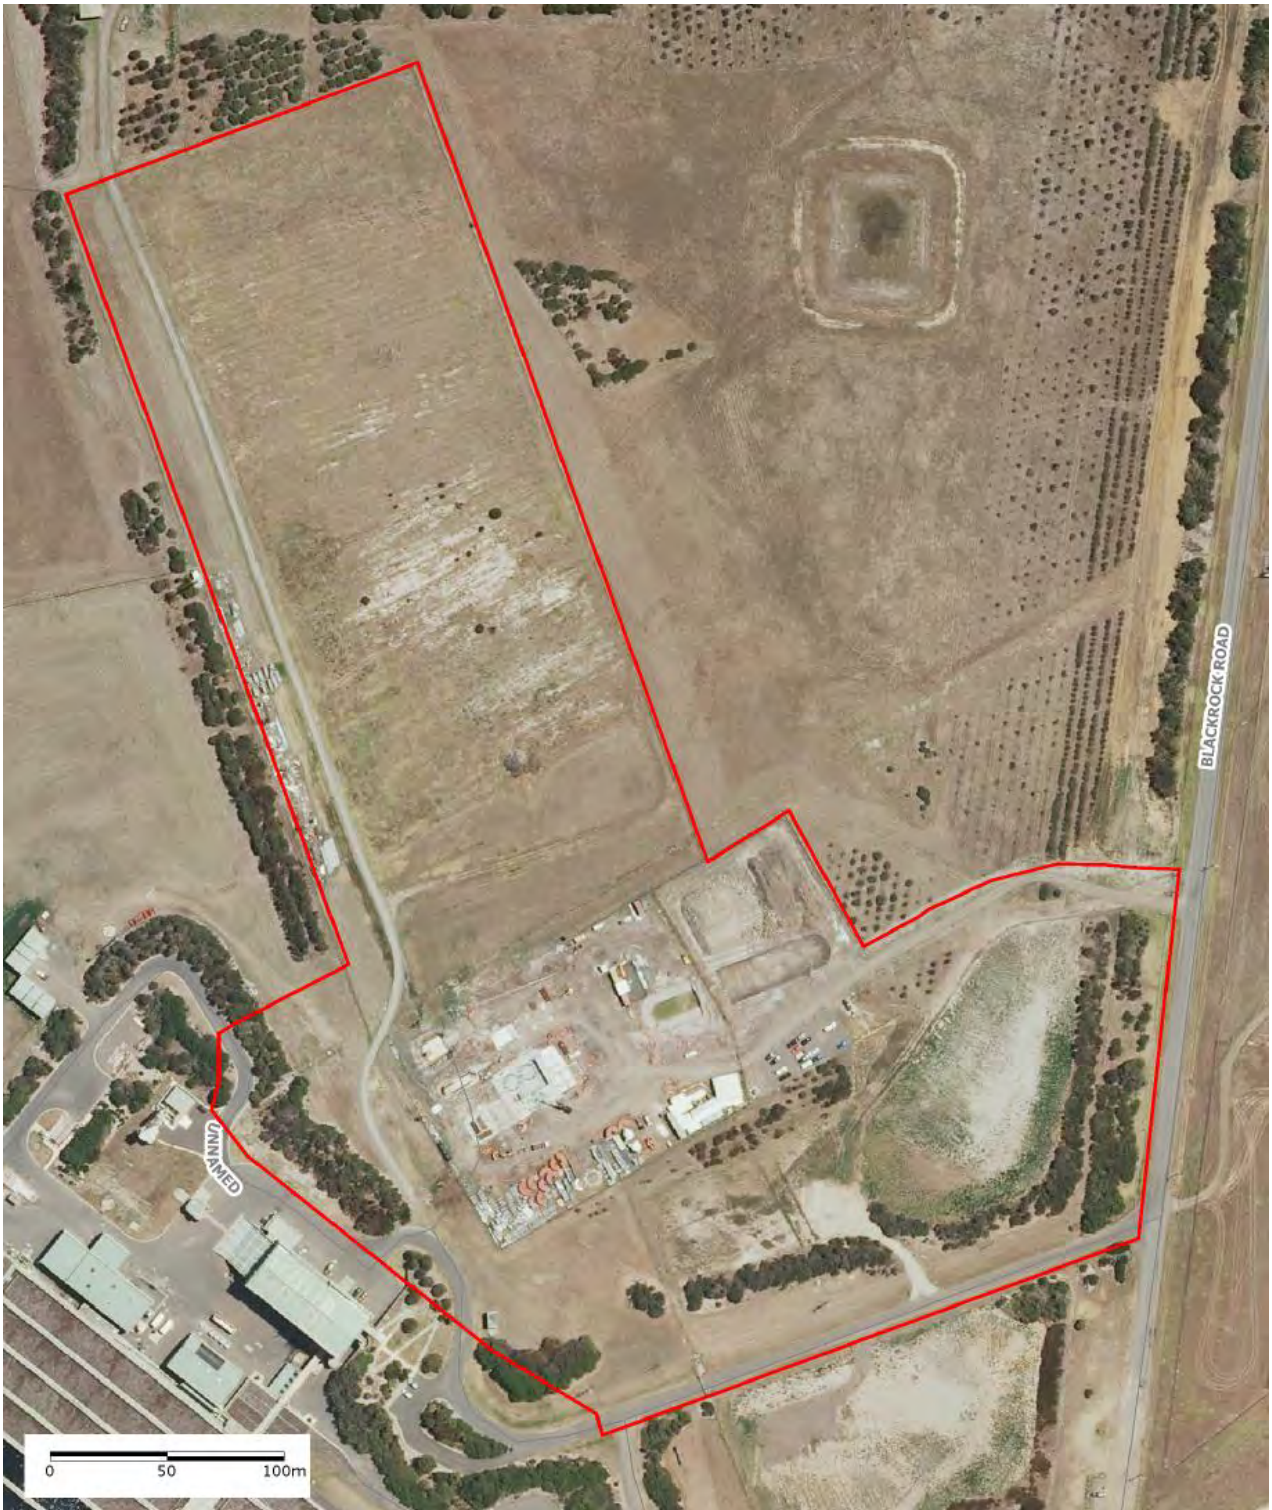
Plate 9 2009 aerial image (DEECA, 2023), Activity Area in red.

The construction of the Biosolids Treatment Plant (BTP) is documented within a 2009 aerial image (Plate 9). The image shows the facility under construction, with earthworks in the north, road upgrades, facility foundations, storage areas and carpark. The ground surface appears to have been scraped and levelled. The 2011 aerial image (Plate 10) shows the BTP nearing completion, road upgrades and carpark expansions, ponds, a swale drain and mound. There is an overhead connecting pipe connecting the BTP to the rest of the WRP. A number of informal tracks can be seen, particularly in the west. A partial storage area can also be seen adjacent to the landfill in the north.

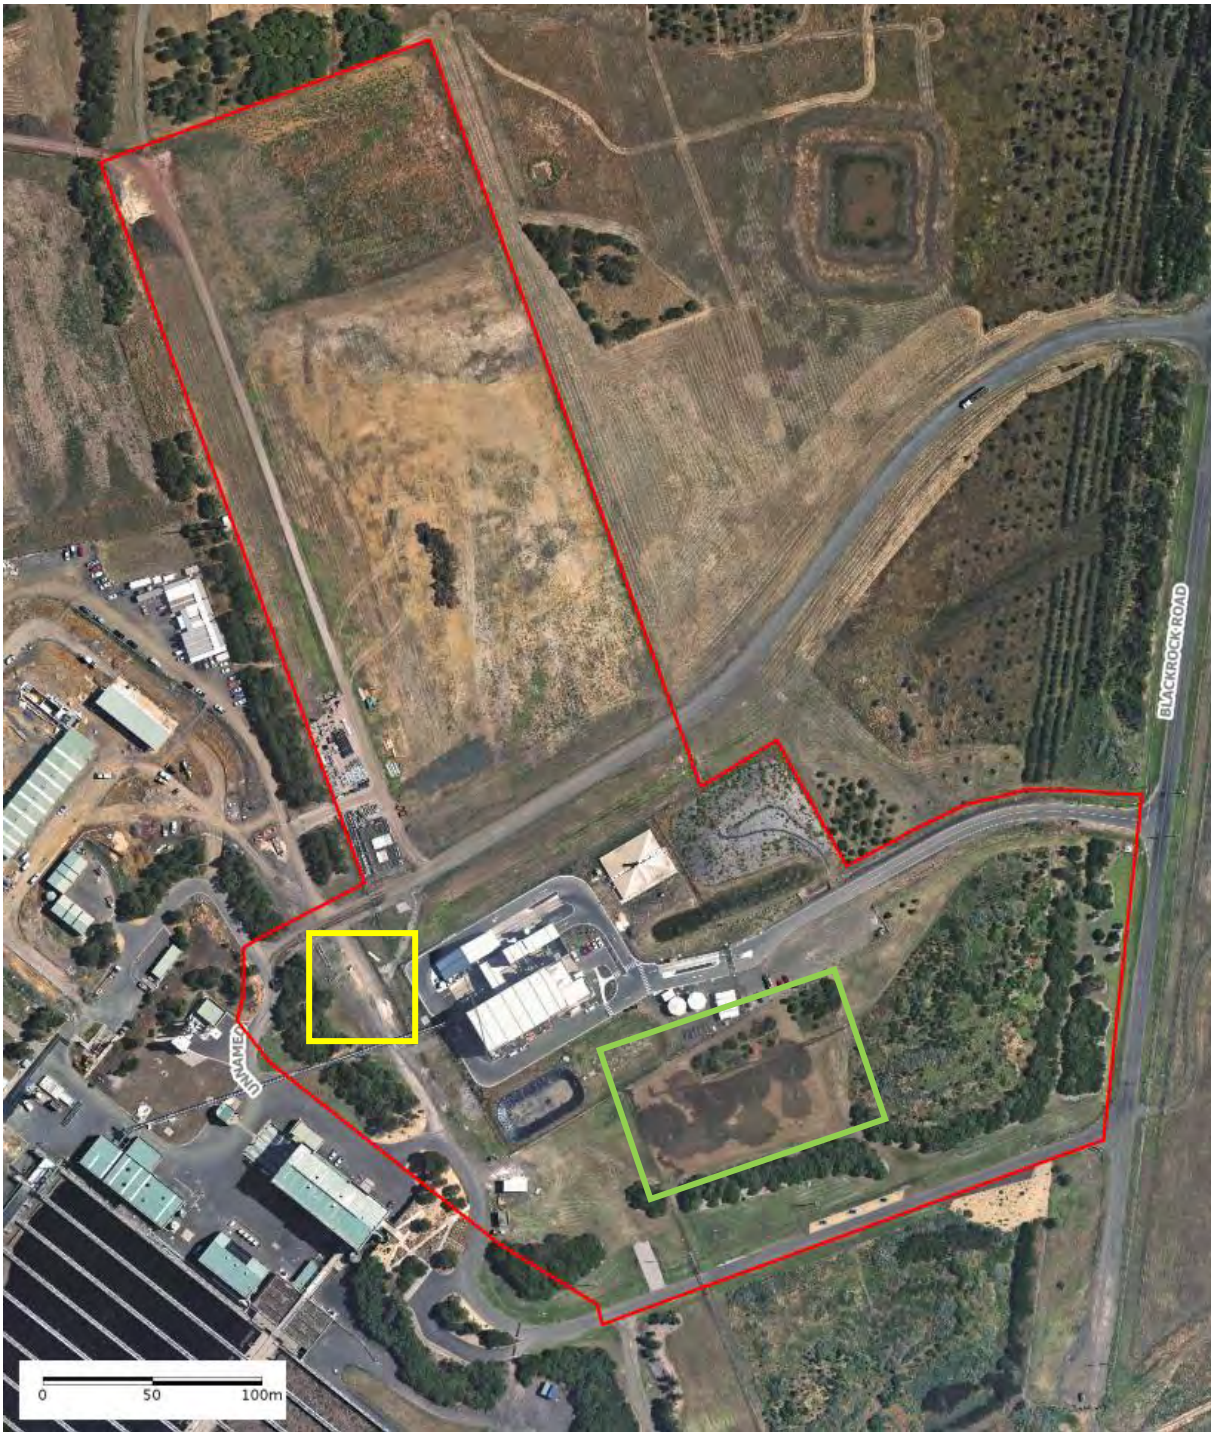
Plate 11 2012 aerial image (DEECA, 2023), Activity Area in red, utility installation areas in yellow, and old carpark in green

In the 2012 aerial image (Plate 11), the construction of the BTP has been finalised, with the removal of the carpark to the south. A number of earthworks can be seen west of the construction, including access track and potential utility installation. The northern edge of the Activity Area features a new access road, with a new structure constructed in the southwestern corner. A utility installation can also be seen in the northeast corner of the Activity Area.

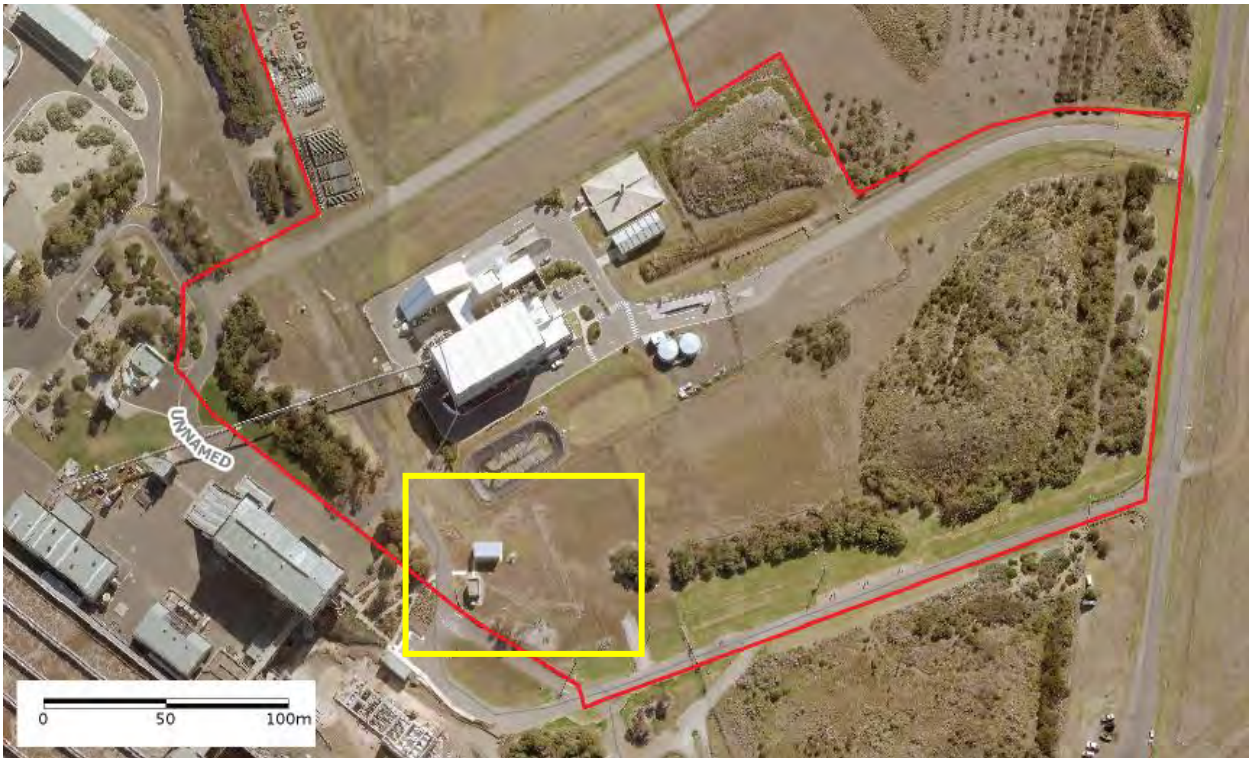
Plate 12 2016 aerial image (DEECA, 2023), Activity Area in red, areas of utility installation outlined in yellow

The grass can be seen returning in a 2016 aerial image (Plate 12), with an area of potential underground utility installations in the southwestern corner. In the 2017 aerial image (Plate 13) the utility area is undergoing additional construction with a new structure.

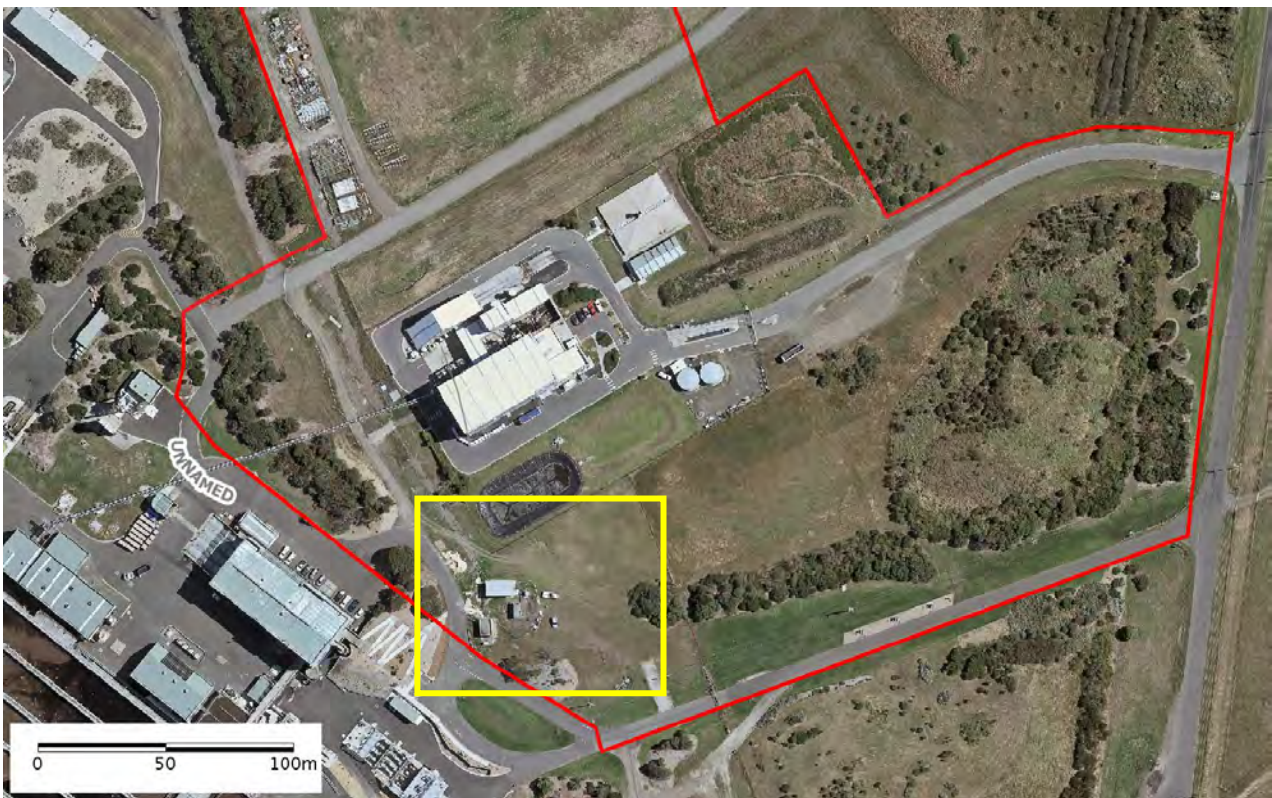
Plate 13 2017 aerial image (DEECA, 2023), Activity Area in red, utility location in yellow

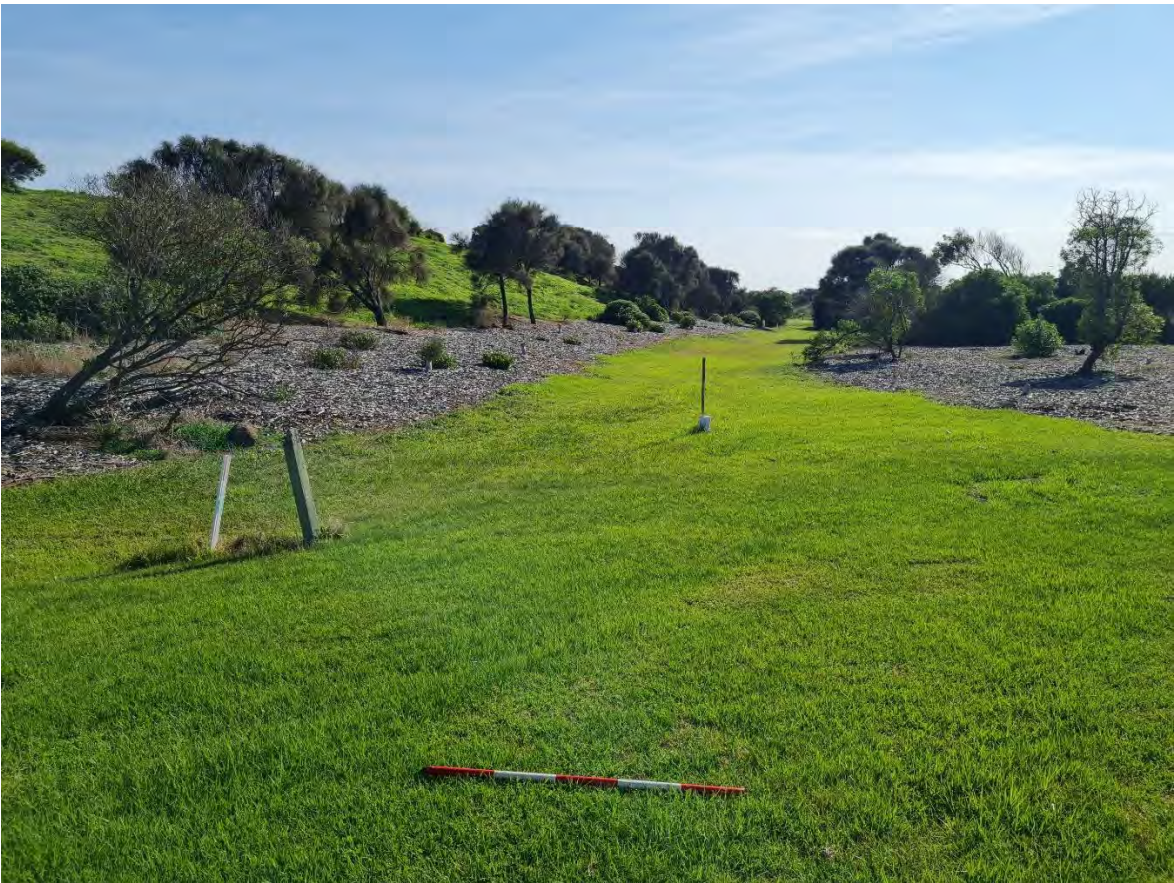
Plate 18 *Eastern edge of SU3, facing north, showing utilities and landscaping (R. Stewart 26.04.2023)*

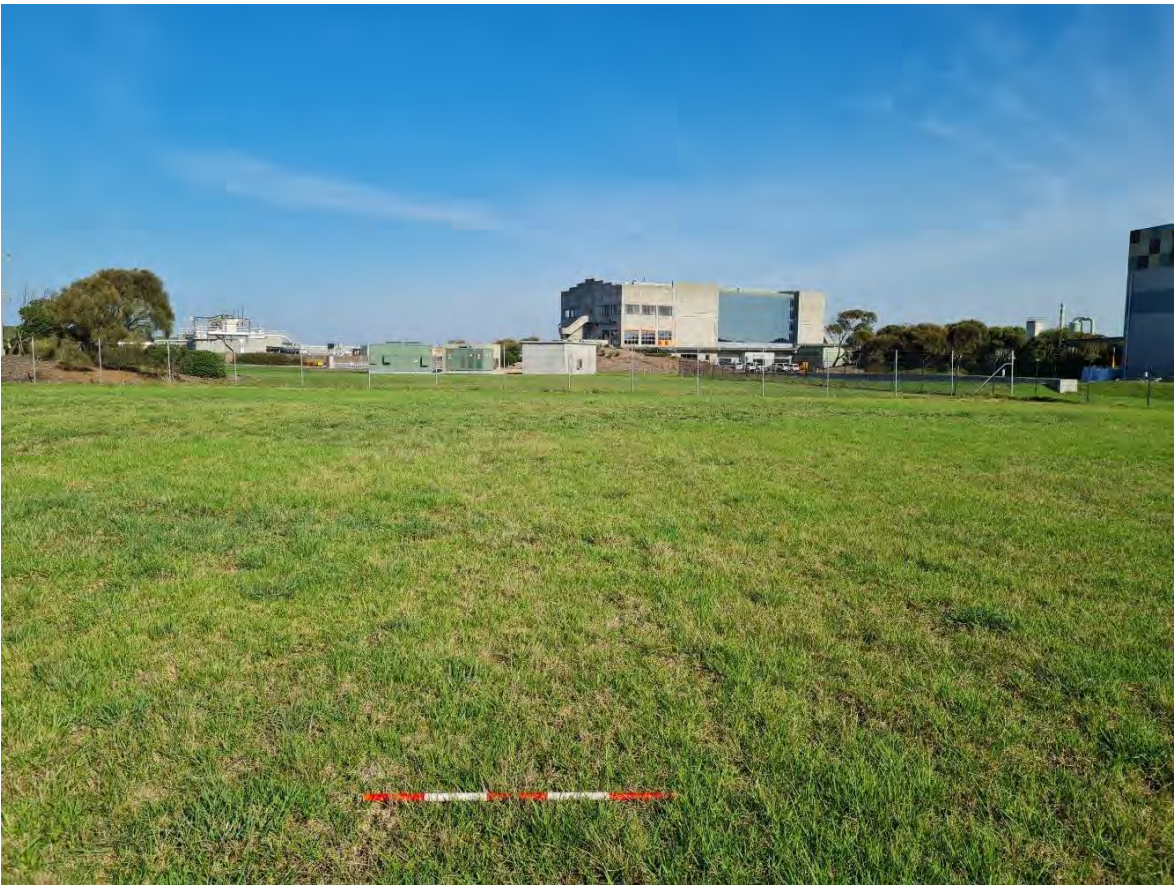
Plate 20 Centre of SU3, facing west. Location of BH 12 (R. Stewart 26.04.2023)

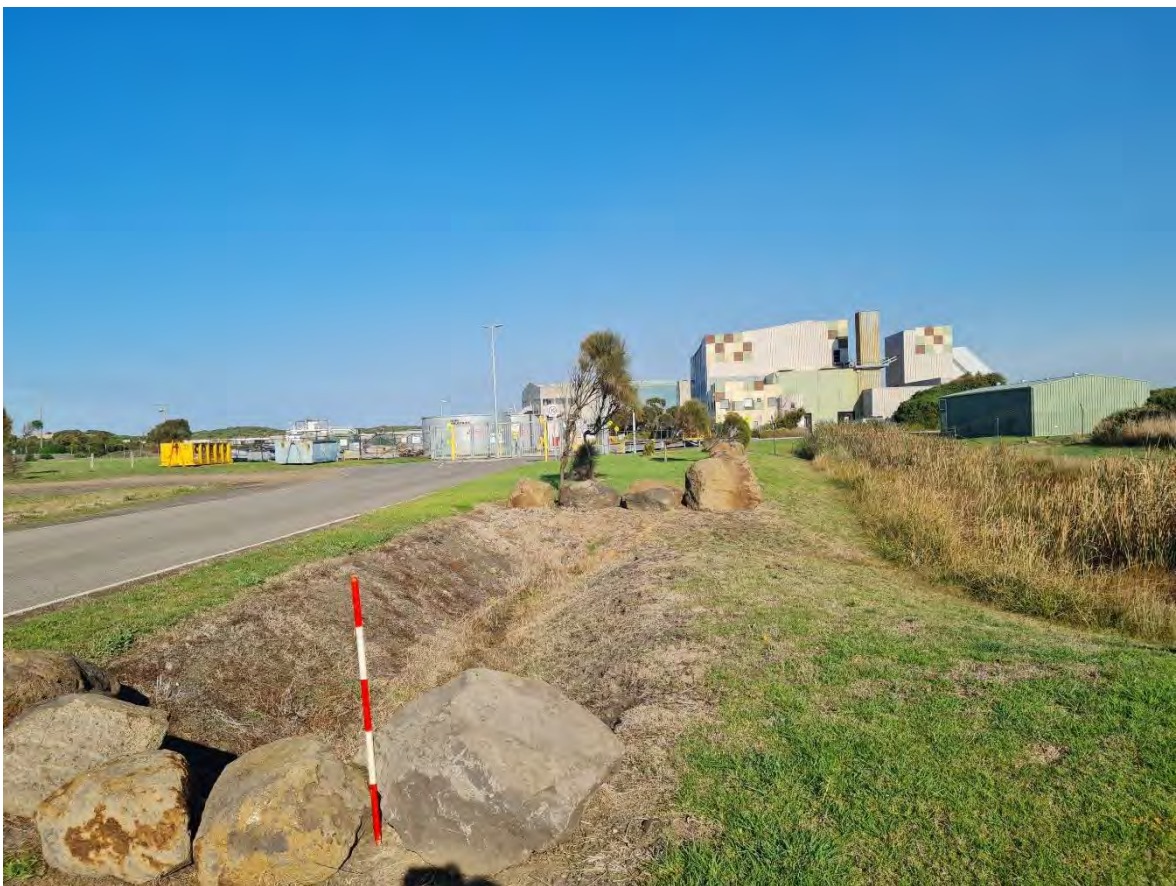
Plate 25 *Drain cut adjacent to swale, facing west towards BTP (R. Stewart 26.04.2023)*

Adjacent to the access road to BTP, a drain has been cut into the ground surface to direct water into a swale pond (Plate 24 to Plate 26). The exposed soil in the drain was a dark grey-black clay, with gravel from the road construction.

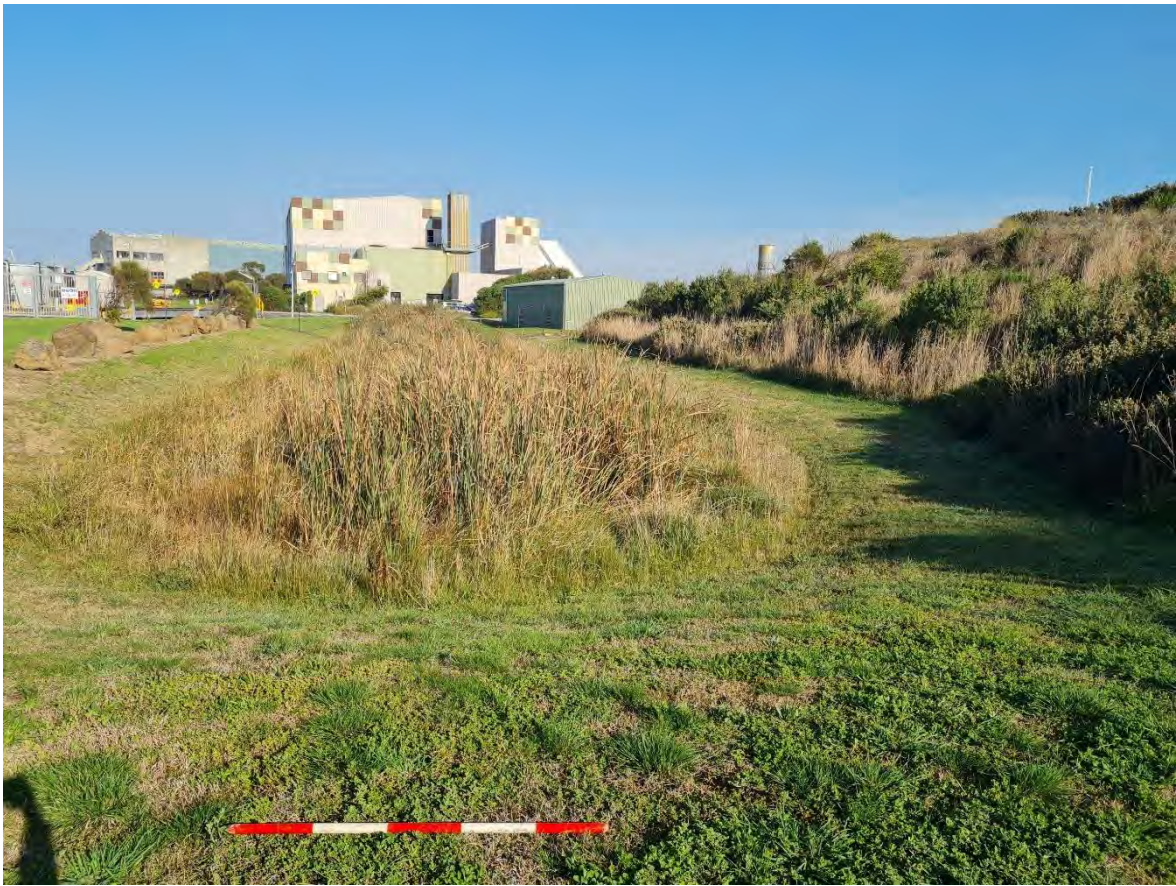
Plate 26 *Swale drain, facing west towards BTP (R. Stewart 26.04.2023)*

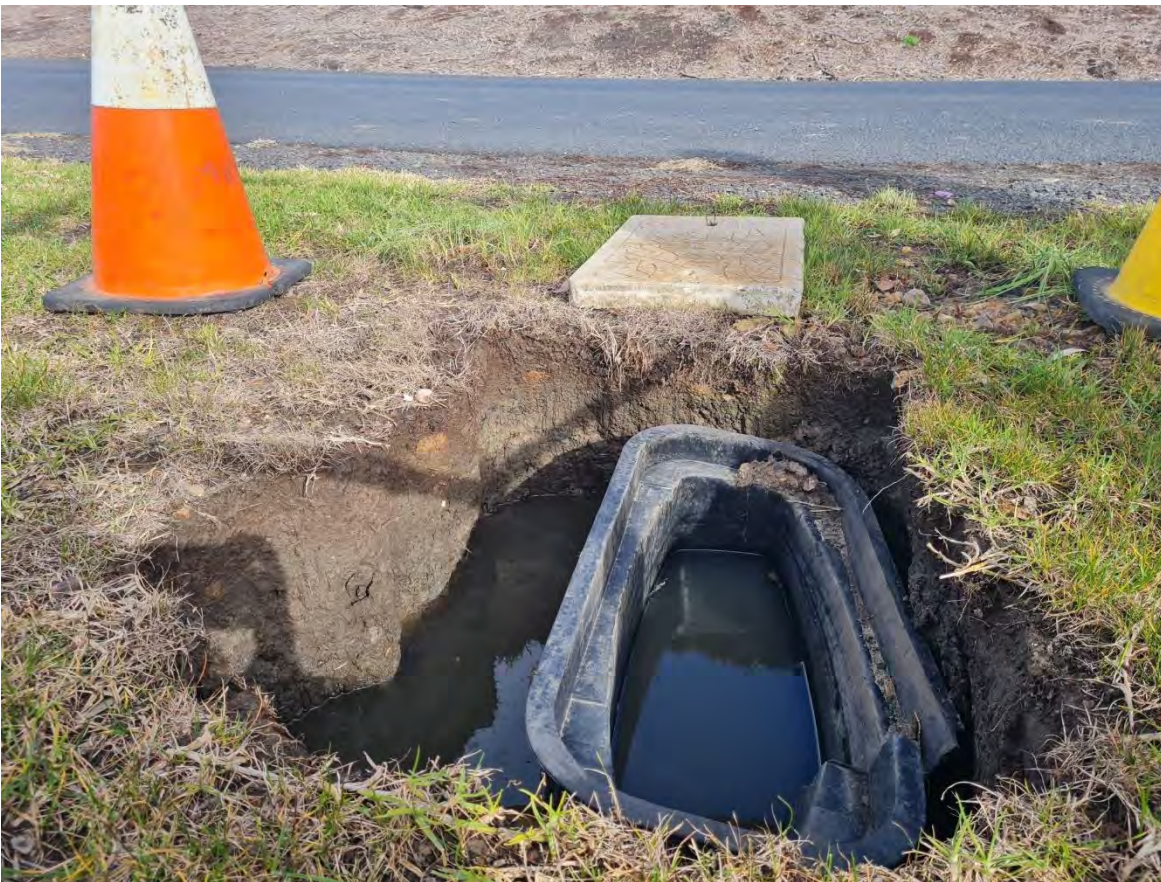
Plate 42 Open utility pit in west of Activity Area – Upper context of reddish brown likely fill, lower grey-black consistent with natural soil profile (see geotechnical logs) (R. Stewart 11.07.2023)

The southwestern extent of the Activity Area consists of a number of utility installations. There are four electrical substations, water infrastructure, utility location signage, junction boxes and drainage (Plate 29 to Plate 43). These locations align with the utility mapping in Figure 2. These locations provided samples of a disturbed ground surface (Plate 41) showing a grey-brown sandy clay. A drainage pit under repair (Plate 42) demonstrated a subsurface soil profile of a reddish-brown clay overlying a dark grey-brown clay, which supports the results of the geotechnical borehole in SU3.

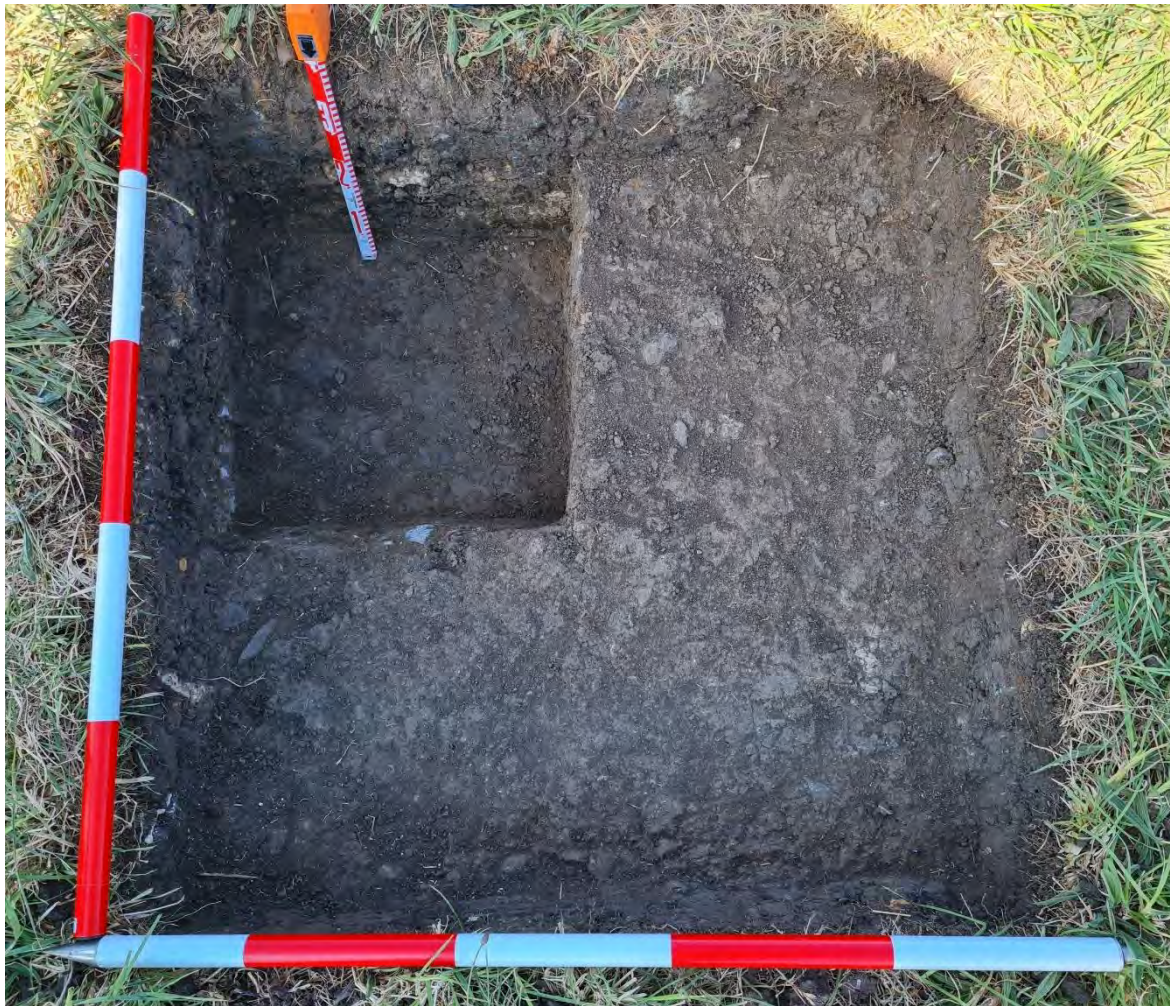
Plate 52 TP01 base, with sondage in south east corner

TP01 was excavated to a depth of approximately 200mm when the surface presented was significantly harder and with increasing amounts of angular bluestone chips (also described as road base). After a discussion between all field team members, a sondage in the south eastern corner of TP01 was excavated to determine the depth of the fill, the presence of a sterile clay base, and if any artefact bearing deposits were present. The sondage was excavated to a depth of 350-400mm where sterile clay base was identified (Plate 52 to Plate 55).

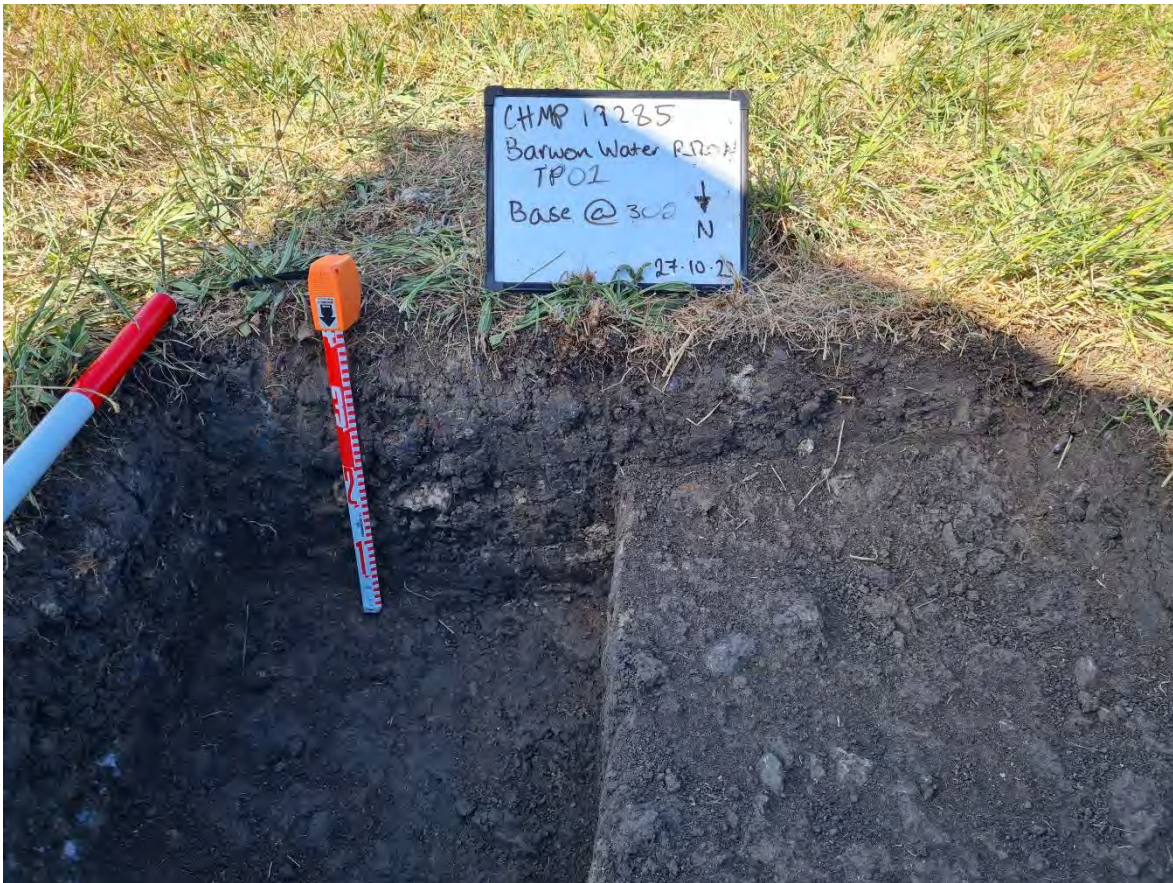
Plate 53 TP01, south wall of TP and sondage

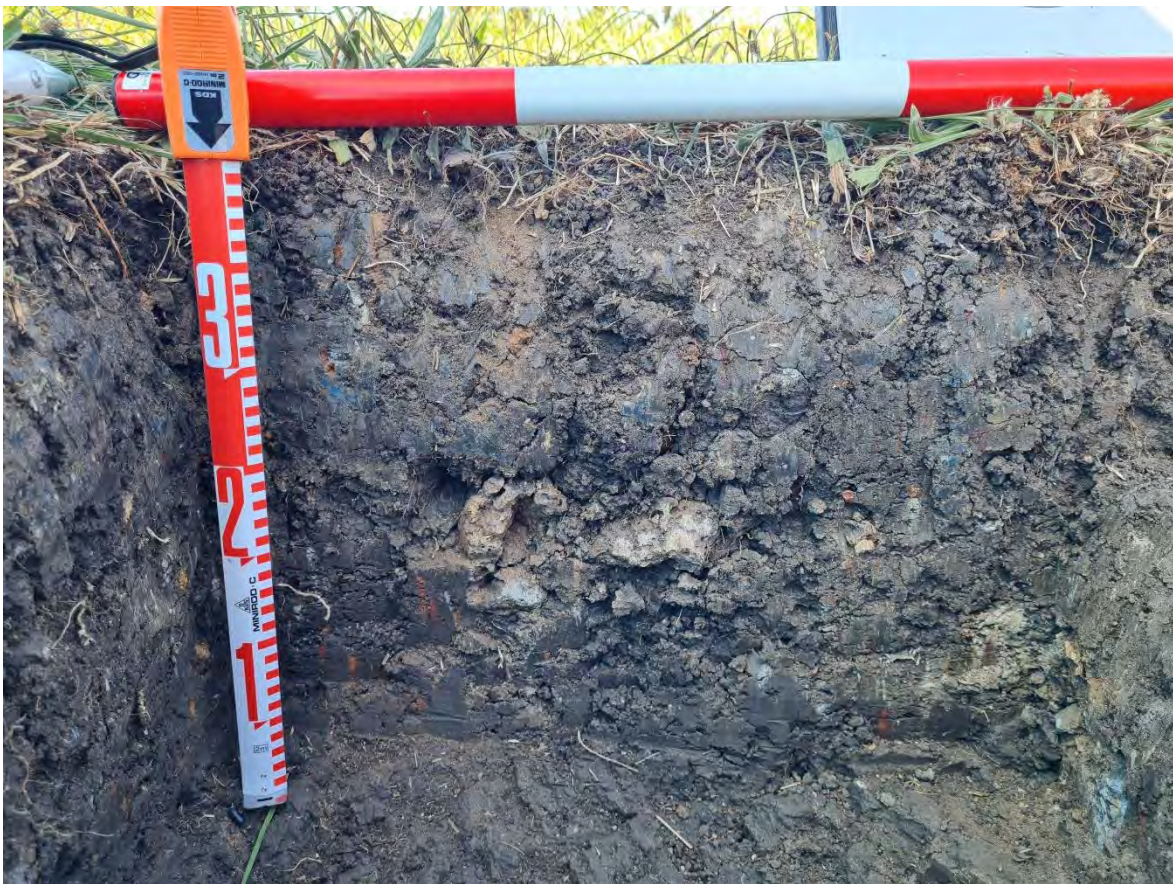
Plate 54 Southern wall of sondage within TP01

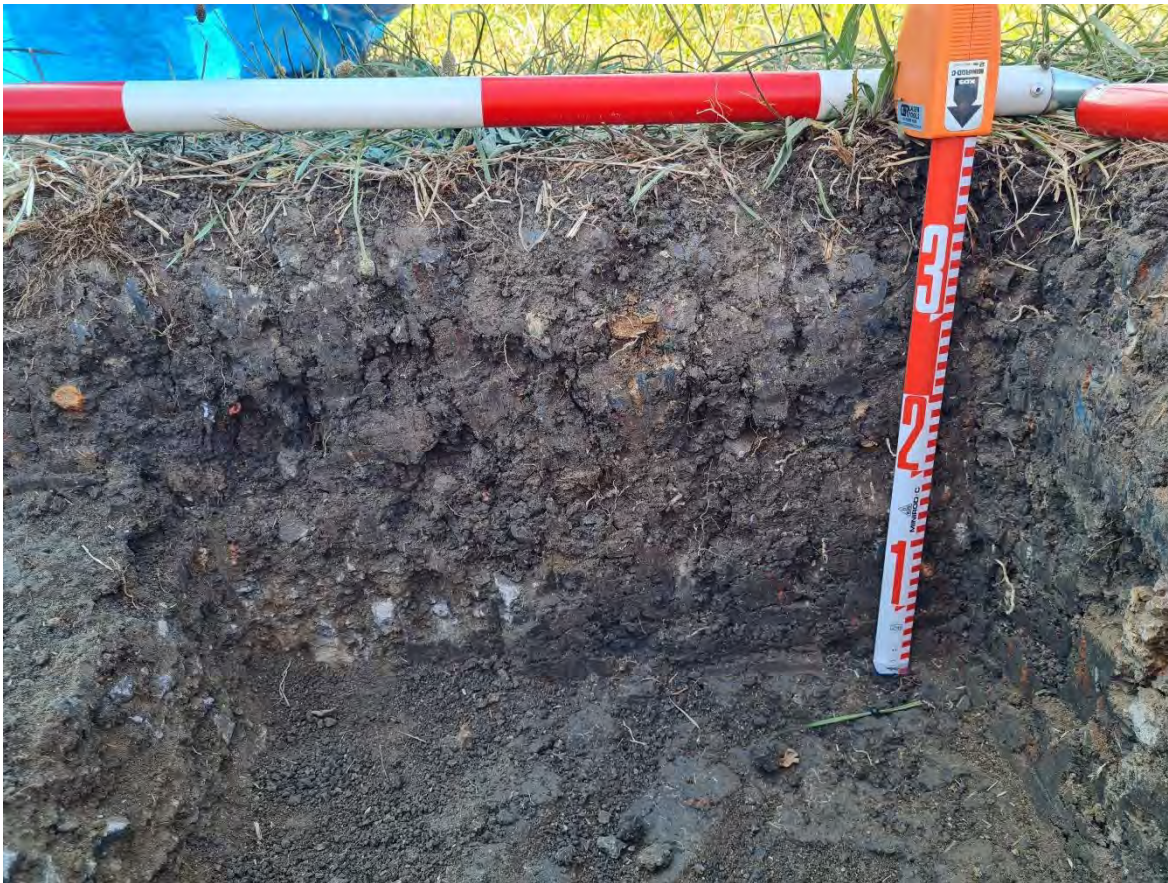
Plate 55 Eastern wall of sondage within TP01

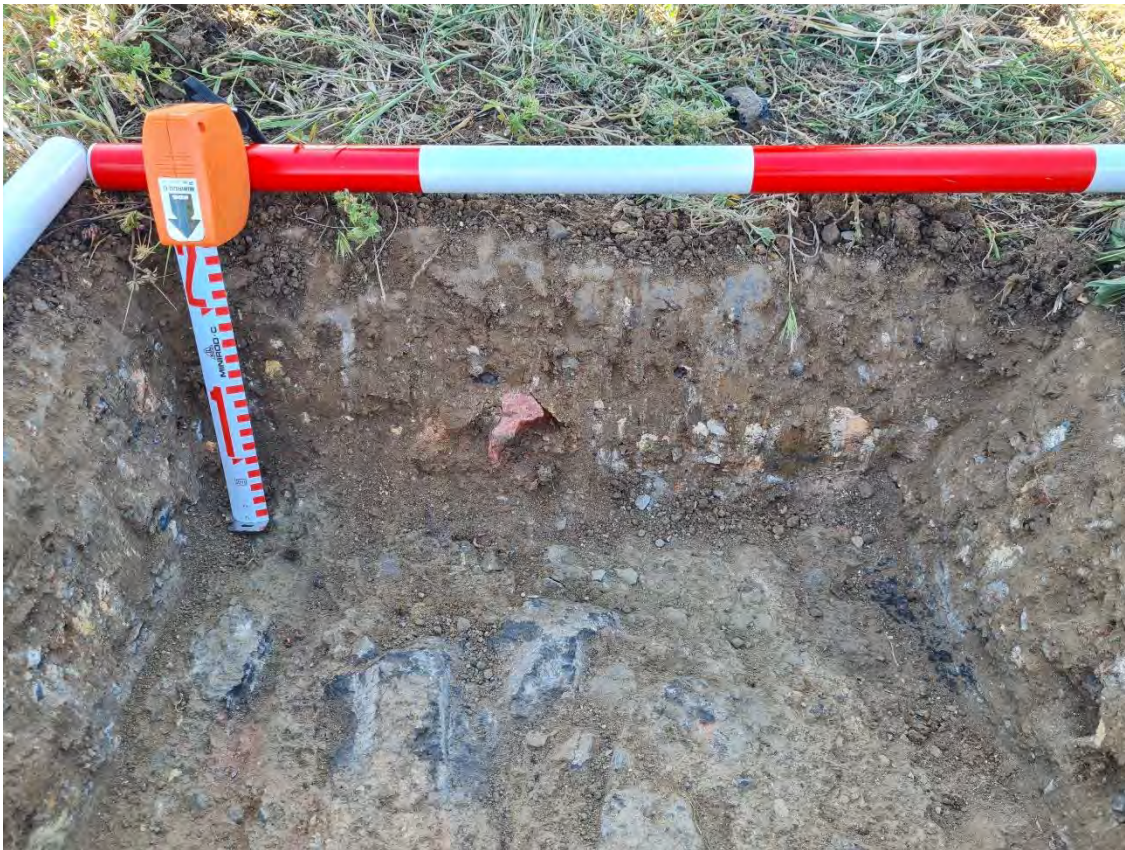
Plate 56 **STP01, southern wall with brick fragment in centre**

Two stratigraphic contexts were identified within STP01 (Plate 56). Context 1 consists of a brown silty clay modern material, including brick fragments and roof tile. This context was identified as fill likely brought in from outside of the site due to the differences in soil colour and texture compared to the natural clay. Context 2 is a basalt base (Plate 57). It is most likely that this is a basalt floater within the natural clay rather than bedrock, however the floater was larger than the STP and no edge could be identified.

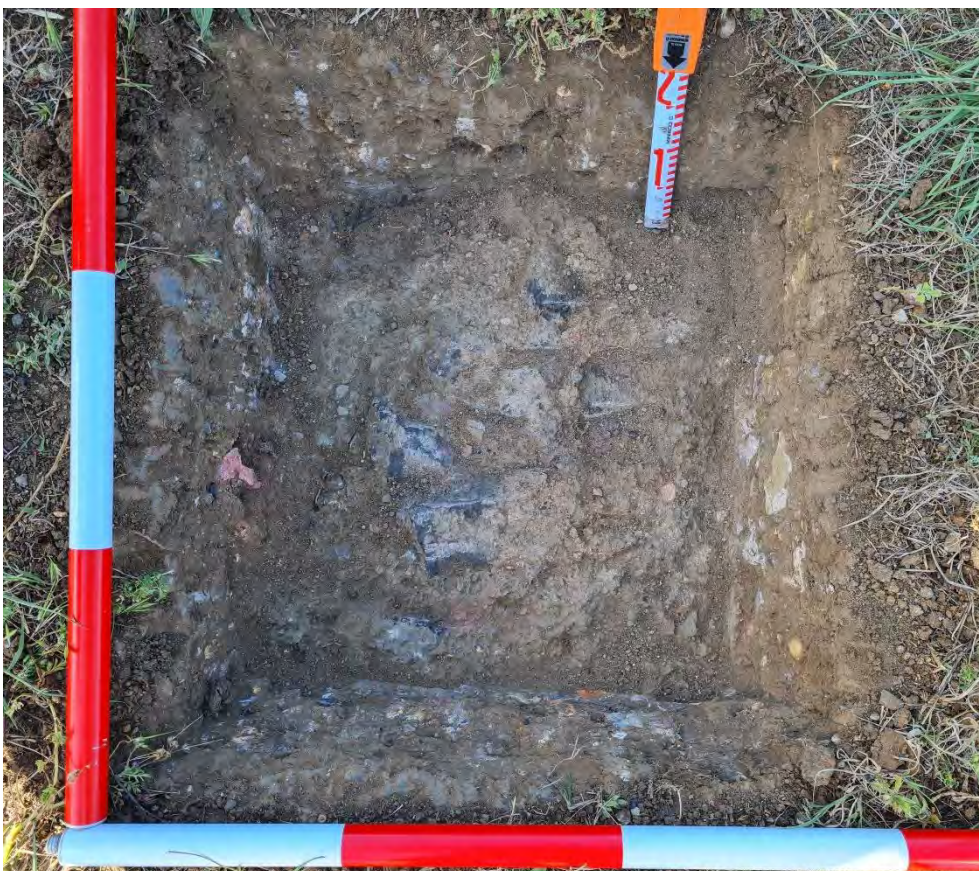
Plate 57 **Base of STP01**
