**Approved Cultural Heritage Management
Plan**

RRON Facility, Black Rock Water Reclamation Plant, Connewarre, Victoria

Cultural Heritage Management Plan 19285

Barwon Water

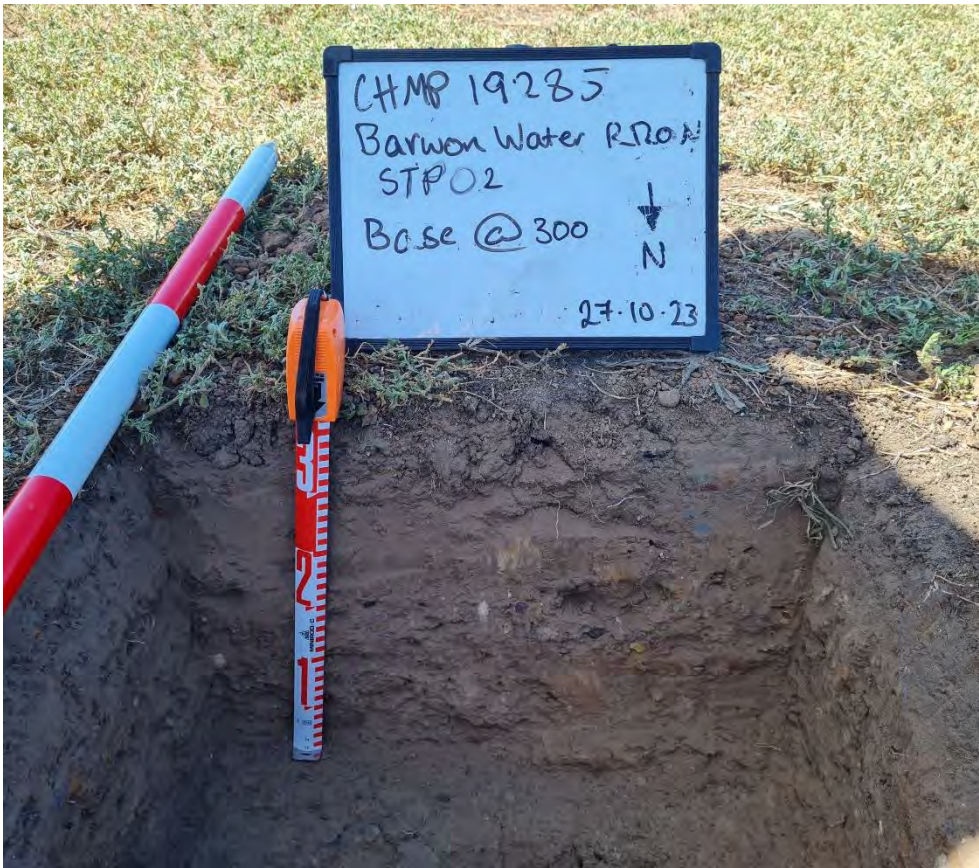
Plate 58 STP02, facing south

STP02 is located in the western extent of the proposed works, 14 m south of the BTP and 47 m east of a high voltage distribution substation. Context 1 (Plate 58) is very similar to Context 1 within STP01, a silty brown clay with modern inclusions, however with smaller fragments of brick ($\leq 30\text{mm}$) and with inclusions of glass, ceramic and plastic to a depth of 300mm. Context 2 is stiff dark grey clay consistent with natural sterile basal clay (Plate 59) identified within TP01.

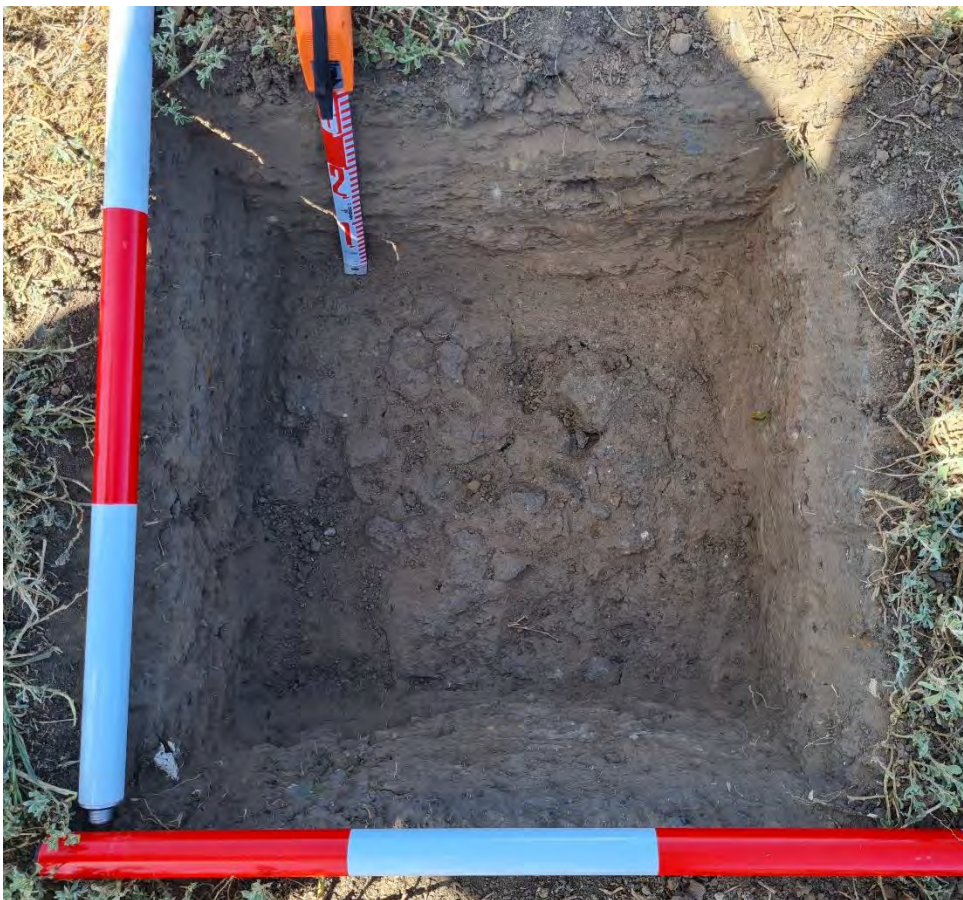
Plate 59 Base of STP02

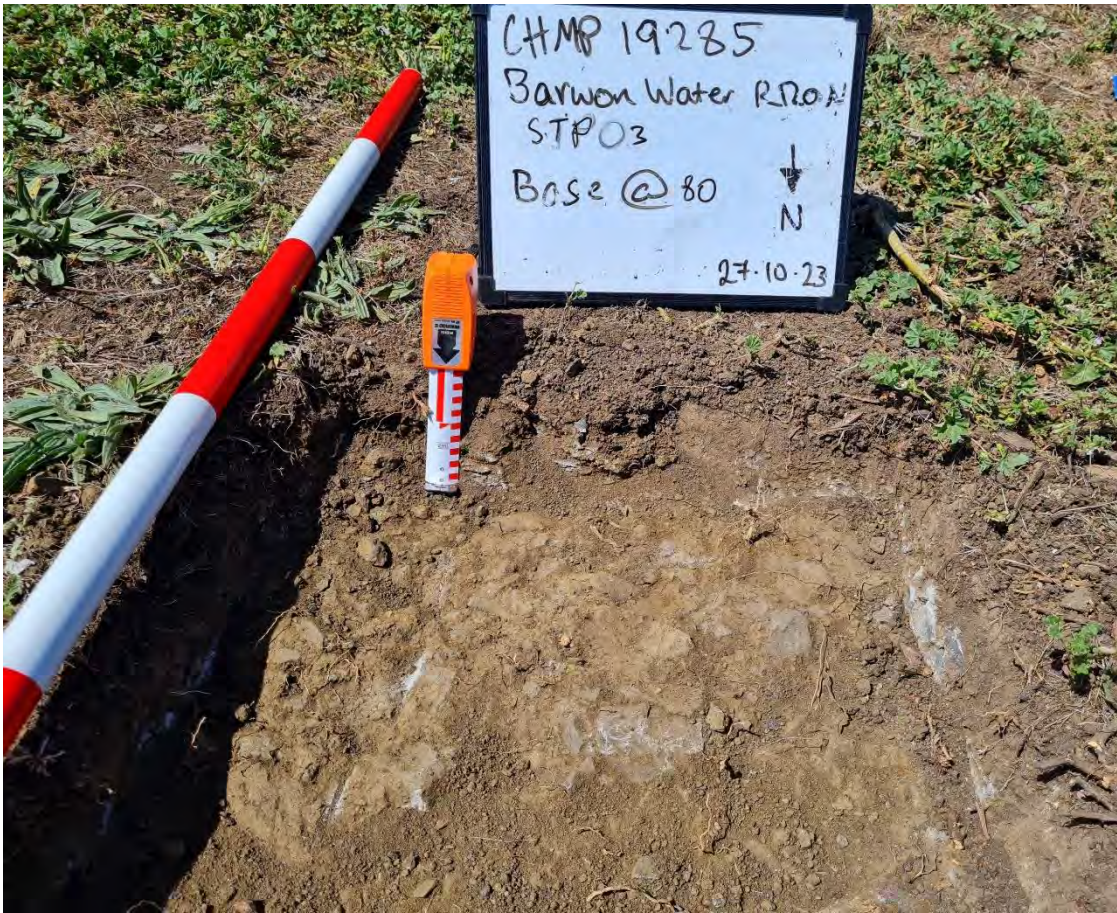
Plate 60 STP03 facing south

STP03 is also located in the western extent of the proposed works, 25 south of STP02 and 3m north of the landscaping. Two stratigraphic contexts were identified. Context 1 is comprised of brown silty clay, and very shallow (0-80mm) (Plate 60). Few inclusions were identified, however small angular fragments of road base ($\leq 40\text{mm}$) and brick were present. Context 2 is a basalt base (Plate 61). It is most likely that this is a basalt floater within the natural clay rather than bedrock, however the floater was larger than the STP and no edge could be identified.

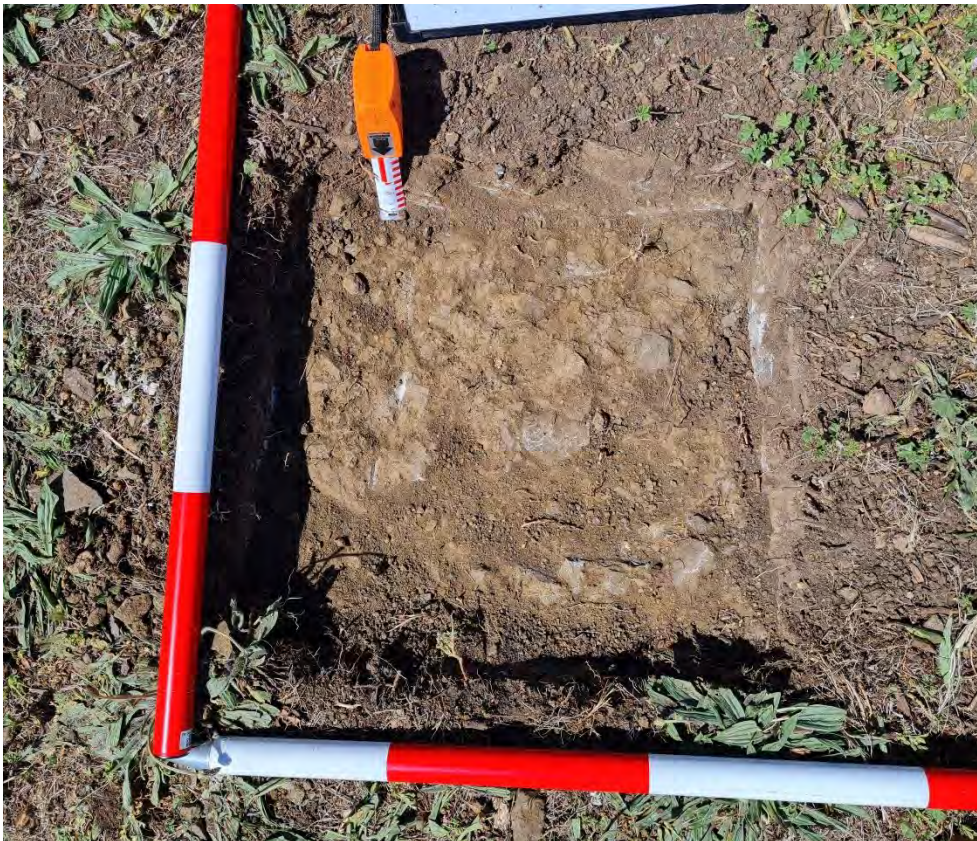
Plate 61 Base of STP03

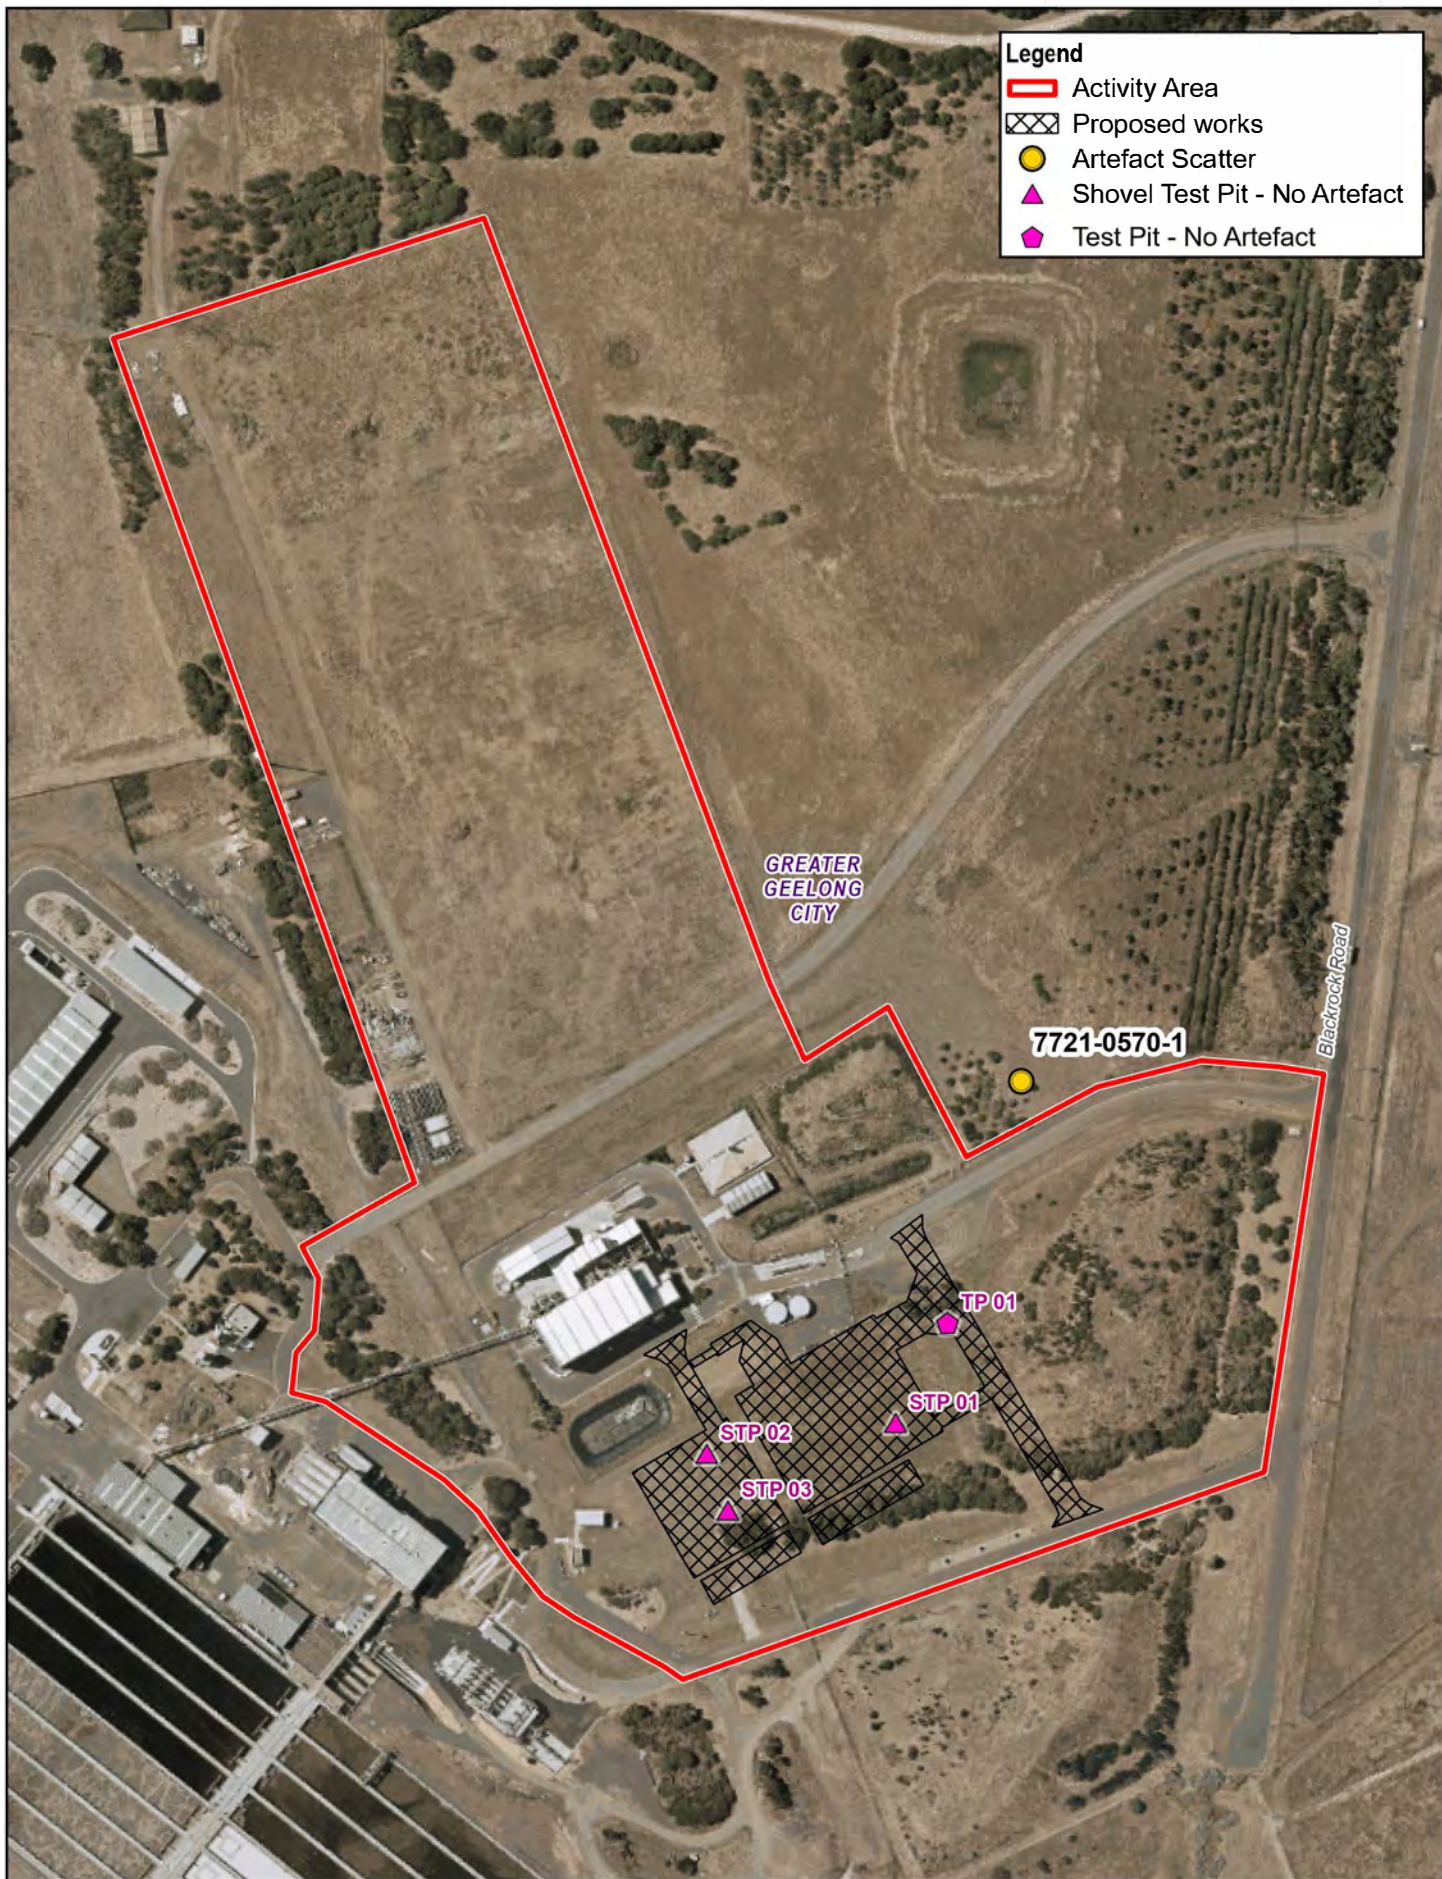
Legend

- Activity Area
- Proposed works
- Artefact Scatter
- ▲ Shovel Test Pit - No Artefact
- ◆ Test Pit - No Artefact

The complex assessment results are consistent with previous assessment within the Activity Area (du Cros and Associates, 1993; Terra Culture, 2003; Unearthed Heritage, 2021), that identified areas of potential on the outer edges of the Black Rock WRP, where disturbance was at a minimum and sandy deposits were present. These areas of potential were not within the current Activity Area.

It is concluded that there is no archaeological potential within the Activity Area and it is reasonably unlikely for Aboriginal cultural heritage material to be present within the Activity Area.

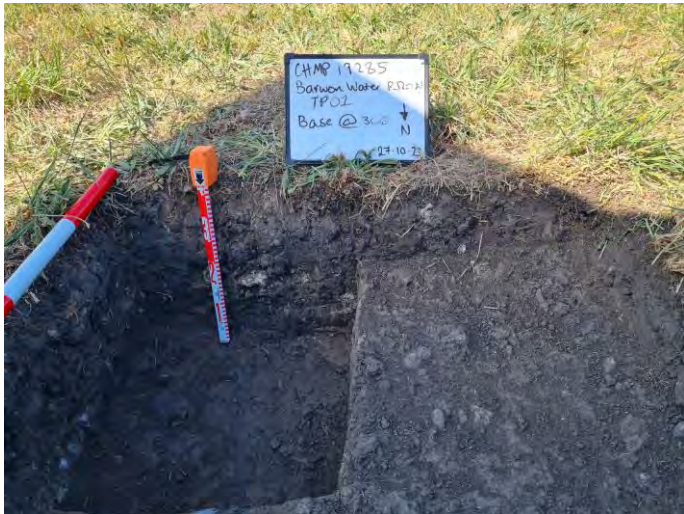
| No. | Grid Coordinates GDA94, Zone 55 | | Depth (mm) | Description | Munsell | pH | Artefacts | Photo |
|--|---|---|---|--|---|---|---|--|
| TP01 Size: 1m x 1m Depth: 0.4m | 274183.15 | 5759589.88 | 0 – 220 | FILL - Unconsolidated sandy clay, dark grey with brown mottling. Frequent angular road base pieces, weathered basalt, limestone and rootlets. | 10 YR 2/2 | 8 | No | |
| | | | 220-300 | FILL Brown silty clay and angular road base fragments (50%) | 10 YR 4/3 | 8 | No | |
| | | | 300 + | Stiff dark grey clay, iron nodules, infrequent | 10 YR 2/1 | 8 | No | |

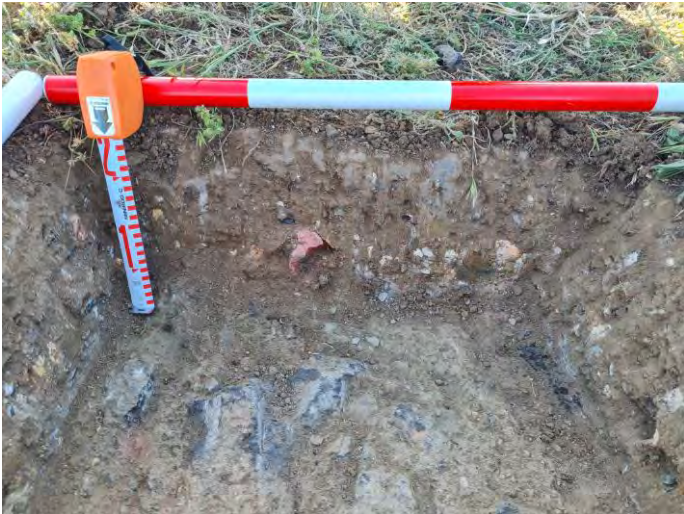
| No. | Grid Coordinates GDA94, Zone 55 | | Depth (mm) | Description | Munsell | pH | Artefacts | Photo |
|--|---|---|---|--|---|---|---|--|
| STP01 Size: 0.5m x 0.5m Depth: 0.2m | 274162.60 | 5759550.47 | 0-200 | FILL brown silty clay with brick, limestone, roof tile fragments | 10 YR 4/3 | 8.5 | No | |
| | | | 200+ | Basalt base | - | - | No | |

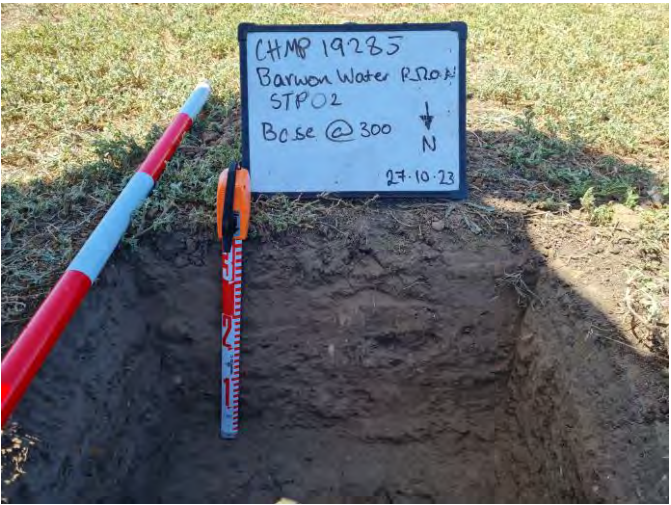
| No. | Grid Coordinates GDA94, Zone 55 | | Depth (mm) | Description | Munsell | pH | Artefacts | Photo |
|--|---|---|---|---|---|---|---|--|
| STP02 Size: 0.5m x 0.5m Depth: 0.3m | 274087.70 | 5759538.37 | 0-290 | FILL brown silty clay with brick, limestone, ceramic, glass and plastic | 10 YR 4/3 | 9 | No | |
| | | | 290+ | Siff dark grey clay base | 2.5 YR 2/1 | 8 | No | |

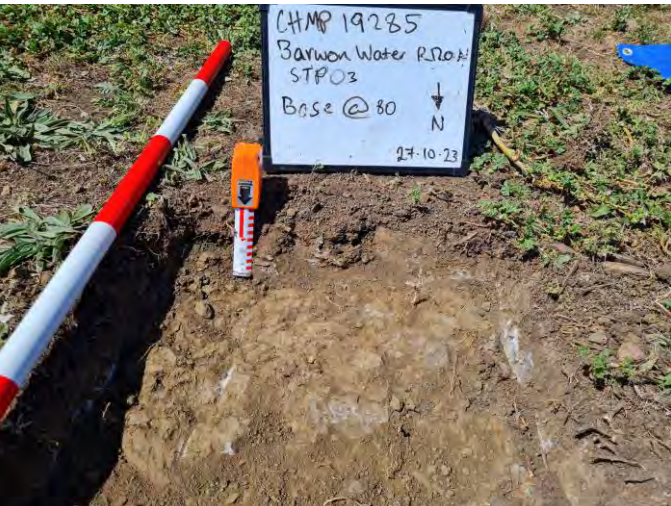
| No. | Grid Coordinates GDA94, Zone 55 | | Depth (mm) | Description | Munsell | pH | Artefacts | Photo |
|--|---|---|---|---|---|---|---|--|
| STP03 Size: 0.5m x 0.5m Depth: 0.1m | 274096.17 | 5759515.78 | 0-80 | Brown silty clay with brick fragments and grass rootlets | 10 YR 4/3 | 9 | No | |
| | | | 80+ | Basalt base | - | - | No | |

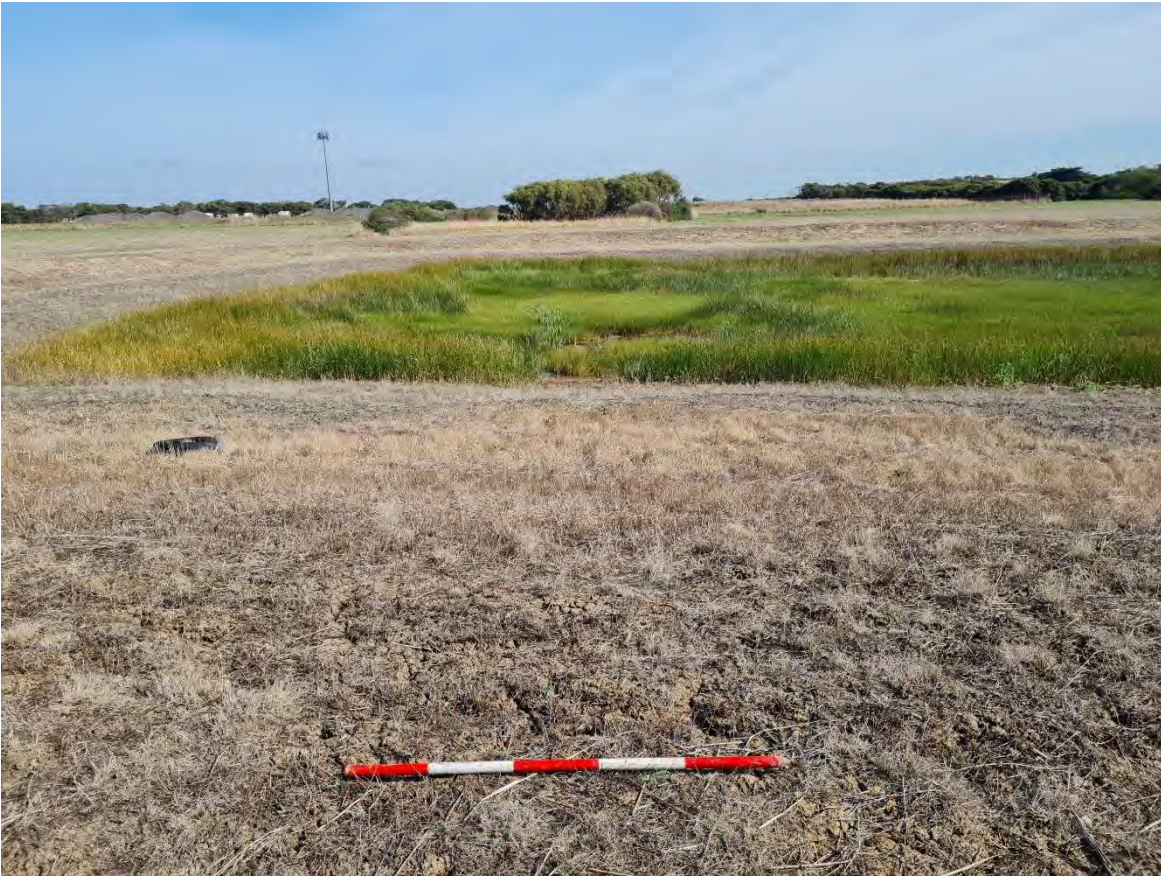
Plate 70 *Top of dam wall facing west (R. Stewart 26.04.2023)*

A dam has also been modified within SU1. The dam wall has been built up from soils taken from the centre of the dam to either modify a natural depression or to create the dam (Plate 70). The ground surface on both sides of the wall is at similar levels, before dipping down into the dam centre (Plate 71). The differences in soil can be noted, the dark grey-black clay of the ground surface and the lighter brown/reddish clay of the dam wall. This area is within the mapped swamp deposits, with the identified soils similar to the results of the BH2 (see below). The dam has been in place since at least 1975 (see section 7.5) and contains an old concrete overflow drain (Plate 72).

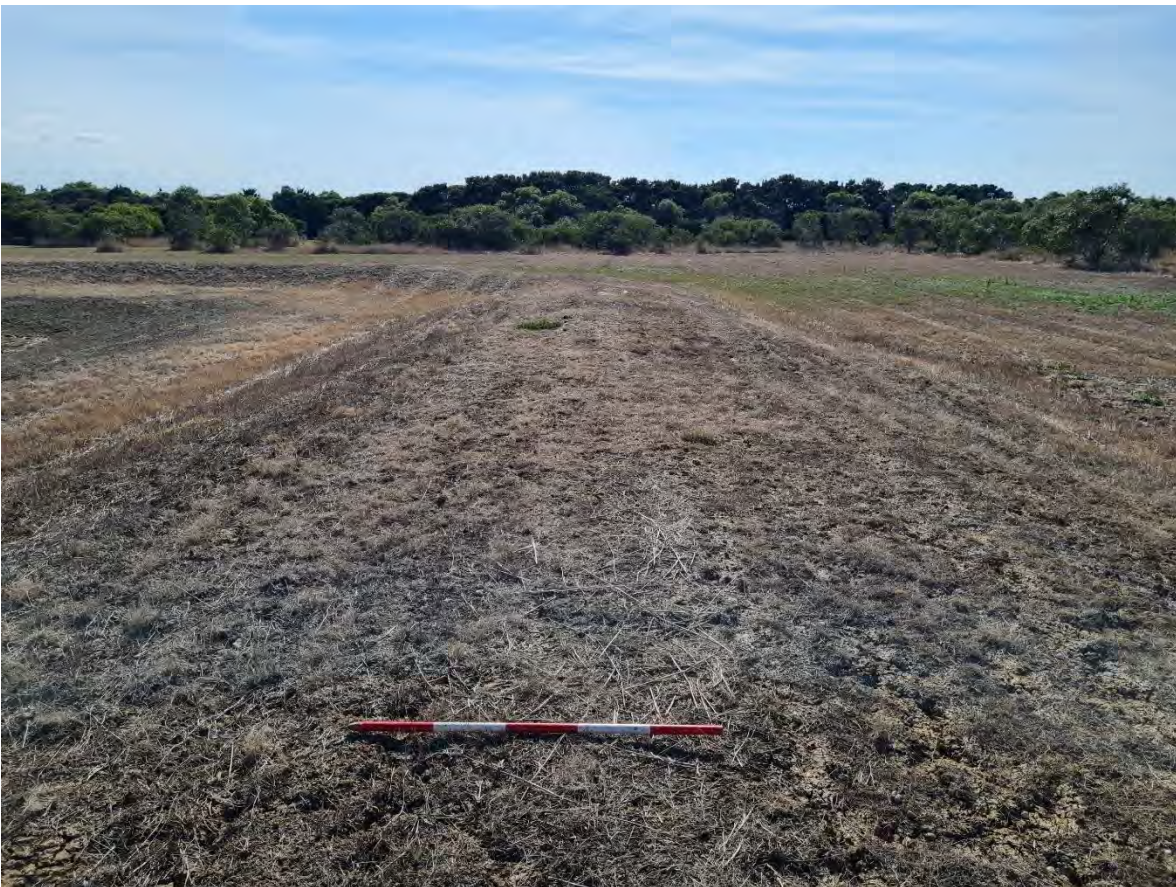
Plate 71 *Top of dam wall, facing north (R. Stewart 26.04.2023)*

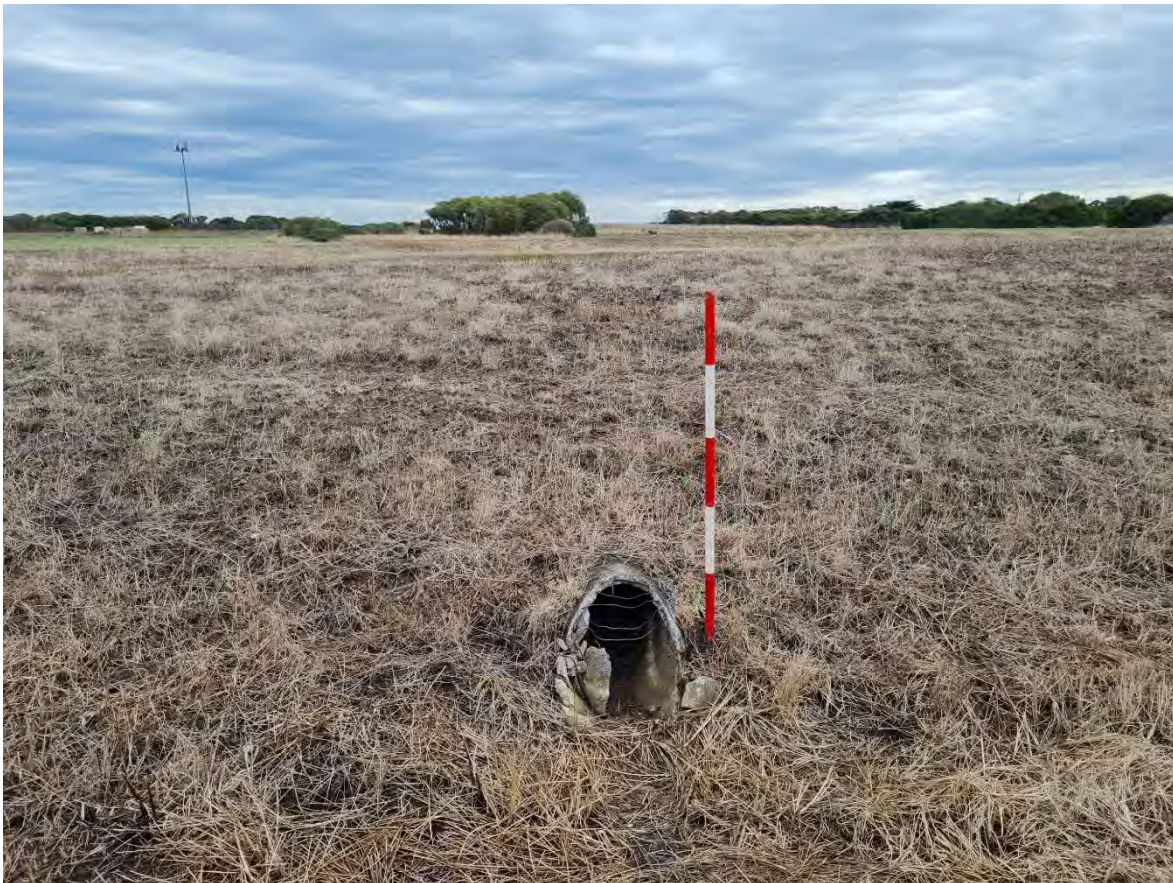
Plate 72 Overflow drain in dam wall, southeast corner of dam, facing west (R. Stewart 26.04.2023)
