# **Ground Control Management Plan**

**Lang Lang Sand Resources Pty Ltd**

09 February 2023

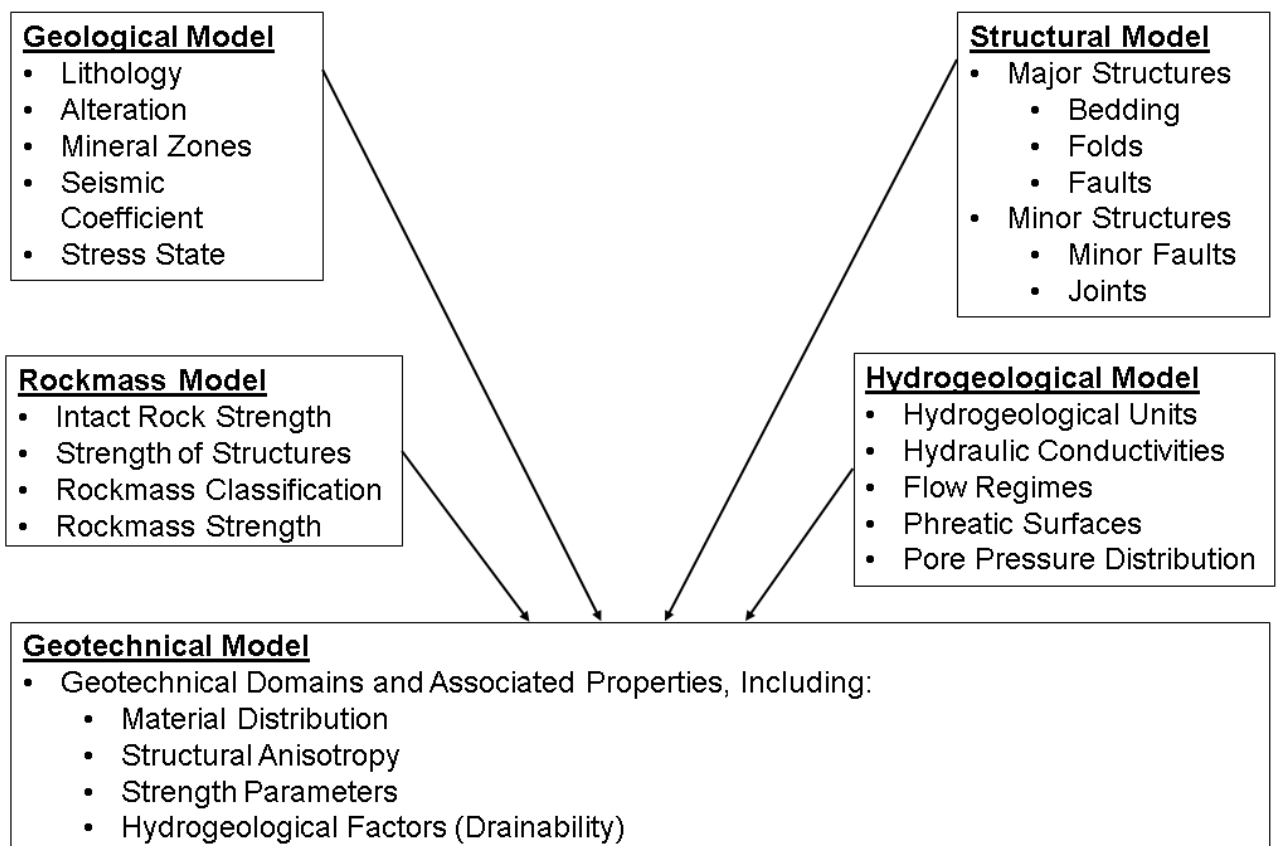
Figure 6 Development of Geotechnical Domain Model after Read and Stacey (2009)

Geotechnical domaining of the Client's site has relied upon the philosophy set out by Read and Stacey (2009). Outlined in the Figure 6 are the considerations that are taken into account when formulating site specific geotechnical domains.

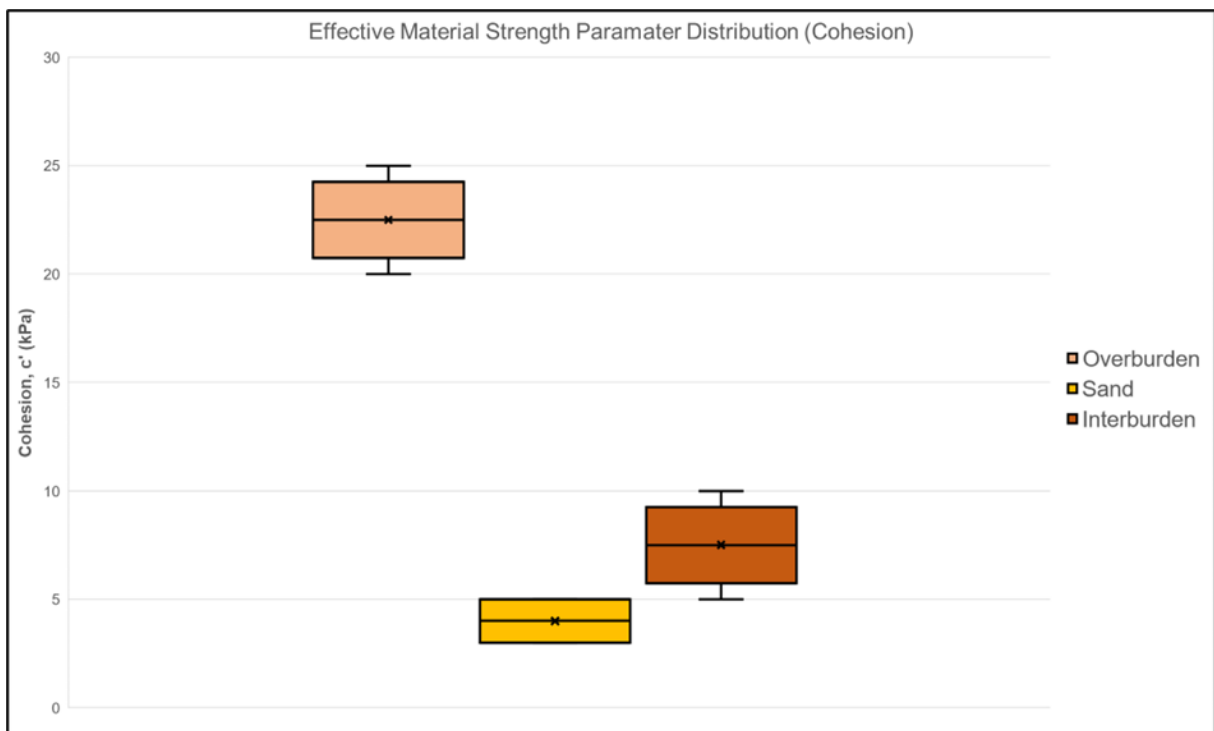
Figure 12 Summary of Effective Strength Distribution (Cohesion)

As noted above and for conservatism, GHD has adopted the lower bound strengths for the analyses. Accordingly, the results presented in this report are considered to be conservative. Table 1 outlines and Figure 12 and Figure 13 depict the material strengths assessed for the site. Figure 13 also presents typical friction angles for sand, sandy gravels and silty sand (after Terzaghi and Peck, 1967).

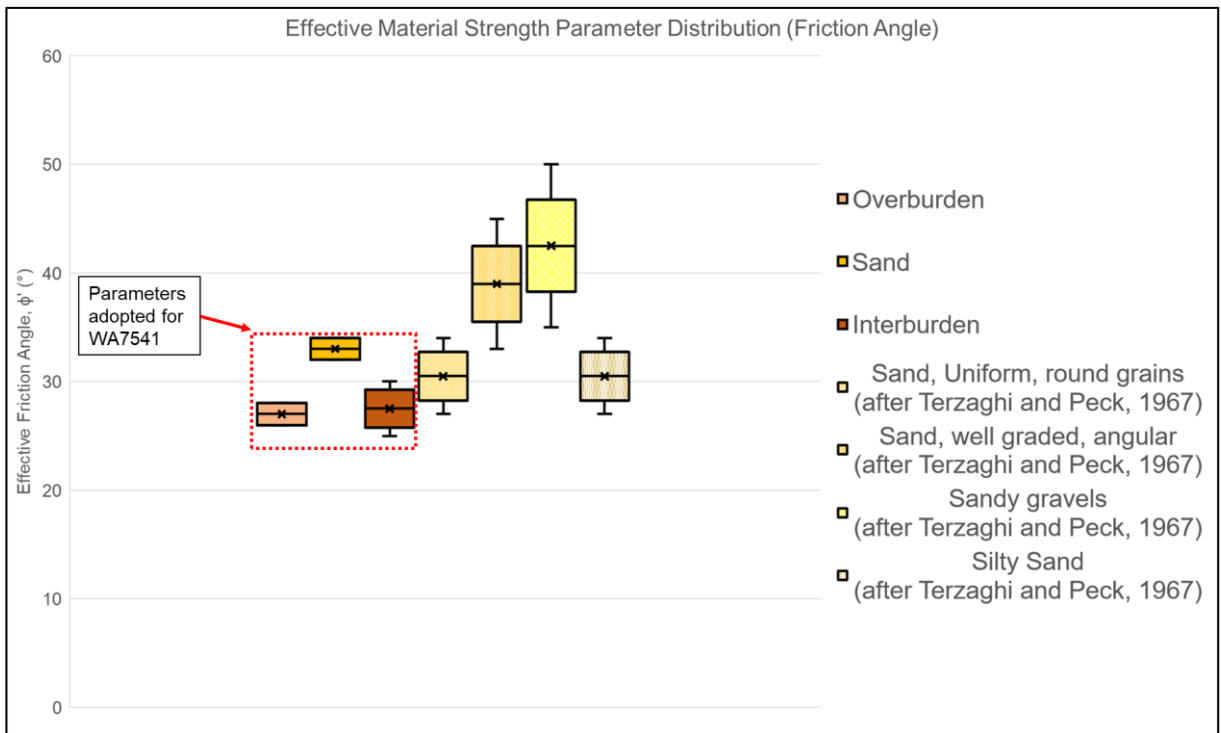
Figure 13 Summary of Effective Strength Distribution (Friction Angle)

As depicted in Figure 15, GHD notes that the material strength parameters adopted for WA7541 are conservative (lower bound) in comparison to the spectrum of typical friction angles (after Terzaghi and Peck, 1967).

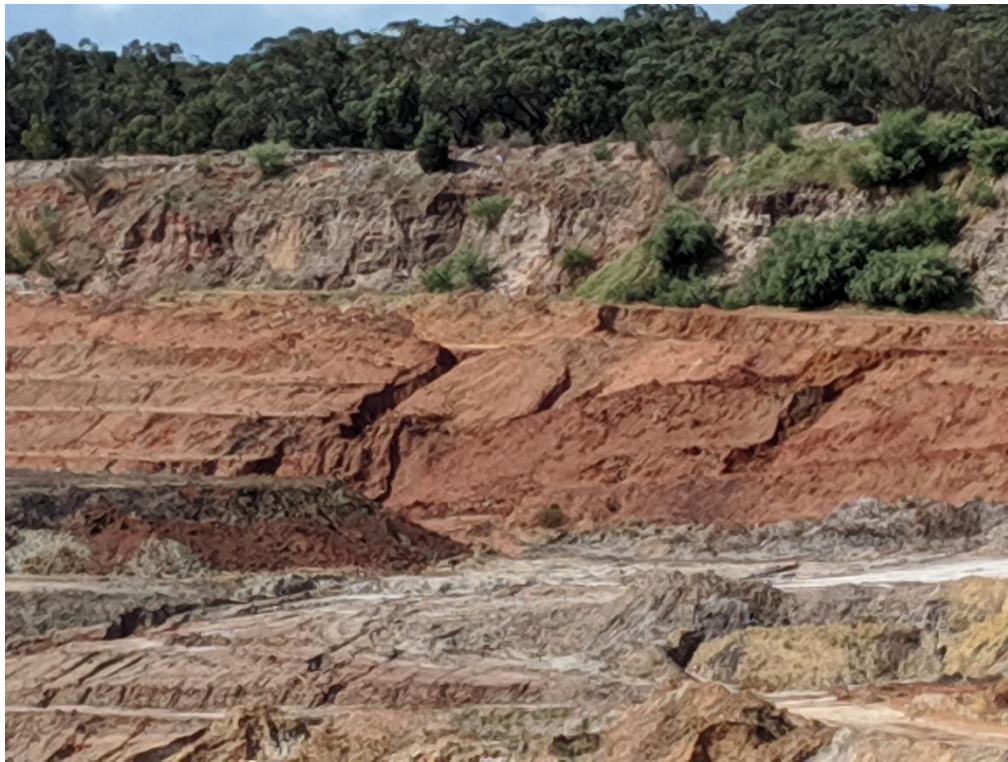
Figure 15 Example of Erosion of Exposed Sand Batters at Nearby Quarry

Piping can occur as water infiltration or perched water may drain via weak zones in the in-situ materials causing the soil to wash out and undercut overlying batters. This can potentially lead to batter instability if not suitably managed. Based on the encountered materials, it is likely that the primary mechanism of failure is circular failure. Circular failure can also result, particularly where the standing groundwater level interfaces with the exposed sand batters above pond level. Undercutting of the base/foundation could potentially increase the likelihood of circular failure of the overlying batter slope. This instability mechanism can be managed with suitable batter design (including offset from base of slope) and surface water management. The secondary mechanism of potential instability can occur from erosion of exposed batters, as the initiation of instabilities within exposed soil units are usually governed by build of pore water pressures as a result of uncontrolled / excessive surface water ingress. This can lead to a decrease in material strength and eventuate as slumping and / or sloughing of batters.
