# **Rehabilitation Plan**

# **Extractive Industry Work Authority WA007541**

# WA007541 - Lang Lang Sand Resources Pty Ltd

Project No. A25\_005 February 2023

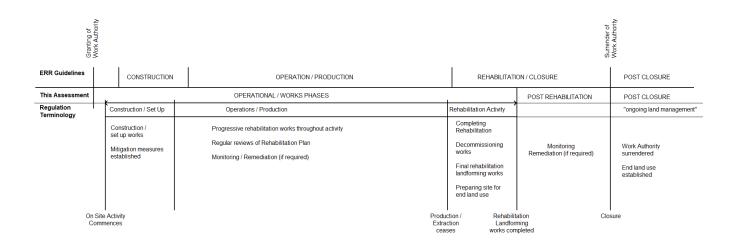
As is the case for the hazard identification and risk assessment process, set out in the Risk Management Plan, the rehabilitation at this site is in the context of the quarry life as represented in the following schematic, which includes the indicative rehabilitation sequence as it relates to any particular part on the site.

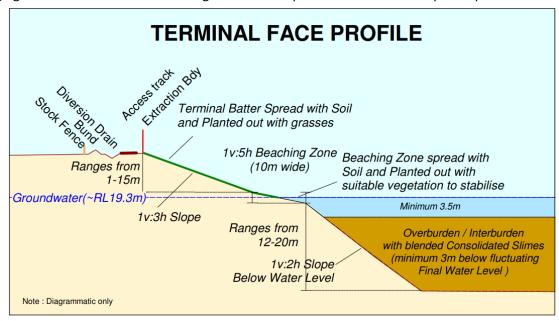
terminal extraction batters above water. Batter slopes will be lightly scoured, covered with minimum 200mm of topsoil and vegetated with pasture grasses within 3 months of completing the earthwork to aid in managing erosion and dust. The beaching zones will be planted with suitable aquatic species.

During the Operational / Works phases, a safety bund will be established around the crest of terminal faces. Such safety bunds will be remodelled into a small mound and swale drain once the final rehabilitation profile has been achieved. The purpose of this crest bund and drain is to prevent surface water from flowing over the rehabilitated batters and minimise the erosion potential on the batter.
