**MANDALAY RESOURCES
COSTERFIELD OPERATIONS**
ABN: 34 006 911 119

**Costerfield Gold Mine
Brunswick West Tailings Storage
Facility Investigation and Design
Credible Failure Mode Assessment**

109014.15-R03-1
March 2023

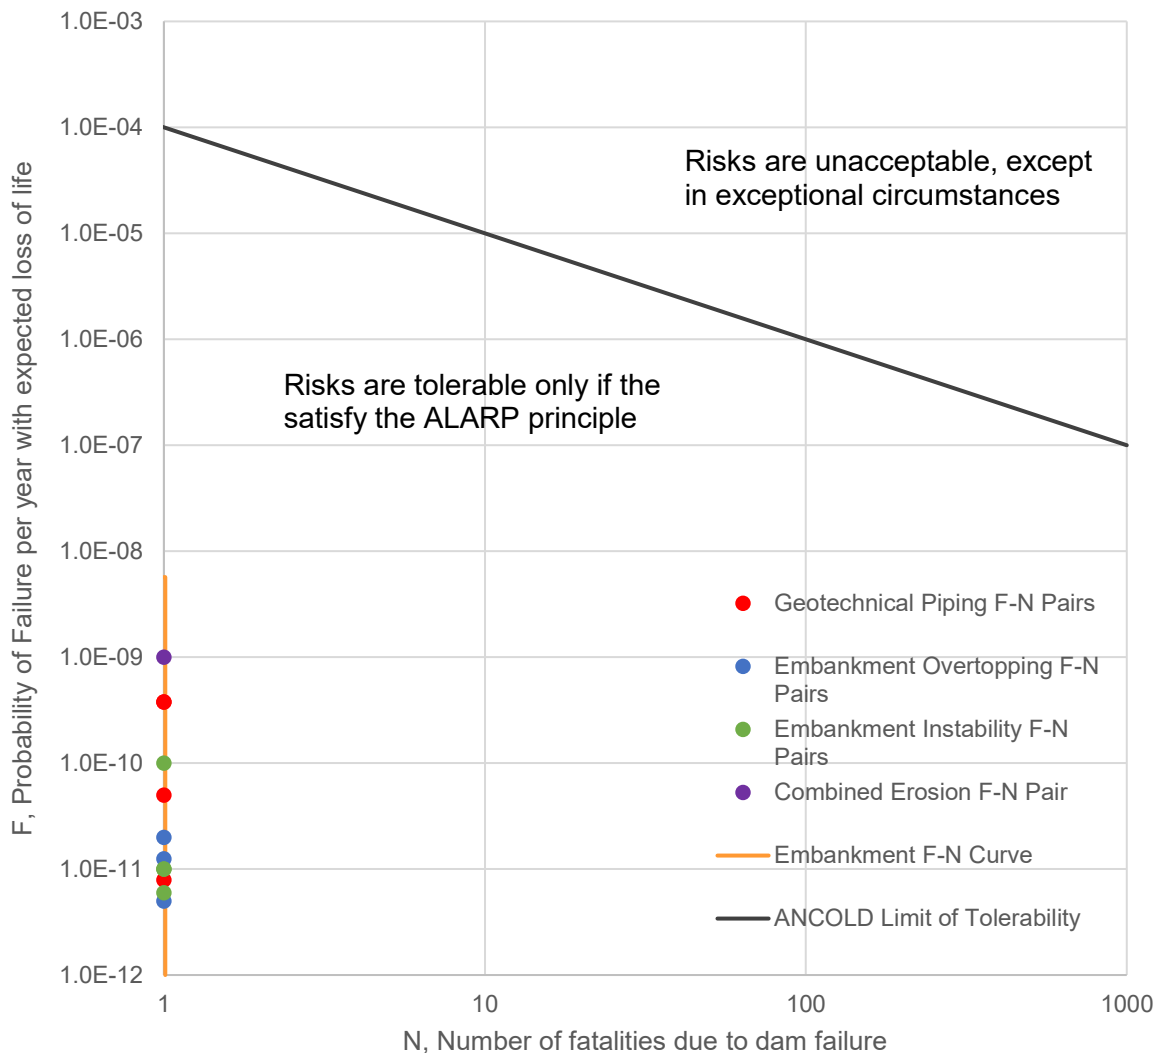
CHART ES1: ANCOLD SOCIETAL RISK GUIDELINES

Note: ANCOLD provides the Limit of Tolerability line to a lower bound N value of 1. For fractional N values (i.e., $N < 1$), the F-N pairs have been presented at $N = 1$, with the probability values adjusted to compensate.

The estimated F-N pairs for the assessed failure cases and the cumulative embankment F-N curve plot significantly below the ANCOLD Limit of Tolerability for new dams, and are within the region where the risk can be considered as tolerable if they satisfy the ALARP principle.

The ANCOLD Guidelines on Risk Assessment provide guidance for the tolerability of public safety risks for the general community and workers associated with the facility, and considers the relationship between the annualised probability of failure and the potential number of fatalities due to dam failure. This is presented as an F-N chart, or the ANCOLD Societal Risk Guidelines. This chart presents the individual F-N pairs for each of the failure cases considered, as well as the combined F-N curve for the Brunswick West TSF, and is presented in **Chart ES1**

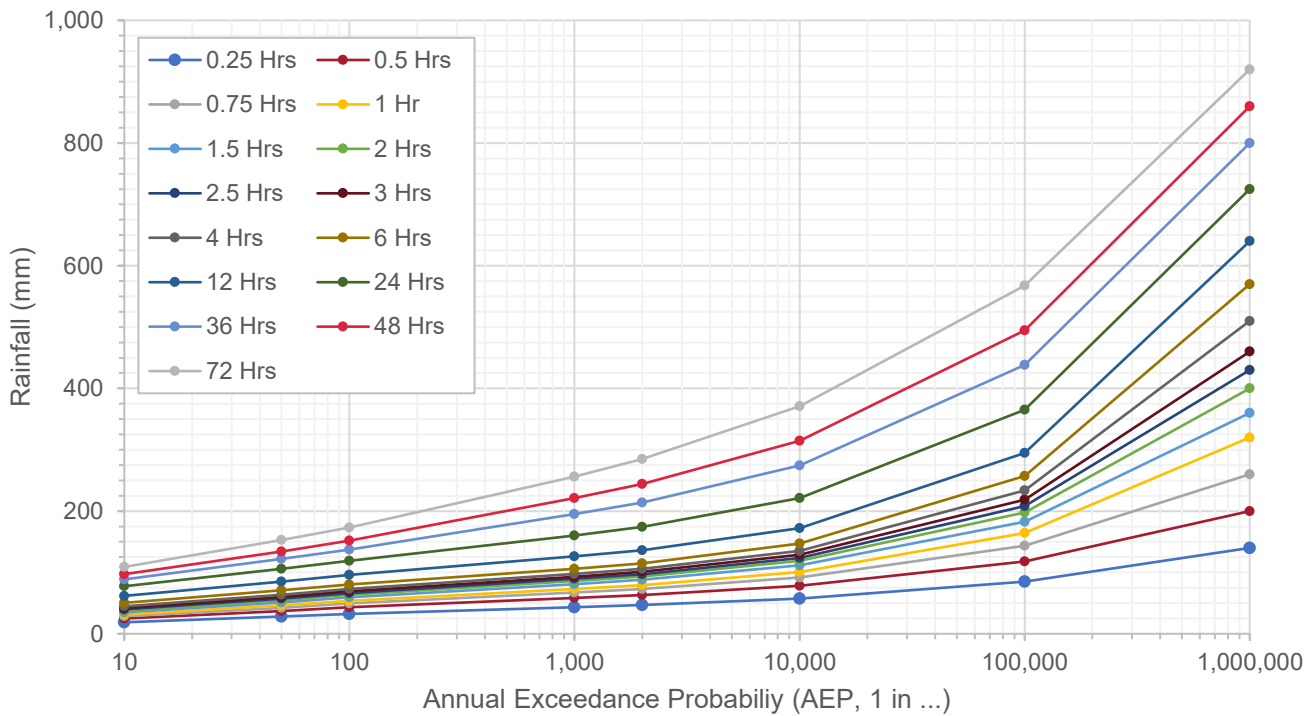
CHART 2: ESTIMATION OF EXTREME RAINFALL DEPTHS

Estimations of the extreme depths used for the quantitative assessment are presented in **Chart 2**.

The preceding events for an overtopping failure are either the raising of water within the TSF (through rainfall events, or inability to remove built up water), or lowering the level at which the water needs to reach to overtop the embankment (through reductions in the embankment crest or spillway capacity). The probability of these events have been estimated based on the required rainfall/AEP as presented in **Chart 2**, or anecdotally using the mapping scheme outlined in **Section 6.1**
