**Costerfield Gold Mine**

**Brunswick West Tailings Storage  
Facility Investigation and Design**

**Detailed Design Report**

109014.15-R04-Rev 3  
March 2023

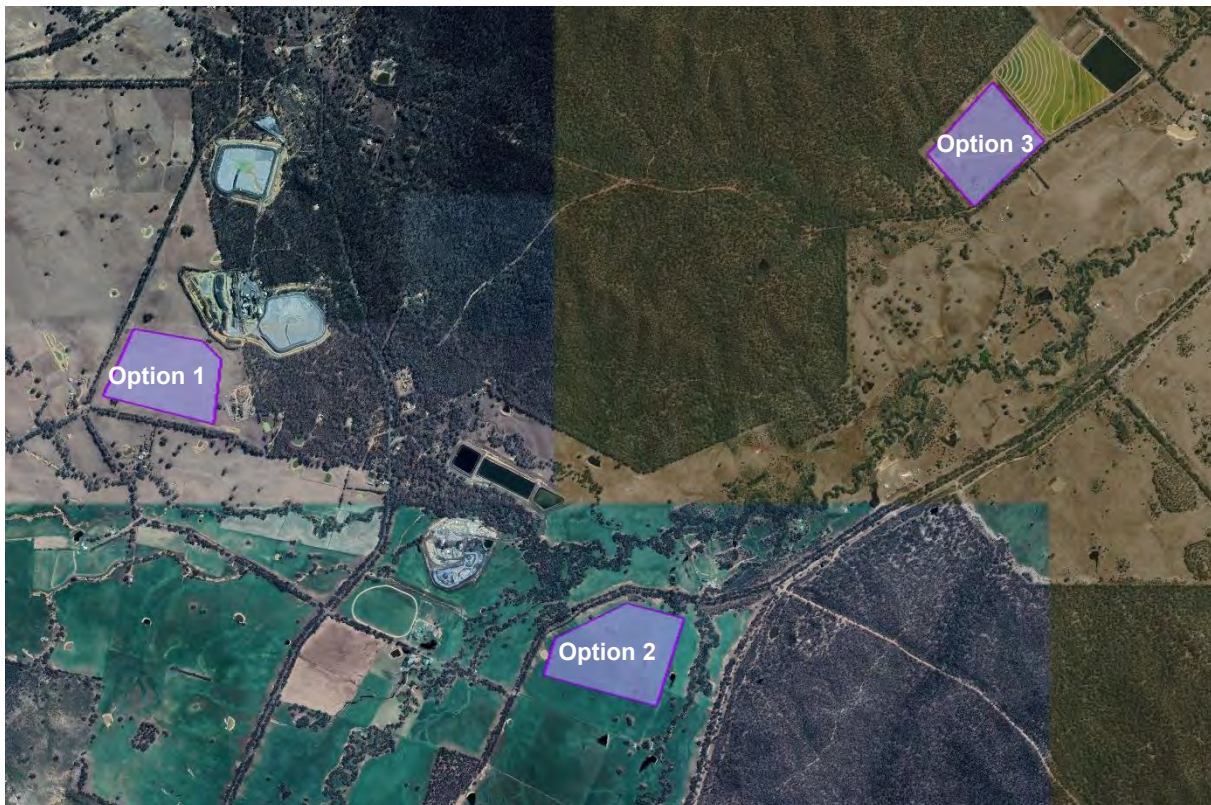
**MAP 1: LIFE OF MINE PRELIMINARY SITE OPTIONS**

- Option 1 Farm paddock immediately south-west of the Brunswick Processing Plant.
- Option 2 Farm paddock approximately 800 m south-east of the Augusta Mine.
- Option 3 Immediately adjacent to the Splitters Creek Evaporation Facility, located approximately 4 km north-east of the Brunswick Processing Plant.

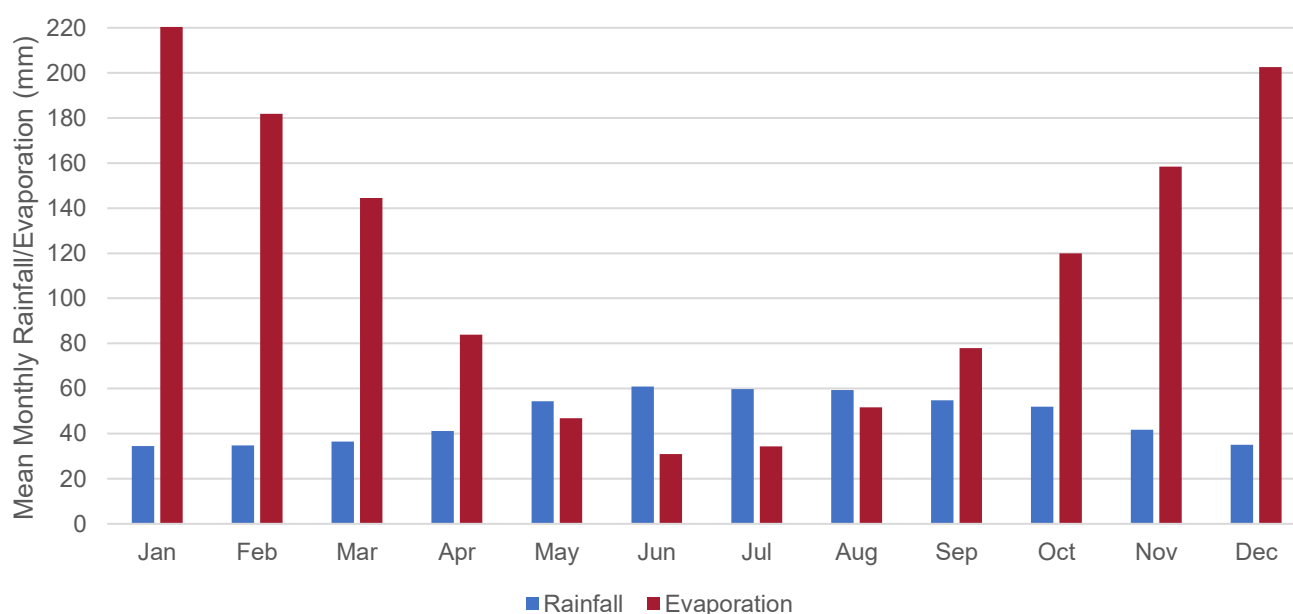
**CHART 1: MEAN MONTHLY RAINFALL AND EVAPORATION (HEATHCOTE WEATHER STATION)**

The mean monthly rainfall and evaporation is presented in **Chart 1**.

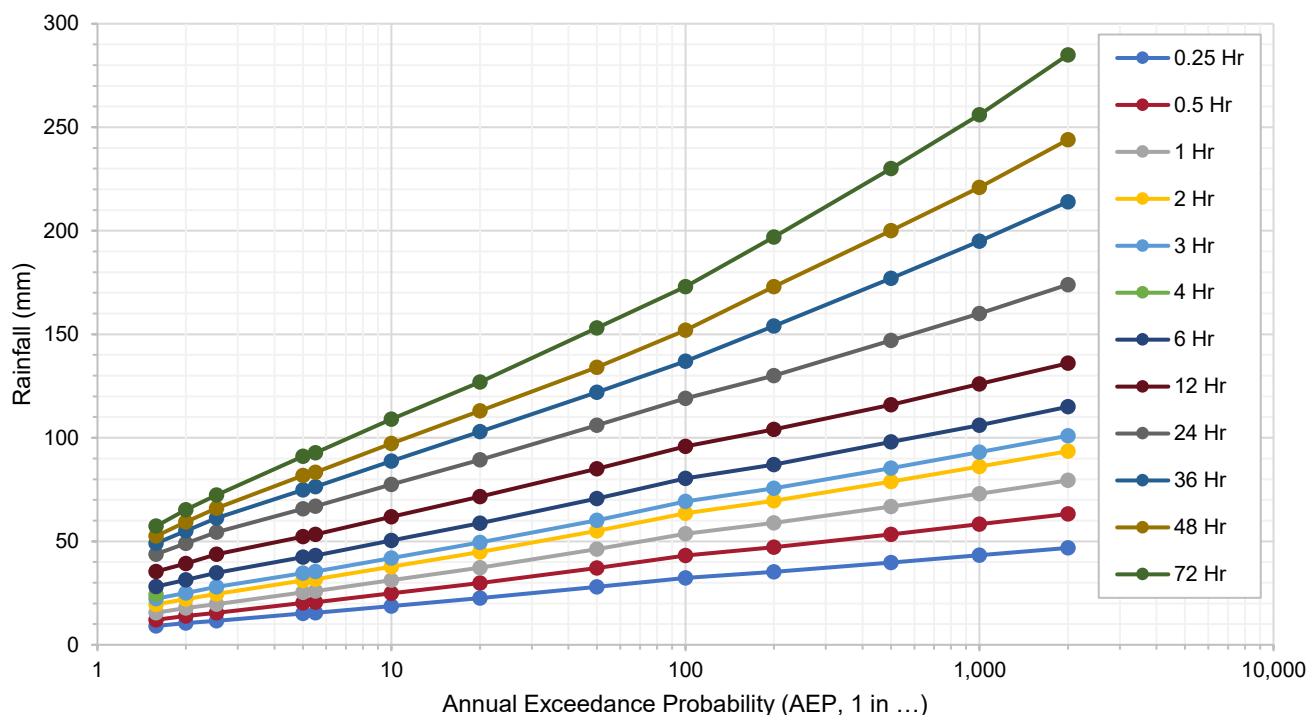
**CHART 2: INTENSITY-FREQUENCY-DURATION CHART (HEATHCOTE WEATHER STATION)**

Intensity-Frequency-Duration (IFD) curves used for calculation of design rainfall events have been extracted from the Bureau of Meteorology's Design Rainfall and Data System (2016) for various durations and Annual Exceedance Probabilities (AEP's) ranging between very common (1 in 1.6 years) to 1 in 2,000 years. The IFD curves are presented in **Chart 2**.

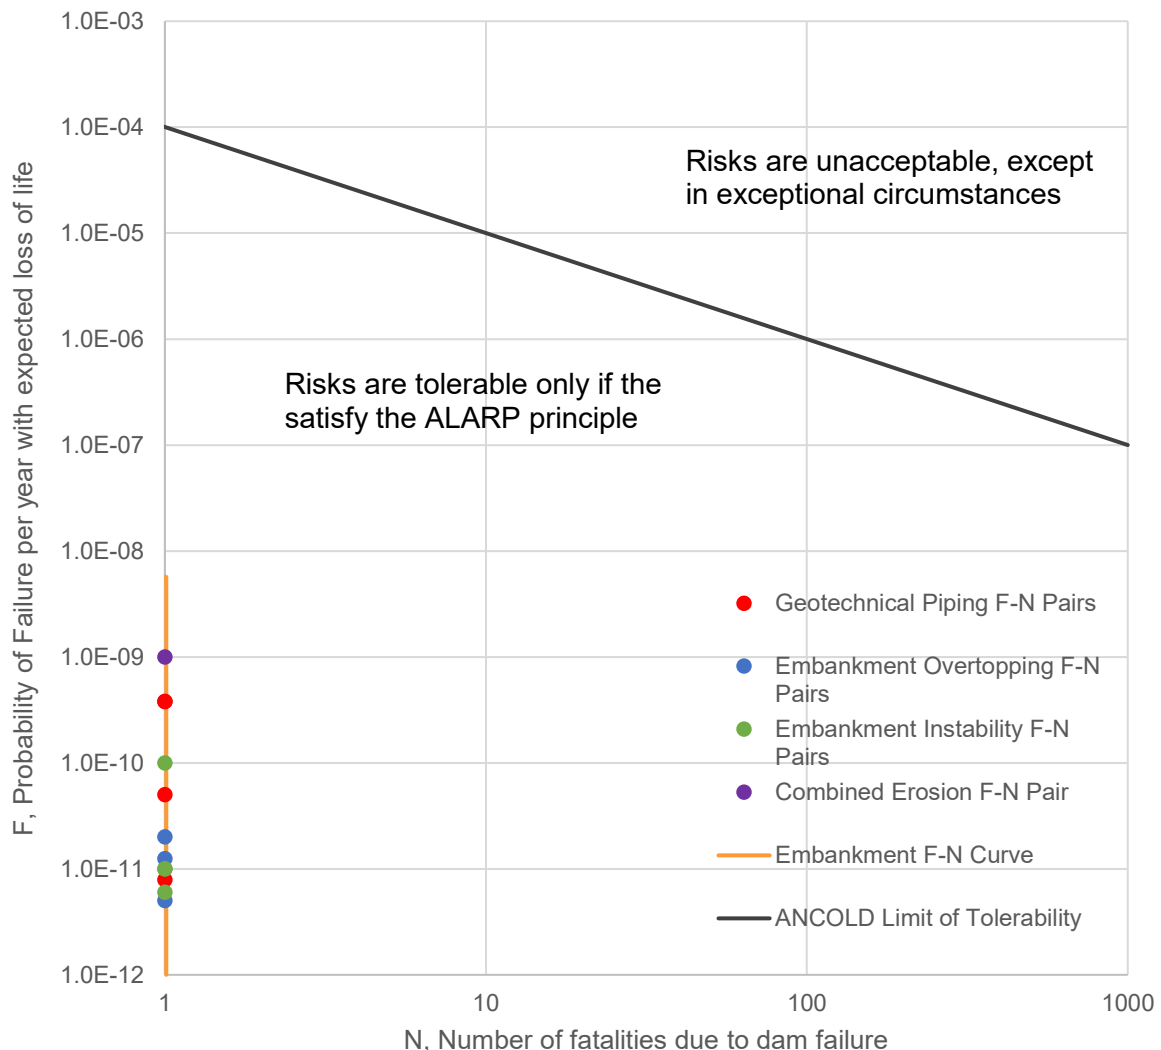
**CHART 4: PROBABILITY OF FAILURE VS NUMBER OF FATALITIES – NEW DAMS**

**Note:** ANCOLD provides the Limit of Tolerability line to a lower bound N value of 1. For fractional N values (i.e.,  $N < 1$ ), the F-N pairs have been presented at  $N = 1$ , with the probability values adjusted to compensate.

It can be seen from **Chart 4** that the F-N pairs for the assessed failure cases and the cumulative embankment F-N curve plots well below the ANCOLD Limit of Tolerability for new dams, and are within the region where the risk can be considered as tolerable if they satisfy the ALARP principle.

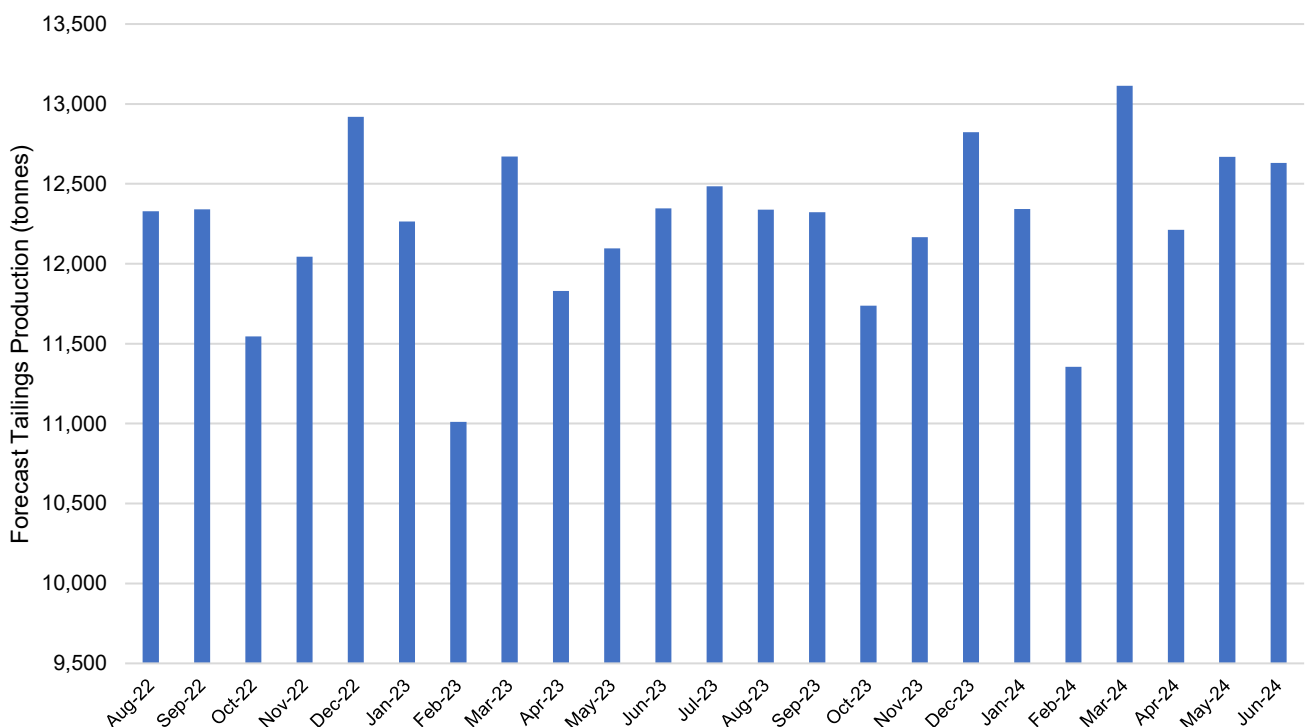
**CHART 5: FORECAST TAILINGS PRODUCTION**

MRCO have provided ATCW with forecast tailings production values for August 2022 to June 2024, which are presented in **Chart 5**.

The current forecast date for the end of filling of Bombay TSF and commencement of deposition into Brunswick West TSF is October 2023. The production rates in **Chart 5** are only forecast until June 2024, whereas the Brunswick West TSF is expected to provide storage until at least 2027. For this assessment, the average daily production rate from October 2023 to June 2024 has been used, which equals 419 tonnes/day.

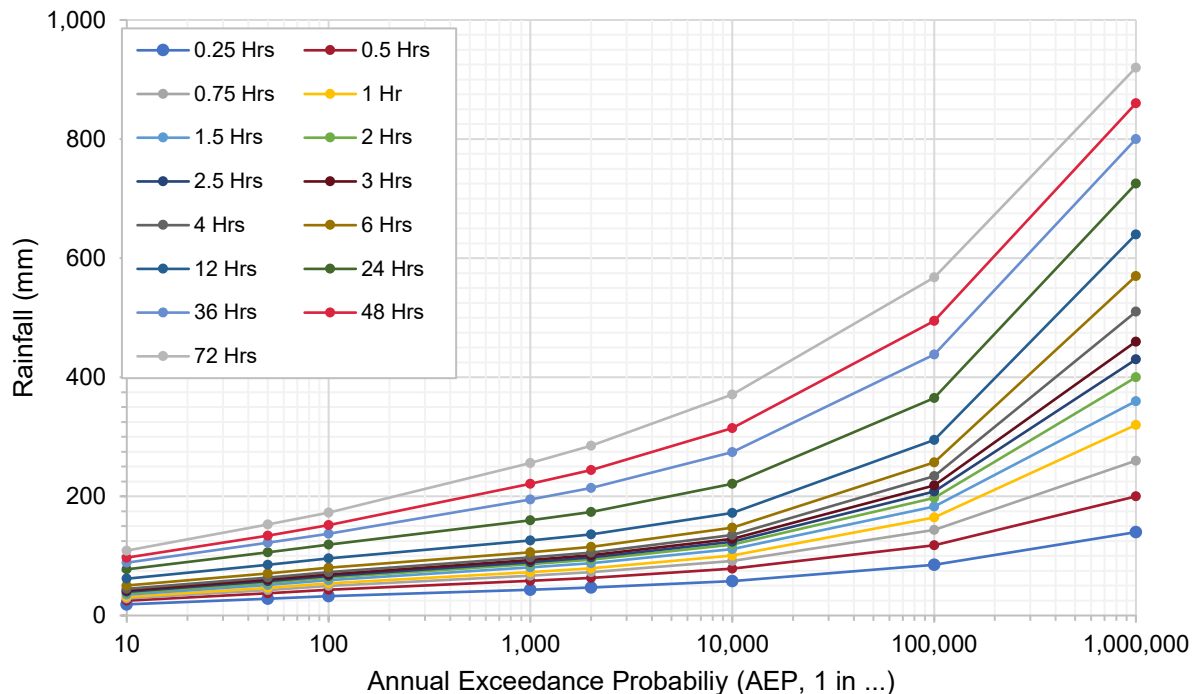
**CHART 6: ESTIMATIONS OF EXTREME RAINFALL DEPTHS**

Estimates of extreme rainfall depths are presented in **Chart 6**.

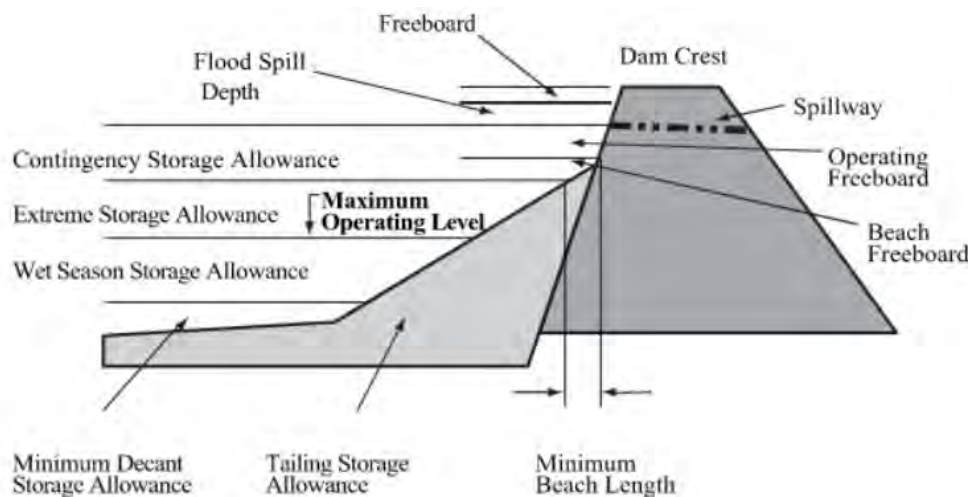
**DIAGRAM 2: FREEBOARD DEFINITIONS (ANCOLD)**

The freeboard design criteria described above are presented in **Diagram 2**.

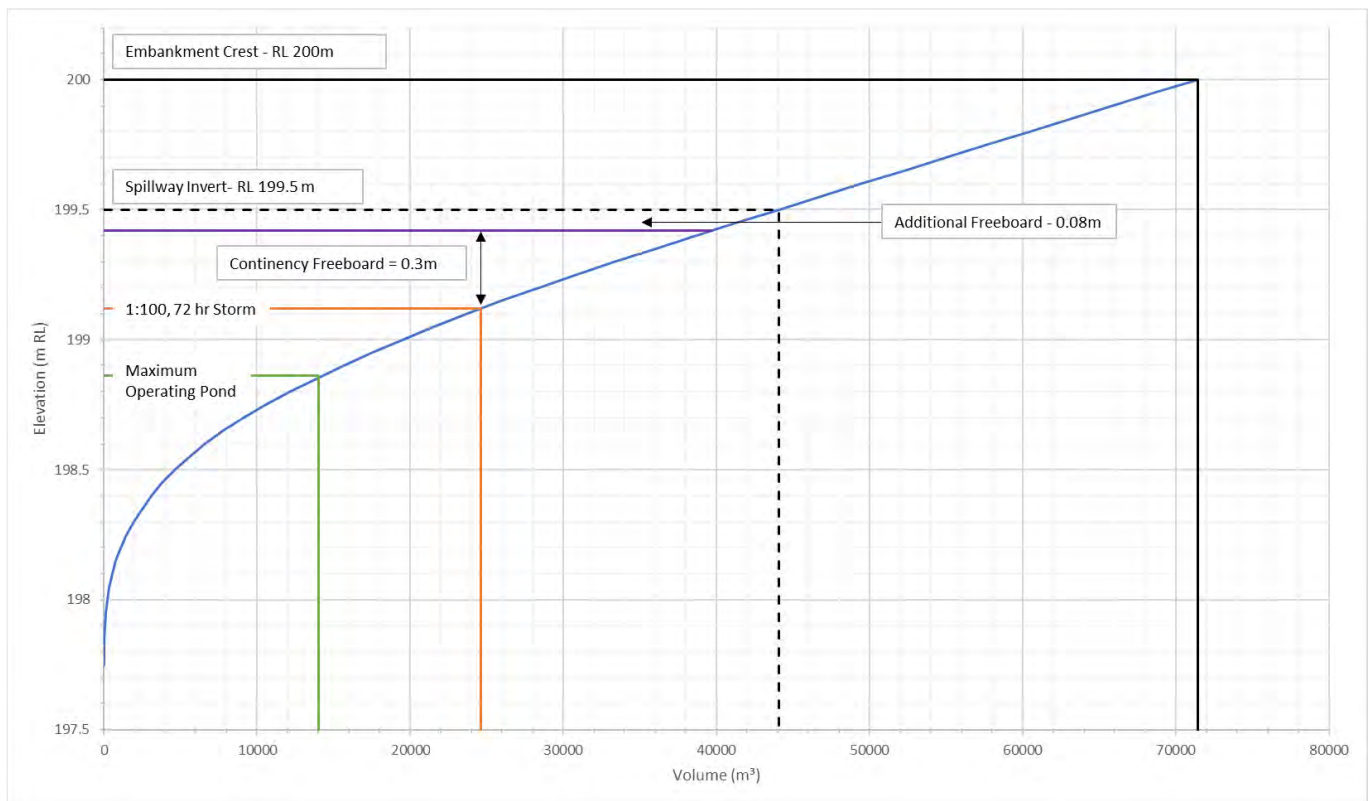
**CHART 8: AVAILABLE STORM STORAGE AT END OF FILLING**

The available storm storage and freeboards on the TSF at the end of filling is presented in **Chart 8** and **Table 20**.

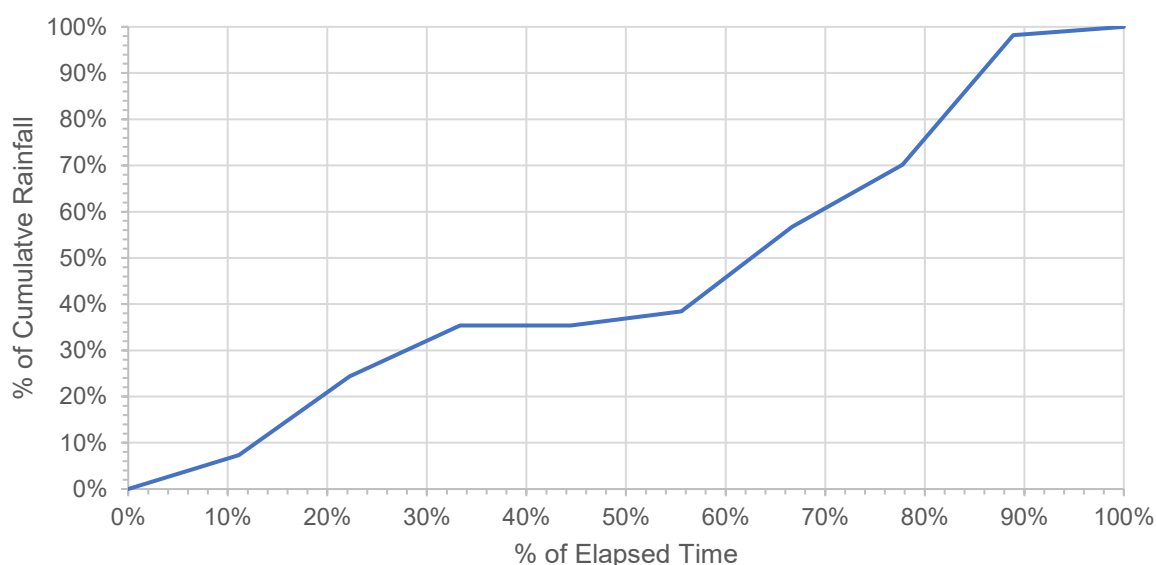
**CHART 9: RAIN-ON-GRID CRITICAL TEMPORAL PATTERN**

Temporal patterns for the model were extracted from the ARR datahub, which provides design rainfall patterns for regions in Australia for varying storm intensity levels. The critical temporal pattern was considered as one that had a small amount of rainfall early and peaked late, as the low intensity rainfall would wet up the catchment, followed by high intensity rainfall resulting in surface runoff. The chosen temporal pattern is presented in **Chart 9**.

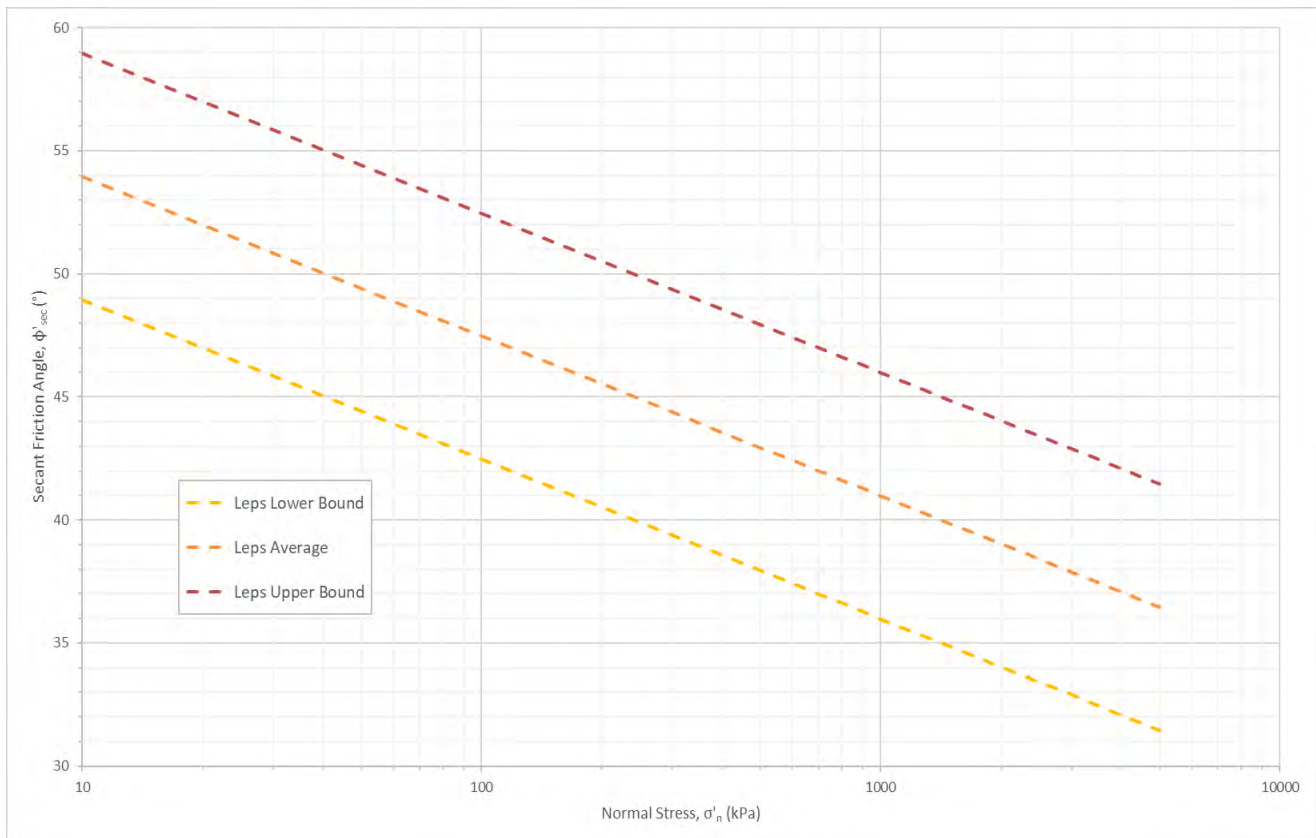
**CHART 14: ZONE 3B STRENGTH PROFILE – NORMAL STRESS VS SECANT FRICITION ANGLE**

methods, such as Douglass (2003) [43], rely on more properties of the rockfill itself, such as the Angularity rating of the rock particles, Unconfined Compressive Strength, and a more detailed particle grading. Given that these factors are unknown, the Leps [42] Lower Bound function has been conservatively adopted, as shown in **Chart 14**.

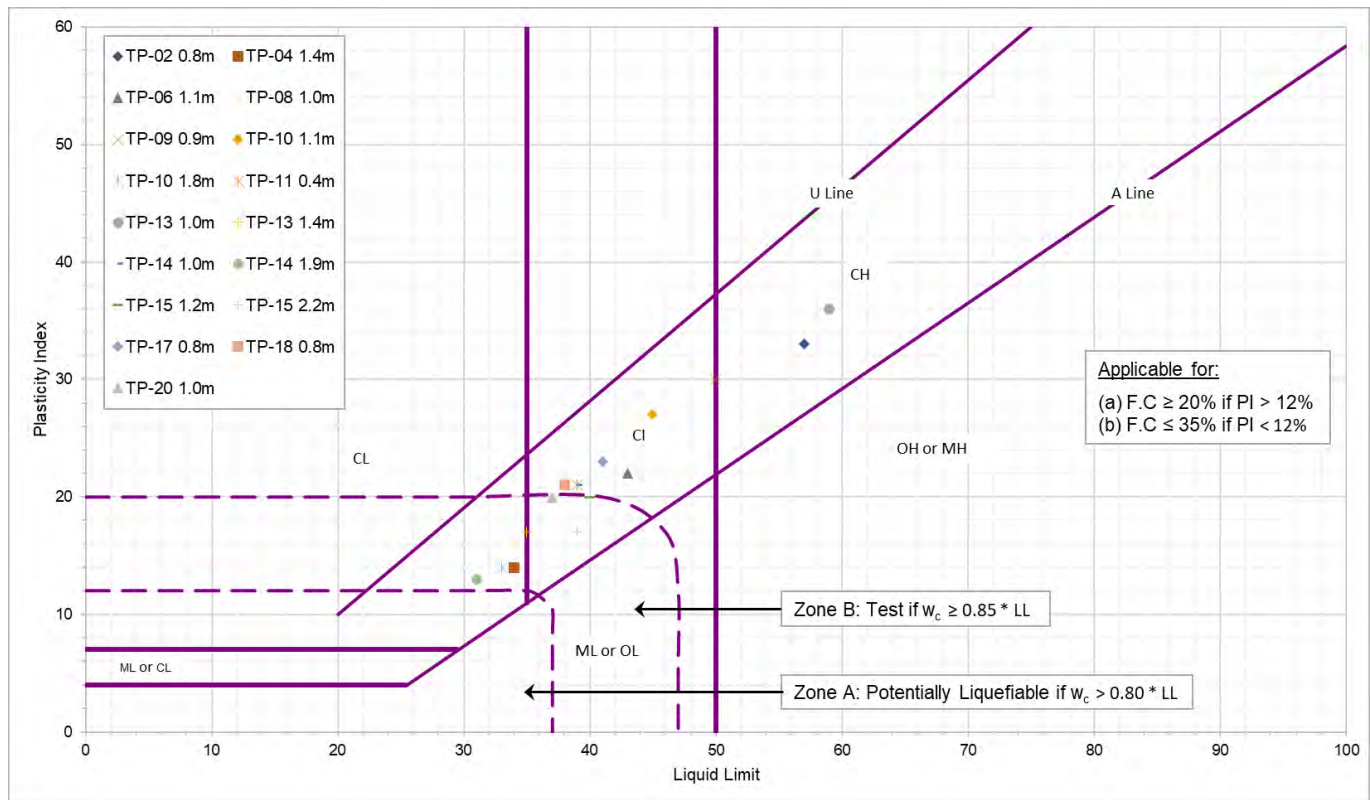
**CHART 15: POTENTIAL FOR LIQUEFACTION – PLASTICITY INDEX CHART**

It can be seen that 8 of the 22 samples collected from the Geotechnical Investigations fall within Zone B, and may be liquefiable. These materials are a mixture of gravelly clays and Extremely Weathered / Residual Soil Siltstone. The results of the Laboratory Testing for these samples, along with the criteria for Zone B, are presented in **Table 25**.

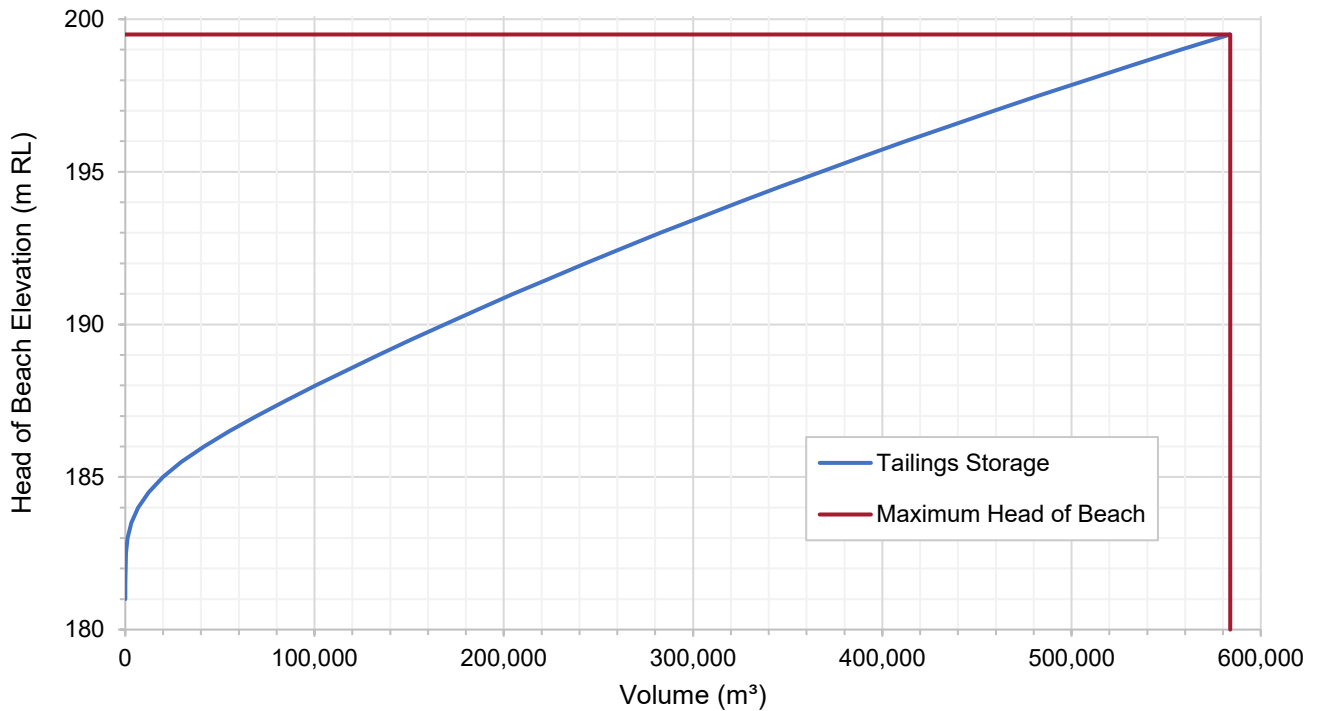
**CHART 18: TAILINGS VOLUMETRIC FILLING CURVE**

The tailings volumetric filling curve for the Brunswick West TSF is presented in **Chart 18**, and the estimated filling schedule (elevation vs time) is presented in **Chart 19**. A layout plan of the facility at the end of filling is presented in **Figure 11**.

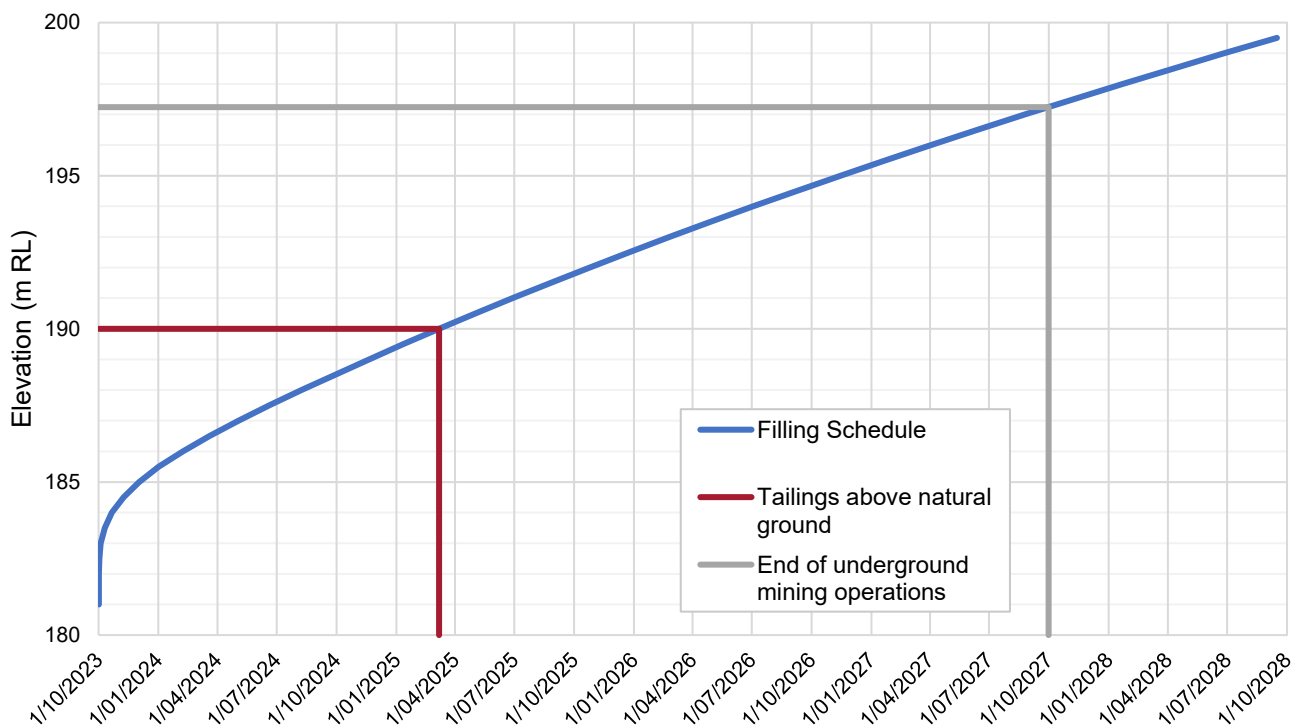
**CHART 19: TAILINGS FILLING SCHEDULE**

At the maximum tailings head of beach of RL 199.5 m, the Brunswick West TSF will have capacity for 584,000 m<sup>3</sup> of tailings, with the tailings rising at between 2.3 and 4.0 m/year, which is generally considered acceptable for this type of facility. The facility will provide storage for the Brunswick Processing Plant for approximately 5 years. Assuming deposition commences in October 2023, storage will be provided until September 2028.

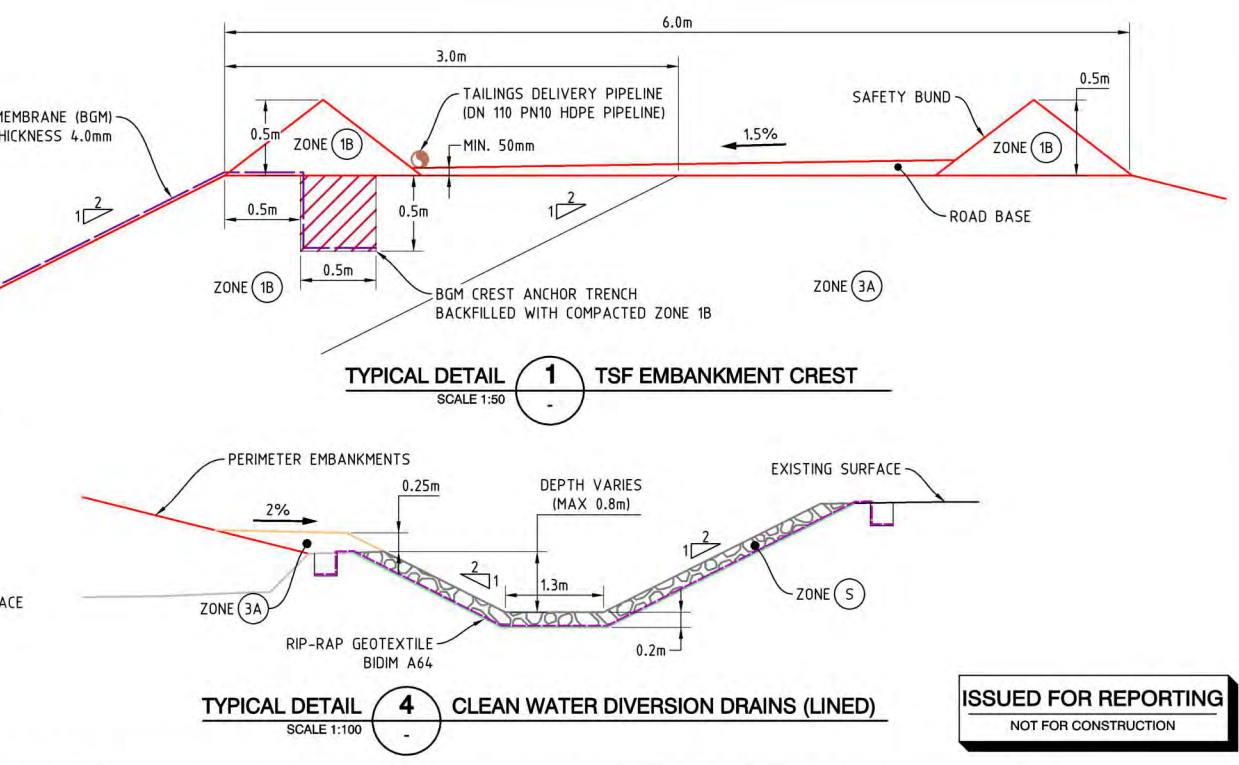
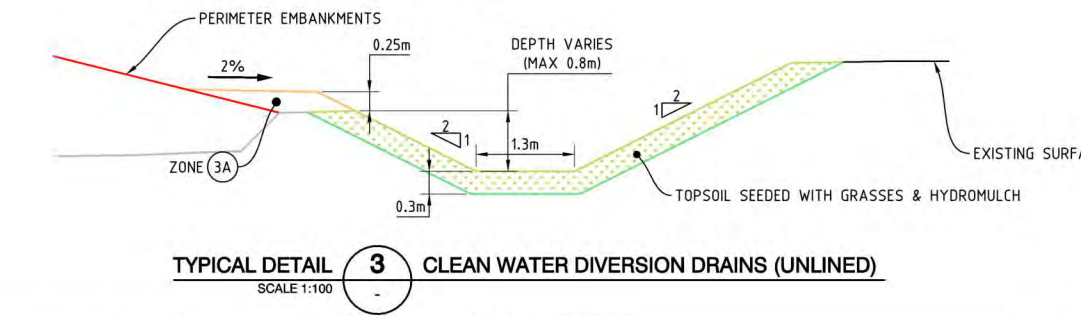
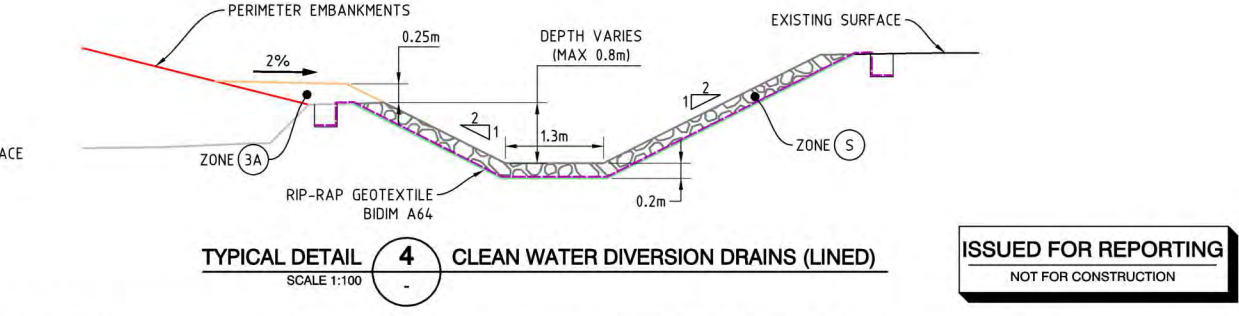
| MATERIAL ZONE DESCRIPTIONS | |
|---|--|
| 1 | COMPACTED CLAY LINER. GRAVELLY CLAY. MATERIAL WON FROM IMPOUNDMENT EXCAVATION AND EMBANKMENT FOUNDATION STRIPPING. MATERIAL PLACED IN 250mm (LOOSE) LAYERS AND COMPACTED TO MIN. 98% STANDARD COMPACTION AND -2% TO +2 % OMC |
| 1B | BGM EARTHFILL SUBGRADE. GRAVELLY CLAY TO CLAYEY GRAVEL. MATERIAL WON FROM IMPOUNDMENT EXCAVATION AND EMBANKMENT FOUNDATION STRIPPING. MATERIAL PLACED IN 300mm (LOOSE) LAYERS AND COMPACTED TO MIN. 98% STANDARD COMPACTION. BATTER SLOPE WITH MAXIMUM ASPERITIES OF LESS THAN 30mm |
| 3A | TRANSITION FILL. RESIDUAL, EXTREMELY & HIGHLY WEATHERED SILTSTONE, WITH GRAVELS, SAND AND CLAYS. MATERIAL WON FROM UPPER IMPOUNDMENT EXCAVATION INTO ROCK. MATERIAL PLACED IN 300mm (LOOSE) LAYERS AND COMPACTED WITH VIBRATORY PADFOOT ROLLER (CONTRACTOR TO DETERMINE EQUIPMENT SIZING AND NUMBER OF PASSES WITH FIELD TRIALS) |
| 3B | ROCKFILL. HIGHLY TO SLIGHTLY WEATHERED SILTSTONE, WITH GRAVELS AND SANDS. MATERIAL WON FROM LOWER IMPOUNDMENT EXCAVATION INTO ROCK, AND FROM STOCKPILE WHERE REQUIRED. MATERIAL PLACED IN 600mm (LOOSE) LAYERS AND COMPACTED WITH VIBRATORY PADFOOT ROLLER (CONTRACTOR TO DETERMINE EQUIPMENT SIZING AND NUMBER OF PASSES WITH FIELD TRIALS) |
| S | EROSION PROTECTION RIP-RAP. MODERATELY WEATHERED TO FRESH ROCK. MATERIAL SCREENED FROM ZONE 3B MATERIAL. PLACED LOOSE IN A SINGLE LAYER WITHIN EXCAVATION |

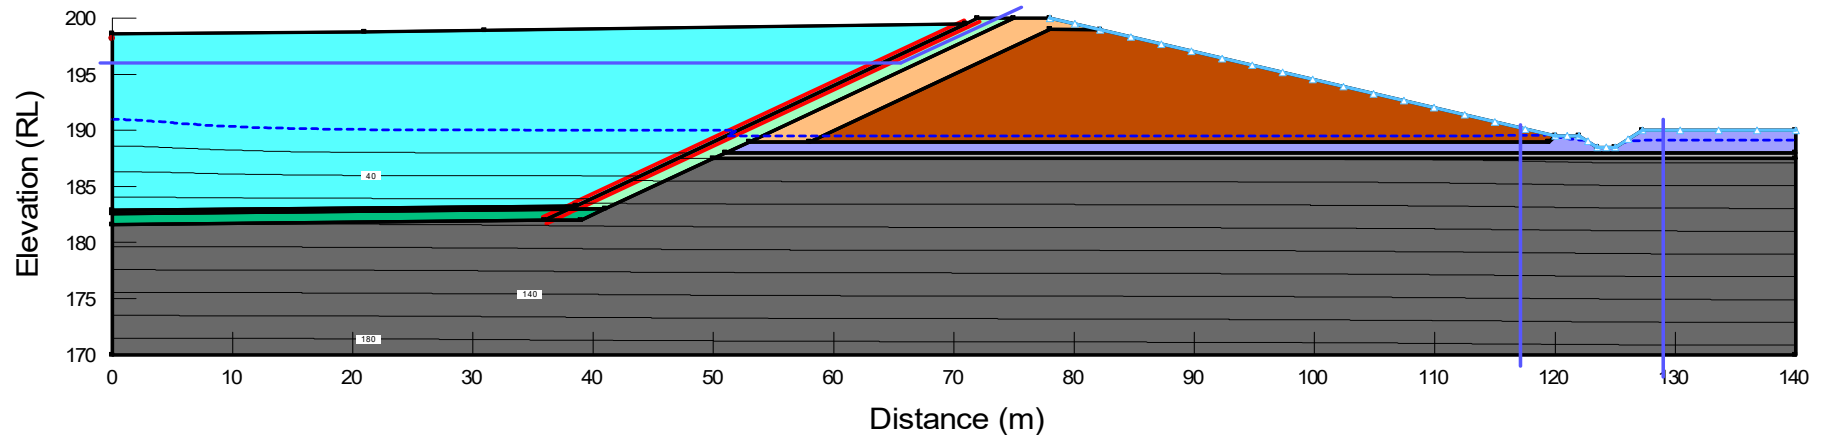
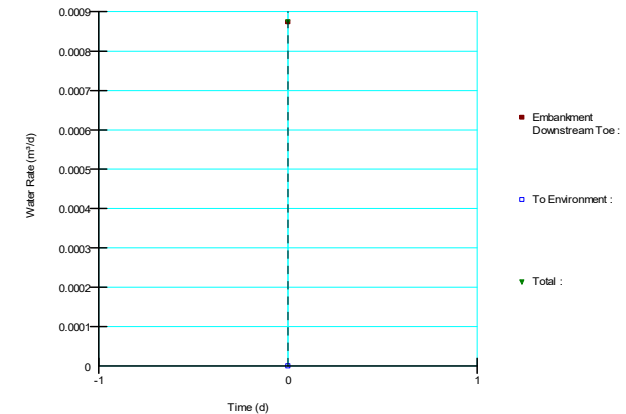
| Color | Name | Category | Kind | Parameters |
|---|---|---|---|---|
| <span style="color: red;">■</span> | Pond RL198.2m | Hydraulic | Water Total Head | 198.2 m |
| <span style="color: blue;">■</span> | Potential Seepage Face | Hydraulic | Water Rate | 0 m³/d |

| Color | Name | Model | Vol. WC. Function | K-Function | Sat Kx (m/sec) | Ky/Kx Ratio | Rotation (°) | Volumetric Water Content | Compressibility (/kPa) |

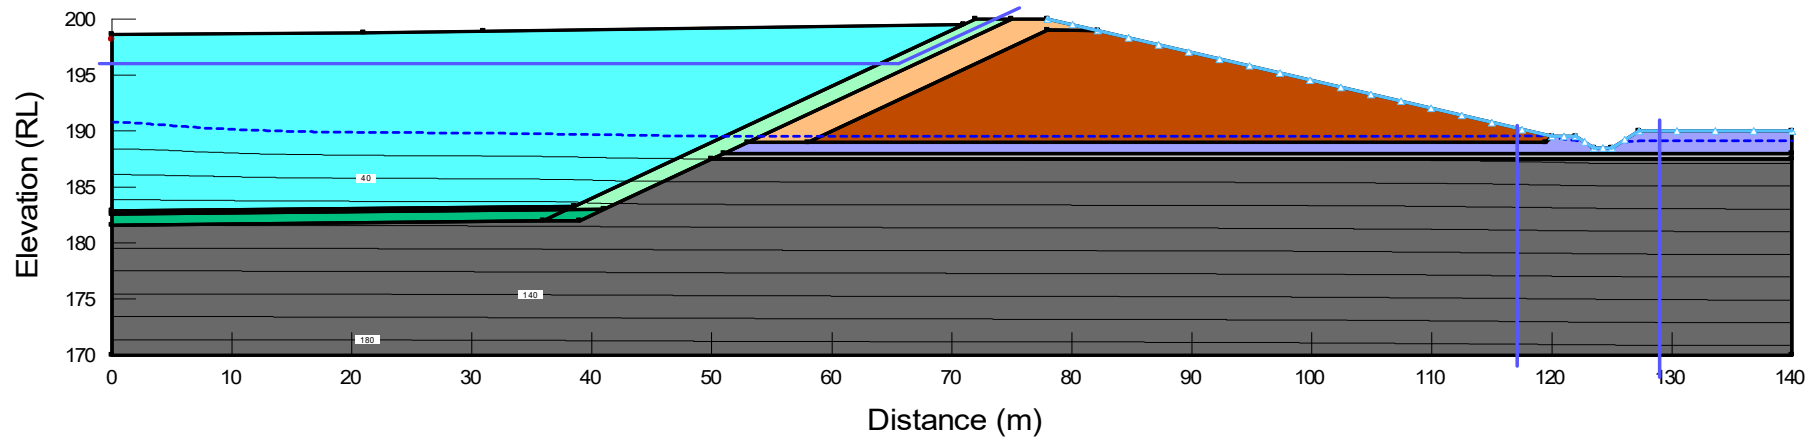
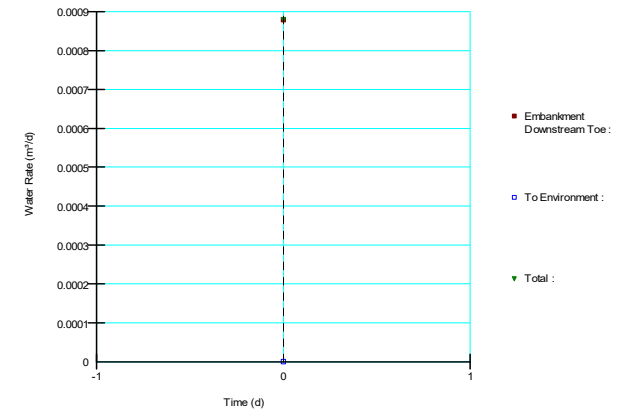
Costerfield Brunswick West TSF Design  
File Name: Brunswick TSF - Embankment Seepage - East Embankment.gsz  
Directory: K:\Projects\109\109014 Costerfield Mine, Costerfield\15 New TSF Investigation and Design\Data and Calcs\SeepW\Rev 2\  
Name: 1.3 - Seepage - Pond RL 198.2 - No Underdrainage + failed liner  
Date: 27/02/2023

| Color | Name | Category | Kind | Parameters |
|---|---|---|---|---|
| <span style="color: red;">■</span> | Pond RL198.2m | Hydraulic | Water Total Head | 198.2 m |
| <span style="color: blue;">■</span> | Potential Seepage Face | Hydraulic | Water Rate | 0 m³/d |

| Color | Name | Model | Sat Kx (m/sec) | Vol. WC. Function | K-Function | Ky/Kx' Ratio | Rotation (°) | Volumetric Water Content | Compressibility (/kPa) |

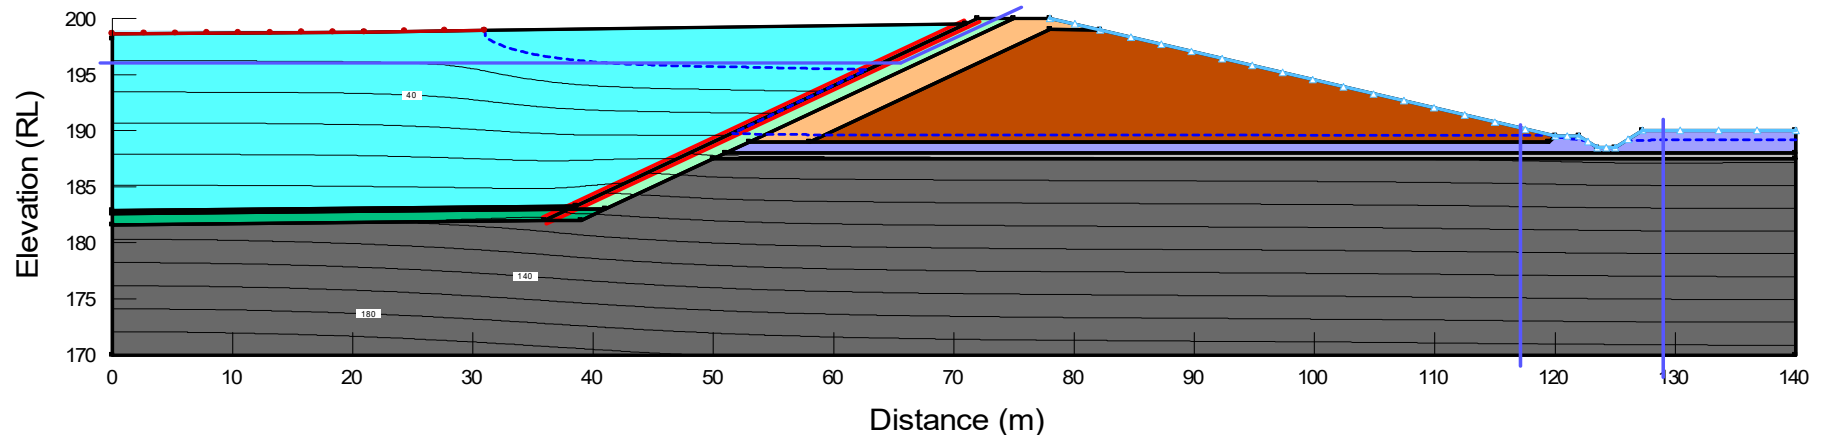
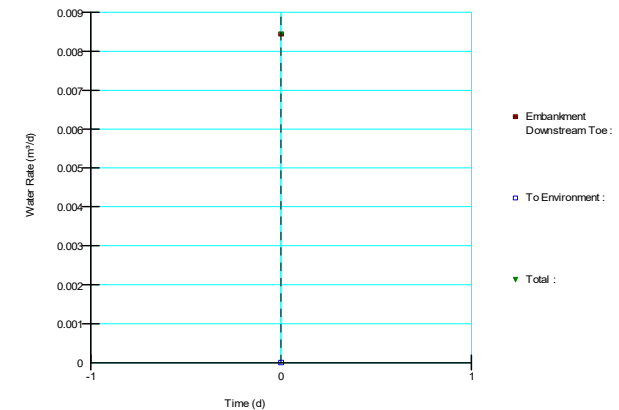
| Color | Name | Category | Kind | Parameters |
|---|---|---|---|---|
| <span style="color: red;">■</span> | Pond RL198.9m | Hydraulic | Water Total Head | 198.9 m |
| <span style="color: blue;">■</span> | Potential Seepage Face | Hydraulic | Water Rate | 0 m³/d |

| Color | Name | Model | Vol. WC. Function | K-Function | Sat Kx (m/sec) | Ky/Kx Ratio | Rotation (°) | Volumetric Water Content | Compressibility (/kPa) |

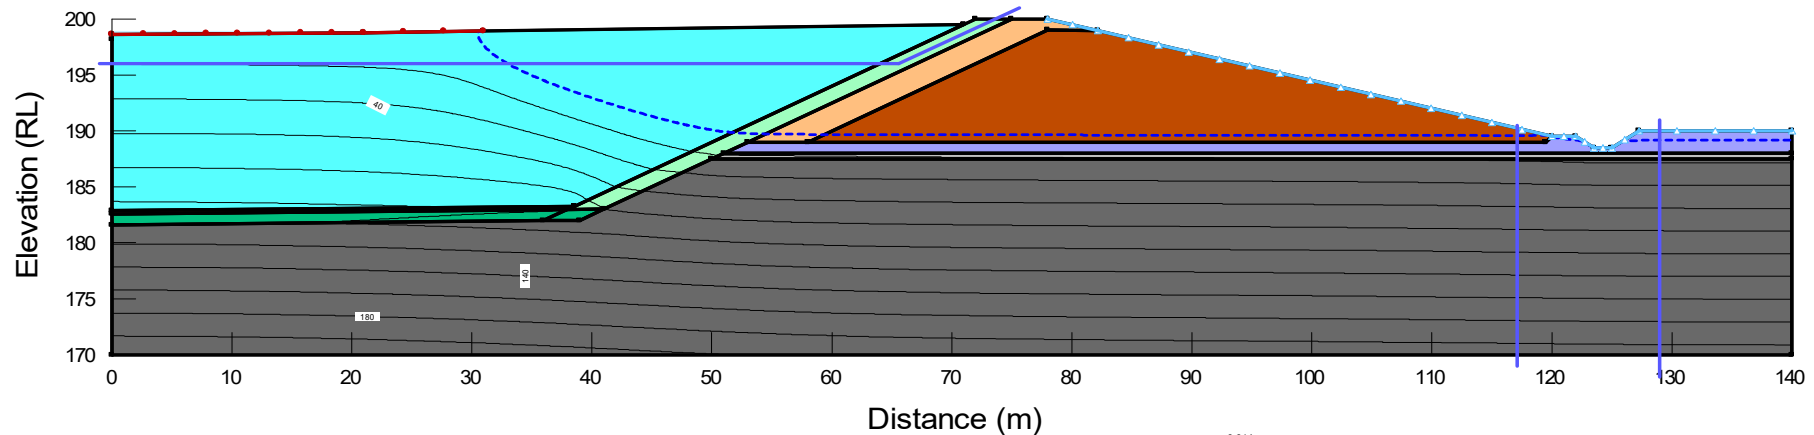
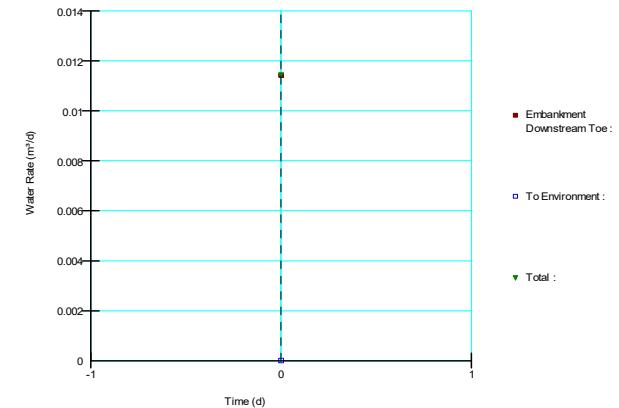
Costerfield Brunswick West TSF Design  
File Name: Brunswick TSF - Embankment Seepage - East Embankment.gsz  
Directory: K:\Projects\109\109014 Costerfield Mine, Costerfield\15 New TSF Investigation and Design\Data and Calcs\SeepW\Rev 2\  
Name: 2.3 - Seepage - Pond RL 198.9 - No Underdrainage + failed liner  
Date: 27/02/2023

| Color | Name | Category | Kind | Parameters |
|---|---|---|---|---|
| <span style="color: red;">■</span> | Pond RL198.9m | Hydraulic | Water Total Head | 198.9 m |
| <span style="color: blue;">■</span> | Potential Seepage Face | Hydraulic | Water Rate | 0 m³/d |

| Color | Name | Model | Sat Kx (m/sec) | Vol. WC. Function | K-Function | Ky/Kx' Ratio | Rotation (°) | Volumetric Water Content | Compressibility (/kPa) |

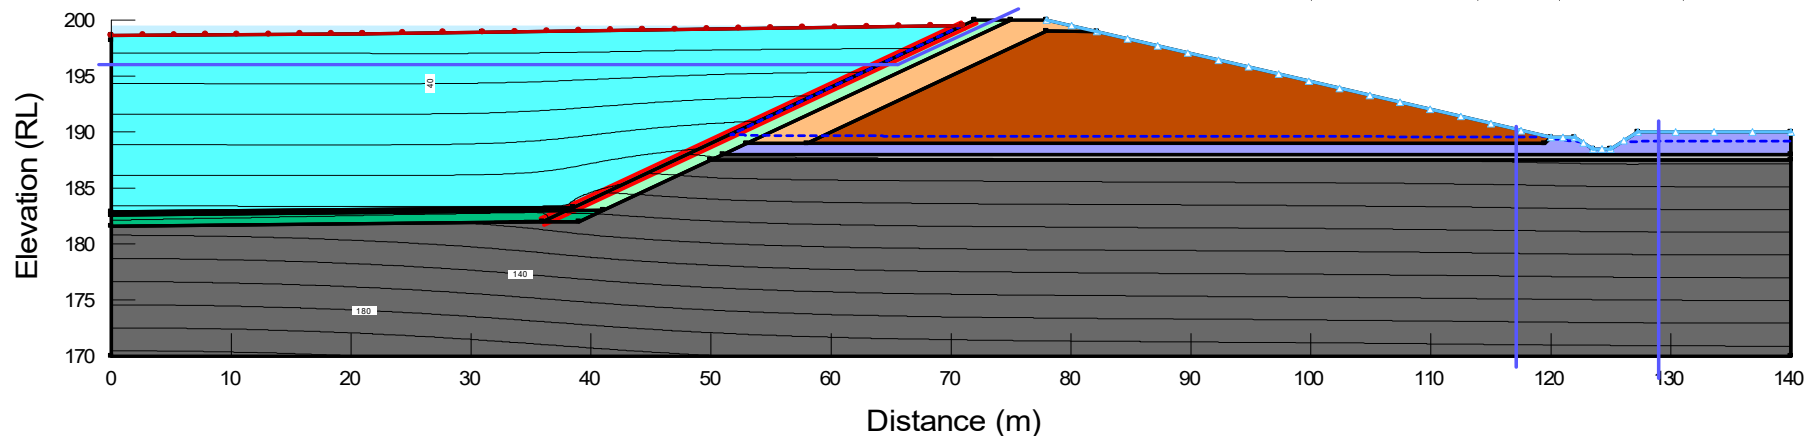
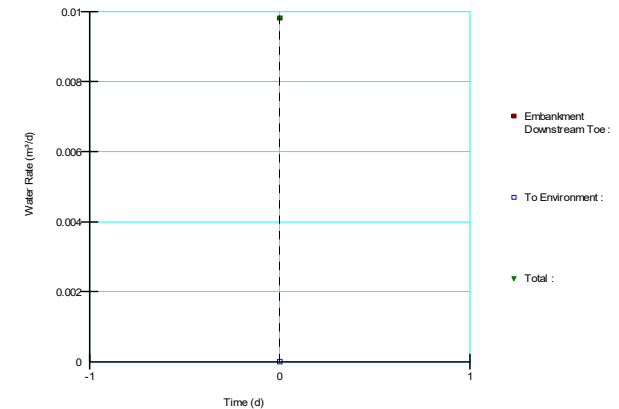
| Color | Name | Category | Kind | Parameters |
|---|---|---|---|---|
| <span style="color: red;">■</span> | Pond RL199.5m | Hydraulic | Water Total Head | 199.5 m |
| <span style="color: blue;">■</span> | Potential Seepage Face | Hydraulic | Water Rate | 0 m³/d |

| Color | Name | Model | Vol. WC. Function | K-Function | Sat Kx (m/sec) | Ky/Kx Ratio | Rotation (°) | Volumetric Water Content | Compressibility (/kPa) |

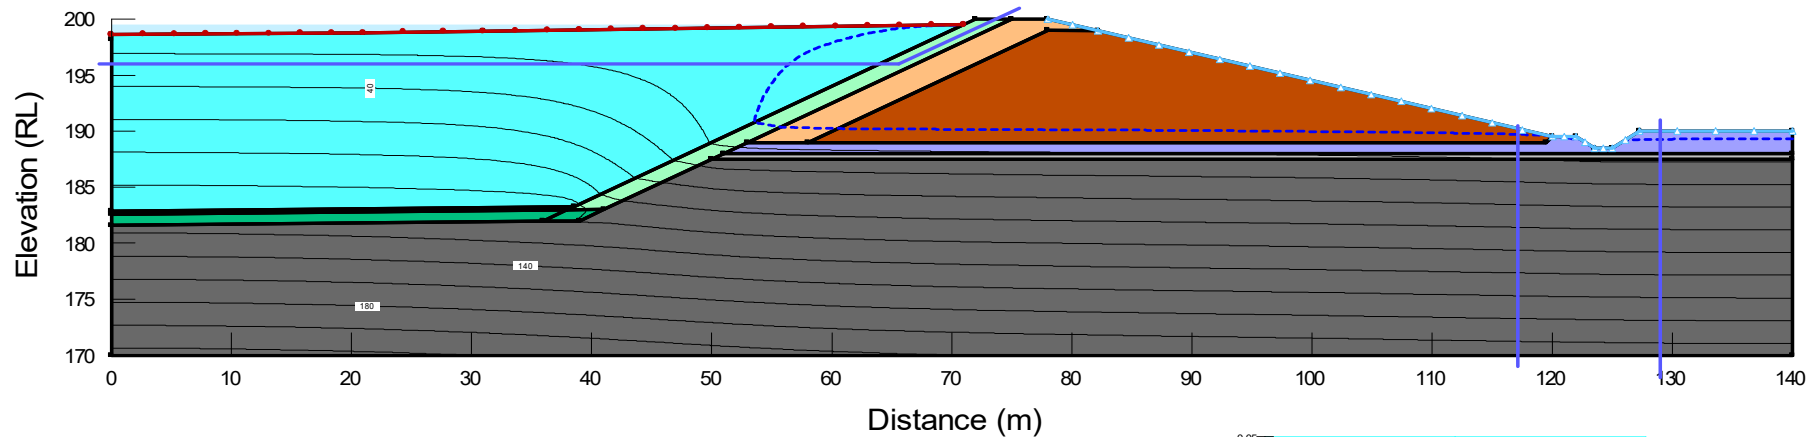
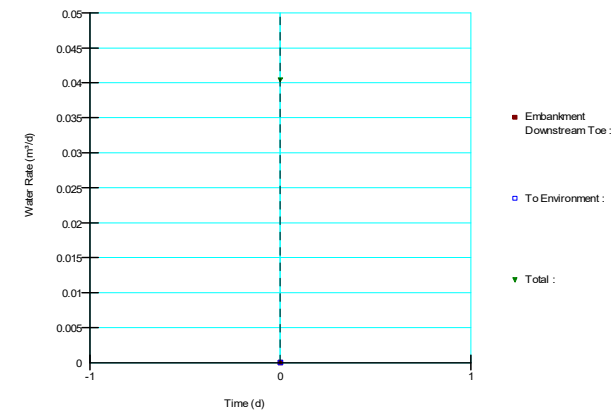
Costerfield Brunswick West TSF Design  
File Name: Brunswick TSF - Embankment Seepage - East Embankment.gsz  
Directory: K:\Projects\109\109014 Costerfield Mine, Costerfield\15 New TSF Investigation and Design\Data and Calcs\SeepW\Rev 2\  
Name: 3.3 - Seepage - Pond RL 199.5 - No Underdrainage + failed liner  
Date: 27/02/2023

| Color | Name | Category | Kind | Parameters |
|---|---|---|---|---|
| <span style="color: red;">■</span> | Pond RL199.5m | Hydraulic | Water Total Head | 199.5 m |
| <span style="color: blue;">■</span> | Potential Seepage Face | Hydraulic | Water Rate | 0 m³/d |

| Color | Name | Model | Sat Kx (m/sec) | Vol. WC. Function | K-Function | Ky/Kx' Ratio | Rotation (°) | Volumetric Water Content | Compressibility (/kPa) |
