**Costerfield Gold Mine**

**Brunswick West Tailings Storage  
Facility Investigation and Design**

**Detailed Design Report**

109014.15-R04-Rev 3  
March 2023

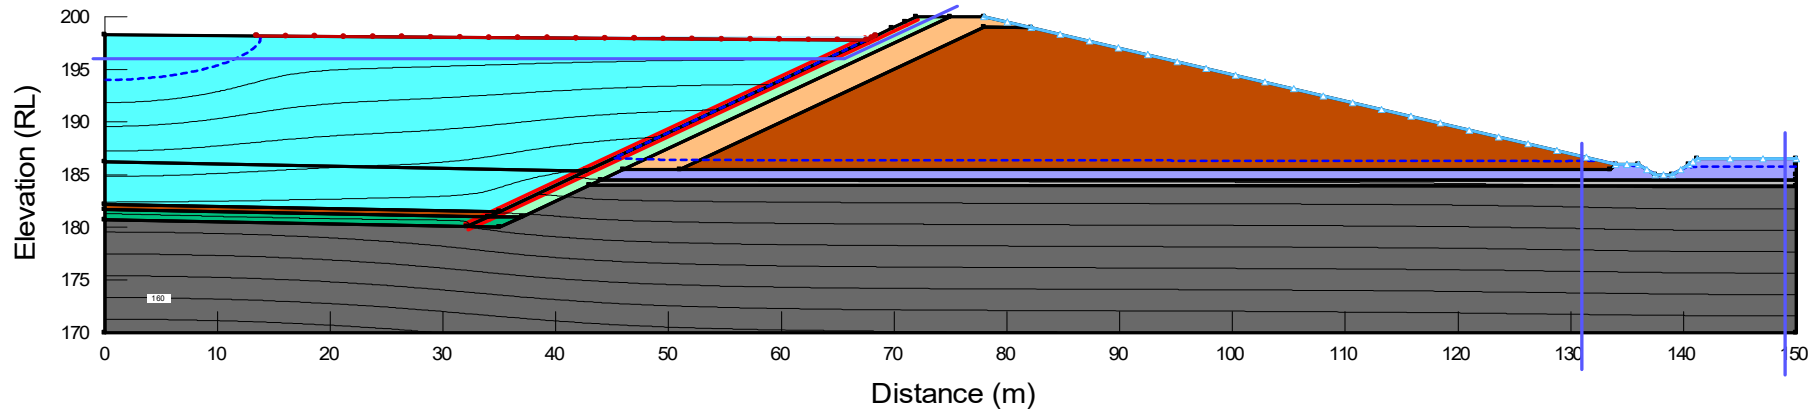
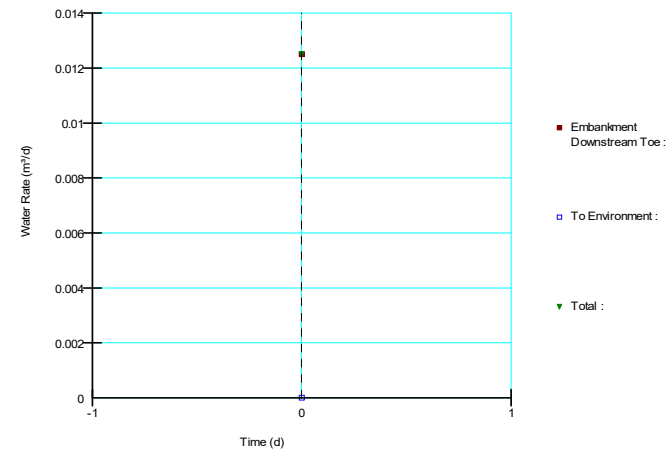
| Color | Name | Category | Kind | Parameters |
|---|---|---|---|---|
| ■ | Pond RL198.2m | Hydraulic | Water Total Head | 198.2 m |
| ■ | Potential Seepage Face | Hydraulic | Water Rate | 0 m <sup>3</sup> /d |

| Color | Name | Model | Vol. WC. Function | K-Function | Sat Kx (m/sec) | Ky/Kx Ratio | Rotation (°) | Volumetric Water Content | Compressibility (1/kPa) |

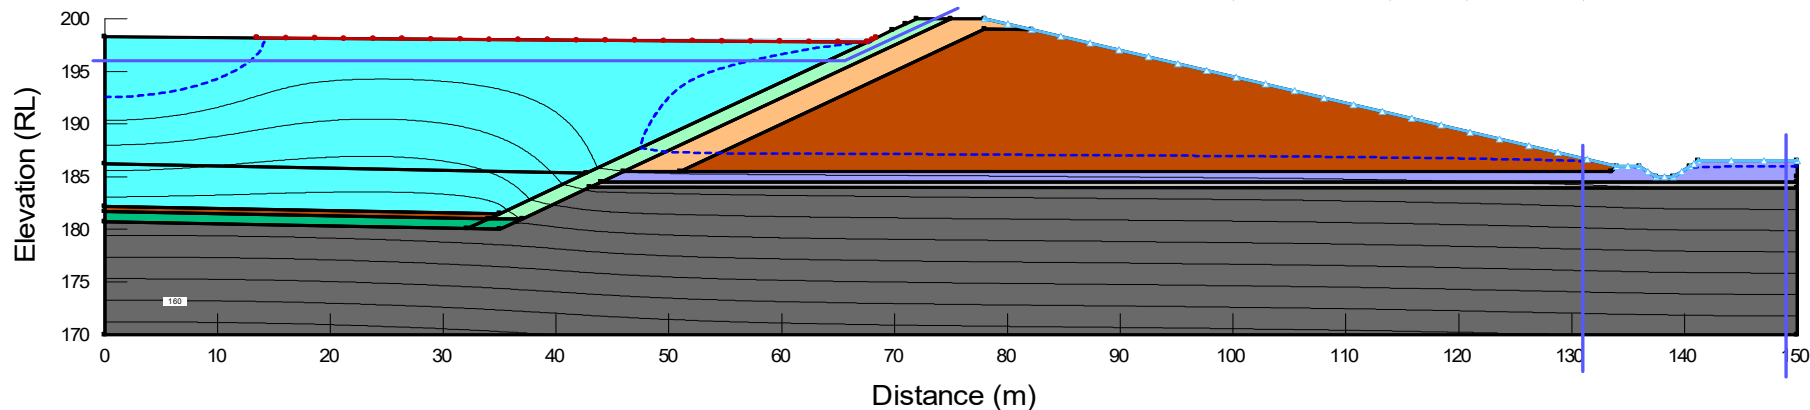
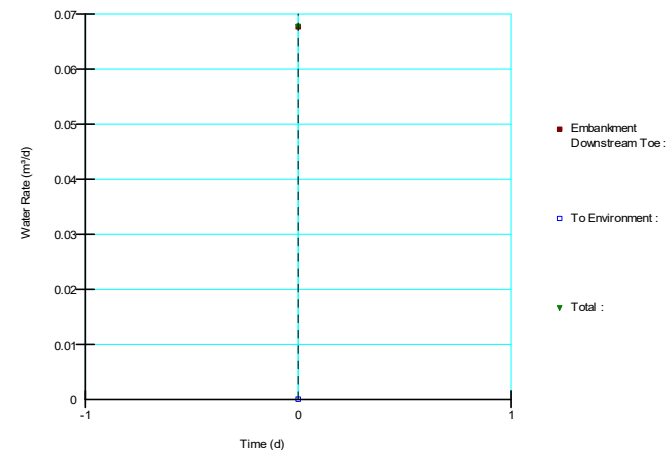
Costerfield Brunswick West TSF Design  
File Name: Brunswick TSF - Embankment Seepage - Decant Area.gsz  
Directory: K:\Projects\109\109014 Costerfield Mine, Costerfield\15 New TSF Investigation and Design\Data and Calcs\SeepW\Rev 2\  
Name: 1.3 - Seepage - Pond RL 198.2 - No Underdrainage + failed liner  
Date: 27/02/2023

| Color | Name | Category | Kind | Parameters |
|---|---|---|---|---|
| ■ | Pond RL198.2m | Hydraulic | Water Total Head | 198.2 m |
| ■ | Potential Seepage Face | Hydraulic | Water Rate | 0 m <sup>3</sup> /d |

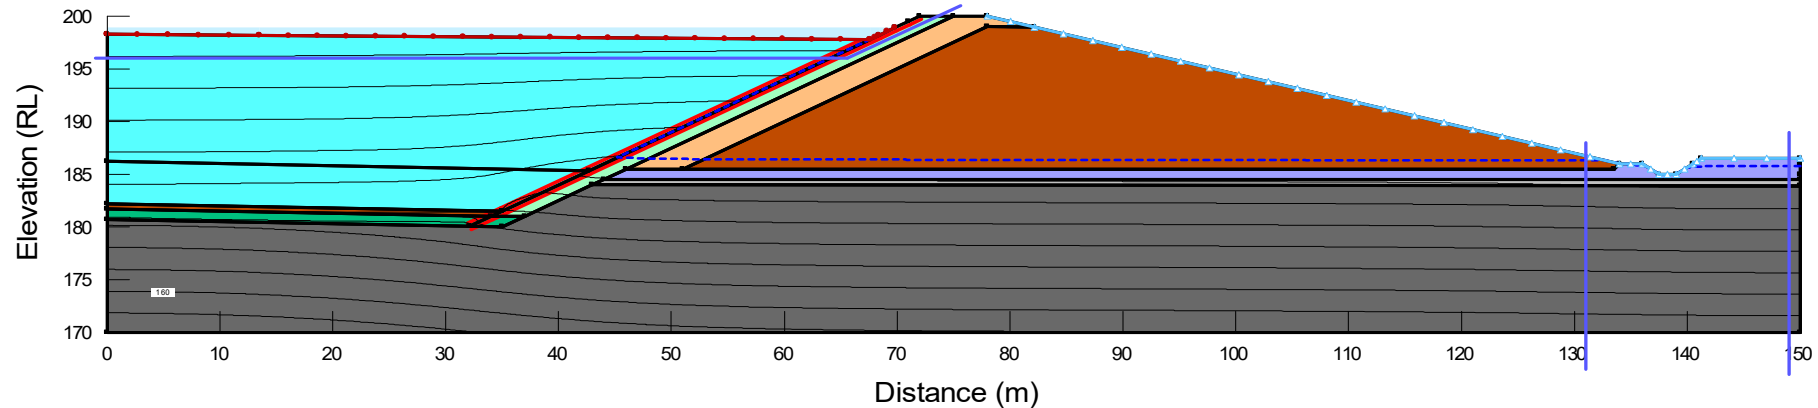
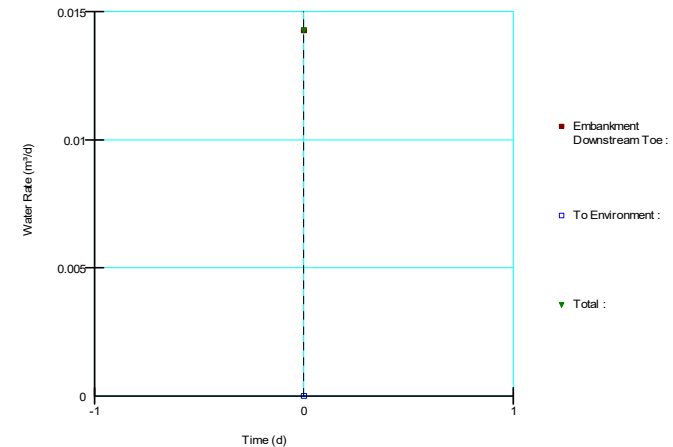
| Color | Name | Category | Kind | Parameters |
|---|---|---|---|---|
| ■ | Pond RL 198.9m | Hydraulic | Water Total Head | 198.9 m |
| ■ | Potential Seepage Face | Hydraulic | Water Rate | 0 m <sup>3</sup> /d |

| Color | Name | Model | Vol. WC. Function | K-Function | Sat Kx (m/sec) | Ky/Kx Ratio | Rotation (°) | Volumetric Water Content | Compressibility (/kPa) |

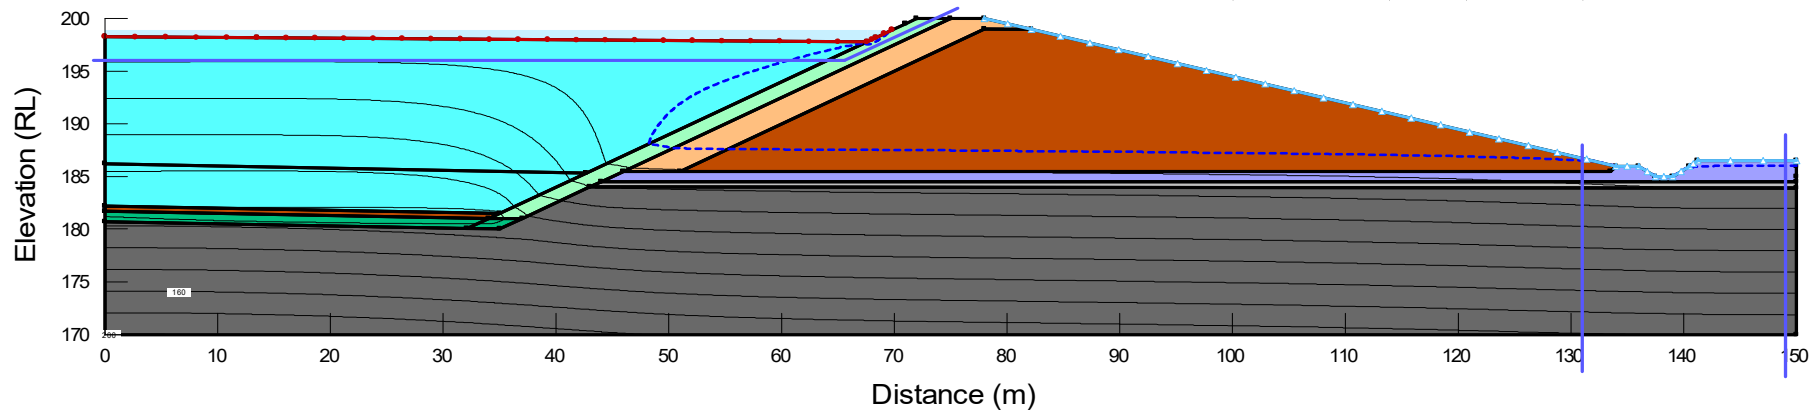
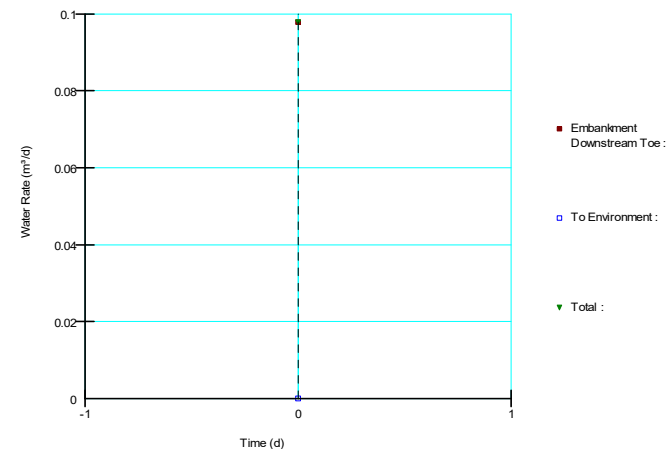
Costerfield Brunswick West TSF Design  
File Name: Brunswick TSF - Embankment Seepage - Decant Area.gsz  
Directory: K:\Projects\109\109014 Costerfield Mine, Costerfield\15 New TSF Investigation and Design\Data and Calcs\SeepW\Rev 2\  
Name: 2.3 - Seepage - Pond RL 198.9 - No Underdrainage + failed liner  
Date: 27/02/2023

| Color | Name | Category | Kind | Parameters |
|---|---|---|---|---|
| <span style="color: red;">■</span> | Pond RL198.9m | Hydraulic | Water Total Head | 198.9 m |
| <span style="color: blue;">■</span> | Potential Seepage Face | Hydraulic | Water Rate | 0 m³/d |

| Color | Name | Model | Sat Kx (m/sec) | Vol. WC. Function | K-Function | Ky/Kx Ratio | Rotation (°) | Volumetric Water Content | Compressibility (/kPa) |

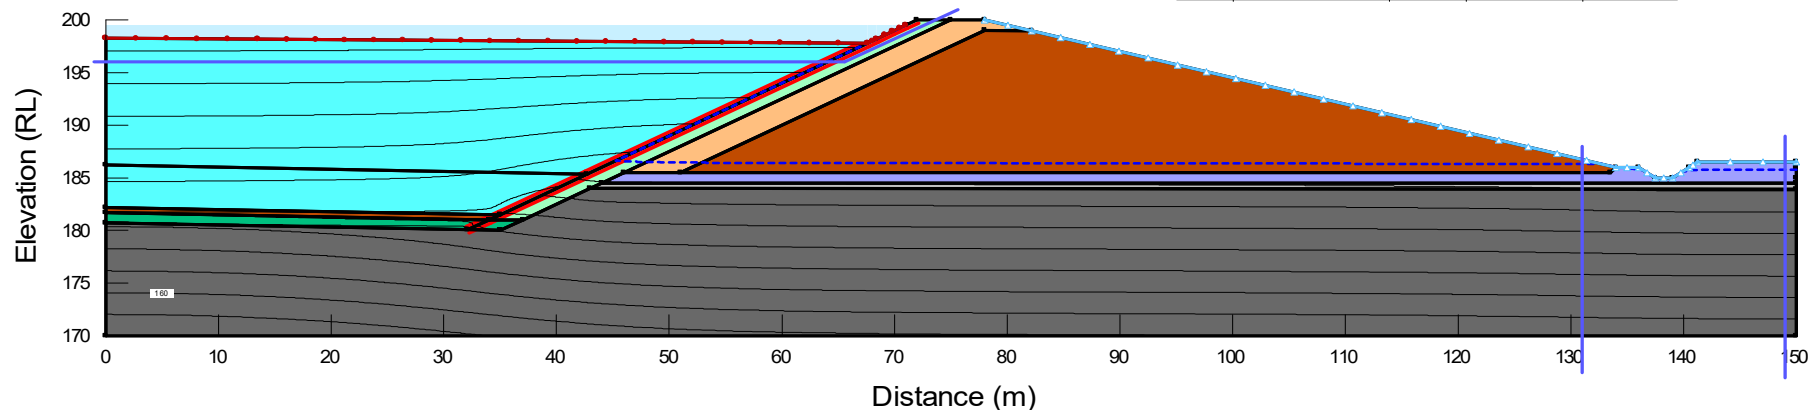
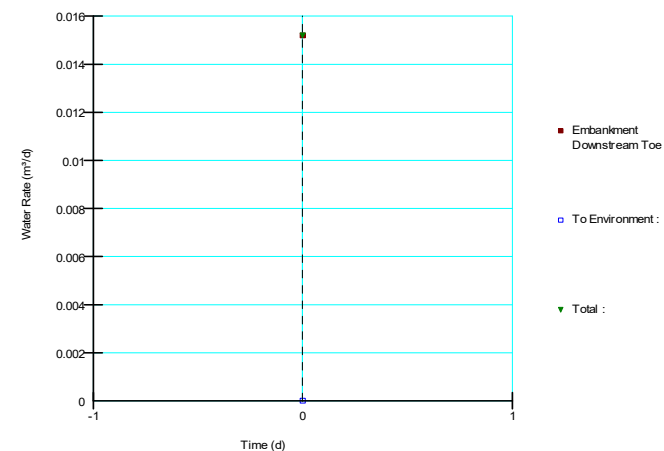
| Color | Name | Category | Kind | Parameters |
|---|---|---|---|---|
| | Pond RL 199.5m | Hydraulic | Water Total Head | 199.5 m |
| | Potential Seepage Face | Hydraulic | Water Rate | 0 m <sup>3</sup> /d |

| Color | Name | Model | Vol. WC. Function | K-Function | Sat Kx (m/sec) | Ky/Kx Ratio | Rotation (°) | Volumetric Water Content | Compressibility (kPa) |

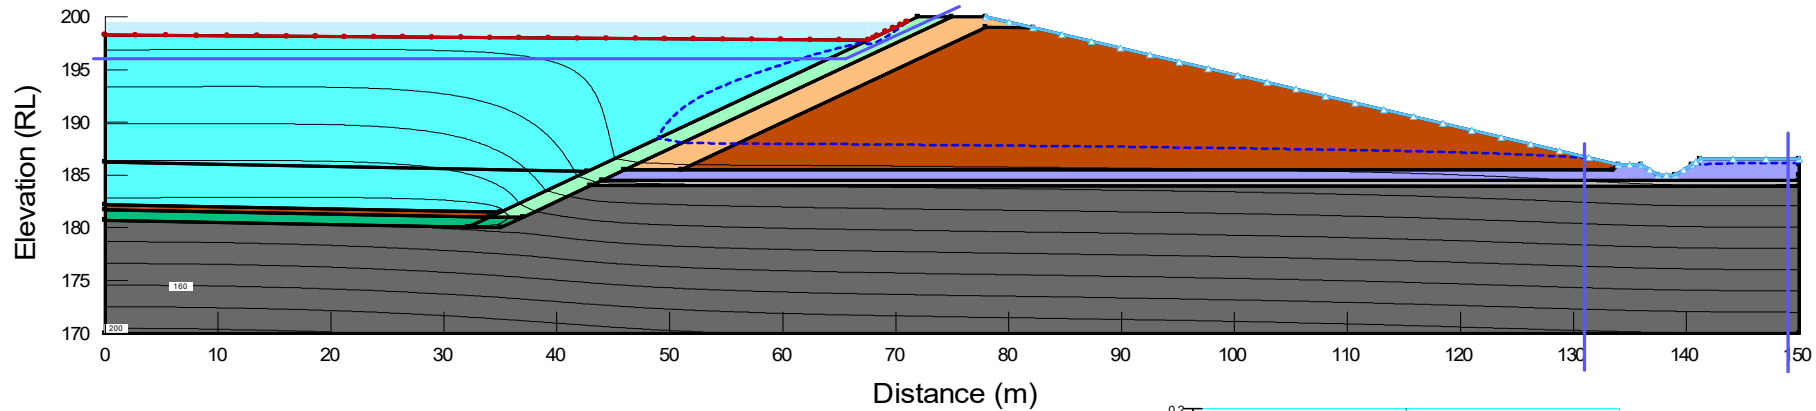
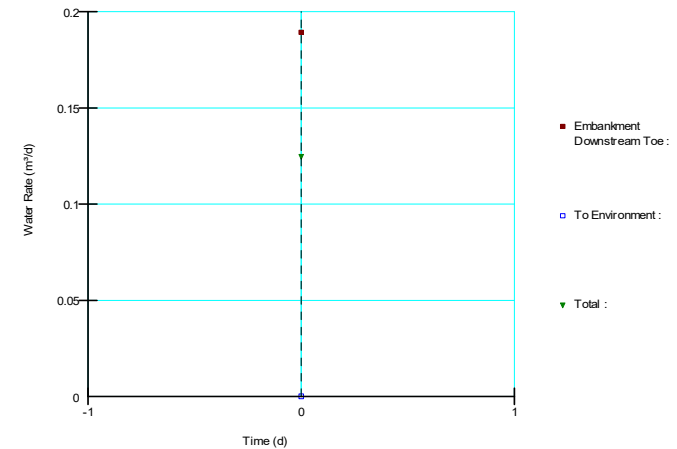
Costerfield Brunswick West TSF Design  
File Name: Brunswick TSF - Embankment Seepage - Decant Area.gsz  
Directory: K:\Projects\109\109014 Costerfield Mine, Costerfield\15 New TSF Investigation and Design\Data and Calcs\SeepW\Rev 2\  
Name: 3.3 - Seepage - Pond RL 199.5 - No Underdrainage + failed liner  
Date: 27/02/2023

| Color | Name | Category | Kind | Parameters |
|---|---|---|---|---|
| | Pond RL199.5m | Hydraulic | Water Total Head | 199.5 m |
| | Potential Seepage Face | Hydraulic | Water Rate | 0 m <sup>3</sup> /d |

| Color | Name | Model | Sat Kx (m/sec) | Vol. WC. Function | K-Function | Ky/Kx Ratio | Rotation (°) | Volumetric Water Content | Compressibility (kPa) |

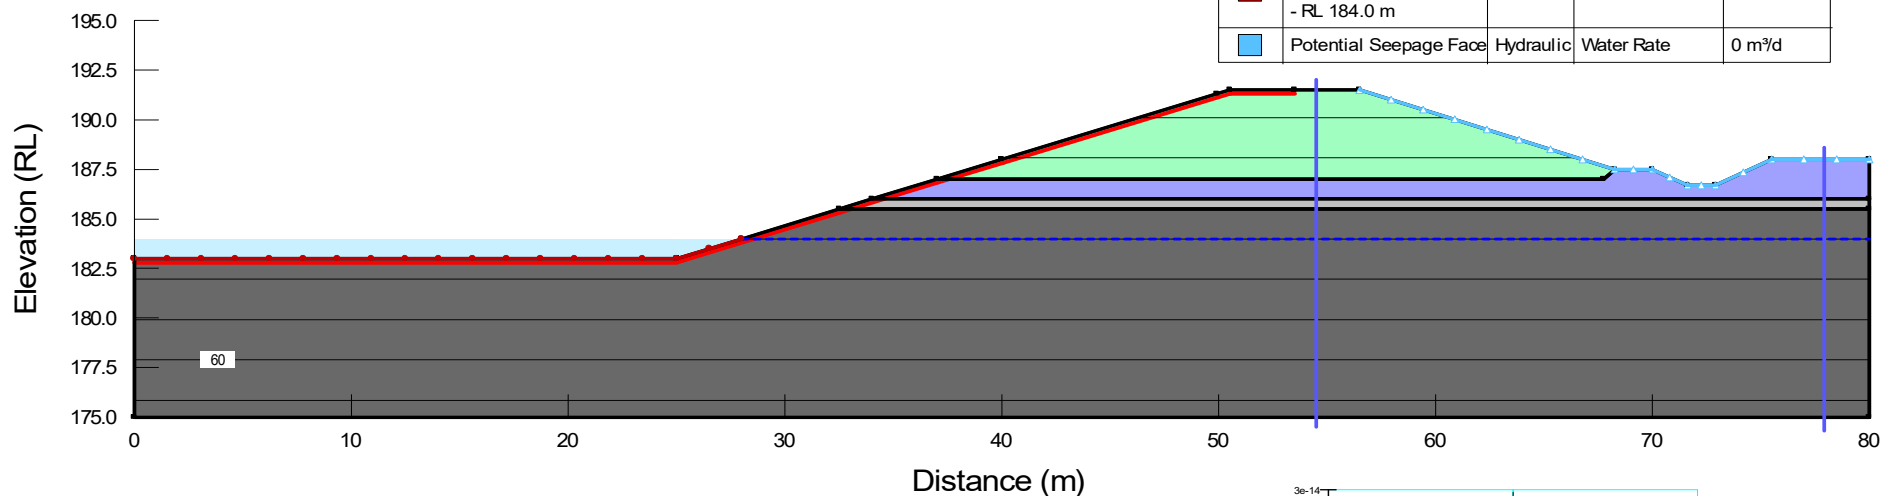
Name: 1.1 - Seepage - Pond RL 184.0 m

| Color | Name | Category | Kind | Parameters |
| ■ | Normal Operating Pond - RL 184.0 m | Hydraulic | Water Total Head | 184 m |

| Color | Name | Model | Vol. WC. Function | K-Function | Sat Kx (m/sec) | Ky/Kx' Ratio | Rotation (°) | Volumetric Water Content | Compressibility (/kPa) |
|---|---|---|---|---|---|---|---|---|---|
| ■ | EW Siltstone Foundation | Saturated / Unsaturated | Weathered Siltstone | Weathered Siltstone | | 1 | 0 | | |
| ■ | Foundation Clay | Saturated / Unsaturated | Clay | Clay (5e-8) | | 1 | 0 | | |
| ■ | HW Siltstone Foundation | Saturated / Unsaturated | Siltstone | Siltstone | | 1 | 0 | | |

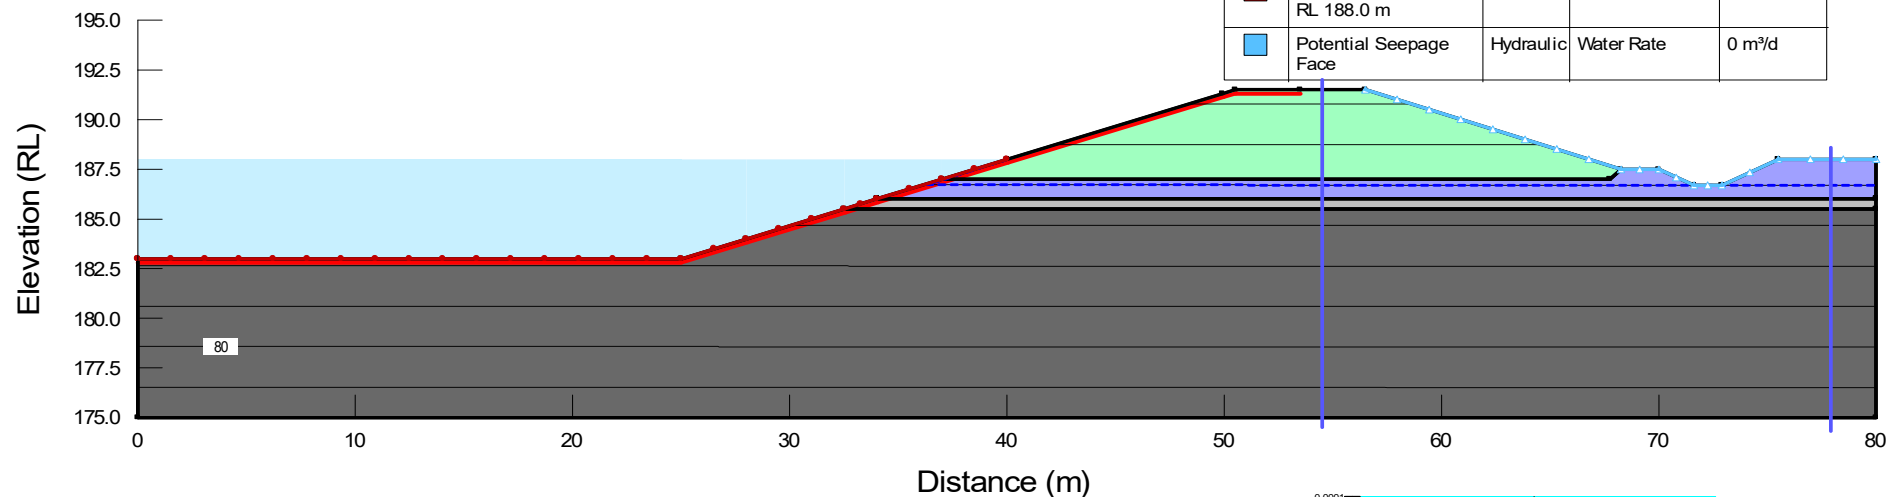
Name: 1.2 - Seepage - Pond RL 188.0 m

| Color | Name | Category | Kind | Parameters |
| ■ | 99th Percentile Pond - RL 188.0 m | Hydraulic | Water Total Head | 188 m |

| Color | Name | Model | Vol. WC. Function | K-Function | Sat Kx (m/sec) | Ky/Kx' Ratio | Rotation (°) | Volumetric Water Content | Compressibility (/kPa) |
|---|---|---|---|---|---|---|---|---|---|
| ■ | EW Siltstone Foundation | Saturated / Unsaturated | Weathered Siltstone | Weathered Siltstone | | 1 | 0 | | |
| ■ | Foundation Clay | Saturated / Unsaturated | Clay | Clay (5e-8) | | 1 | 0 | | |
| ■ | HW Siltstone Foundation | Saturated / Unsaturated | Siltstone | Siltstone | | 1 | 0 | | |

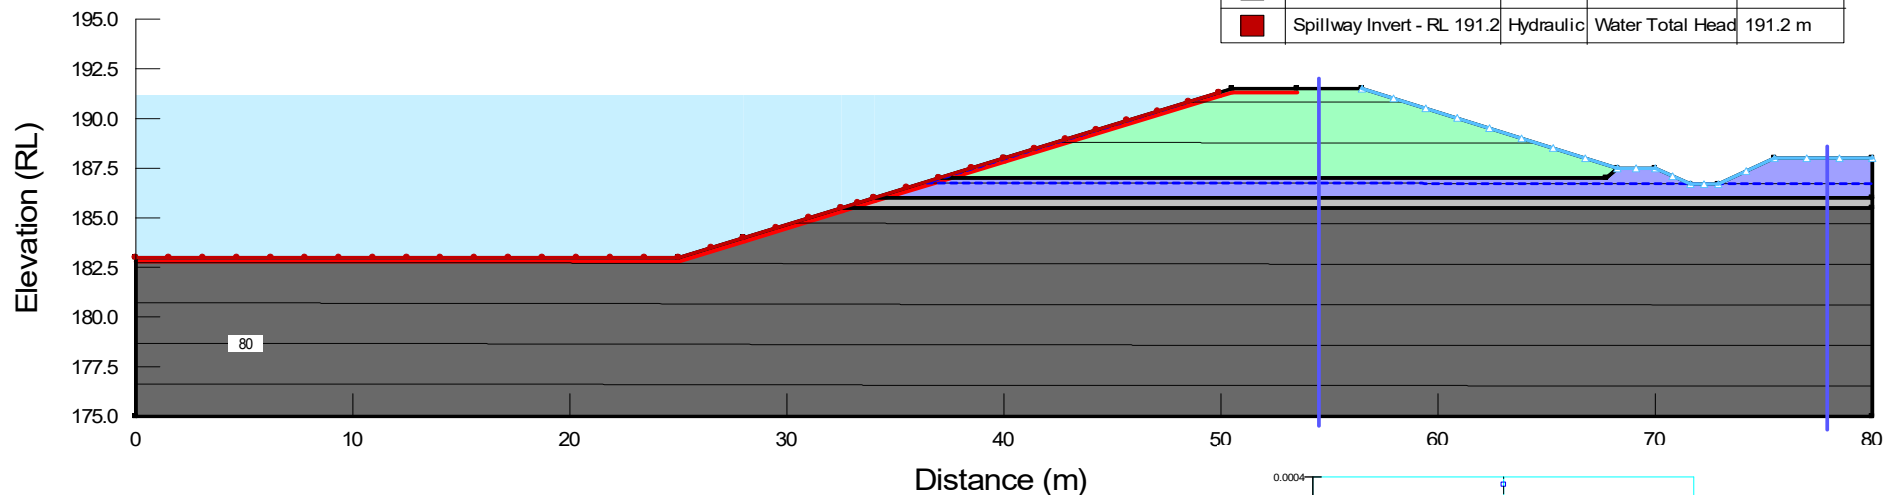
| Color | Name | Category | Kind | Parameters |
|--|---|---|---|---|
| <span style="color: lightblue;">■</span> | Potential Seepage Face | Hydraulic | Water Rate | 0 m³/d |
| <span style="color: red;">■</span> | Spillway Invert - RL 191.2 | Hydraulic | Water Total Head | 191.2 m |

| Color | Name | Model | Vol. WC. Function | K-Function | Sat Kx (m/sec) | Ky/Kx' Ratio | Rotation (°) | Volumetric Water Content | Compressibility (/kPa) |
| <span style="color: red;">■</span> | BGM Liner | Saturated Only | | | 1e-12 | 1 | 0 | 0 | 0 |

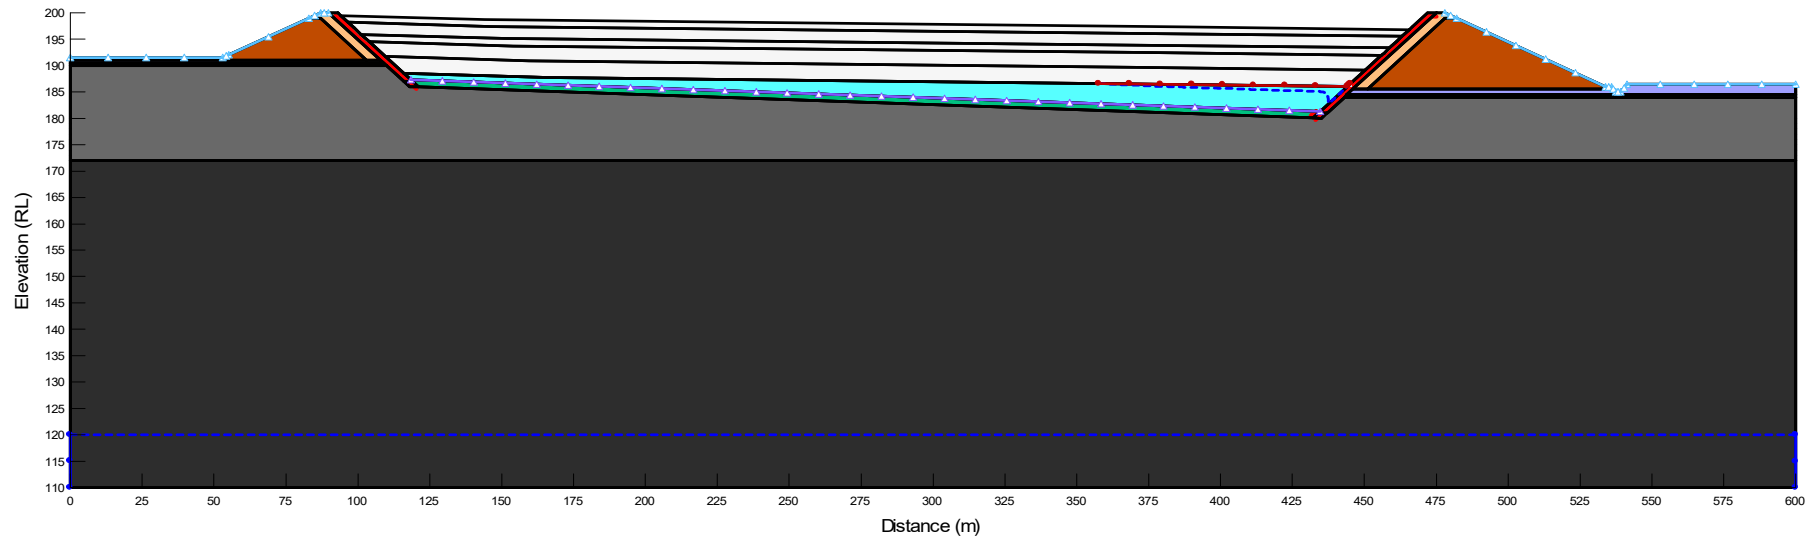
Name: Year 1 (End Apr 2025)

| Color | Name | Model | Vol. WC. Function | K-Function | Sat Kx (m/sec) | Ky/Kx Ratio | Rotation (°) | Volumetric Water Content | Compressibility (1/kPa) |
| Red | BGM Liner | Saturated Only | | | 1e-12 | 1 | 0 | 0 | 0 |
| Blue | Foundation Clay | Saturated / Unsaturated | Clay | Clay (5e-8) | | 1 | 0 | | |
| Black | HW/MV Siltstone Foundation (Lower) | Saturated / Unsaturated | Siltstone | Siltstone (Lower) | | 0.1 | 0 | | |

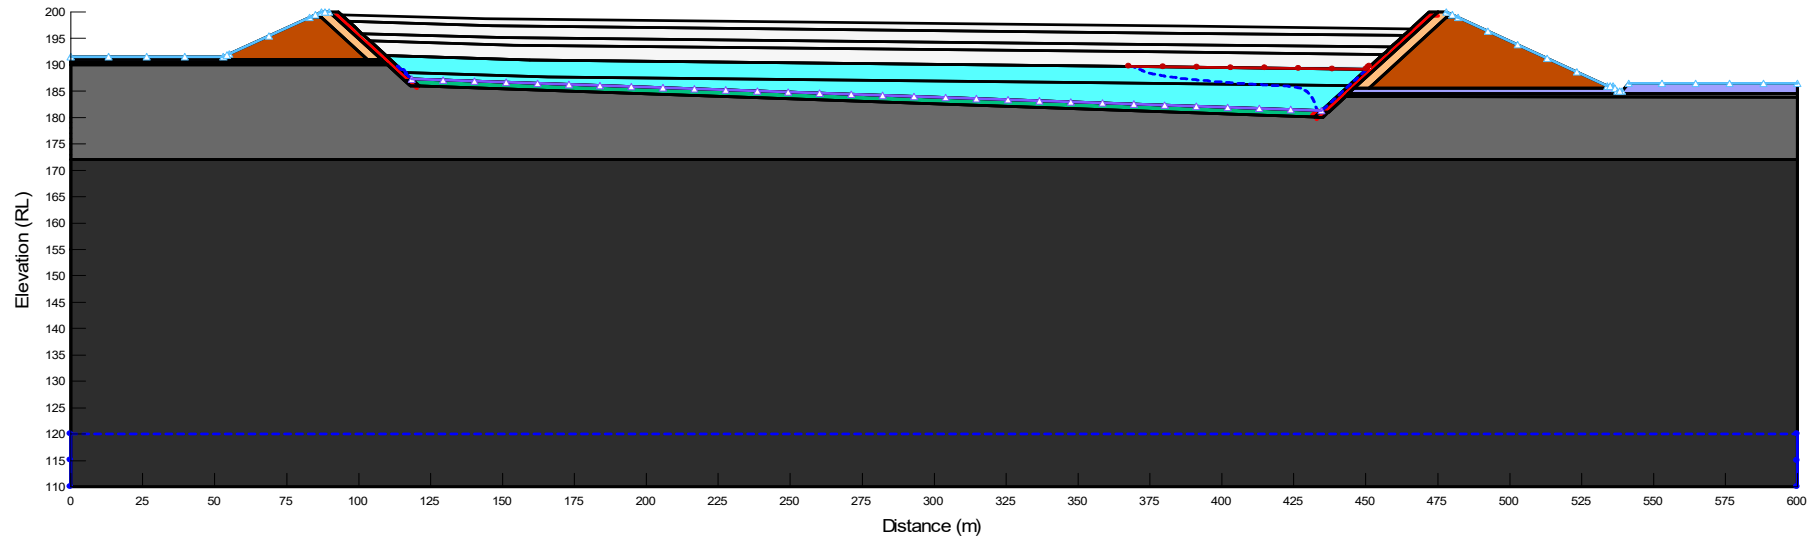
Name: Year 2 (End Apr 2026)

| Color | Name | Model | Vol. WC. Function | K-Function | Sat Kx (m/sec) | Ky/Kx Ratio | Rotation (°) | Volumetric Water Content | Compressibility (1/kPa) |
| Red | BGM Liner | Saturated Only | | | 1e-12 | 1 | 0 | 0 | 0 |
| Blue | Foundation Clay | Saturated / Unsaturated | Clay | Clay (5e-8) | | 1 | 0 | | |
| Black | HW/MV Siltstone Foundation (Lower) | Saturated / Unsaturated | Siltstone | Siltstone (Lower) | | 0.1 | 0 | | |

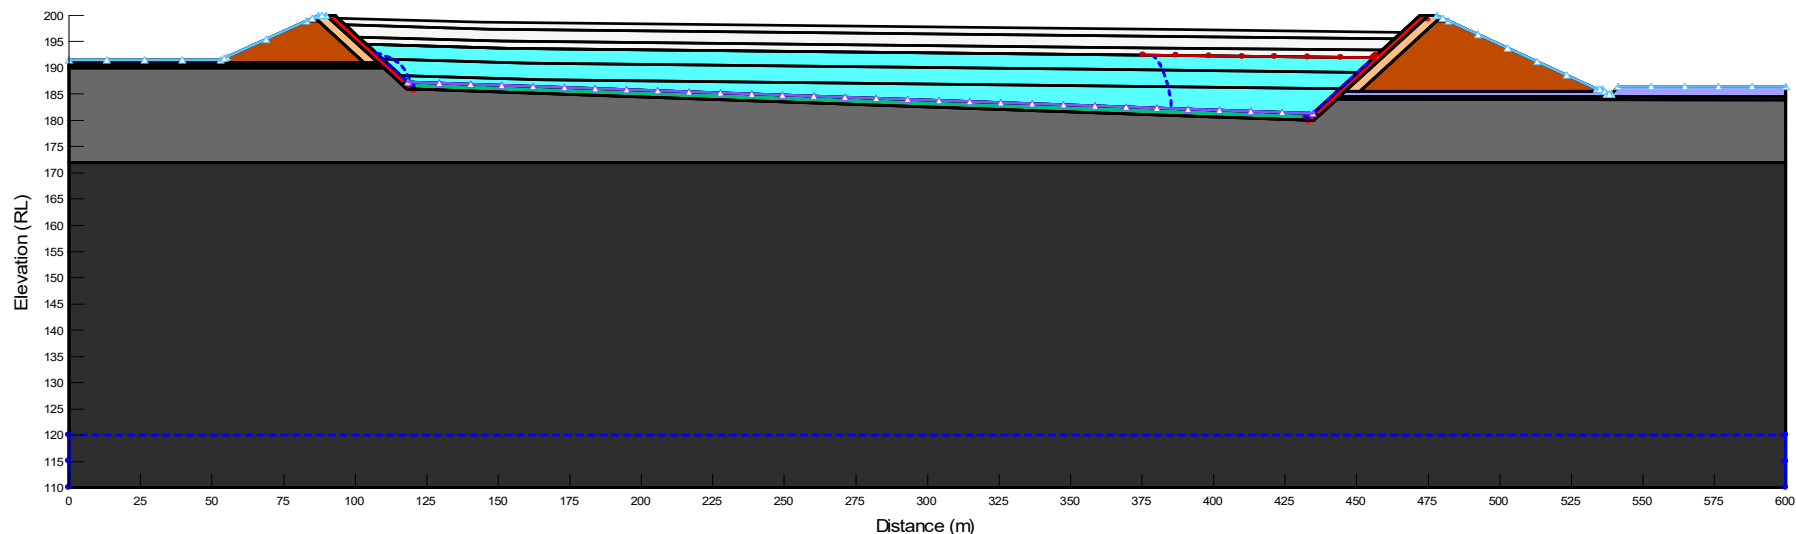
Name: Year 3 (End Apr 2027)

| Color | Name | Model | Vol. WC. Function | K-Function | Sat Kx (m/sec) | Ky/Kx Ratio | Rotation (°) | Volumetric Water Content | Compressibility (1/kPa) |
| Red | BGM Liner | Saturated Only | | | 1e-12 | 1 | 0 | 0 | 0 |
| Blue | Foundation Clay | Saturated / Unsaturated | Clay | Clay (5e-8) | | 1 | 0 | | |
| Black | HWMW Siltstone Foundation (Lower) | Saturated / Unsaturated | Siltstone (Lower) | Siltstone (Lower) | | 0.1 | 0 | | |

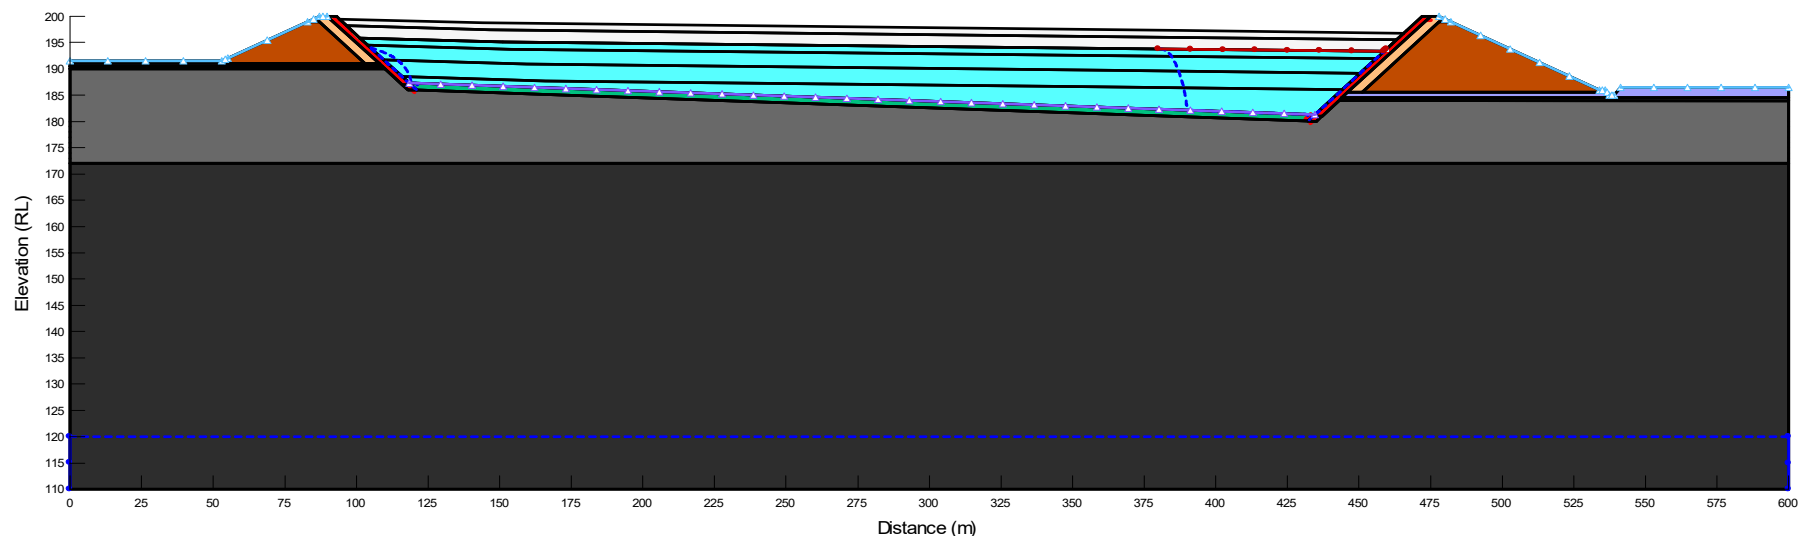
Name: Year 3.5 (End Sept 2027)

| Color | Name | Model | Vol. WC. Function | K-Function | Sat Kx (m/sec) | Ky/Kx Ratio | Rotation (°) | Volumetric Water Content | Compressibility (kPa) |
| Red | BGM Liner | Saturated Only | | | 1e-12 | 1 | 0 | 0 | 0 |
| Blue | Foundation Clay | Saturated / Unsaturated | Clay | Clay (5e-8) | | 1 | 0 | | |
| Black | HWMW Siltstone Foundation (Lower) | Saturated / Unsaturated | Siltstone (Lower) | Siltstone (Lower) | | 0.1 | 0 | | |

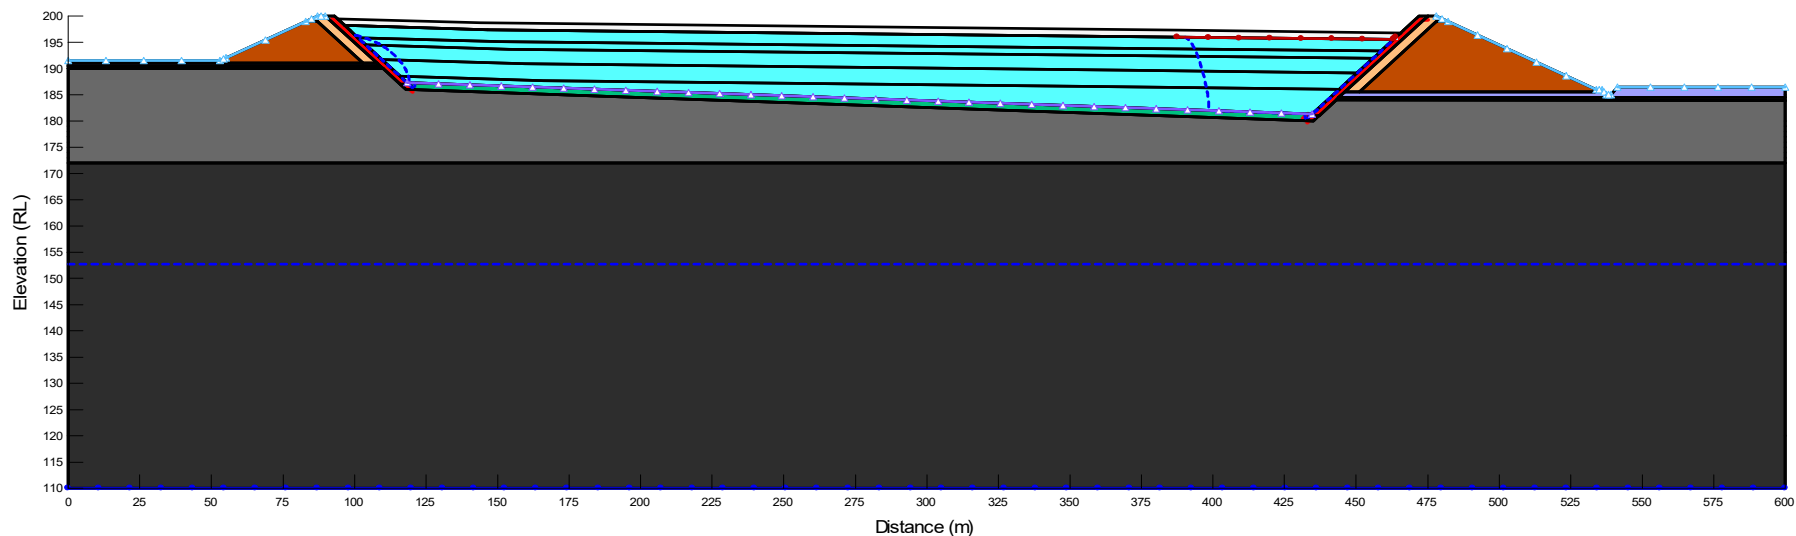
Name: Year 4.5 (End Sept 2028)

| Color | Name | Model | Vol. WC. Function | K-Function | Sat Kx (m/sec) | Ky/Kx Ratio | Rotation (°) | Volumetric Water Content | Compressibility (1/kPa) |
| Red | BGM Liner | Saturated Only | | | 1e-12 | 1 | 0 | 0 | 0 |
| Blue | Foundation Clay | Saturated / Unsaturated | Clay | Clay (5e-8) | | 1 | 0 | | |
| Black | HW/MV Siltstone Foundation (Lower) | Saturated / Unsaturated | Siltstone | Siltstone (Lower) | | 0.1 | 0 | | |

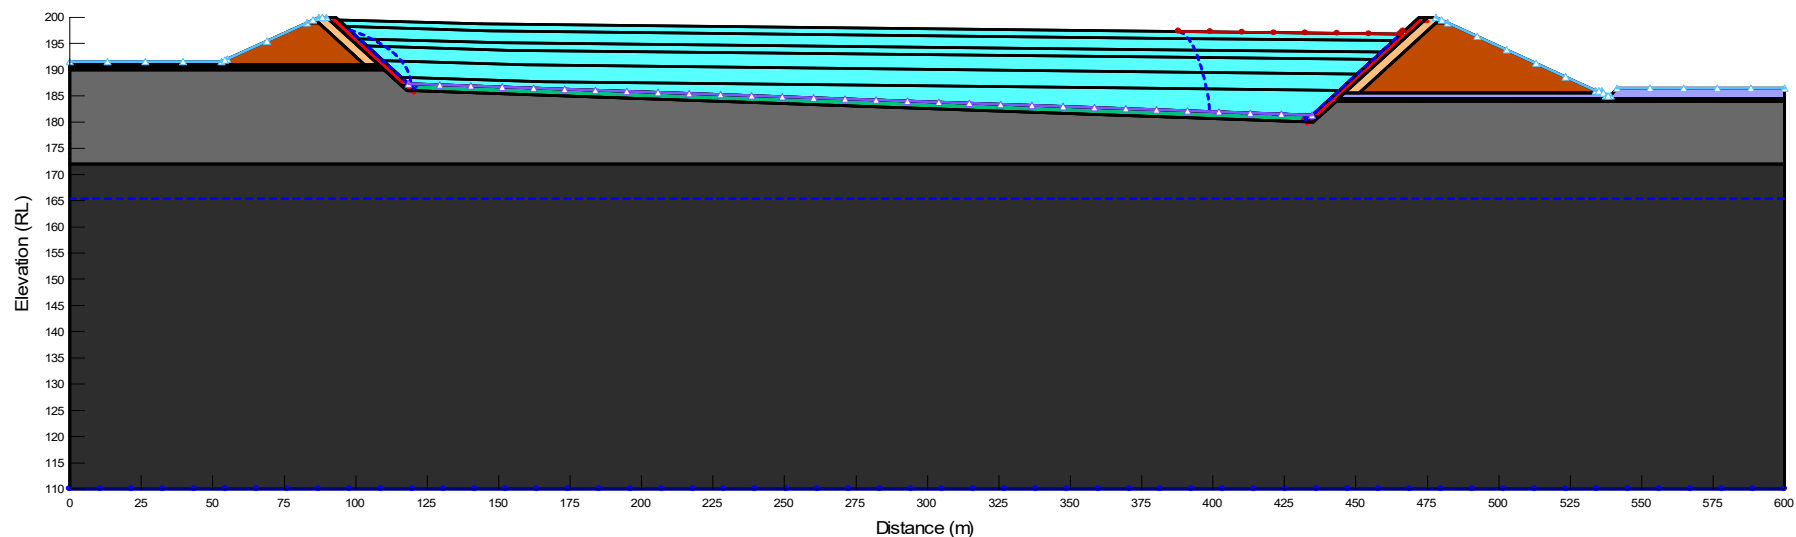
Name: Year 5 (End Apr 2029)

| Color | Name | Model | Vol. WC. Function | K-Function | Sat Kx (m/sec) | Ky/Kx Ratio | Rotation (°) | Volumetric Water Content | Compressibility (/kPa) |
| Red | BGM Liner | Saturated Only | | | 1e-12 | 1 | 0 | 0 | 0 |
| Blue | Foundation Clay | Saturated / Unsaturated | Clay | Clay (5e-8) | | 1 | 0 | | |
| Black | HWMV Siltstone Foundation (Lower) | Saturated / Unsaturated | Siltstone | Siltstone (Lower) | | 0.1 | 0 | | |

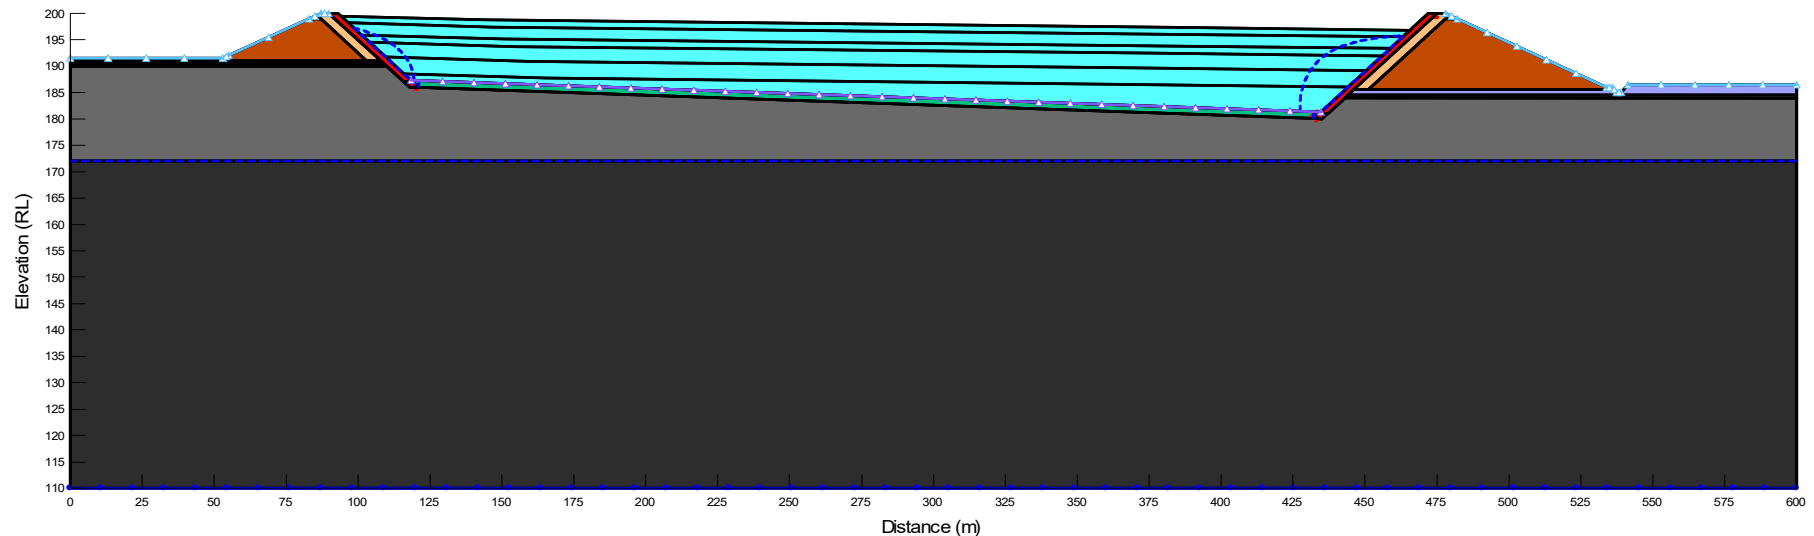
Name: Year 6

| Color | Name | Model | Vol. WC. Function | K-Function | Sat Kx (m/sec) | Ky/Kx Ratio | Rotation (°) | Volumetric Water Content | Compressibility (1/kPa) |
| Red | BGM Liner | Saturated Only | | | 1e-12 | 1 | 0 | 0 | 0 |
| Blue | Foundation Clay | Saturated / Unsaturated | Clay | Clay (5e-8) | | 1 | 0 | | |
| Black | HW/MW Siltstone Foundation (Lower) | Saturated / Unsaturated | Siltstone | Siltstone (Lower) | | 0.1 | 0 | | |

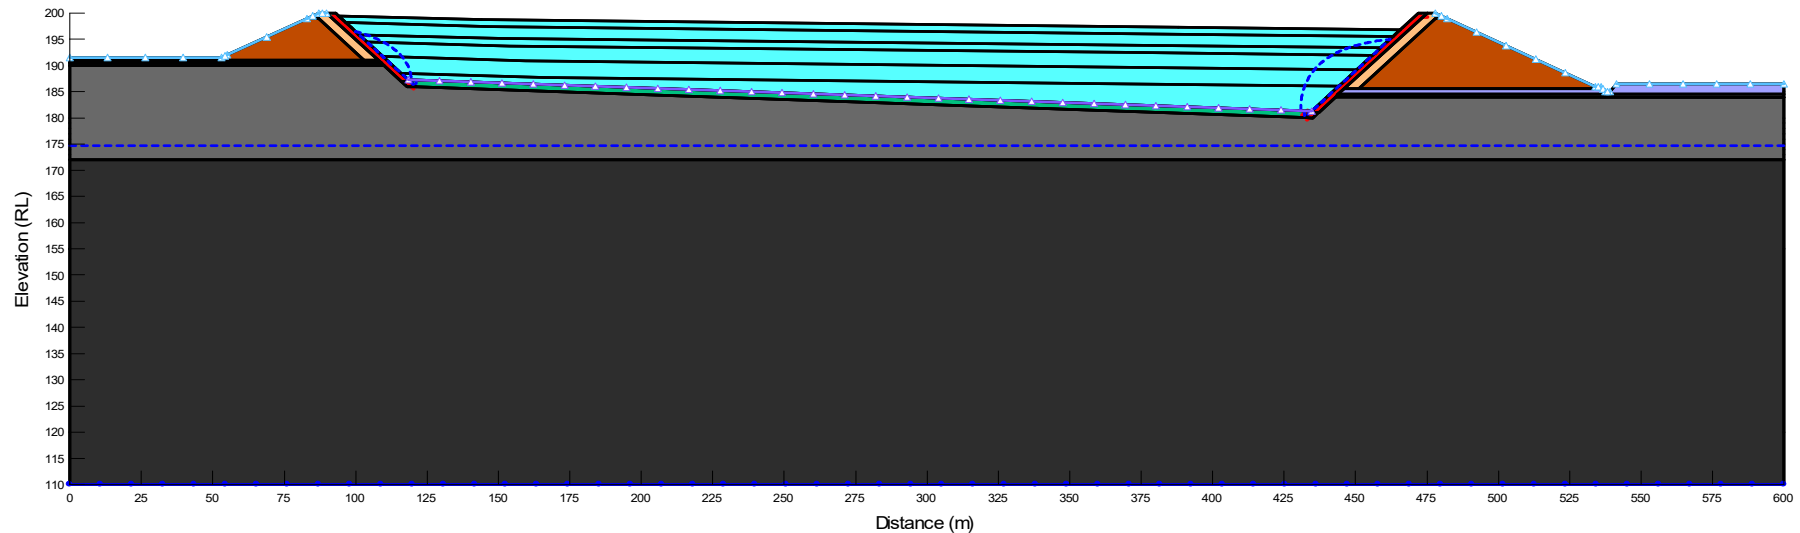
Name: Year 8

| Color | Name | Model | Vol. WC. Function | K-Function | Sat K <sub>x</sub> (m/sec) | K <sub>y</sub> /K <sub>x</sub> Ratio | Rotation (°) | Volumetric Water Content | Compressibility (1/kPa) |
| Red | BGM Liner | Saturated Only | | | 1e-12 | 1 | 0 | 0 | 0 |
| Blue | Foundation Clay | Saturated / Unsaturated | Clay | Clay (5e-8) | | 1 | 0 | | |
| Black | HWMV Siltstone Foundation (Lower) | Saturated / Unsaturated | Siltstone (Lower) | Siltstone (Lower) | | 0.1 | 0 | | |

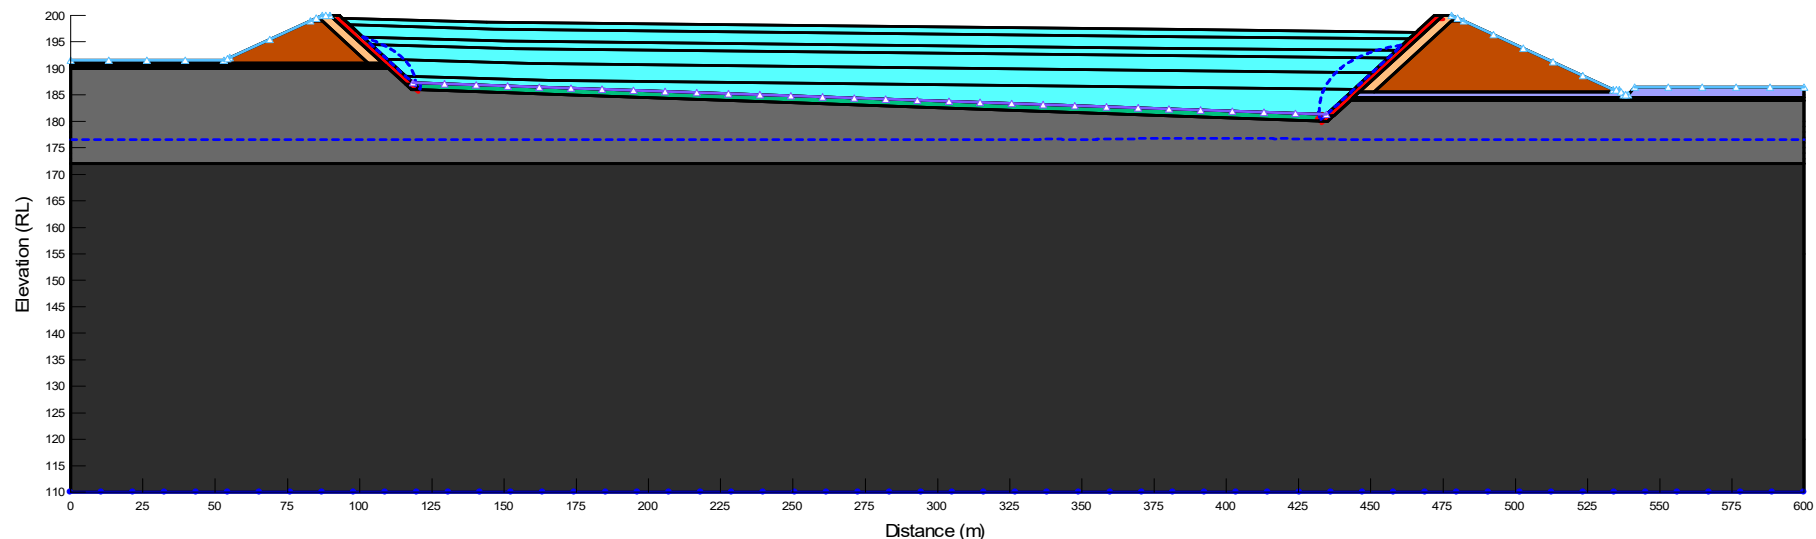
Name: Year 10

| Color | Name | Model | Vol. WC. Function | K-Function | Sat Kx (m/sec) | Ky/Kx Ratio | Rotation (°) | Volumetric Water Content | Compressibility (1/kPa) |
| Red | BGMLiner | Saturated Only | | | 1e-12 | 1 | 0 | 0 | 0 |
| Blue | Foundation Clay | Saturated / Unsaturated | Clay | Clay (5e-8) | | 1 | 0 | | |
| Black | HW/MW Siltstone Foundation (Lower) | Saturated / Unsaturated | Siltstone | Siltstone (Lower) | | 0.1 | 0 | | |

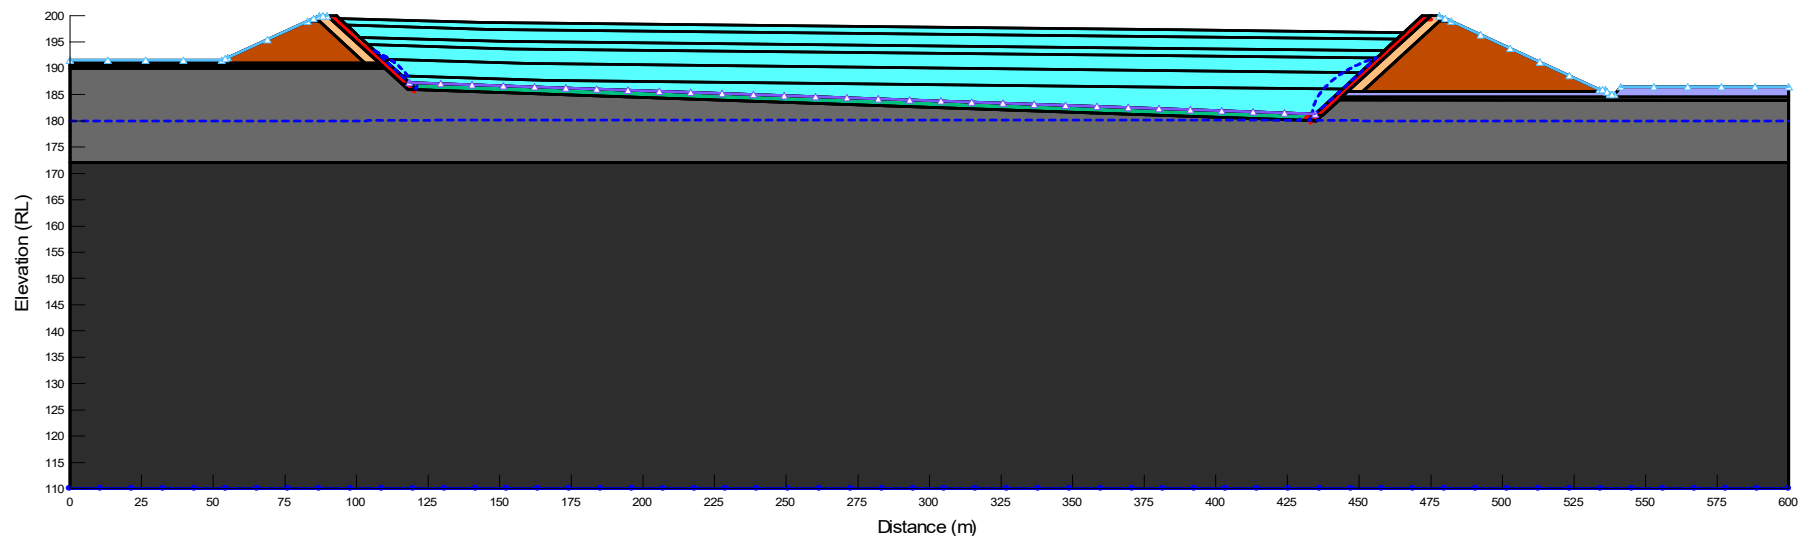
Name: Year 20

| Color | Name | Model | Vol. WC. Function | K-Function | Sat Kx (m/sec) | Ky/Kx Ratio | Rotation (°) | Volumetric Water Content | Compressibility (/kPa) |
| Red | BGM Liner | Saturated Only | | | 1e-12 | 1 | 0 | 0 | 0 |
| Blue | Foundation Clay | Saturated / Unsaturated | Clay | Clay (5e-8) | | 1 | 0 | | |
| Black | HMMW Siltstone Foundation (Lower) | Saturated / Unsaturated | Siltstone | Siltstone (Lower) | | 0.1 | 0 | | |

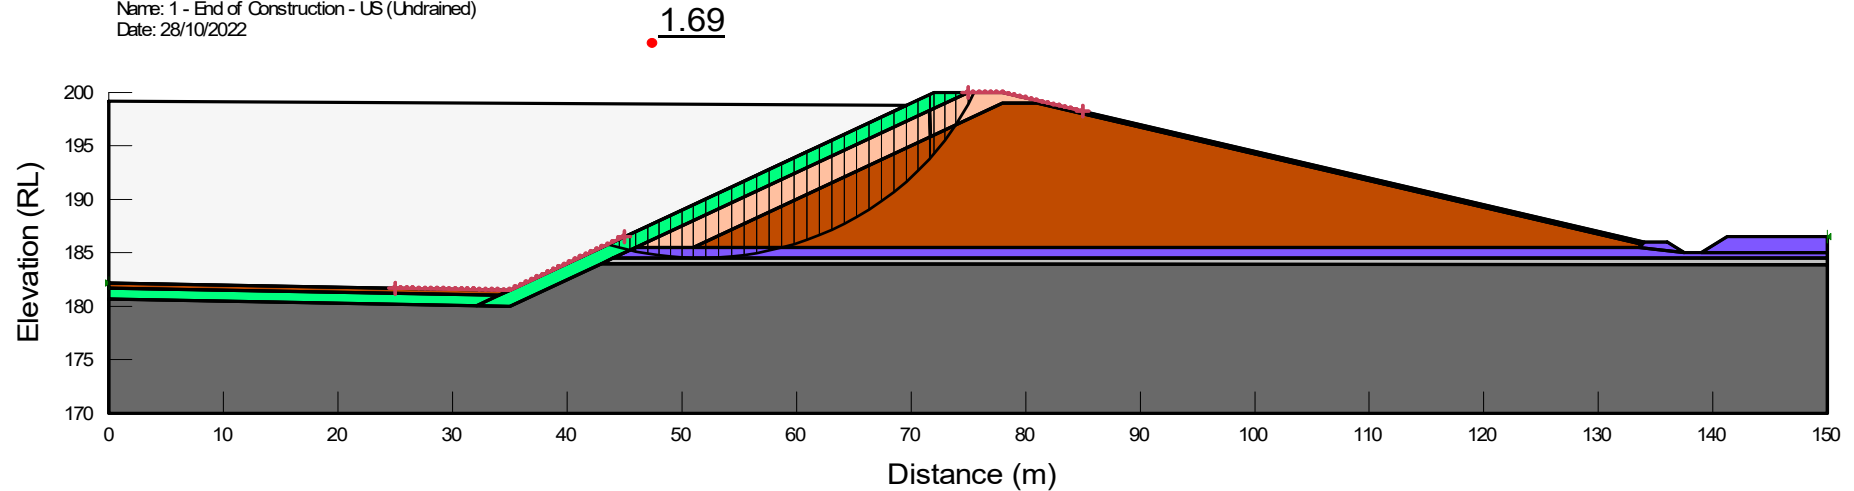
Costerfield Brunswick West TSF Design  
 File Name: New TSF - BGM Design (Stability).gsz  
 Directory: K:\Projects\109\109014 Costerfield Mine, Costerfield\15 New TSF Investigation and Design\Data and Calcs\SlopeVM  
 Name: 1 - End of Construction - US (Undrained)  
 Date: 28/10/2022

| Color | Name | Model | Unit Weight (kN/m <sup>3</sup> ) | Strength Function | Cohesion* (kPa) | Phi* (°) | Phi-B (°) | Minimum Strength (kPa) | Tau/Sigma Ratio |
| Green | Compacted Clay (Zone 1/1B) (Undrained) | SHANSEP | 19 | | | | | 20 | 0.28 |
| Grey | EW Siltstone Foundation | Mohr-Coulomb | 22 | | 0 | 36 | 0 | | |
| Purple | Foundation Clay (Undrained) | SHANSEP | 20.5 | | | | | 20 | 0.35 |

Stability Assessment - Short Term Static Stability  
 End of Construction (Undrained), Upstream Failure
