**Costerfield Gold Mine**

**Brunswick West Tailings Storage  
Facility Investigation and Design**

**Detailed Design Report**

109014.15-R04-Rev 3  
March 2023

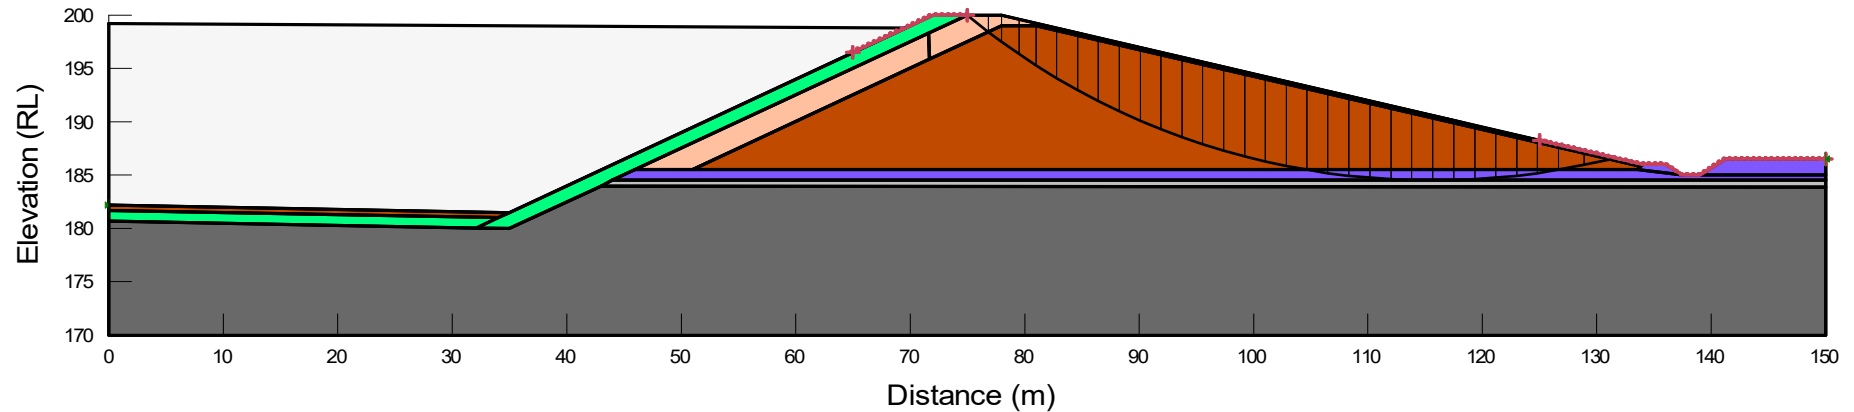
Costerfield Brunswick West TSF Design  
File Name: New TSF - BGM Design (Stability).gsz  
Directory: K:\Projects\109\109014 Costerfield Mine, Costerfield\15 New TSF Investigation and Design\Data and Calcs\SlopeW  
Name: 2 - End of Construction - DS (Undrained)  
Date: 28/10/2022

| Color | Name | Model | Unit Weight (kN/m <sup>3</sup> ) | Strength Function | Cohesion <sup>1</sup> (kPa) | Phi <sup>1</sup> (°) | Phi-B (°) | Minimum Strength (kPa) | Tau/Sigma Ratio |
| Green | Compacted Clay (Zone 1/1B) (Undrained) | SHANSEP | 19 | | | | | 20 | 0.28 |
| Blue | Foundation Clay (Undrained) | SHANSEP | 20.5 | | | | | 20 | 0.35 |

Stability Assessment - Short Term Static Stability  
End of Construction (Undrained), Downstream Failure

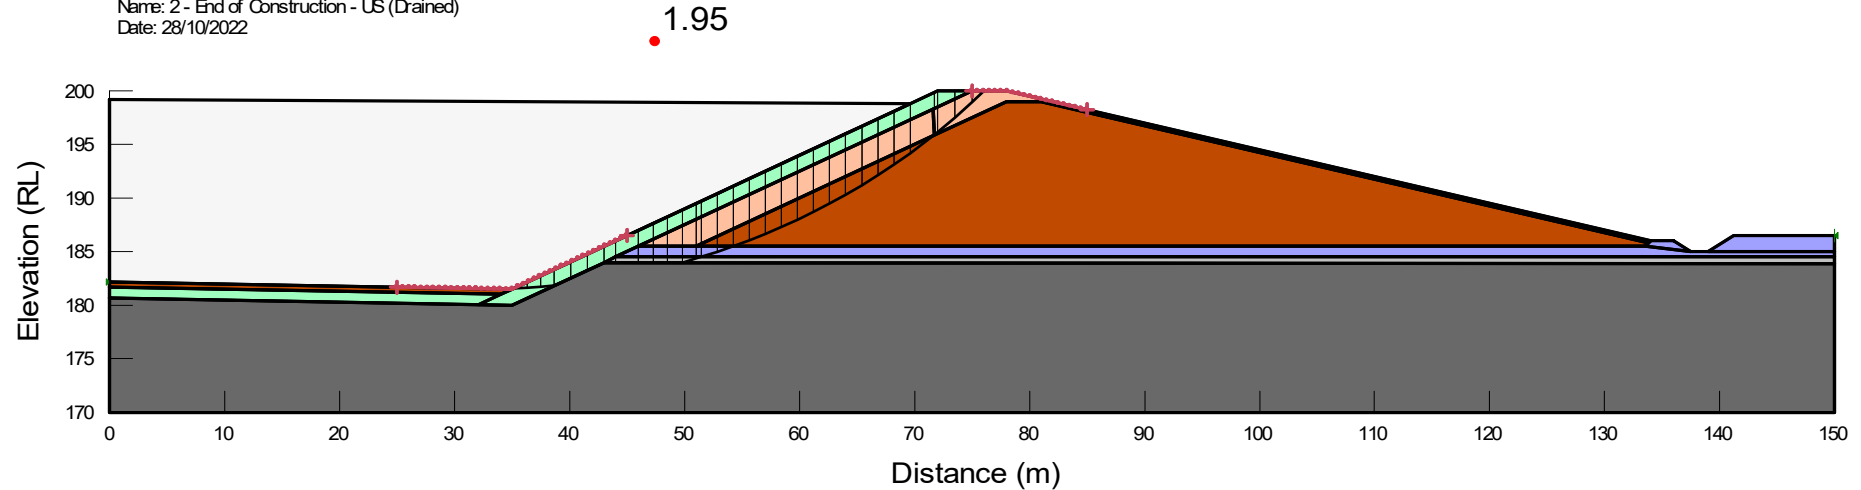
**FIGURE G2**

Costerfield Brunswick West TSF Design  
File Name: New TSF - BGMDesign (Stability).gsz  
Directory: K:\Projects\109\109014 Costerfield Mine, Costerfield\15 New TSF Investigation and Design\Data and Calcs\SlopeVM  
Name: 2 - End of Construction - US (Drained)  
Date: 28/10/2022

| Color | Name | Model | Unit Weight (kN/m³) | Strength Function | Cohesion' (kPa) | Phi' (°) | Phi-B (°) |
| Green | Compacted Clay (Zone 1/1B) (Drained) | Mohr-Coulomb | 19 | | 0 | 30 | 0 |
| Blue | Foundation Clay (Drained) | Mohr-Coulomb | 20.5 | | 38 | 20 | 0 |

Stability Assessment - Short Term Static Stability  
End of Construction (Drained), Upstream Failure

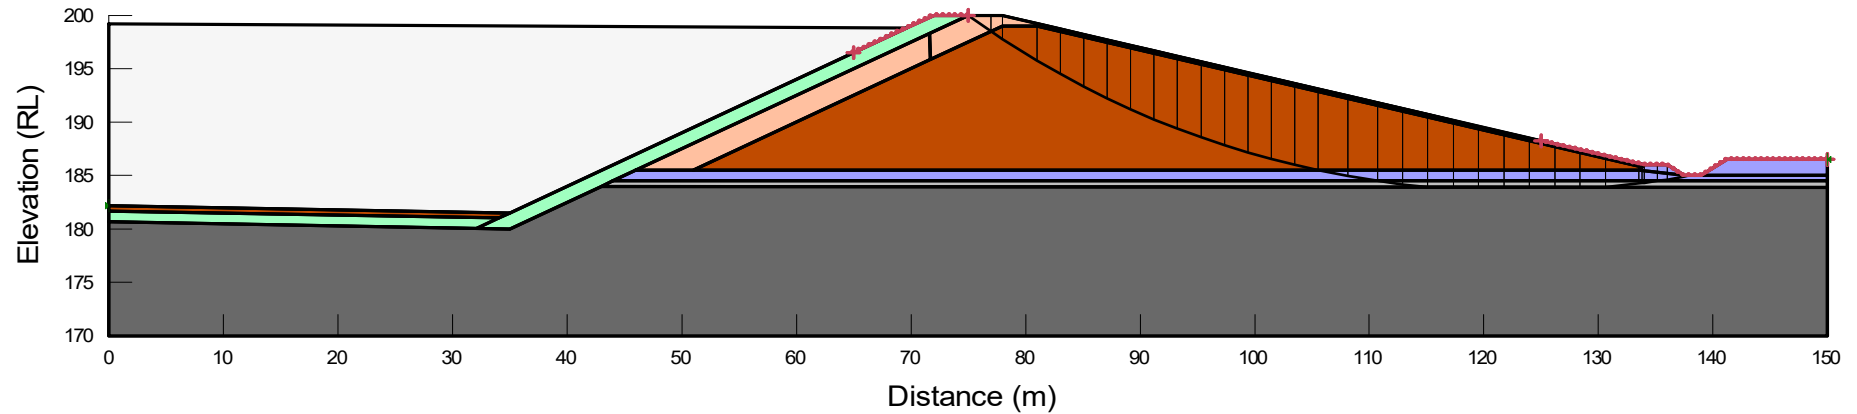
Costerfield Brunswick West TSF Design  
 File Name: New TSF - BGM Design (Stability).gsz  
 Directory: K:\Projects\109\109014 Costerfield Mine, Costerfield\15 New TSF Investigation and Design\Data and Calcs\SlopeW  
 Name: 4 - End of Construction - DS (Drained)  
 Date: 28/10/2022

| Color | Name | Model | Unit Weight (kN/m³) | Strength Function | Cohesion* (kPa) | Phi* (°) | Phi-B (°) |
| Light Green | Compacted Clay (Zone 1/1B) (Drained) | Mohr-Coulomb | 19 | | 0 | 30 | 0 |
| Blue | Foundation Clay (Drained) | Mohr-Coulomb | 20.5 | | 38 | 20 | 0 |

Stability Assessment - Short Term Static Stability  
 End of Construction (Drained), Downstream Failure

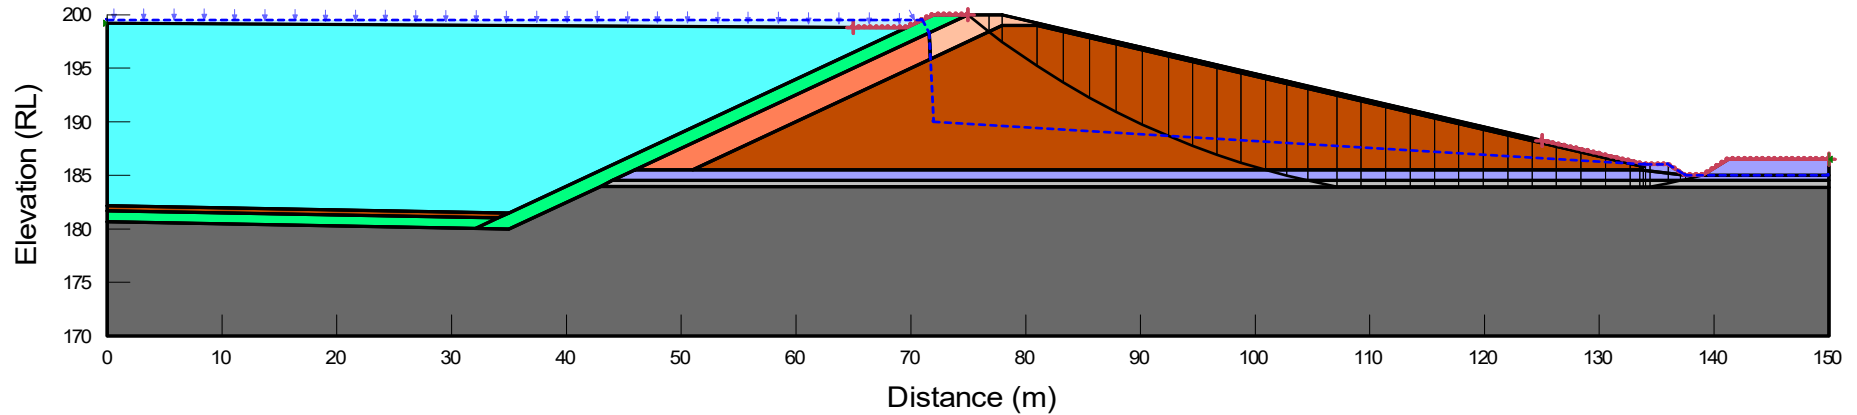
Costerfield Brunswick West TSF Design  
File Name: New TSF - BGM\Design (Stability).gsz  
Directory: K:\Projects\109\109014 Costerfield Mine, Costerfield\15 New TSF Investigation and Design\Data and Calcs\SlopeW  
Name: 5 - End of Filling - DS  
Date: 28/10/2022

| Color | Name | Model | Unit Weight (kN/m³) | Strength Function | Cohesion (kPa) | Phi (°) | Phi-B (°) | Minimum Strength (kPa) | Tau/Sigma Ratio | Piezometric Line |
| ■ | Compacted Clay (Zone 1/1B) (Undrained) | SHANSEP | 19 | | | | | 20 | 0.28 | 1 |
| ■ | Foundation Clay (Drained) | Mohr-Coulomb | 20.5 | | 38 | 20 | 0 | | | 1 |

#### Stability Assessment - Long Term Static Stability End of Filling, Downstream Failure

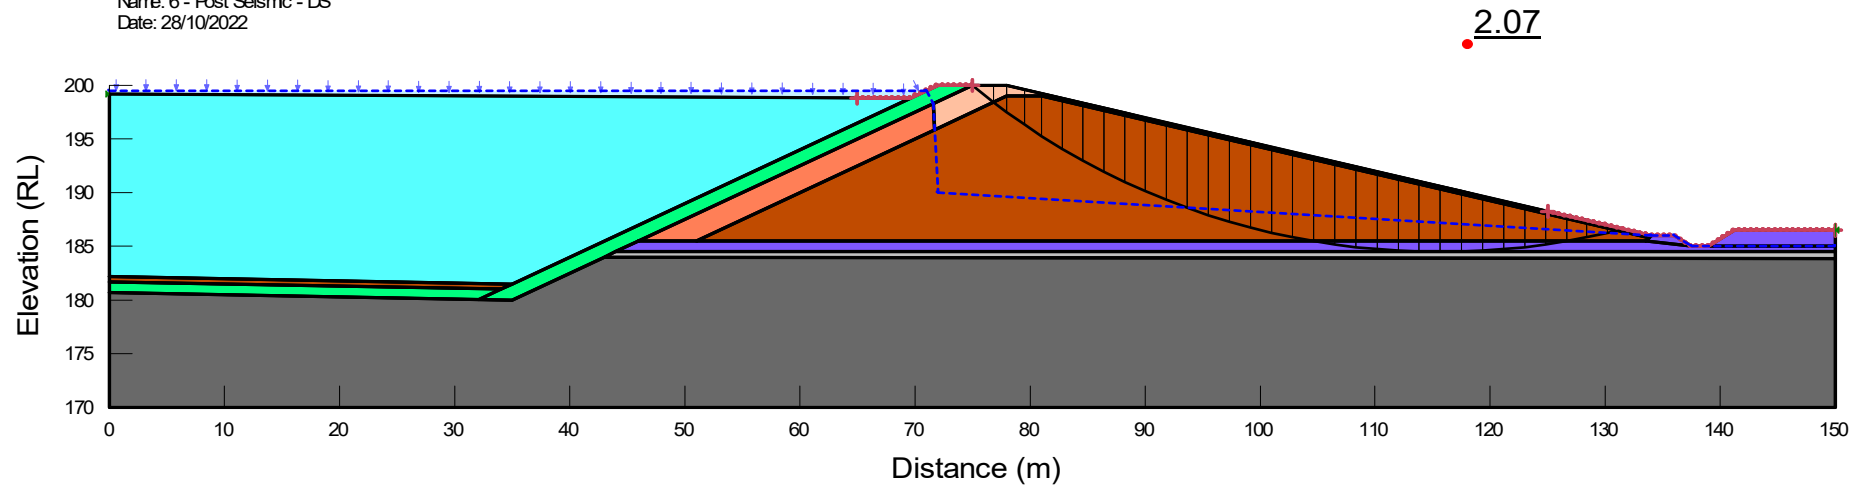
FIGURE G5

Costerfield Brunswick West TSF Design  
 File Name: New TSF - BGM\Design (Stability).gsz  
 Directory: K:\Projects\109\109014 Costerfield Mine, Costerfield\15 New TSF Investigation and Design\Data and Calcs\SlopeW\A  
 Name: 6 - Post Seismic - DS  
 Date: 28/10/2022

| Color | Name | Model | Unit Weight (kN/m³) | Strength Function | Cohesion (kPa) | Phi' (°) | Phi-B (°) | Minimum Strength (kPa) | Tau/Sigma Ratio | Piezometric Line |
| Green | Compacted Clay (Zone 1/1B) (Post Seis) | SHANSEP | 19 | | | | | 16 | 0.224 | 1 |
| Grey | BW Siltstone Foundation (80%) | Mohr-Coulomb | 22 | | 0 | 28.8 | 0 | | | 1 |
| Purple | Foundation Clay (Post Seis) | SHANSEP | 20.5 | | | | | 16 | 0.28 | 1 |

#### Stability Assessment - Post Seismic Stability End of Filling, Downstream Failure
