## Colac Northern Development Area Quarry Project - Open Mine Pit Wall Rehabilitation - Geotechnical Assessment

Prepared for Holcim Australia Pty Ltd

3 November 2023

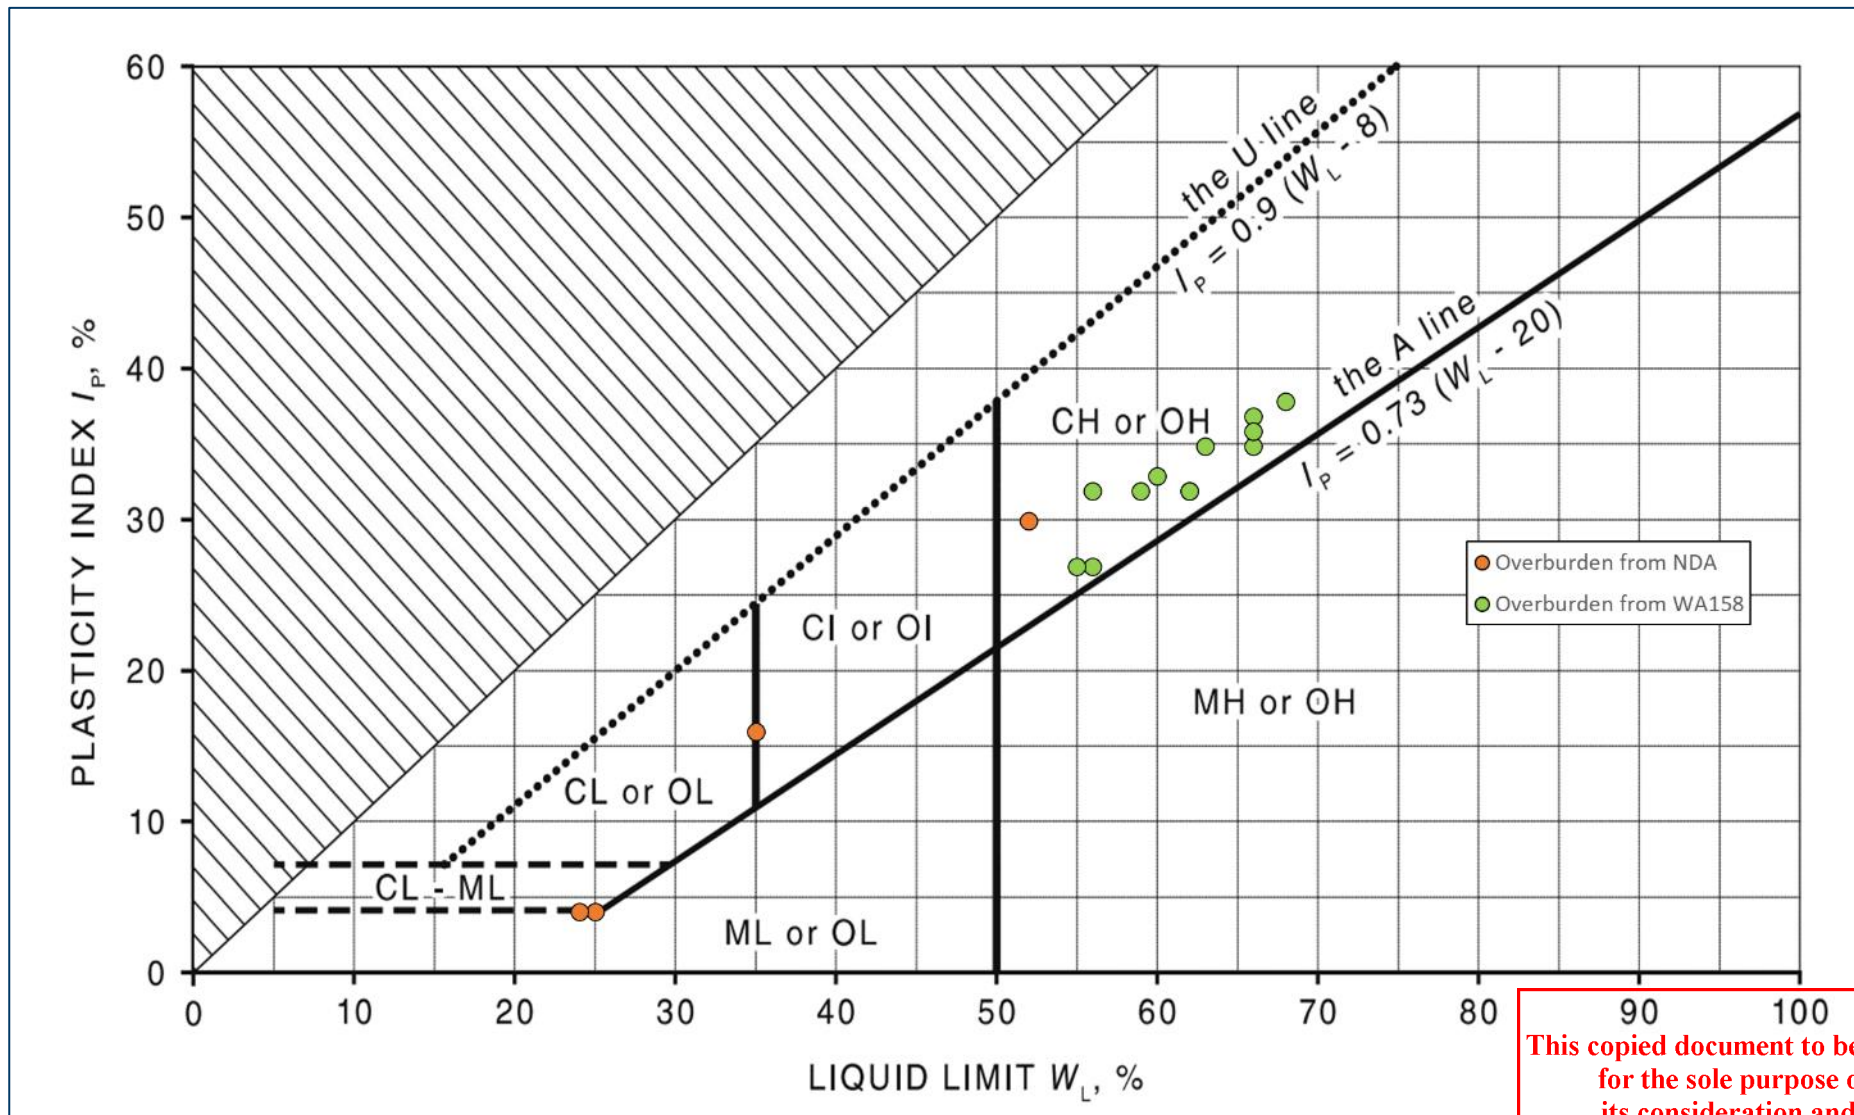
Figure 2: Atterberg Limits test result for tested overburden samples

PSD grading curves for all tested overburden samples, including plotting of Atterberg Limits test data onto a Casagrande chart, is presented in Figure 1 and Figure 2 respectively.

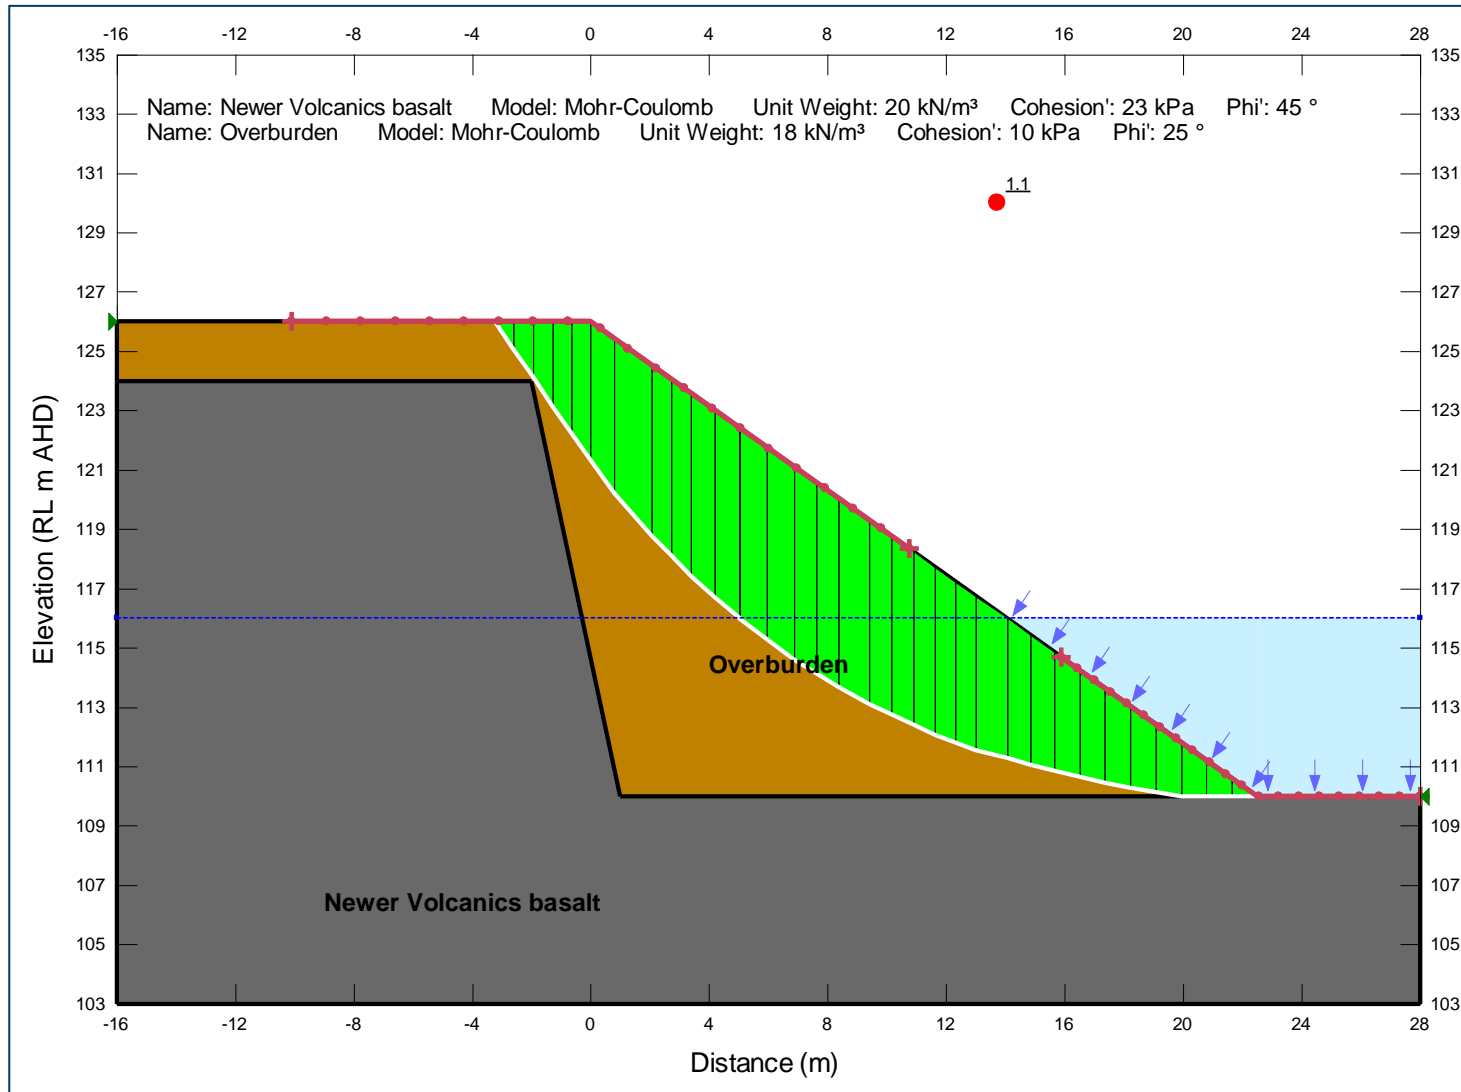
Figure 3: SLOPE/W output – Back-analysis of as-built WA158 rehabilitated pit wall slope

SLOPE/W output illustrating the back-analysed as-built WA158 rehabilitated slope is presented in Figure 3. From this back-analysis, it can be inferred that the placed overburden material to rehabilitate the WA158 quarry pit walls possess  $\phi'$  and  $c'$  of at least  $25^\circ$  and 10 kPa respectively. These back-analysed Mohr-Coulomb parameter values are anticipated to be applicable for the proposed NDA quarry pit wall rehabilitation exercise, subject to placement of the overburden material in a similar / identical manner to that previously adopted for WA158.

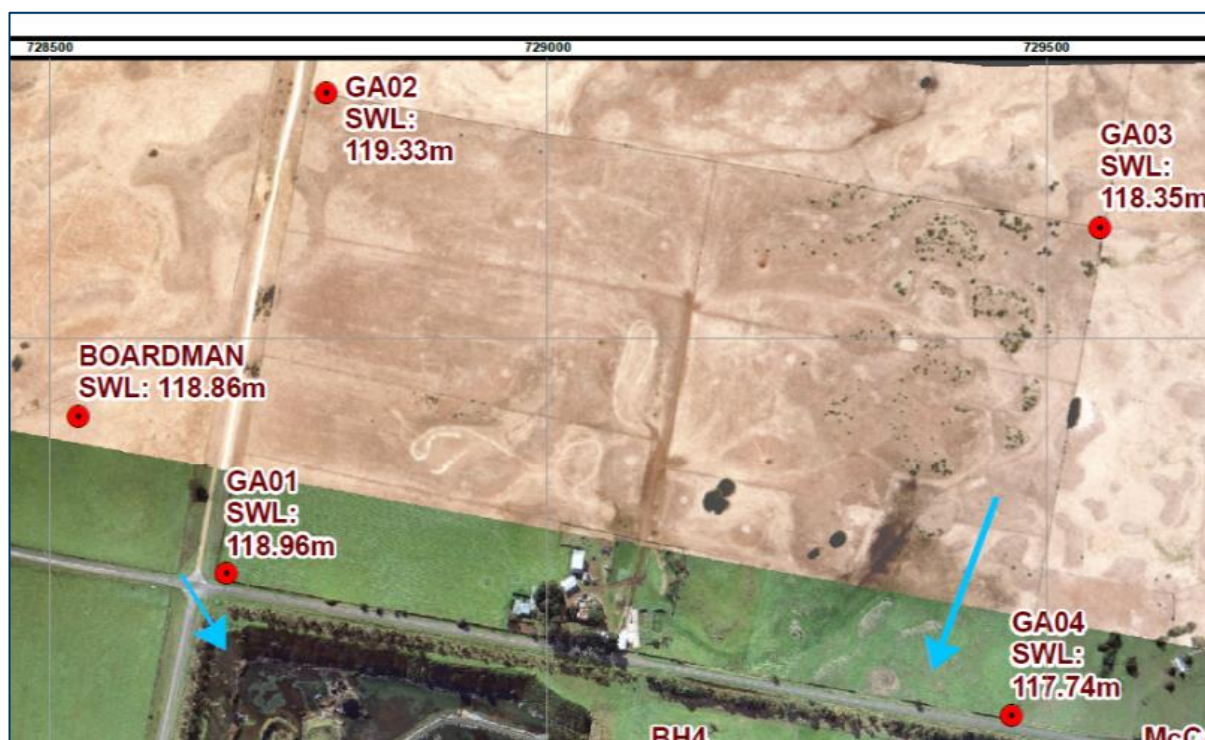
Figure 4: Groundwater monitoring wells in NDA

There are four (4) groundwater monitoring wells located at each corner of the NDA site boundary (GA01 to GA04). A site layout plan with indicative location of each well is presented in Figure 4. Groundwater level records have been made available for the four monitoring wells, taken from the following Aurecon report: Colac Northern Development Area: Surface Water and Groundwater Impact Assessment and Water Management Plan (Aurecon, 2023) Monitoring commenced in December 2004 through to March 2022.

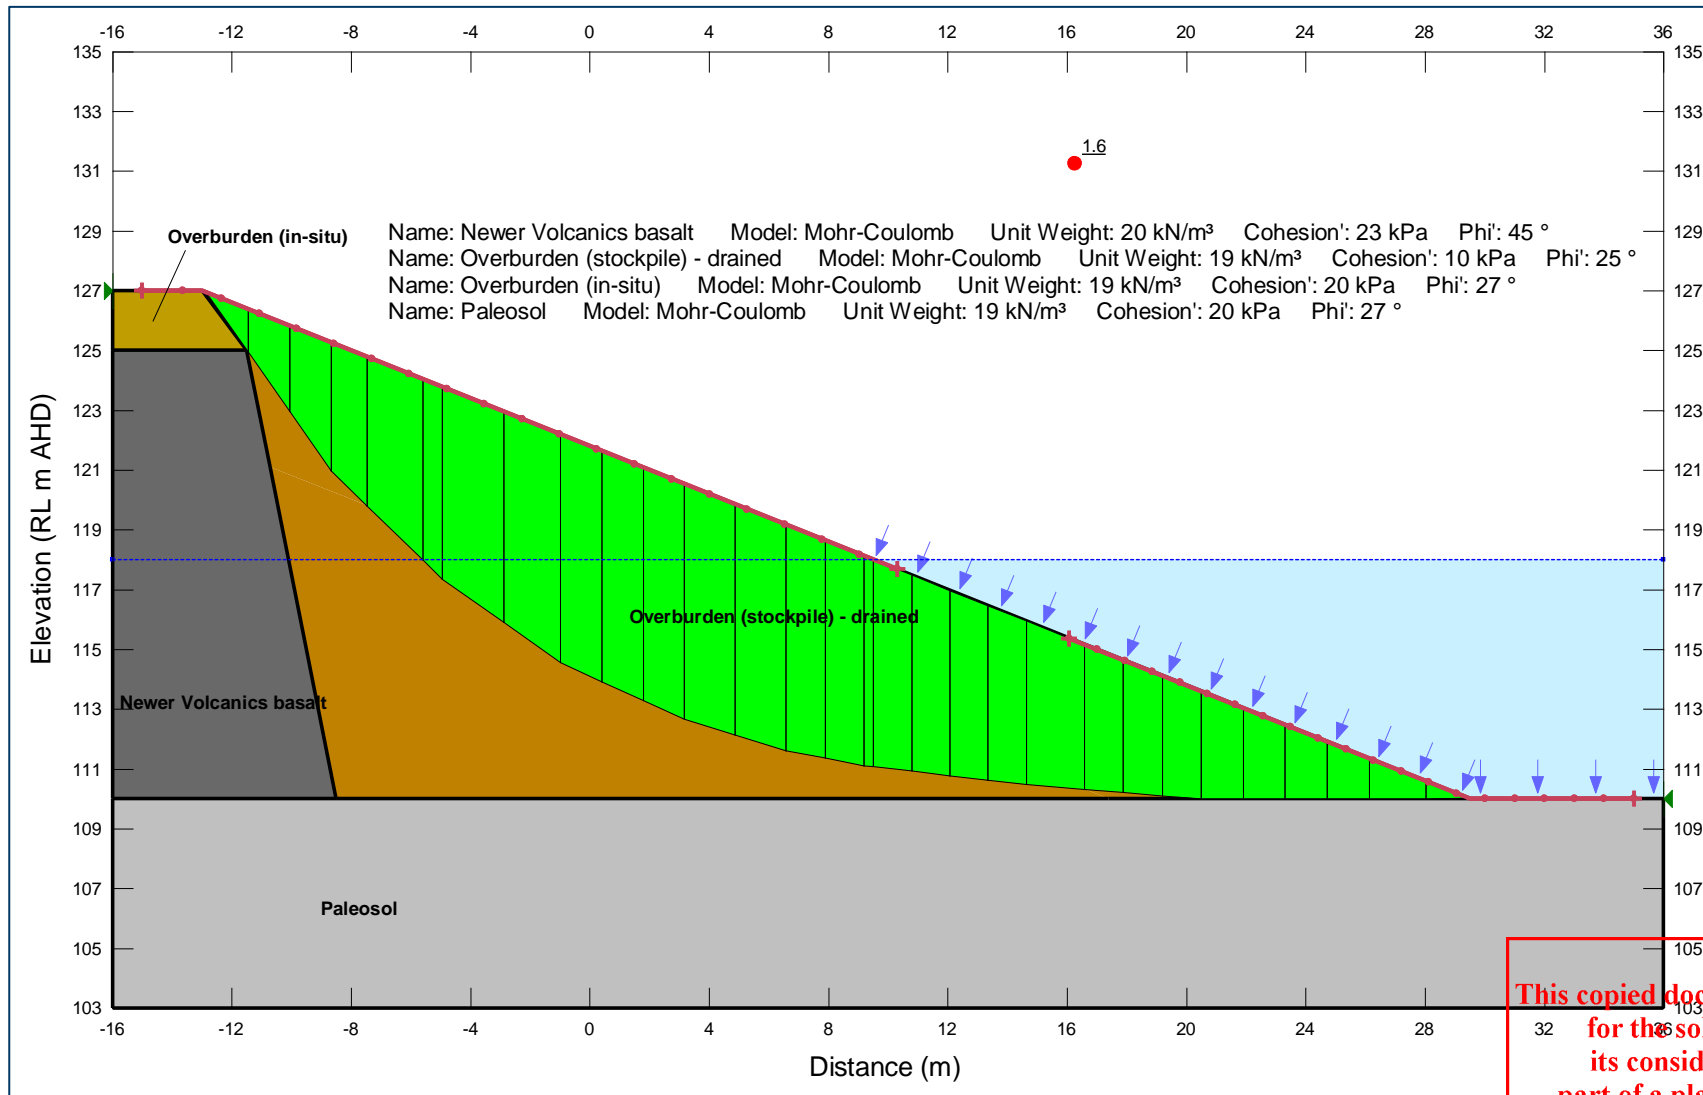
Figure 5: SLOPE/W output – Long-term static operating condition

SLOPE/W output illustrating the critical slope failure mechanism (minimum FoS surface) based on the above batter requirement is presented in Figure 5 to Figure 7.

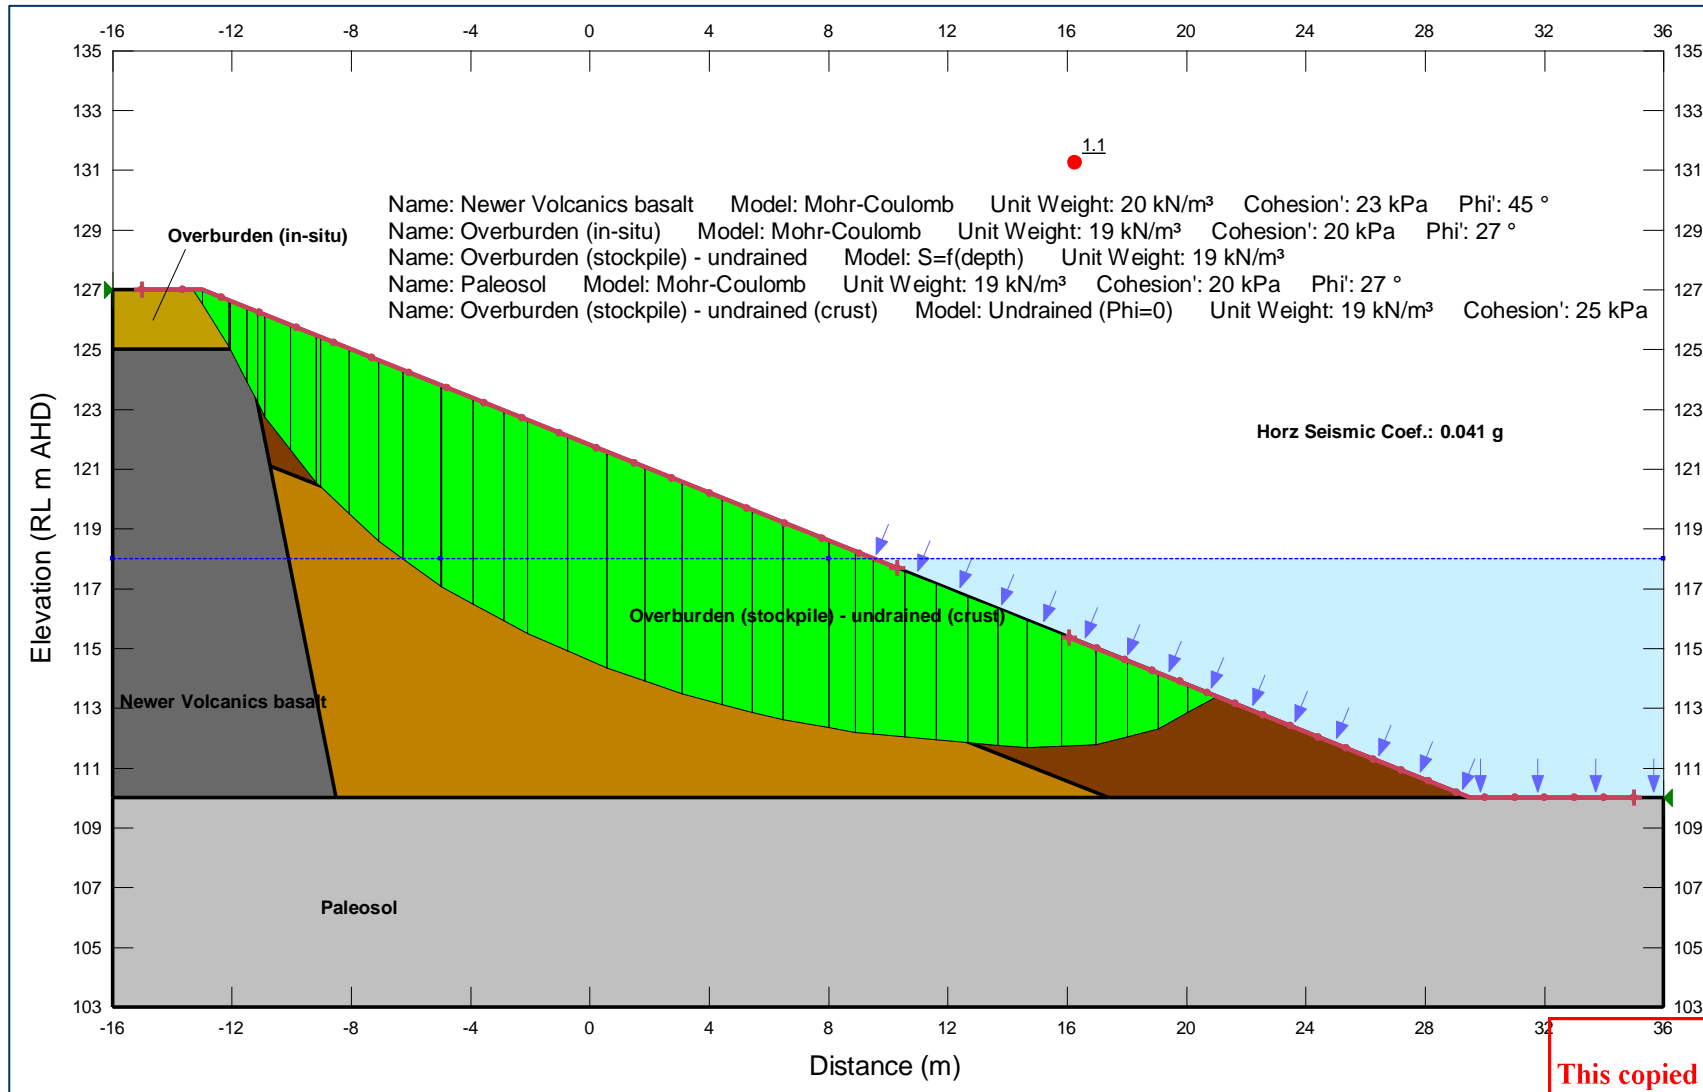
Figure 7: SLOPE/W output – Seismic condition

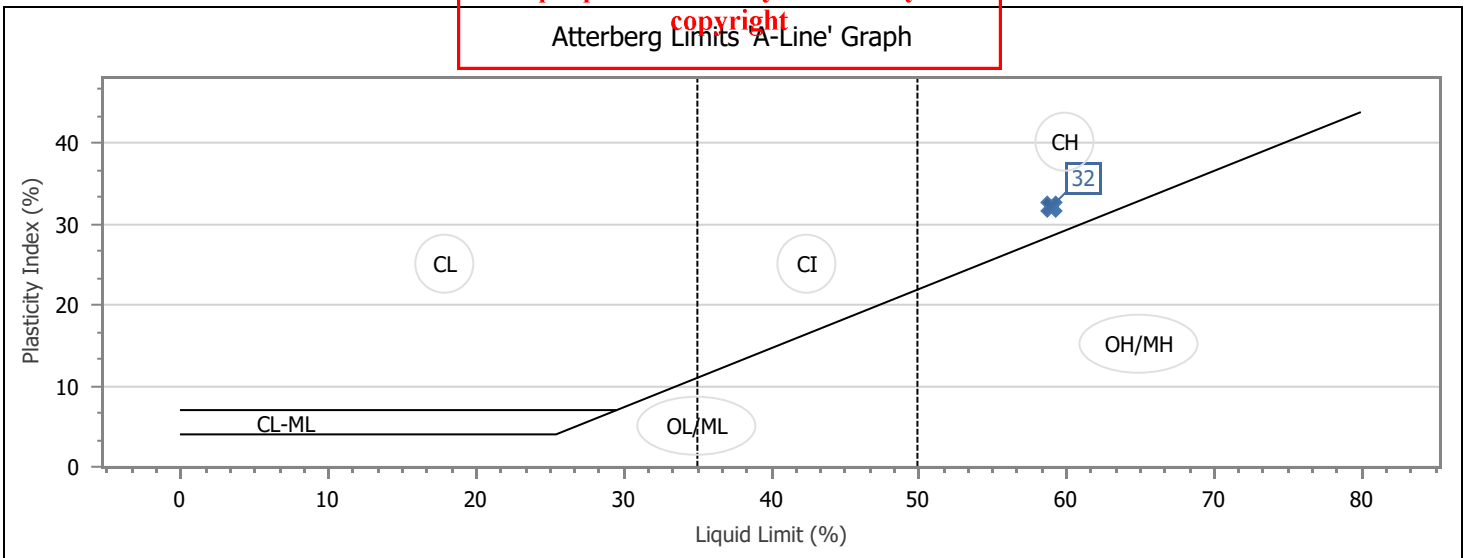
Atterberg Limit	Specification Minimum / Test Result	Specification Maximum
Liquid Limit (%)	59	
Plastic Limit (%)	27	
Plasticity Index (%)	32	
Linear Shrinkage (%)	15.0	
Linear Shrinkage Mould Length / Defects:	Mould Length: 250.5mm / Cracking

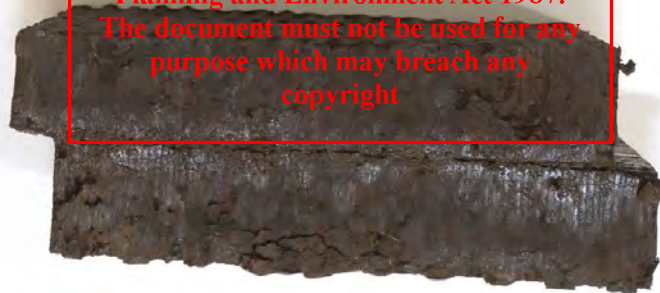
<b>CLIENT:</b>	Construction Sciences Pty Ltd	
<b>PROJECT:</b>	13739/P/858 - Quality Control Testing	<b>AFTER TEST</b>
<b>LAB SAMPLE No.</b>	22120123	<b>DATE:</b> 31/01/2023
<b>BOREHOLE:</b>	Pit 1/ 0.5 / Sample 1 / NDA - 13739/S/42177	<b>DEPTH:</b> Not Supplied

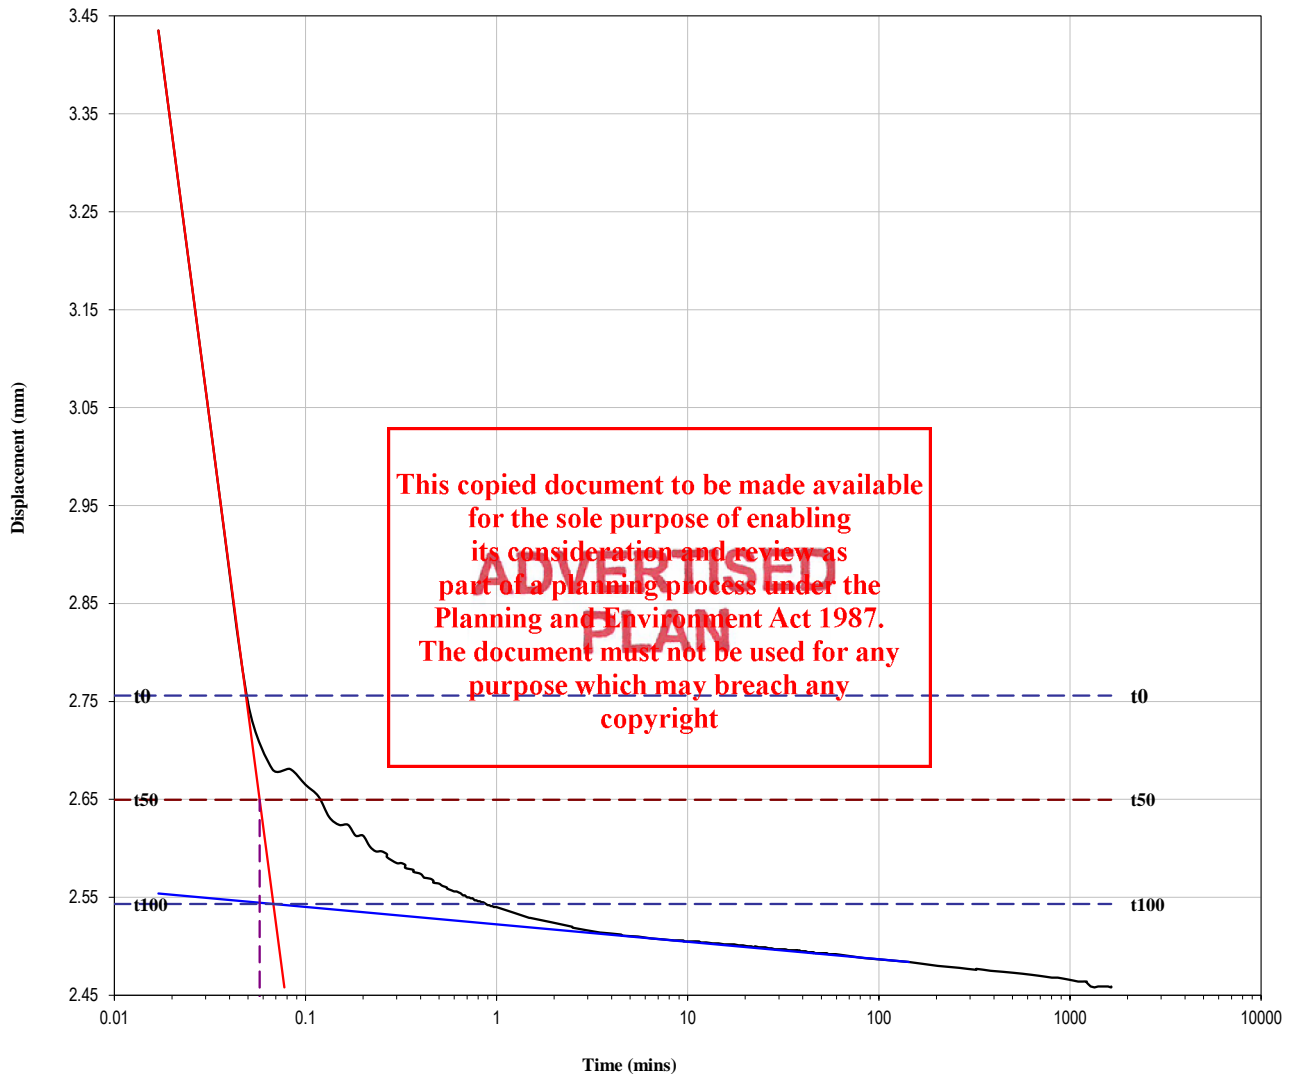
### Stage 1 Consolidation

Displacement v's Time (Log Scale)

$t_{50}$	0.06	mins
$t_{100}$	0.07	mins
Time to Failure =	132.48	mins
Estimated Displacement to Failure =	10	mm
Displacement Rate =	0.0754829	mm/min

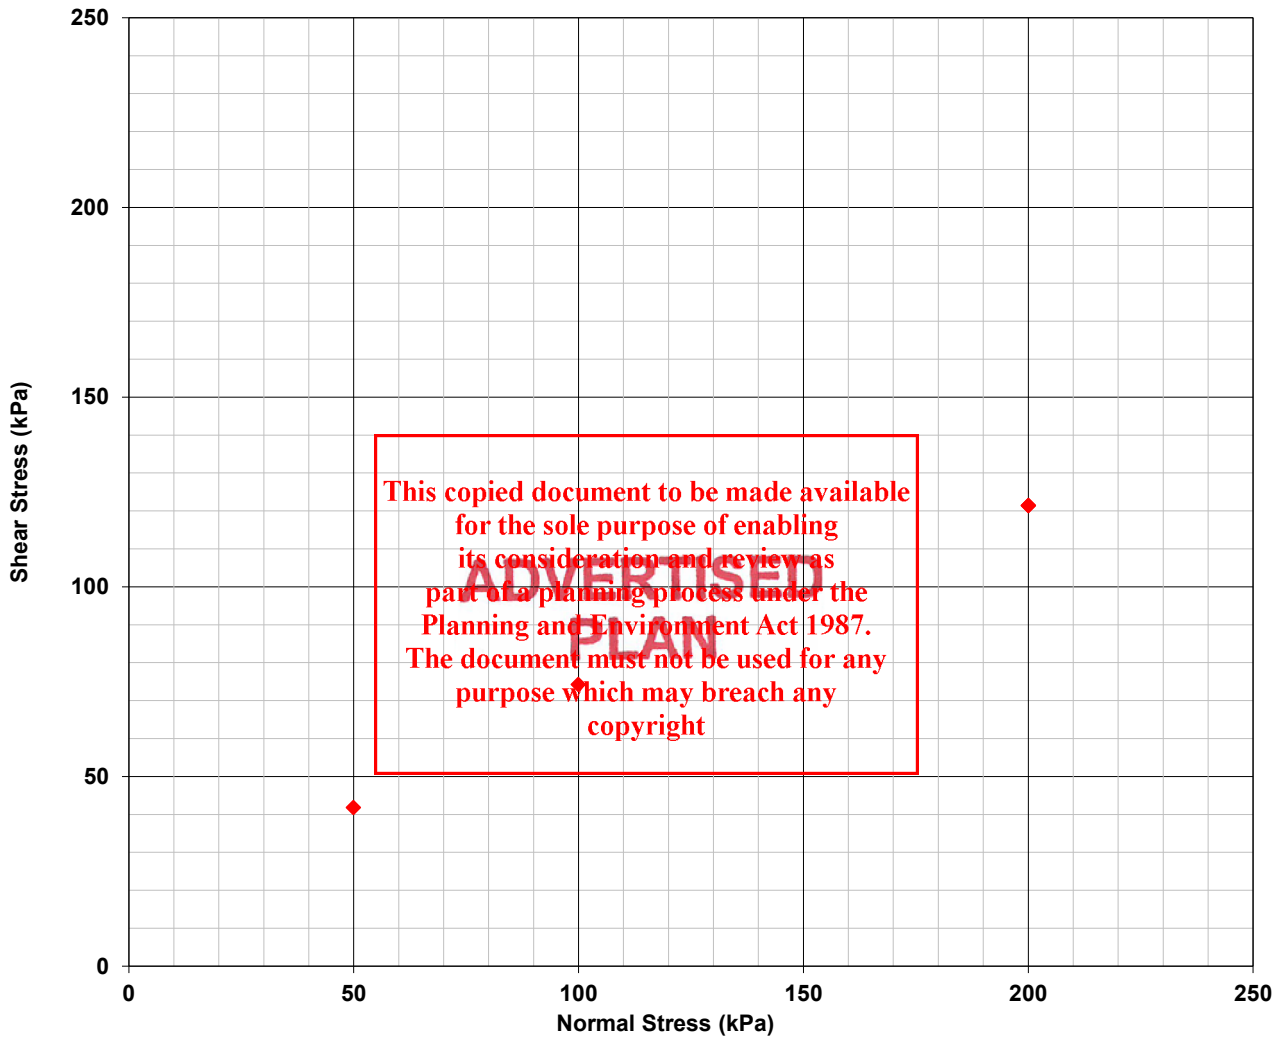
### Peak - Normal Stress vs Shear Stress

**Peak**

**Shear Angle (°)** 27.6

**Cohesion (kPa)** 18.3

Specimen Condition	Inundated
Specimen Dimensions (mm)	100 * 100
Initial Height (mm)	42.0
Rate of Strain (mm/min)	0.008
Initial Moisture Content (%)	22.4
Initial Wet Density(t/m <sup>3</sup> )	1.91
Initial Dry Density(t/m <sup>3</sup> )	1.56

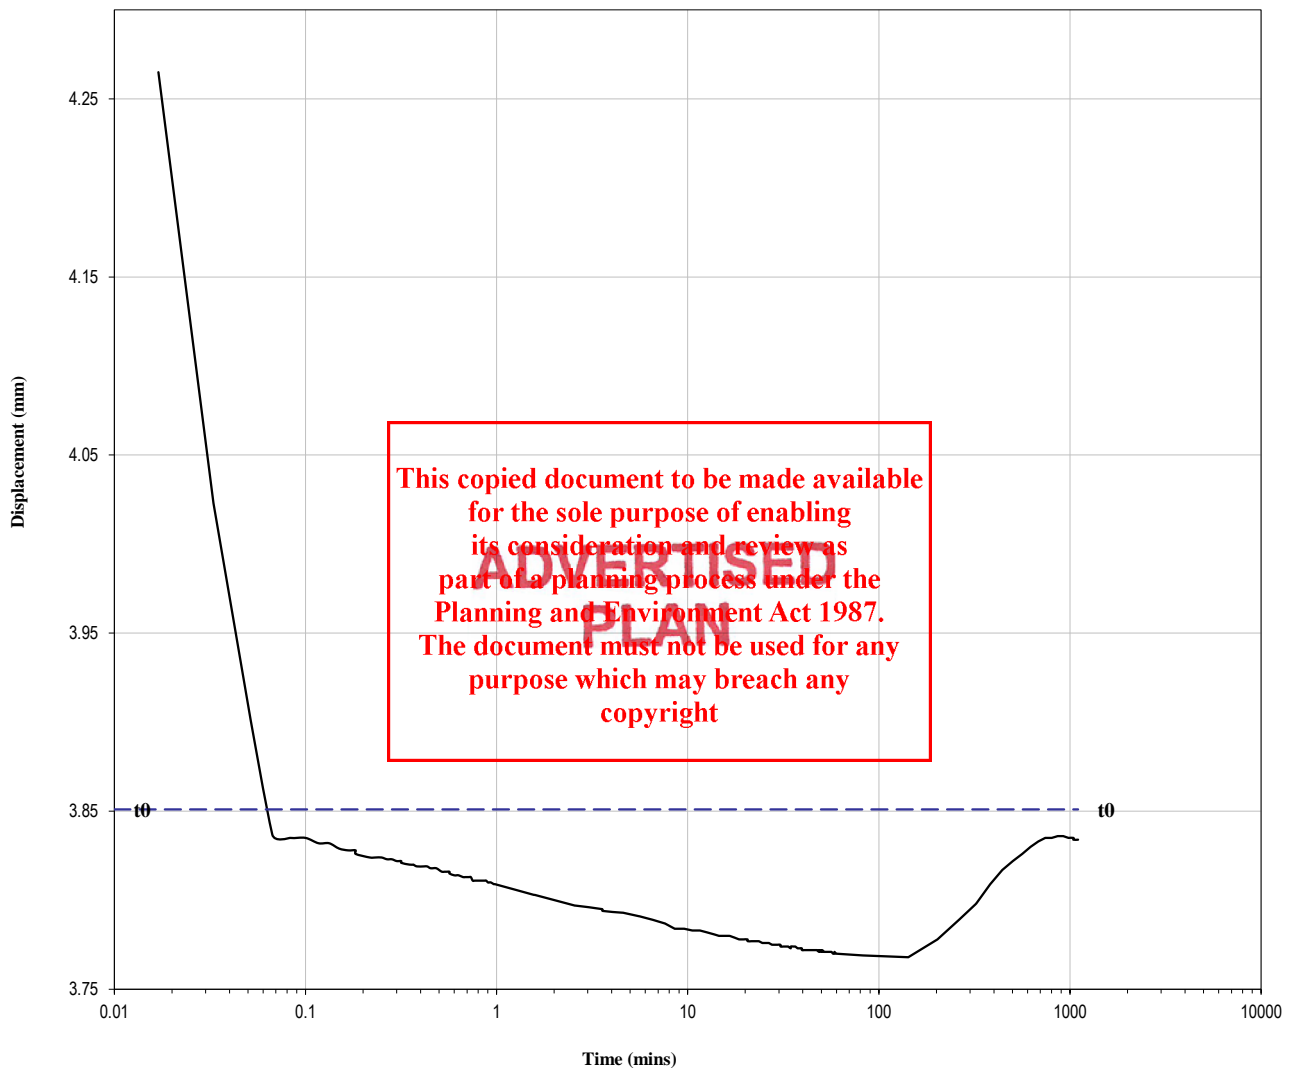
### Stage 1 Consolidation

Displacement v's Time (Log Scale)

$t_{50}$	#N/A	mins
$t_{100}$	#N/A	mins
Time to Failure =	#N/A	mins
Estimated Displacement to Failure =	10	mm
Displacement Rate =	#N/A	mm/min
