# Heritage Impact Statement

Our Lady of Sion Convent  
York Street, Sale

Author Janice Yeung M.Arch M.UCH  
Claire Miller M.Arch Ph.D M.ICOMOS  
Trethowan Architecture  
Date 18 September 2023

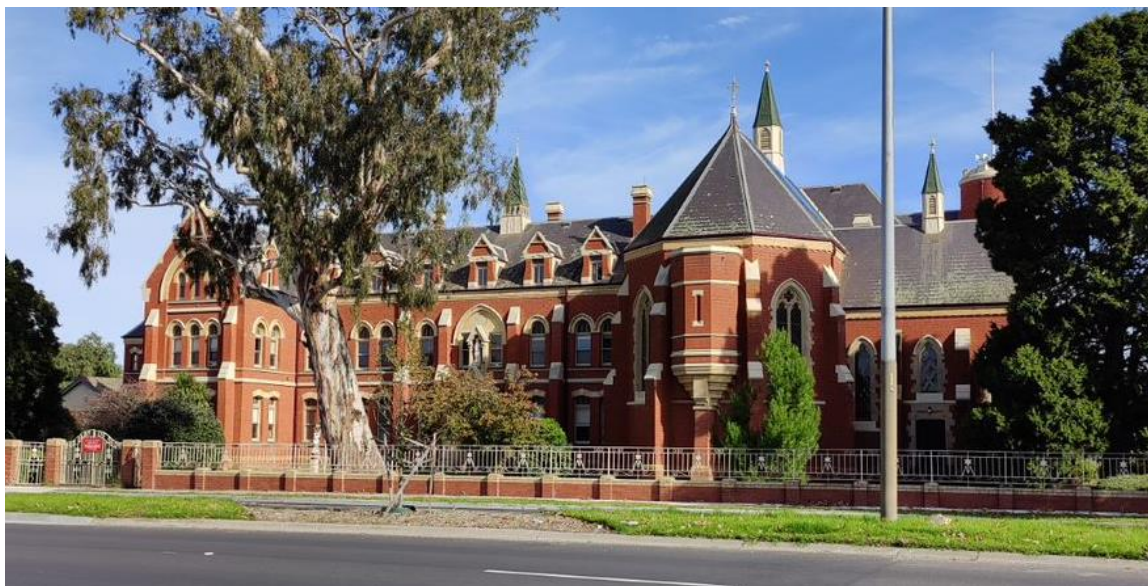
Figure 4: View of the east (main) façade of the Our Lady of Sion Convent building from across York Street. Source: Trethowan Architecture, 2023.

Known as the Our Lady of Sion Convent building, a large, three-storey, red brick building with slate and metal sheet roofing is located centrally along the east site boundary (Figure 4). The steeply pitched roof contains chimneys, flèches/spirelets, and bell towers. The building generally has an H-shape plan, with a central wing (c.1893) that spans from north to south, a Chapel added to the north-east (1901) and projecting north (1953) and south (c.1938) wings (Figure 5). Circulation towers (c.1970s) project from the north and South Wings. Services such as metal work platforms, ramps, stairs, and air-conditioning units are installed throughout the façades.

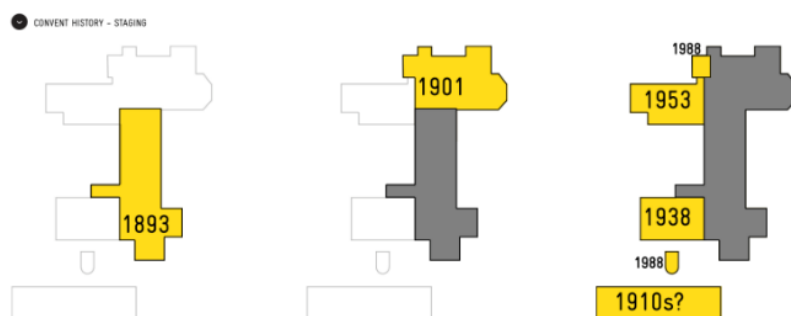
Figure 5: Diagram showing the stages of construction at the subject site. Source: Y2 Architecture, 2023.

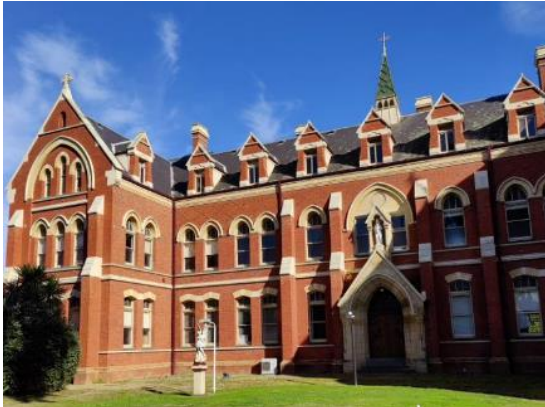
Figure 6: View of the east façade of the original 1893 building. Note the decorative features, statue on the front lawn, and main entrance. Source: Trethowan Architecture, 2023.

The original 1893 portion of the Convent building is generally rectangular in shape, with smaller forms projecting in the east, west, and south. The roof is generally in gable form, clad in slate and features dormer windows on both east and west sides. The main entrance is located centrally on its east façade to York Street (Figure 6). Decorative elements, such as stringcourses, buttresses, and simple decorative stones to windows, can be found on all façades (Figure 7). Additional to these elements, the east (main) façade is more ornate with a main entrance that features diaper-pattern brickwork below the eaves, a freestone arch and a stone pediment above, decorative stones to the windows, and stained-glass fanlights.

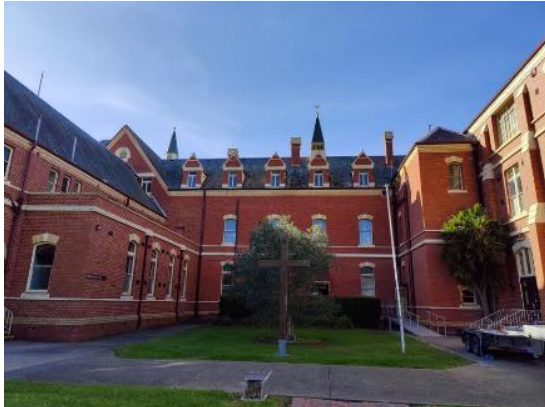
Figure 7: View of the west façade of the original 1893 building. Note that it has been partially concealed by later extensions (indicated in red). Source: Trethowan Architecture, 2023.

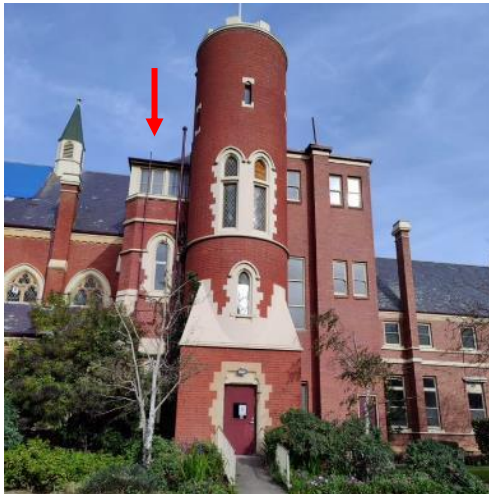
Figure 9: View of the north façade of the Chapel stair tower and adjoining Sunroom to its east (indicated in red). Note the damaged roof, covered in blue tarp, in the far left. Source: Trethowan Architecture, 2023.

The Chapel was constructed in 1901 (Figure 8). A section of its roof is damaged and is currently covered with a tarp. A polygonal, hip-roofed volume that contains the chapel is projected to the east, and a circular stair tower is to the north. A Sunroom (CO 301) abuts the east of the stair tower on the second level; this was previously an accessible flat roof which was later infilled (Figure 9).

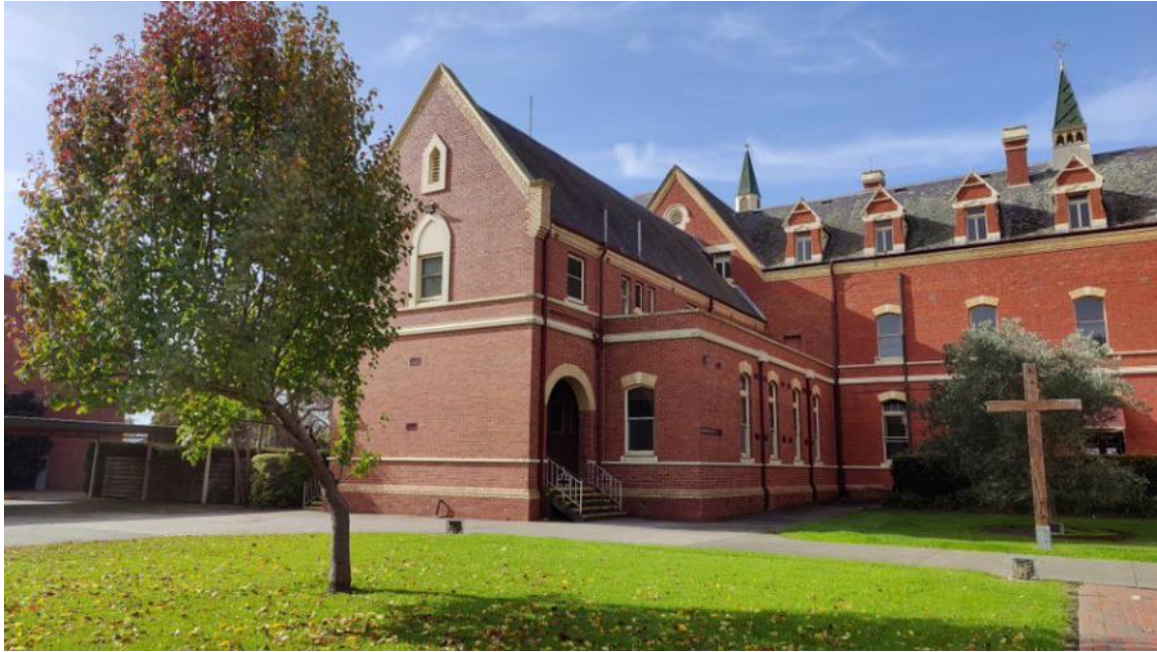
Figure 10: View of the 1953 portion of the North Wing from the west lawn. Note the flat-roofed structure with an accessible outdoor area abutting its south. Source: Trethowan Architecture, 2023.

The North Wing was constructed in 1953. It adopts a similar design to the original building. The two-storey, west-projecting 1953 portion is a gable-roofed structure, with a one-storey, flat-roofed volume abutting its south (Figure 10). A lift tower, built in c1970s, is located to its north.

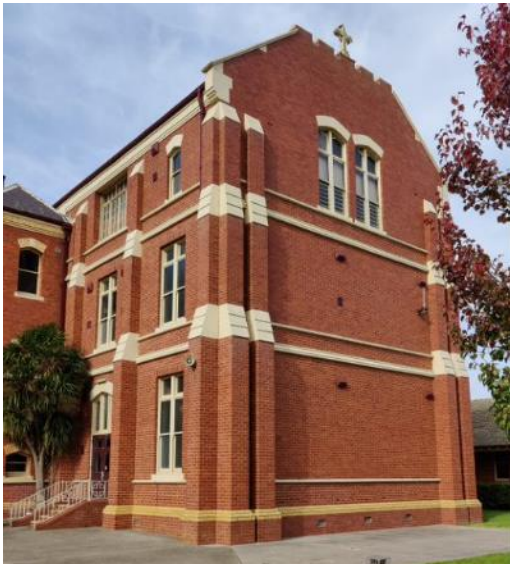
Figure 11: View of the north and west façades of the South Wing. Source: Trethowan Architecture, 2023.

The South Wing was constructed in 1938 and projects towards the west. It has a gable roof with a truncated, crenelated parapet and adopts a similar design language as the original building through red brick construction, rendered stringcourses and buttresses (Figure 11). Internally, the South Wing consists of large classrooms. An external two-storey fire-escape staircase in a rounded rectangular form was built in 1988 (Figure 12). It is connected to the south façade of the South Wing by a lightweight metal walkway.

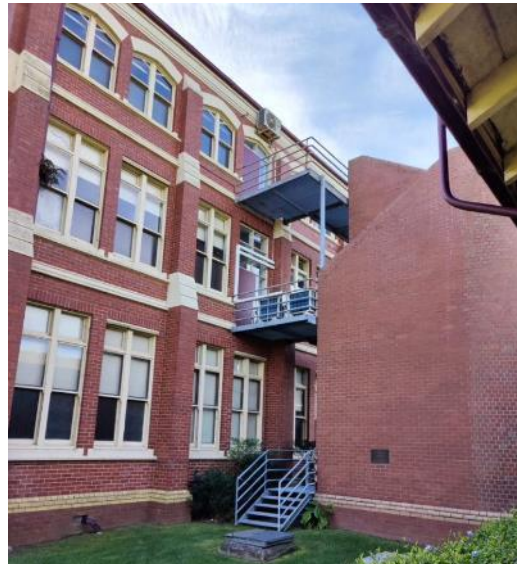
Figure 12: View of the south façade of the South Wing, connected to the external staircase by a work platform. Source: Trethowan Architecture, 2023.

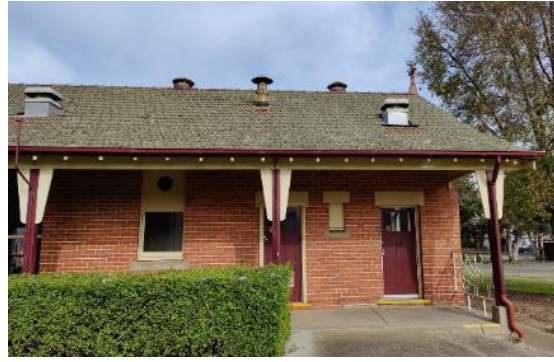
Figure 19: View of the north façade of the c.1910 Building. This façade appears to be relatively intact. Source: Trethowan Architecture, 2023.

To the south of the Convent building lies a single-storey, red brick building dating from c.1910s, which has been used for arts and music classes (Figure 19). The building has a tiled gable roof with chimneys, vents, and finials on both gable ends. The roof cantilevers out to the north and is supported by evenly spaced posts. The west end of the building appears to have a fair level of integrity with exposed brickwork and original/early door and window openings. However, its central and east portions have been extensively modified, where walls are rendered and painted in dark grey, openings altered, and modern entrance porch projecting towards the south (Figure 20). Internally, this building has been substantially altered with no evidence of original layout or fabric evident.

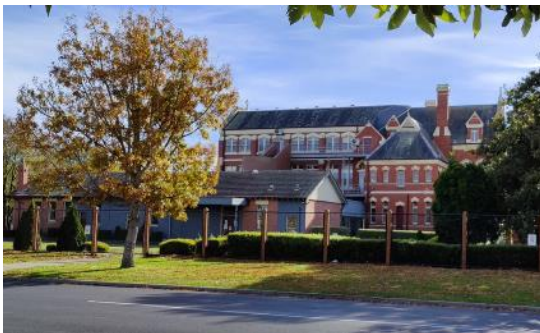
Figure 20: View of the west and south façades of the c.1910 Building. The central and east portions appear to have been extensively modified. The Convent building can be seen in the background. Source: Trethowan Architecture, 2023.

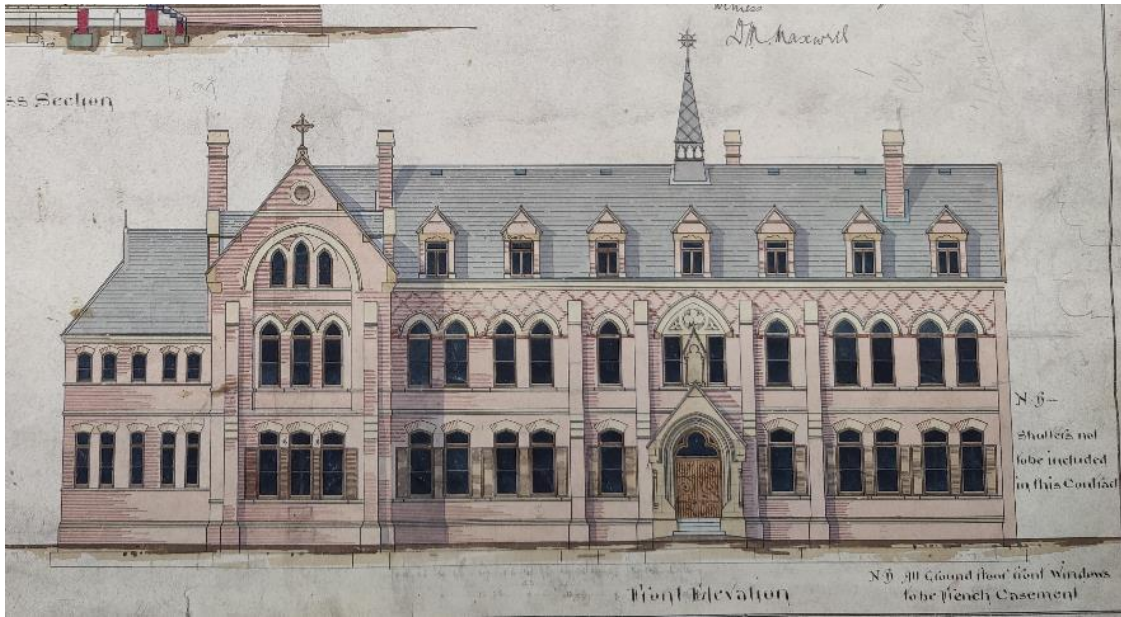
Figure 22: Original drawing of the east (front) façade, dated 1892. Source: Bates Smart Archive, 68/13 Job #15, University of Melbourne Archive.

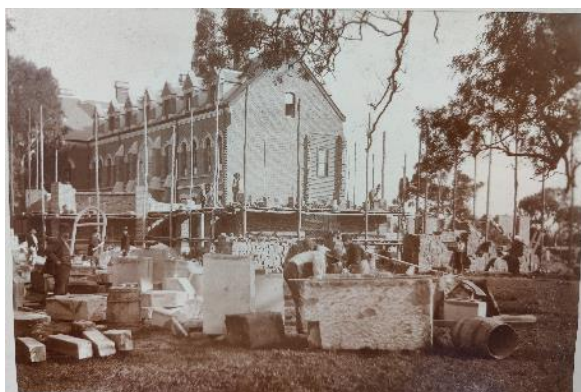
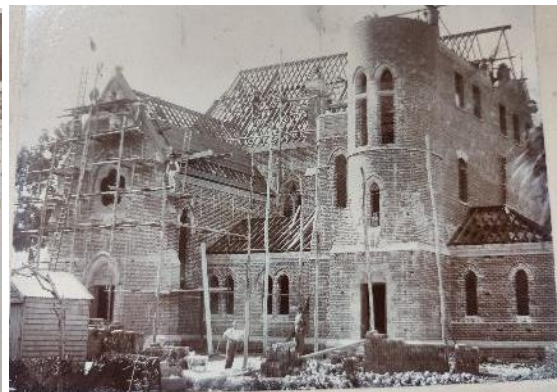
Figure 25: Photographs of the Chapel under construction, c1901. Source: Bates Smart Archive, 68/13 Job #15, University of Melbourne Archive.

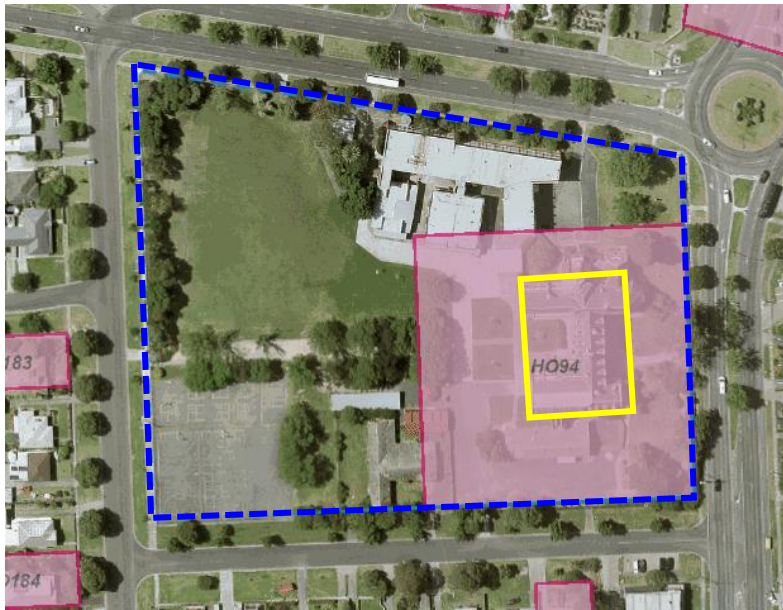
Figure 28: Curtilage of HO94 (indicated in pink) within the subject site (indicated in blue). Note the Convent building's location (indicated in yellow) within the HO. Source: VicPlan, 2023.

Part of the subject site is located within Heritage Overlay *HO94: Our Lady of Sion Convent*, in the Wellington Planning Scheme (Figure 28). It is listed as *individually significant*. The Heritage Overlay (HO) extent covers the former convent building and forms a curtilage that covers part of some adjacent buildings and landscaped areas. This area is known as the heritage place.

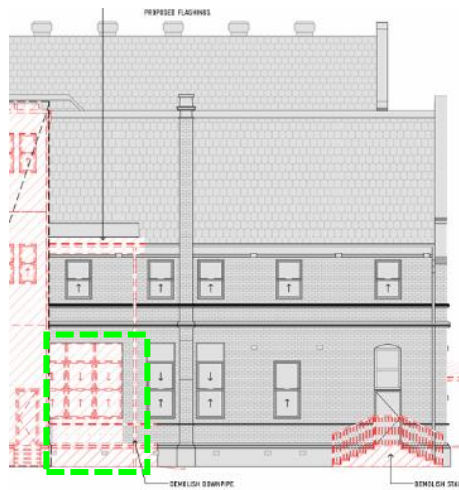
Figure 30: Extract of TP14 P2 E1, showing proposed demolition of windows and a section of wall at the North Wing's north façade (indicated in green). Source: Y2 Architecture, 2023.

At the north façade, some windows and a section of wall on the ground level are to be removed (Figure 30).

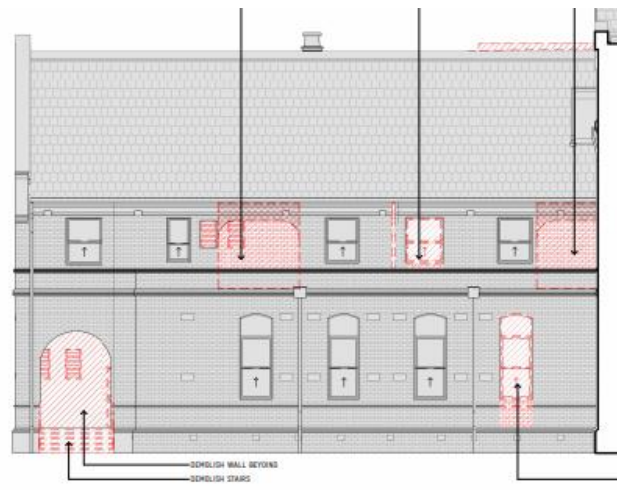
Figure 31: Extract of TP16 P2 E8, showing the proposed demolition of the North Wing at the south façade. Source: Y2 Architecture, 2023.

At the south façade on ground level, a window and section of wall removed at WC CO 117G (Figure 31). On the first level, some areas of wall and existing openings are to be removed / altered to enable access to the new breakout space. The roof sheeting for the Outdoor Area (CO 211) is to be removed.

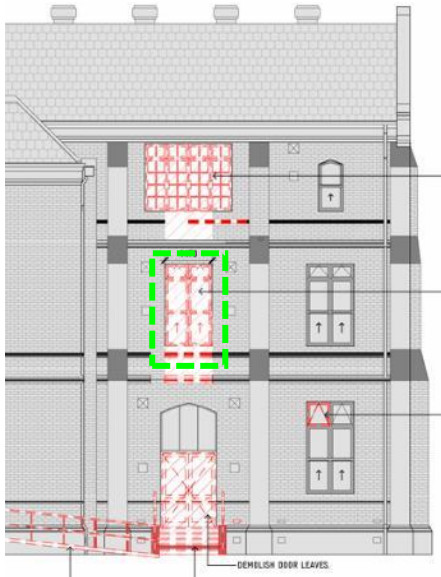
Figure 32: Extract of TP16 P2 E6, showing the extent of demolition of the South Wing at the north façade. A window on the first level is to be salvaged and reused (indicated in green). Source: Y2 Architecture, 2023.

At the north façade, a double swing door is to be removed on ground level, and the top section of a window is to be removed. Windows and sections of walls are to be demolished on first and second levels. At south façade, contemporary glazing and doors, and sections of walls that connect to the fire escape staircase and associated walkways are to be removed. In particular, a window on the first level of the north façade is to be removed and reused (Figure 32).

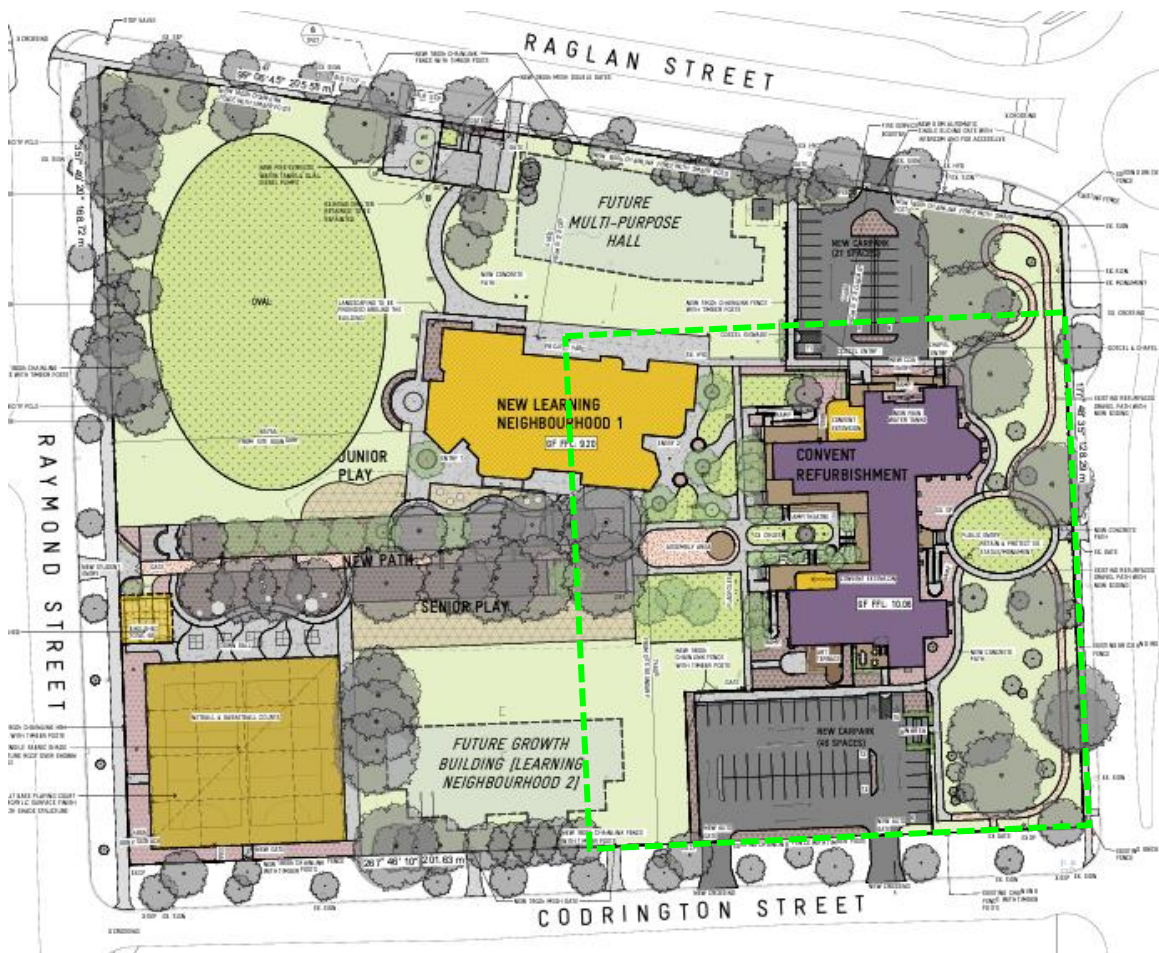
Figure 33: Extract of TP03 P2, proposed site plan. The HO curtilage is indicated in green, the Convent building in purple, and new buildings/additions in yellow. Source: Y2 Architecture, 2023.

Following the proposed demolition works, new works seek to make alterations and additions to the wider site and the heritage place. The proposed new work has been informed by long-term master planning to future-proof the use of the site as a primary school. The proposal is constrained by the need to ensure future capacity for growth at the site, as well as specific compliance obligations related to school use. Alteration works are proposed to new sports courts, play areas, services and infrastructure, paths, and soft landscaping are to be constructed (Figure 33). Additional spaces are planned to accommodate two new buildings for future capacity.

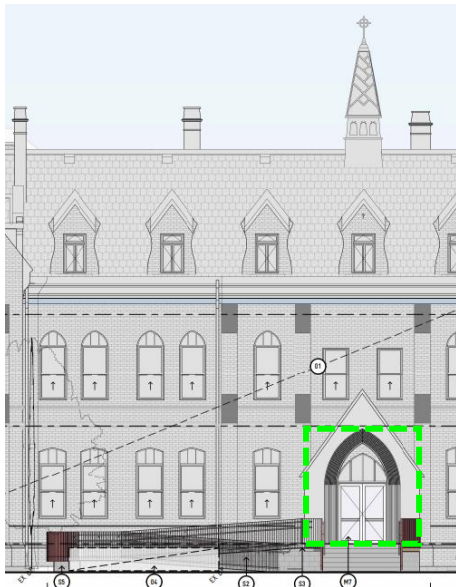
Figure 34: Extract of TP22 P2 1, showing the new double swing doors at the east façade of the original building. Source: Y2 Architecture, 2023.

At the east façade, new aluminium-framed, powder coated, glazed double swing doors are to be affixed to the original main entrance opening (Figure 34). The original doors will be retained, but not in use.

Likewise, the new glazed double swing doors is a contemporary interpretation of the historic double swing doors with stained-glass panels, which will be retained.

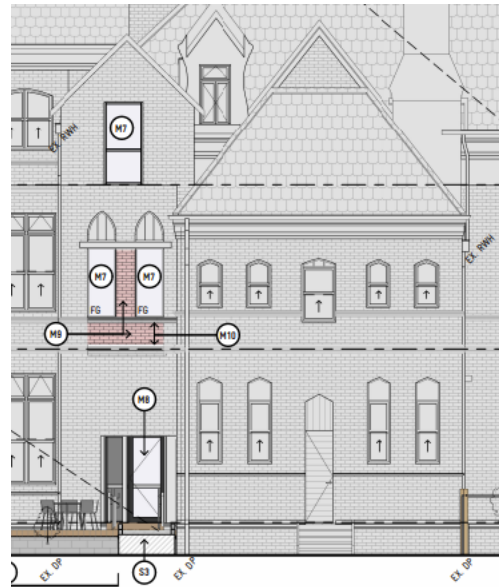
Figure 35: Extract of TP23 P2 1, showing the alterations to the original building's south façade. Source: Y2 Architecture, 2023.

At the south façade on the ground level, an existing door in the Toilet (CO 110) is to be sealed shut. To its left, new black aluminium framed glazing and doors glazed door is to be installed to an existing opening (Figure 35). On the first level, two new white-coloured, aluminium-framed windows are to be installed. Beneath the windows, the existing cavity is to be infilled with brickwork recovered from demolished areas of the building. Where appropriate bricks are not available, like-for-like replacements are to be used. Rendered mouldings are also to be installed with composition and profile that matches existing. On second level, one new white-coloured, aluminium framed window is to be installed.

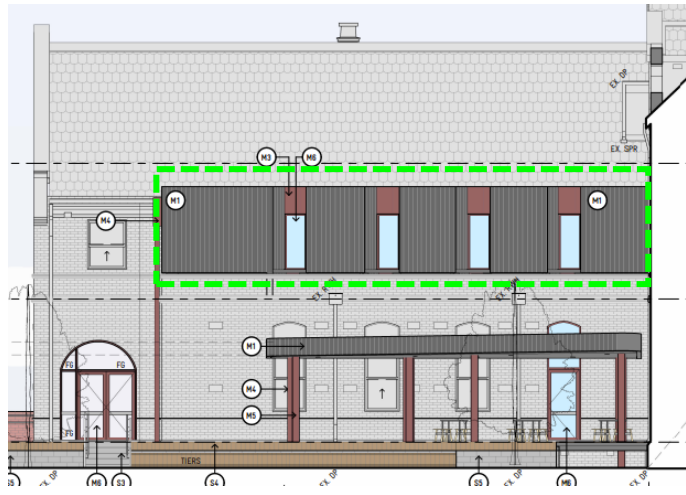
Figure 37: Extract of TP22 P2, showing the south façade of the North Wing first level extension. Source: Y2 Architecture, 2023.

At the first level, a one-storey volume is to be built on top of the existing Outdoor area (CO 211), it will be a Breakout space for the adjacent classrooms. Externally, it has Colorbond 'Woodland Grey' profiled longline metal sheet cladding, burgundy glazing frames, and a sheet metal flat roof. From the south façade, the window openings are aligned with the existing windows on the ground level and are directed to provide views to the courtyard. Three evenly-spaced, circular skylights are located in the roof (Figure 36 and Figure 37). Internally, existing openings in the north wall are partially infilled to create arched doorways.

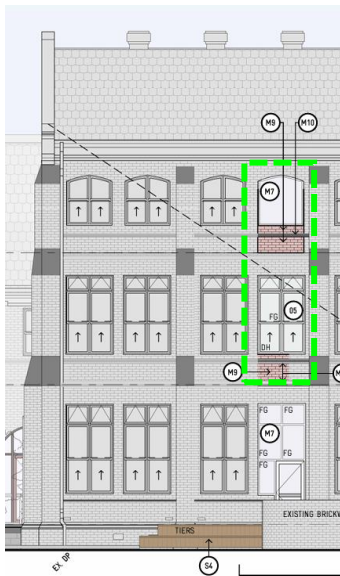
Figure 38: Extract of TP23 P2 1, showing alterations to the windows and walls on the first and second levels. Source: Y2 Architecture, 2023.

At the south façade, altered windows and glazed doors associated with the external fire escape are to be modified (Figure 38). On the first level, an existing window is recovered from a demolished window from the north façade first level, as discussed in Section 4.1.5. A wall cavity is to be infilled with bricks recovered from demolition. Rendered moulding is also to be reinstated, with render composition and profile to match existing. On the second level, a new white aluminium framed window is to be installed. Similar to the first level, the wall cavity below is to be infilled with bricks recovered from demolition and rendered moulding reinstated.

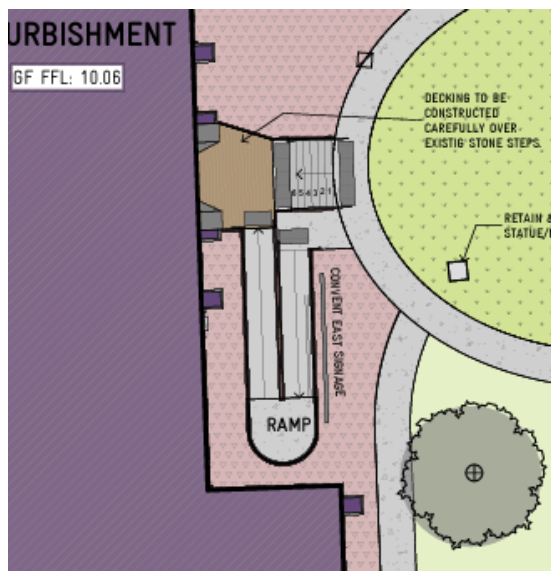
Figure 39: Extract of TP06 P2, showing the proposed plan of the new ramp, stair, and timber landing deck that connect to the Convent building's main entrance at the east façade. Source: Y2 Architecture, 2023.

A new accessible ramp and stairs are proposed to connect the Convent's main entrance to the proposed new concrete path in the east landscaping area (Figure 39). Balustrades are to be of burgundy solid metal fins. The ramp and stairs both adjoin a new timber landing deck that connects to the main entrance.

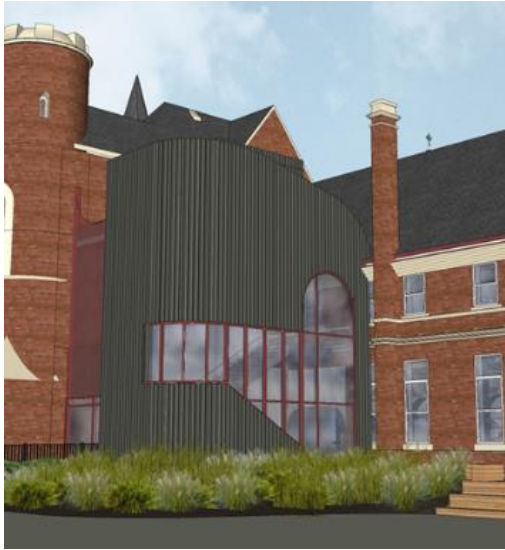
Figure 40: Render view of the North Wing addition from the northwest. Note that the colour of the 'Woodland Grey' cladding closely resembles that of the slate roof, and the burgundy perforated metal screens and glazing frames resemble that of the red brick. Source: Y2 Architecture, 2023.

A new three-storey addition is to be constructed at the north façade, roughly at the same location as the 1970s lift tower (Figure 40). The addition provides separated circulation and access for the new school and DOSCEL, containing a lift, new stairs, an associated lift lobby and storage spaces, and an outdoor plant platform at the roof level. Externally, it is clad in Colorbond 'Woodland Grey' profiled longline metal sheeting and burgundy perforated metal screens. The metal screens conceal the roof-level plant platform. Large areas of glazing are located in the addition's north and west facades, with frames in matching burgundy colour. The new entry is via double swing doors on the north façade.

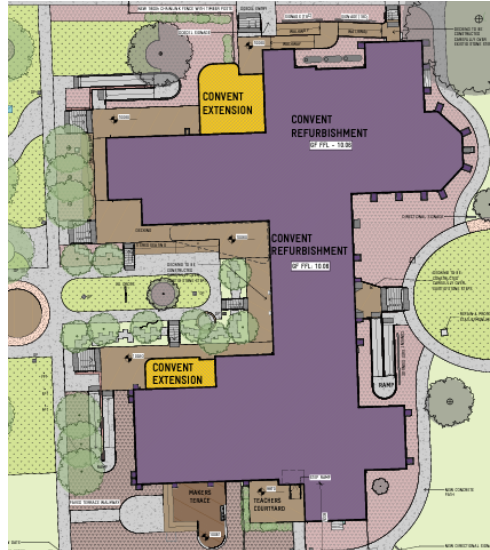
Figure 41: Extract of TP06 P2, proposed site plan. Note that a raised timber deck (indicated in brown) wraps around the North Wing and west courtyard. Source: Y2 Architecture, 2023.

A new raised timber deck is proposed to wrap around the North Wing and courtyard (Figure 41). A porch that abuts the south façade ground floor is to be constructed on top of the deck. It has a thick-profiled, Colorbond 'Woodland Grey' profiled longline sheet metal roof and burgundy-coloured cylindrical columns (Figure 42). To the west of the porch, a new double swing door and glazed panels are to be installed to a new arched opening.

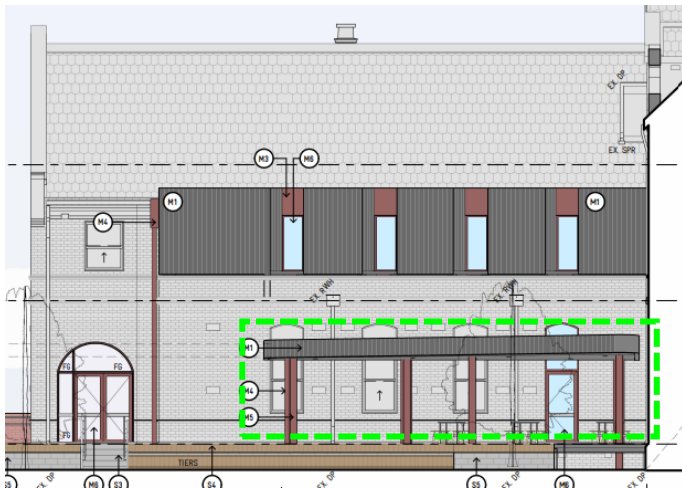
Figure 42: Extract of TP23 P2 2, showing the North Wing porch (indicated in green). Source: Y2 Architecture, 2023.

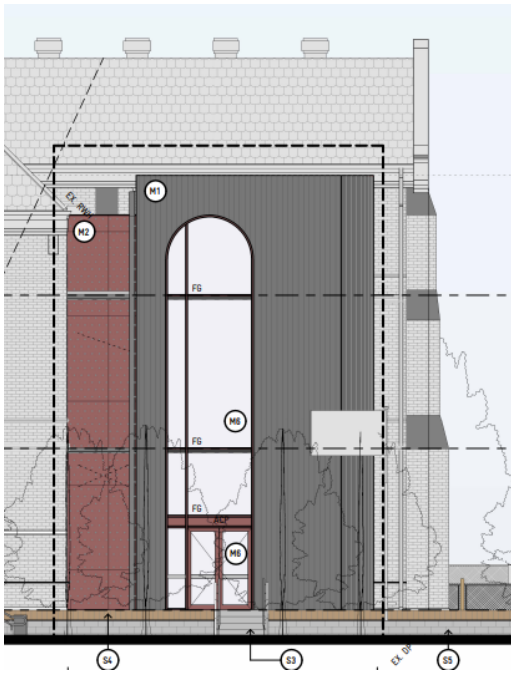
Figure 43: Extract of TP21 P2 2, showing the north façade of the South Wing addition. Source: Y2 Architecture, 2023.

A new three-storey addition is to be constructed at the north façade, providing circulation and access for the new school (Figure 43). Similar to the North Wing addition, it contains a lift, new stairs, an associated lift lobby and storage spaces, and an outdoor plant platform at the roof level. Externally, it is clad in Colorbond 'Woodland Grey' profiled longline metal sheeting and burgundy perforated metal screens. Large areas of glazing are in the addition's north façade, with frames in matching burgundy colour. The new entry is via double swing doors on the north façade.

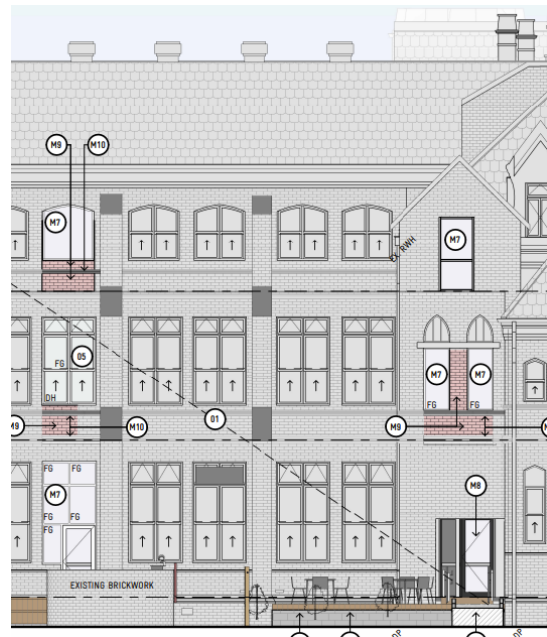
Figure 44: Extract of TP23 P2 1, showing the elevated Learning Terrace and Teachers Terrace. Source: Y2 Architecture, 2023.

At south façade on the ground level, an elevated Learning Terrace and a Teachers Terrace project from the south façade (Figure 44). They are to be constructed with concrete blocks and surrounded by landscaping.

The proposed elevated Learning Terrace and Teachers Terrace are acceptable as they are integral to the functioning of the school building. They are lightweight structures that can be read as separate but complementary to the heritage fabric.

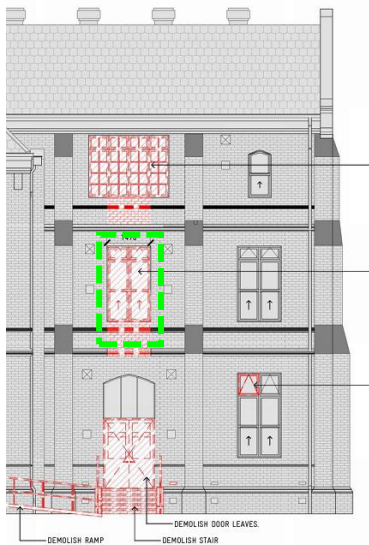
Figure 49: Extract of TP16 P2 E6, showing the window to be relocated (indicated in green). Source: Y2 Architecture, 2023.

material and colour palette, as well as the use of flat roof, are sympathetic to the heritage fabric and do not detract from its cultural heritage significance. It is acknowledged that some windows, doors, and sections of walls are to be removed as a result of this work, they are necessary to support the functioning of the addition and have been minimised as far as possible. Contrastingly, the relocation and reuse of a window from the first level of the north façade to that of the south façade is generally a good heritage outcome as it makes use of redundant materials removed from the heritage fabric (Figure 49 and Figure 50).

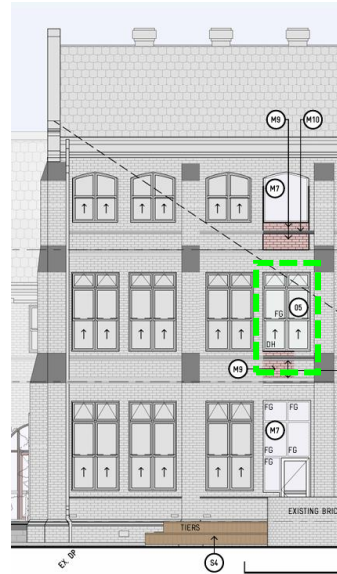
Figure 50: Extract of TP23 P2 1, showing the relocated window (indicated in green). Source: Y2 Architecture, 2023.
