Final Report

Fire Impact Assessment for the Meadow Creek Solar Farm: 1033 Oxley-Meadow Creek Road, Meadow Creek, Victoria

Urbis Pty Ltd

June 2024

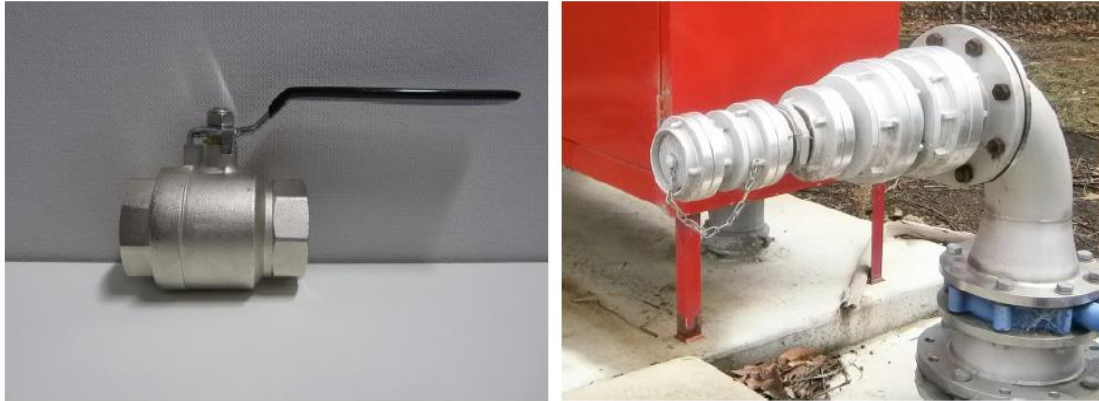
Figure 1 The 150mm full bore isolation valve (shown on the left) and the 125mm x 90mm, 75mm and 65mm Storz tree adapters (shown on the right)

- The hard-suction point shall be provided, with a 150mm full bore isolation valve (Figure 1) equipped with a Storz connection, sized to comply with the required suction hydraulic performance. Adapters that may be required to match the connection are 125mm, 100mm, 90mm, 75mm, 65mm Storz tree adapters (Figure 4) with a matching blank end cap to be provided.
