Cranbourne West Battery Energy Storage System (BESS), Evans Road, Cranbourne West 3977 – Fire Management Plan (FMP)

Fire Management Plan

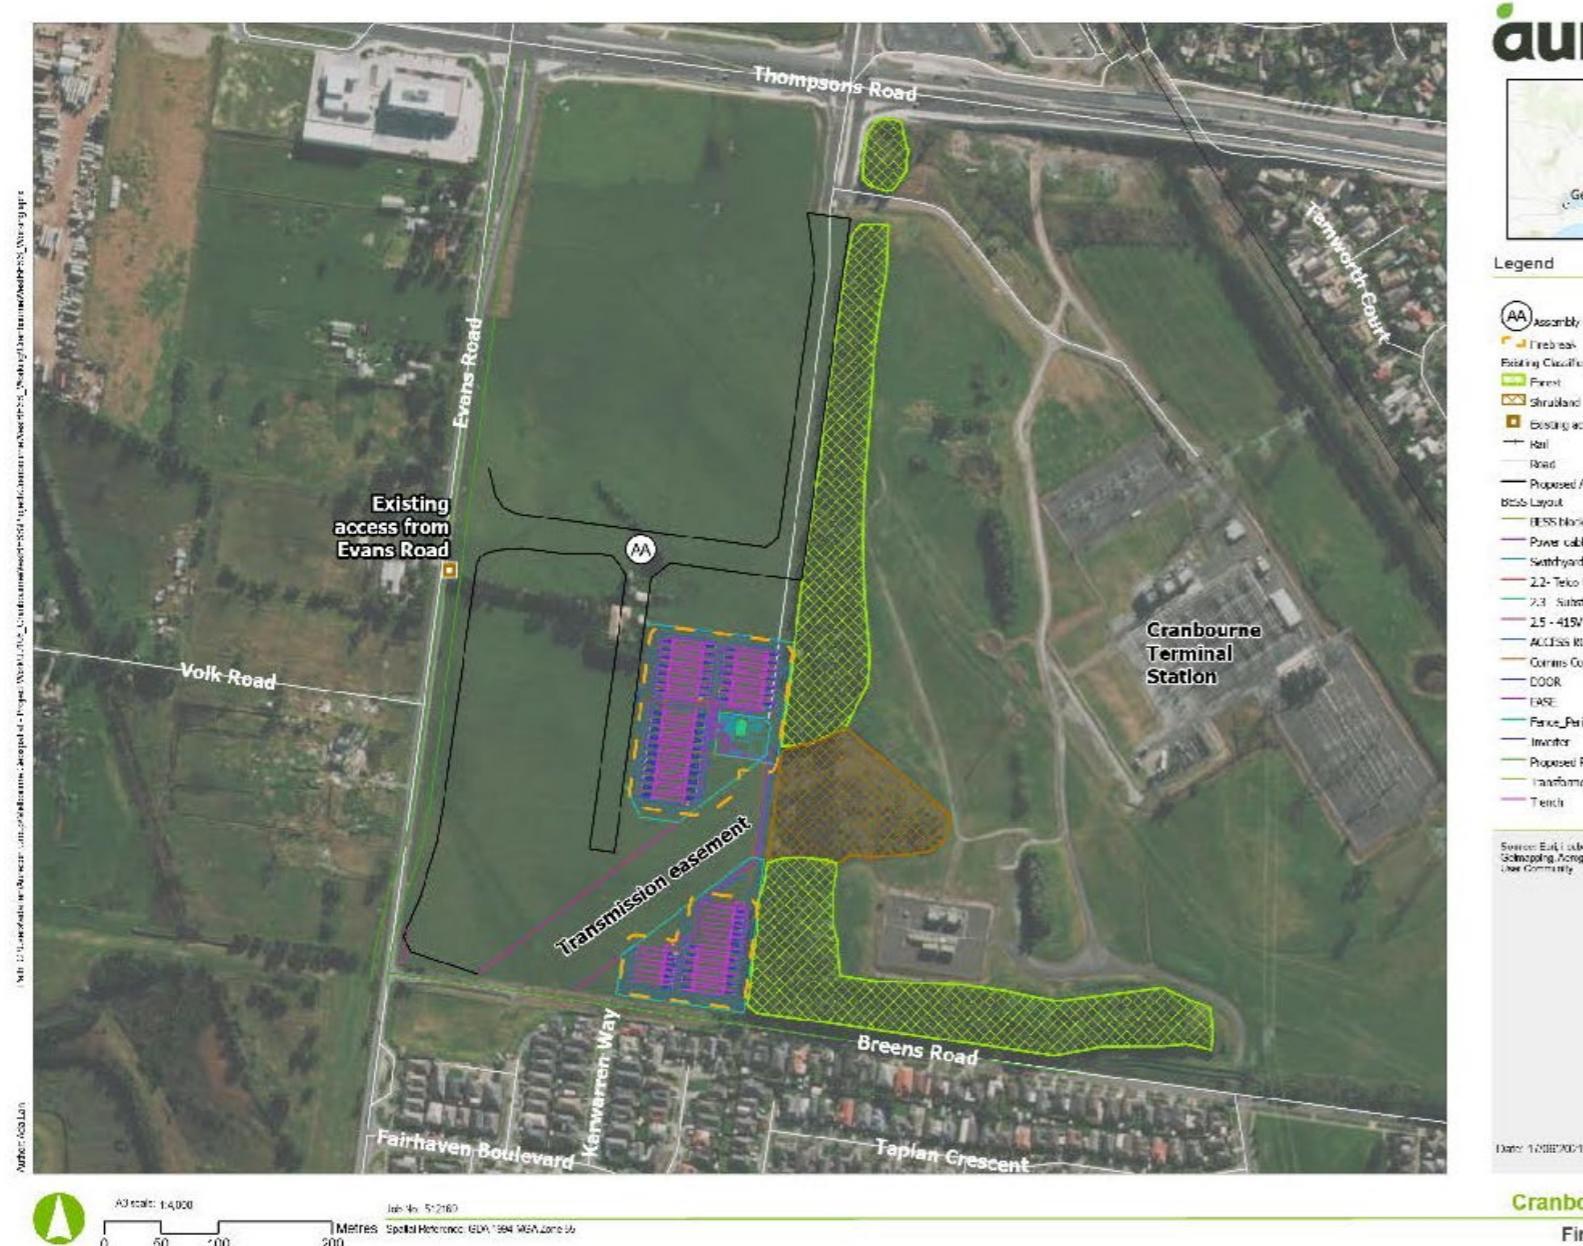
(AA) Assambly area - Trebreak Existing Classified Vegetation Erest Shrubland E Basting access Read - Proposed Acces BESS Layout EESS block - Power cables Setteryard - 2.2- Teko Racks 2.3 Substation Gost - ACCESS ROADWA - Corrans Concuit - DOOR - Fence_Perimeter

The BESS facility site supervisor is responsible for providing a briefing to the responding authorities on arrival The designated assembly area (shown as AA) is at the intersection of the court bowl and Rangebank Drive.

- A fire break area of at least ten (10) metres width as shown in this FMP must be maintained around the perimeter of the BESS facility (including around all containers and infrastructure). The fire break must comprise either mineral earth or non-combustible mulch such as crushed rock, and be free of vegetation and

A four-metre-wide perimeter road must be provided within the 10m perimeter firebreak to provide access to emergency response vehicles. Roads must be of all-weather construction and capable of accommodating a vehicle of 15 tonnes. Passing bays must be incorporated at least every 600 metres, and be at least 20 metres long with a minimum trafficable width of 6 metres. Where roads are less than 600 metres long, at least one passing bay must be incorporated.

Previous bushfires have occurred in the region, including two small grassfires, one of which occurred 2kms north of the site in 2015, and the other 4kms north east in 2009. The next closest bushfire was 6km north west of the site in 2019. The broader surrounding land use, particularly to the north, east and south currently supports residential development, while the subject site (as well as land to the west of Evans Road) is earmarked in the Cranbourne West Precinct Structure Plan (PSP) for future development as a Business Park. As such, bushfire hazards in the area are limited. The main bushfire hazard in proximity to the subject site is the linear strip of planted vegetation adjacent to the eastern boundary. This area has been classified as follows:
