# **APPENDIX J** GEOTECHNICAL DESKTOP STUDY

#### EnergyConnect (Victorian Section) - Geotechnical Desktop Study

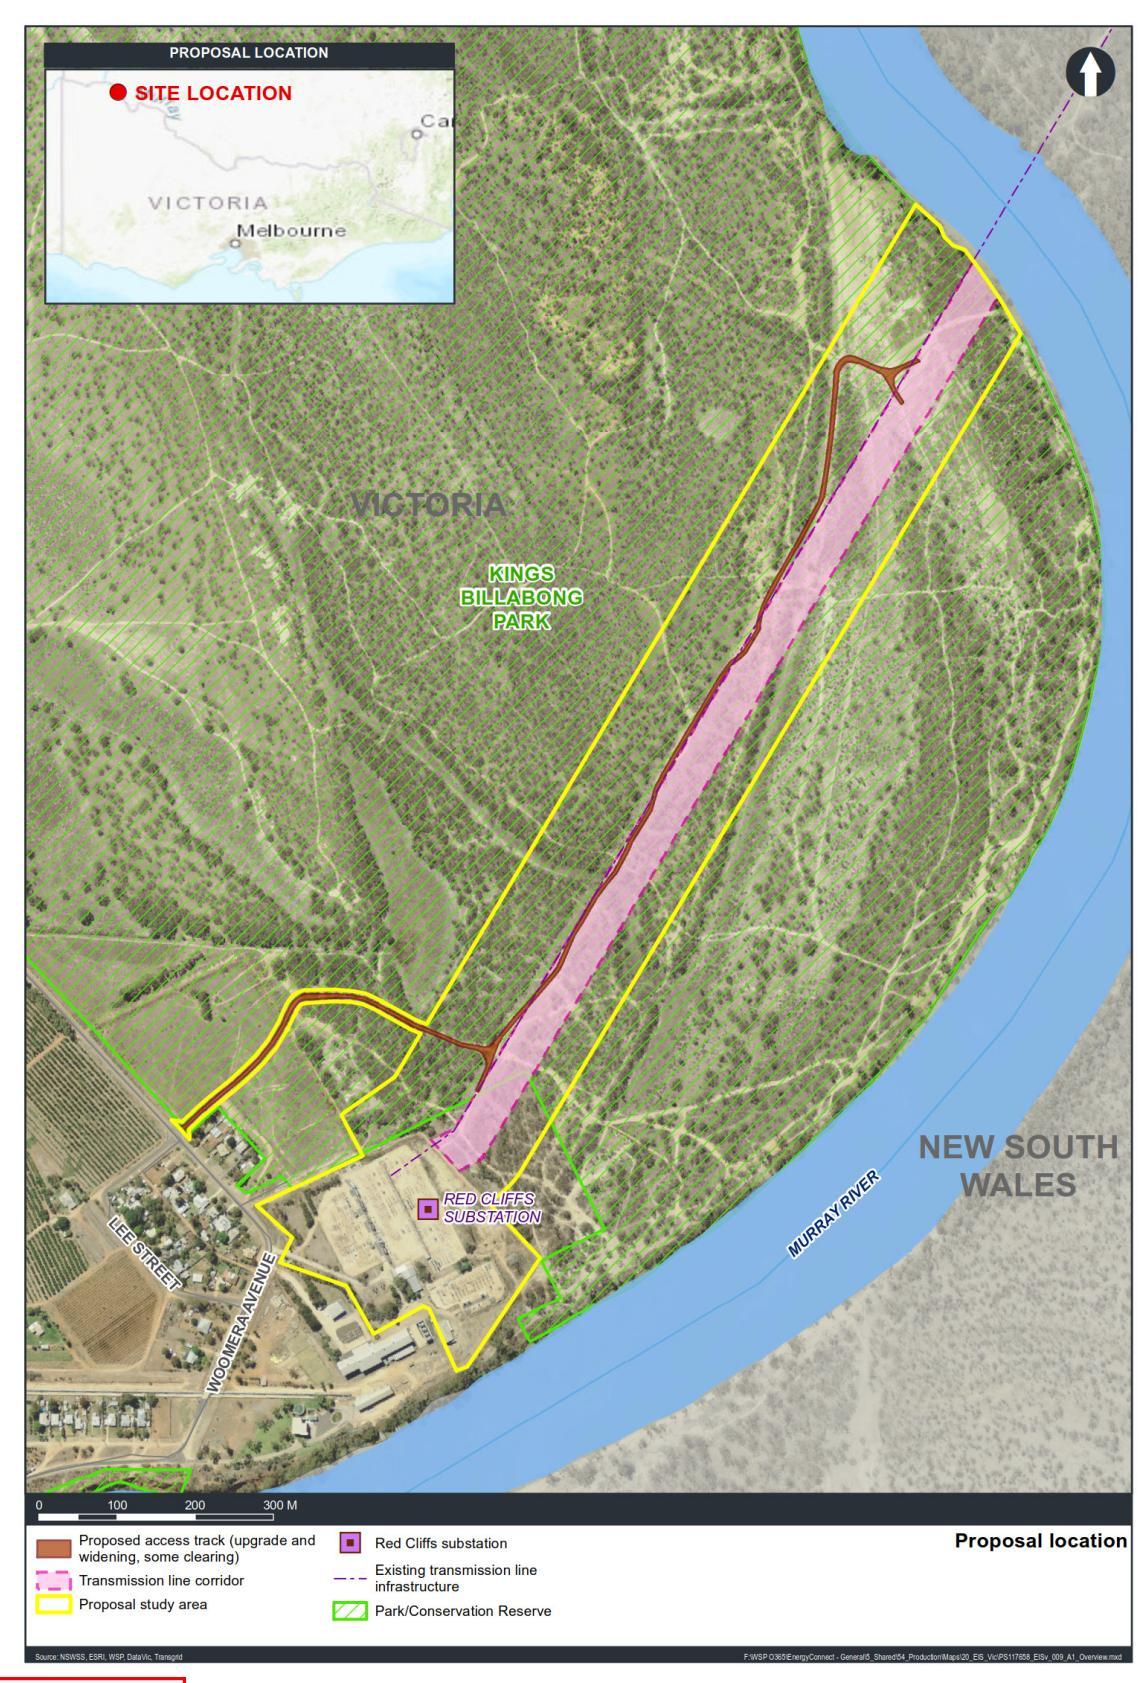
Red Cliffs Main Pumping Station and Red Cliffs substation are in the south west corner of the site. The remainder of the site area falls within the Kings Billabong Park. The aerial image of site area, accessed from <u>maps.au.nearmap.com</u> and site boundary provided, are shown in Figure 1.

#### Figure 1: Study area

- the existing Red Cliffs substation and transmission line structures in the vicinity
- the site is relatively flat
- the Kings Billabong Park is vegetated with trees and shrubs
- site is located on a bend of the Murray River (see Figure 1)
- historical aerial images show the north-east section of site show historic occurrences of inundation (see Figure 2).

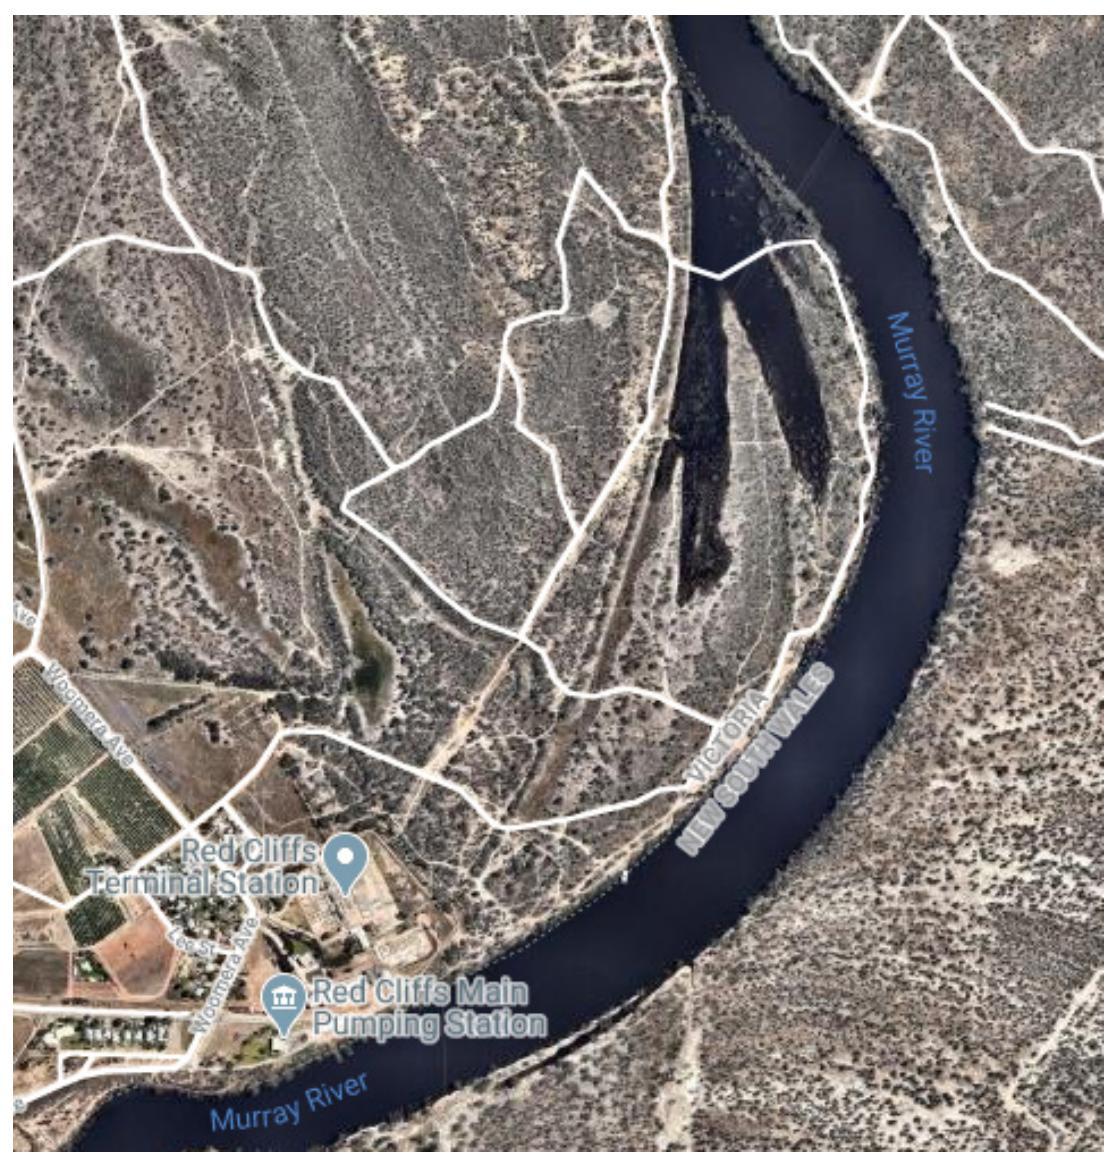
Figure 2: Historical image displaying inundation (Source: Google Earth)

According to the historical imagery, accessed via Google Earth, in Figure 2, it is understood that site has historically been subject to inundation in areas within the vicinity of the Murray River. These factors are indicative of the potential for presence of soft and compressible clay/silty clay layers.
